DEMOLITION ASBESTOS SURVEY
OF
BUILDING 135,
HMS DAEDALUS,
BROOM WAY,
LEE ON SOLENT,
HAMPSHIRE
PO13 9YA
ON BEHALF OF
HOMES & COMMUNITIES AGENCY

SECTION 1 - Executive Summary

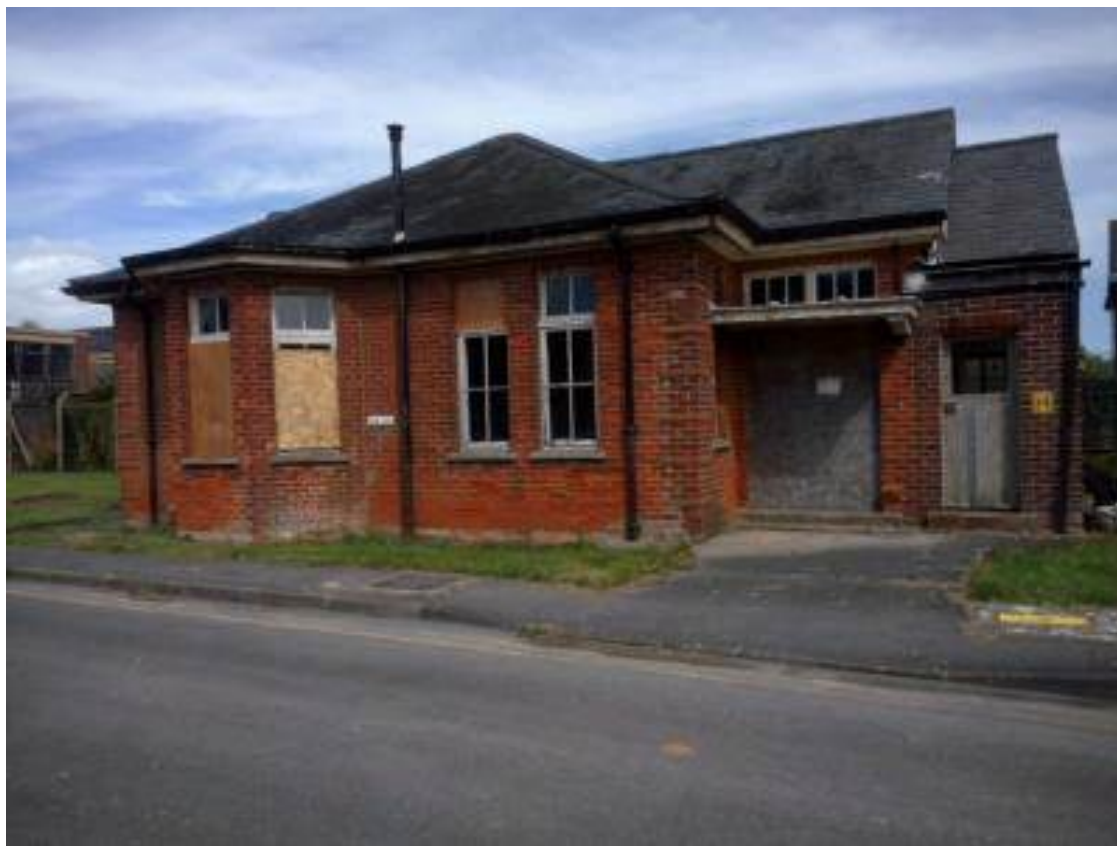
Externally the building is constructed of Brick walls, slate damp proof course to brick walls, cement tiles to pitched roofs, lead covering to flat entrance canopy, lead flashing to roofs, wooden soffit and fascia boards, wooden soffit panel to underside of entrance canopy, wooden window frames, wooden and stone window sills, wooden doors, cast iron and plastic guttering and downpipes, cement guttering and downpipe, metal pipework, MMMF insulation to metal pipework.

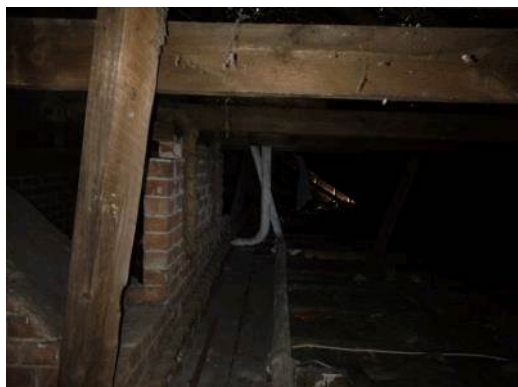
Sample 16: Building 135. Roof Void. Roof void. Insulation within white woven cloth to pipe running between small header tank dropping into room below

Sample 16	Building 135. Roof Void. R.01 Roof void, Insulation within white woven cloth to pipe running between small header tank dropping into room below	Lagging	Removal of licensed ACMs (Remove (licensed))
Sample 17	Building 135. Roof Void. R.01 Roof void, Insulation within white woven cloth to pipe running between large tanks	Lagging	Removal of licensed ACMs (Remove (licensed))
Sample 18	Building 135. Roof Void. R.01 Roof void, Insulation within white woven insulating pads to sides of small metal header tank	Lagging	Removal of licensed ACMs (Remove (licensed))
Sample 19	Building 135. Roof Void. R.01 Roof void, Insulation within white woven insulating pads to sides of large metal tank	Lagging	Removal of licensed ACMs (Remove (licensed))
Sample 20	Building 135. Roof Void. R.01 Roof void, Dust and debris to floor throughout roof void	Lagging	Removal of licensed ACMs (Remove (licensed))
Sample 21	Building 135. Roof Void. R.01 Roof void, Dust and debris to floor throughout roof void	Lagging	Removal of licensed ACMs (Remove (licensed))

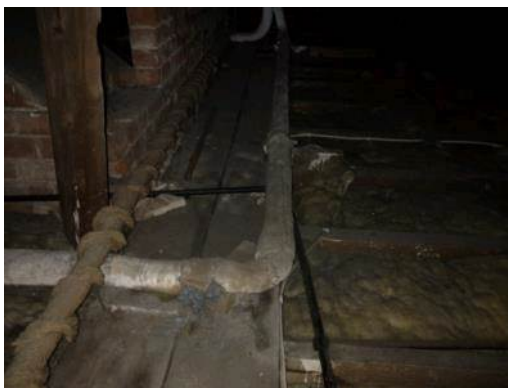
Sample 17: Building 135. Roof Void. Roof void. Insulation within white woven cloth to pipe running between large tanks

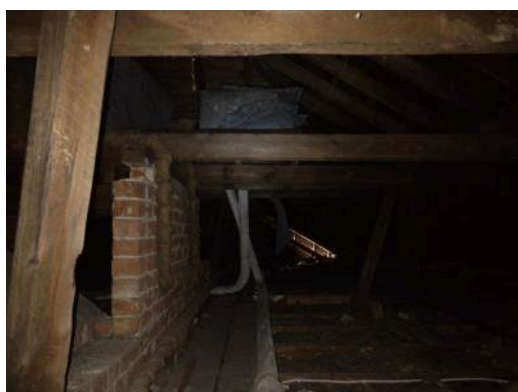
Sample 18: Building 135. Roof Void. Roof void. Insulation within white woven insulating pads to sides of small metal header tank

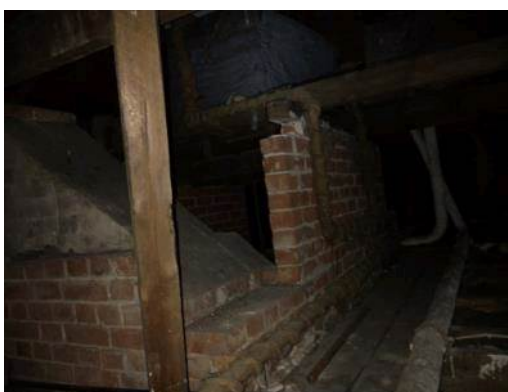
Sample 19: Building 135. Roof Void. Roof void. Insulation within white woven insulating pads to sides of large metal tank

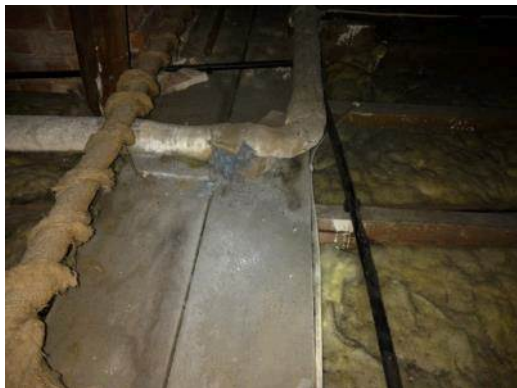
Sample 20: Building 135. Roof Void. Roof void.
Dust and debris to floor throughout roof void

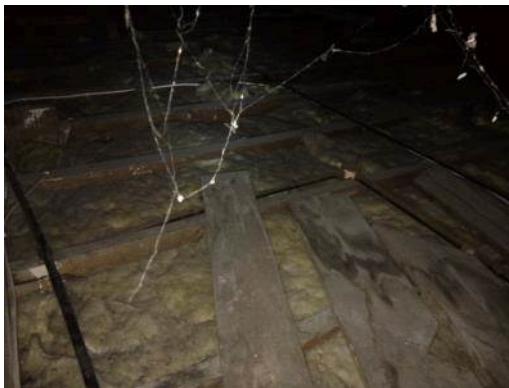
Sample 21: Building 135. Roof Void. Roof void.
Dust and debris to floor throughout roof void

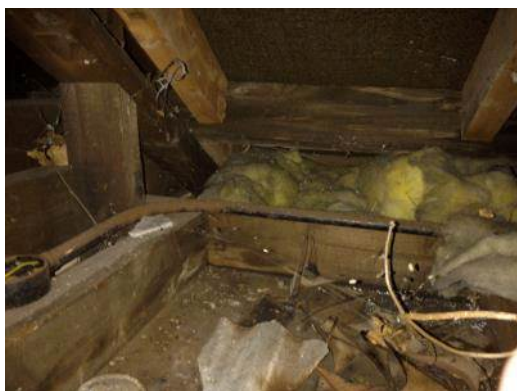
Sample 23: Building 135. Roof Void. Roof void.
Cement debris to floor throughout roof void

Sample 23	Building 135. Roof Void. R.01 Roof void, Cement debris to floor throughout roof void	Cement	Removal of non-licensed ACMs (Remove (non-licensed))

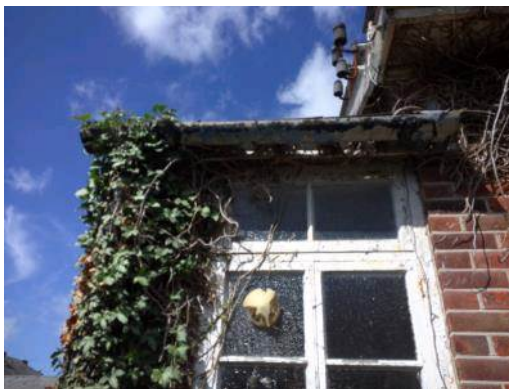
Sample 27: Building 135. External. External.
Cement guttering and downpipe adjacent to room 002

Sample 27	Building 135. External. E.01 External, Cement guttering and downpipe adjacent to room 002	Cement	Removal of non-licensed ACMs (Remove (non-licensed))
Sample 28	Building 135. External. E.01 External, Typical gasket to external pipework joints to rear and right hand side of building	Gasket	Removal of non-licensed ACMs (Remove (non-licensed))

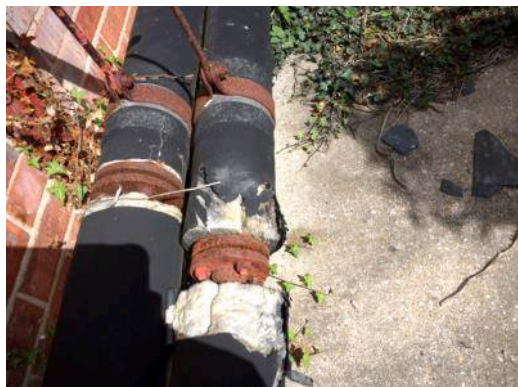
Sample 28: Building 135. External. External.
Typical gasket to external pipework joints to rear
and right hand side of building

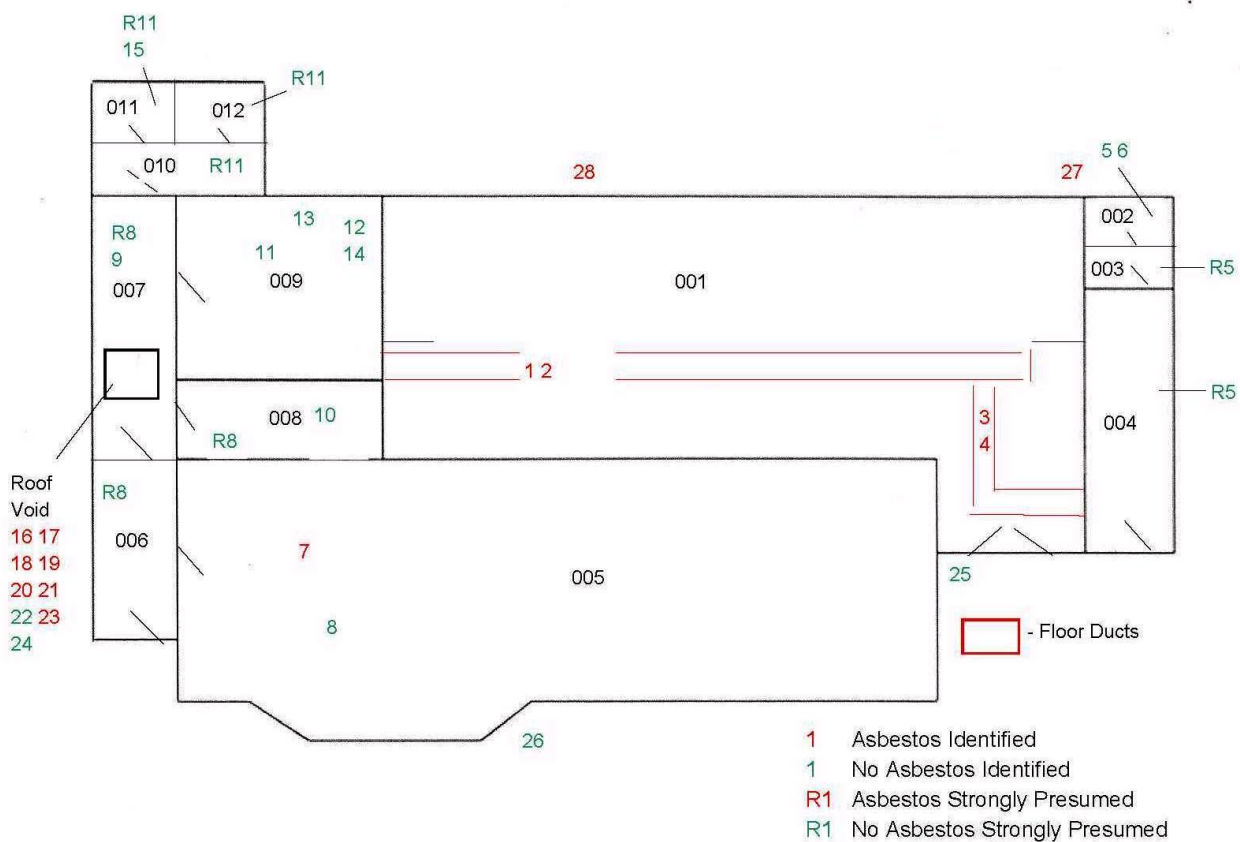
APPENDIX 5 - Marked Plans

Client: Homes & Communities Agency
Site: Building 135
HMS Daedalus
Broom Way
Lee on Solent
Hampshire
PO13 9YA
