APPENDIX E

Option SL3 Supporting Information

7 Self-regulating tidal flaps and gates

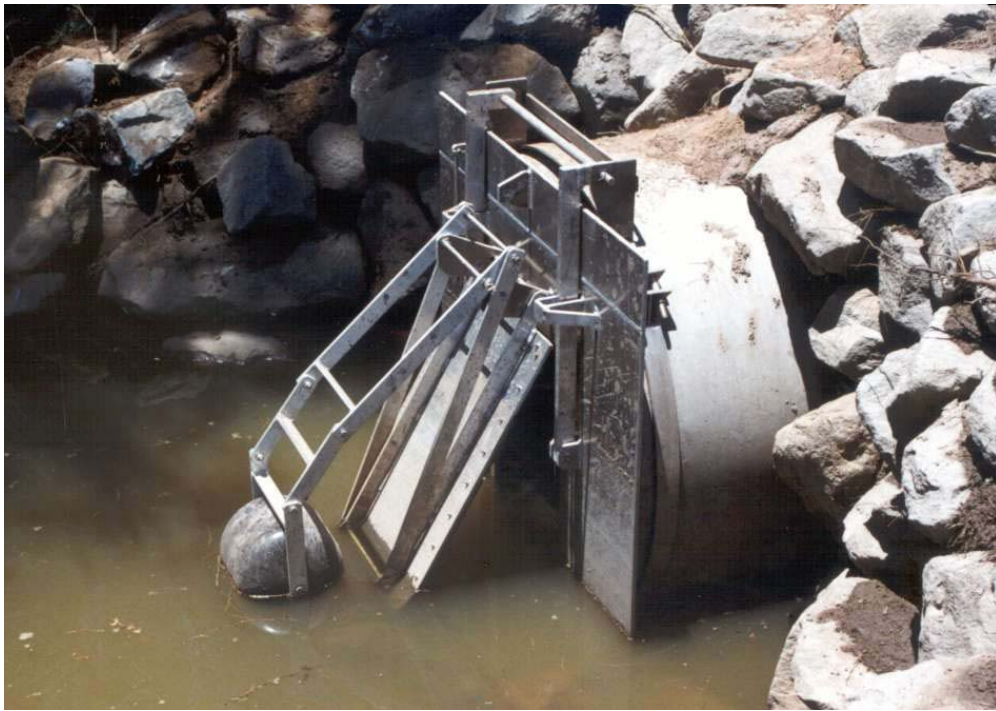
Figure 7.2: Automatic tidal flap in New South Wales, Australia.

Figure 7.2 shows an Australian development of this type (Green and Pease 2007). The gate is held open during the first part of the flood tide by the weight of the float and its associated metalwork. As the tide rises it lifts the float, gradually shutting the flap. On the falling tide the weight of the float opens the flap wider than normal, even at very low seaward flows. You can adjust the water level at which the gate closes by re-arranging the alignment of the float.

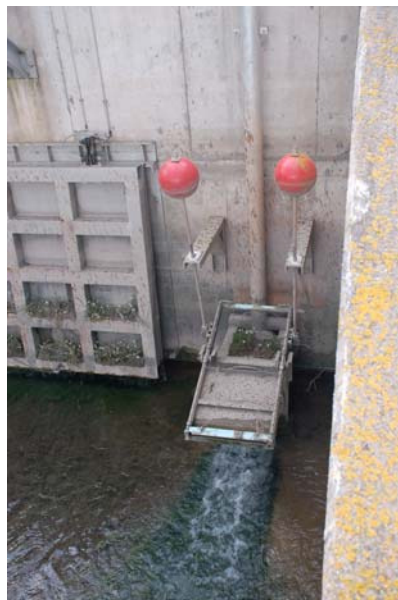
Figure 7.3: Waterman SRT

The Waterman SRT is manufactured by Waterman Industries in the US. Two of these gates have been installed in the UK: one at Goosemoor on the estuary of the Exe; the other at Cone Pill, a small stream draining into the Severn Estuary (Figure 7.3).

The Cone Pill structure was the first of its type to be installed, in 2004. Matthews and Crundwell (2004) describe the installation, operation and lessons learned.

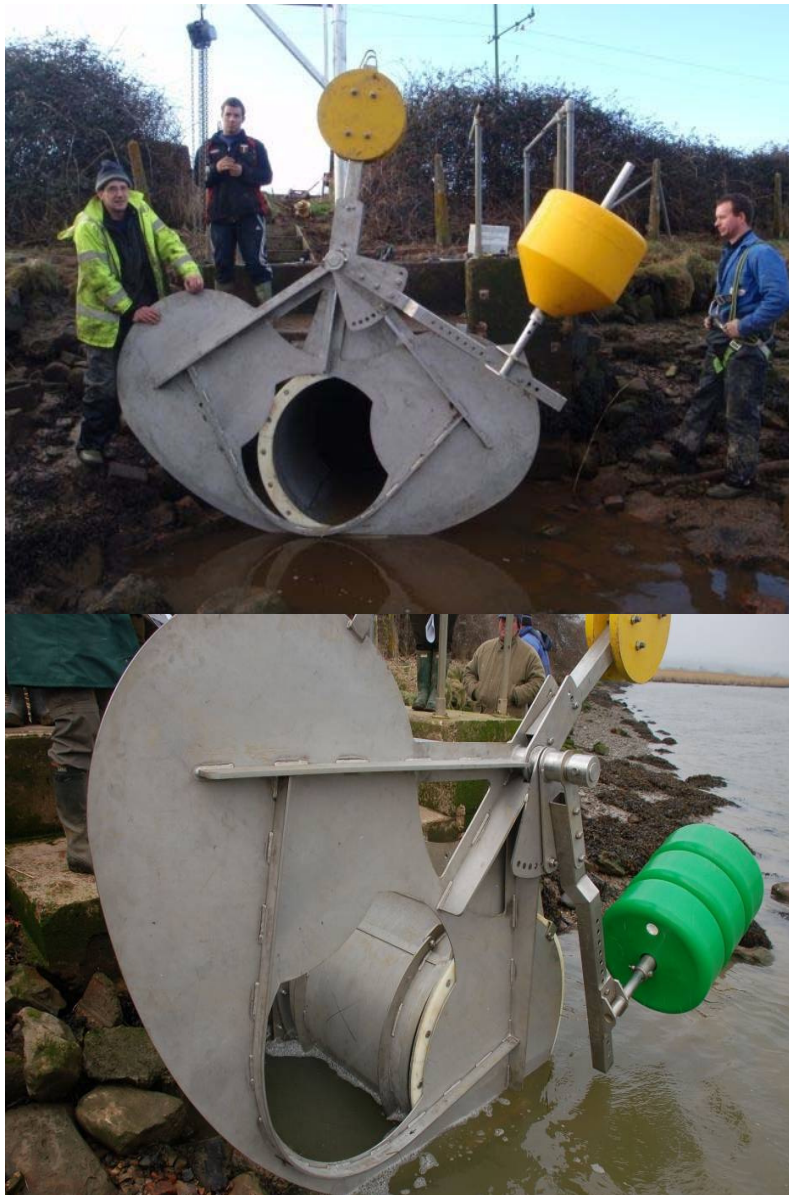
Figure 7.4: Williams SRT during installation on the Axe Estuarv. Devon

The device is fundamentally a steel plate that rotates across the mouth of a circular-section culvert (Figure 7.4). A weighted float rotates the plate. The operating sequence is shown in Figure 7.5.

The prototype was installed on an outfall on the estuary of the River Axe in January 2009, and has so far operated without significant problems.

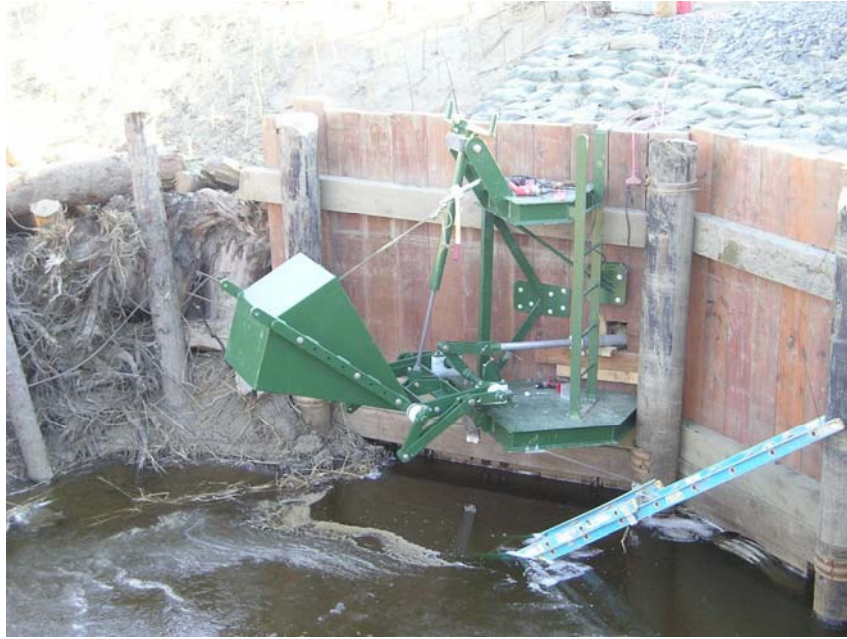
Figure 7.7: Float mechanism for an MTR gate at Schneider Creek, Washington State, US. Photograph courtesy of Tom Slocum, Washington Conservation District's North West Region Engineering Program.

In this interesting example, the gate is controlled by the water level on the landward side of the structure. This is usually the target of regulation. A float on the landward side operates the gate using a series of levers and a rod that projects through the structure (see Figures 7.7 and 7.8).

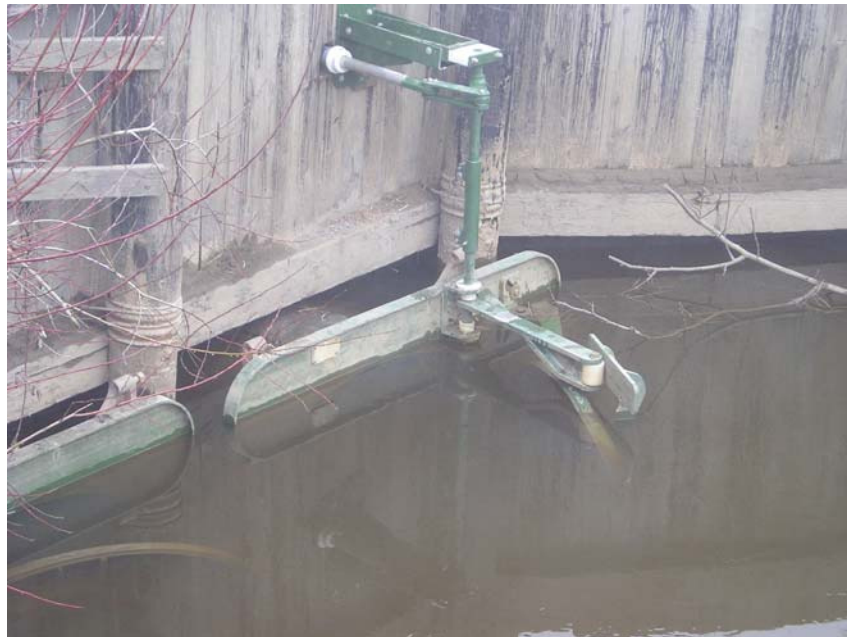
Figure 7.8: Gate actuating mechanism for an MTR gate at Schneider Creek, Washington State, US. The door is being held open. Photograph courtesy of Tom Slocum, Washington Conservation District's North West Region Engineering Program.

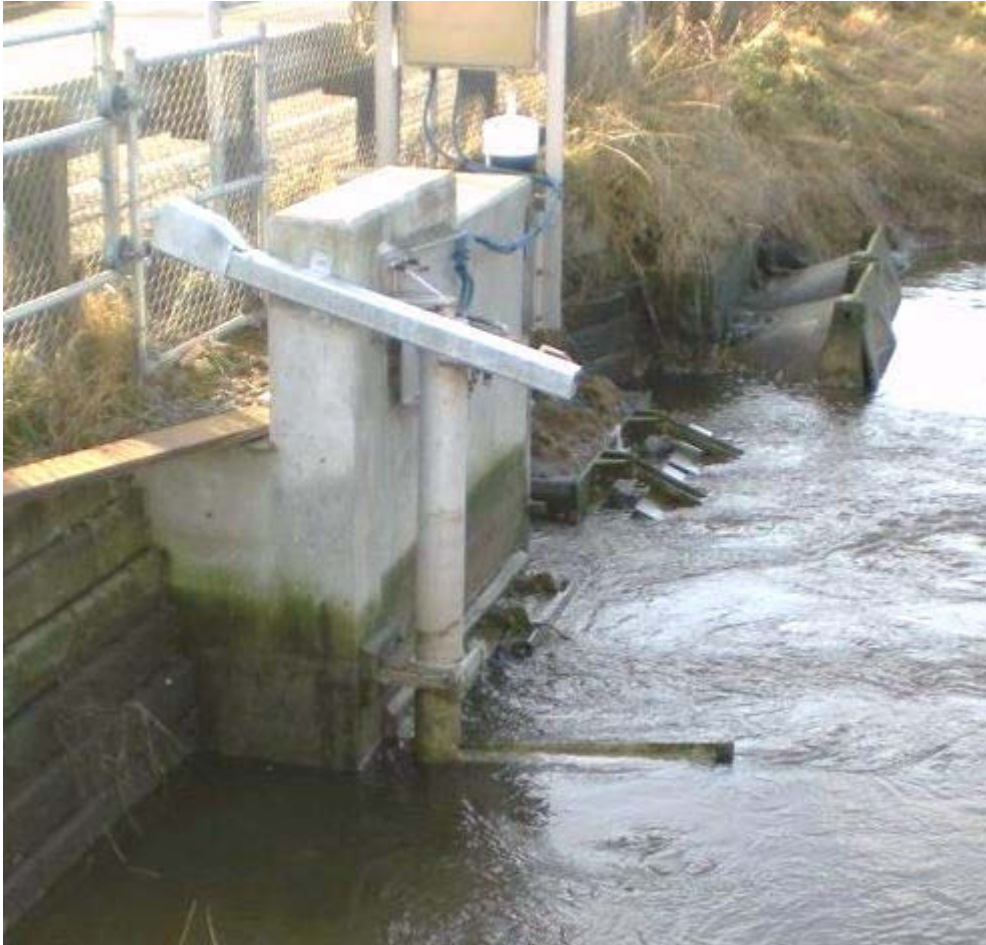
Figure 7.9: Juel Variable Backflow Flap Gate (VBFG™). The gate is fully open, on the ebb tide. Photos reproduced with permission from Juel Tide Gates of Seattle, Washington, US (www.jueltide.com).

This variable backflow flap gate (VBFG™) builds on the principle of the slow-closing flap described in Section 6.2.5. In the original design, the gate was held open by a hydraulic cylinder until the flow of water landwards – and the head acting upon the open gate – exerted enough force to overcome the cylinder. The gate then closed. Current models use a shock-cord rigging arrangement to create the same effect. When the rigging is correctly balanced, the tension increases as the gate closes. This prevents the gate from slamming shut. A major advantage of this design is that the gate is either fully open, or is closed. The rigging can be adjusted to effect closing with almost any level of tidal intrusion.

The gate is made from heavy-duty, 316 stainless steel and copolymer. It is designed to require minimal maintenance.
