3.1 Solid Geology

4.1 Introduction

A site visit and a desk study have been undertaken to investigate reasons for the collection of water at the Holmfield portal and detail further investigations required.

HQU/3D – Queensbury Tunnel

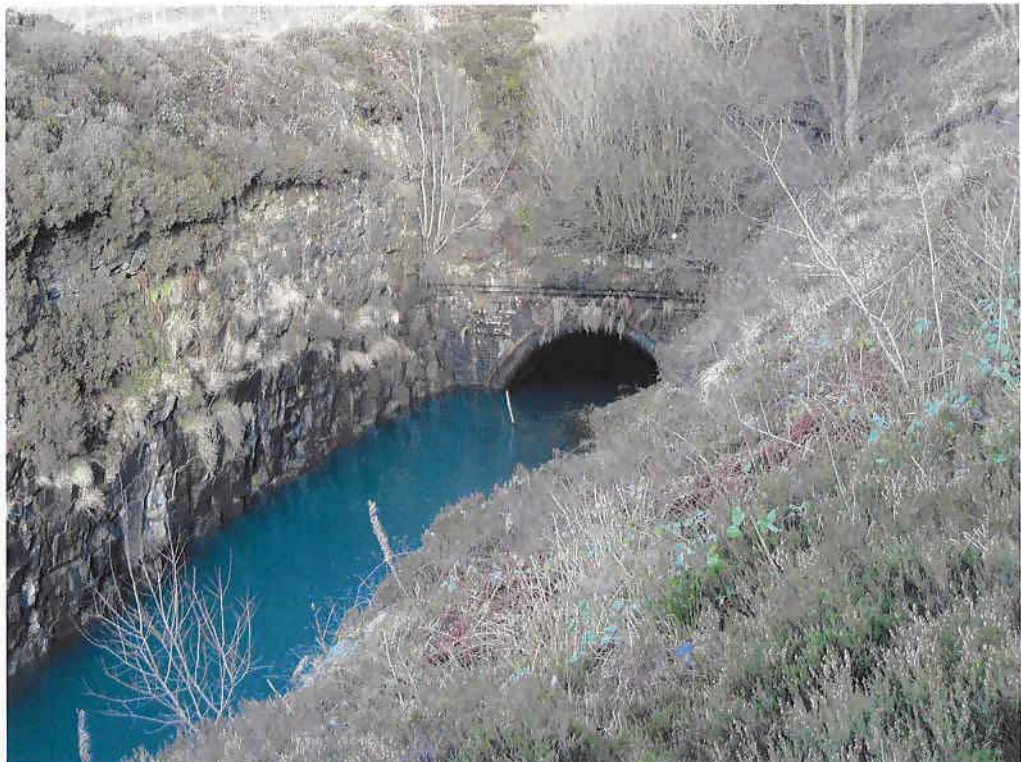
Photograph 2

The void under the aqueduct had been filled, as had the cutting to the south west of this location (Refer to Photographs 2 and 3). This filling has the effect of restricting the flow of water downstream and results in the water below a certain level ponding

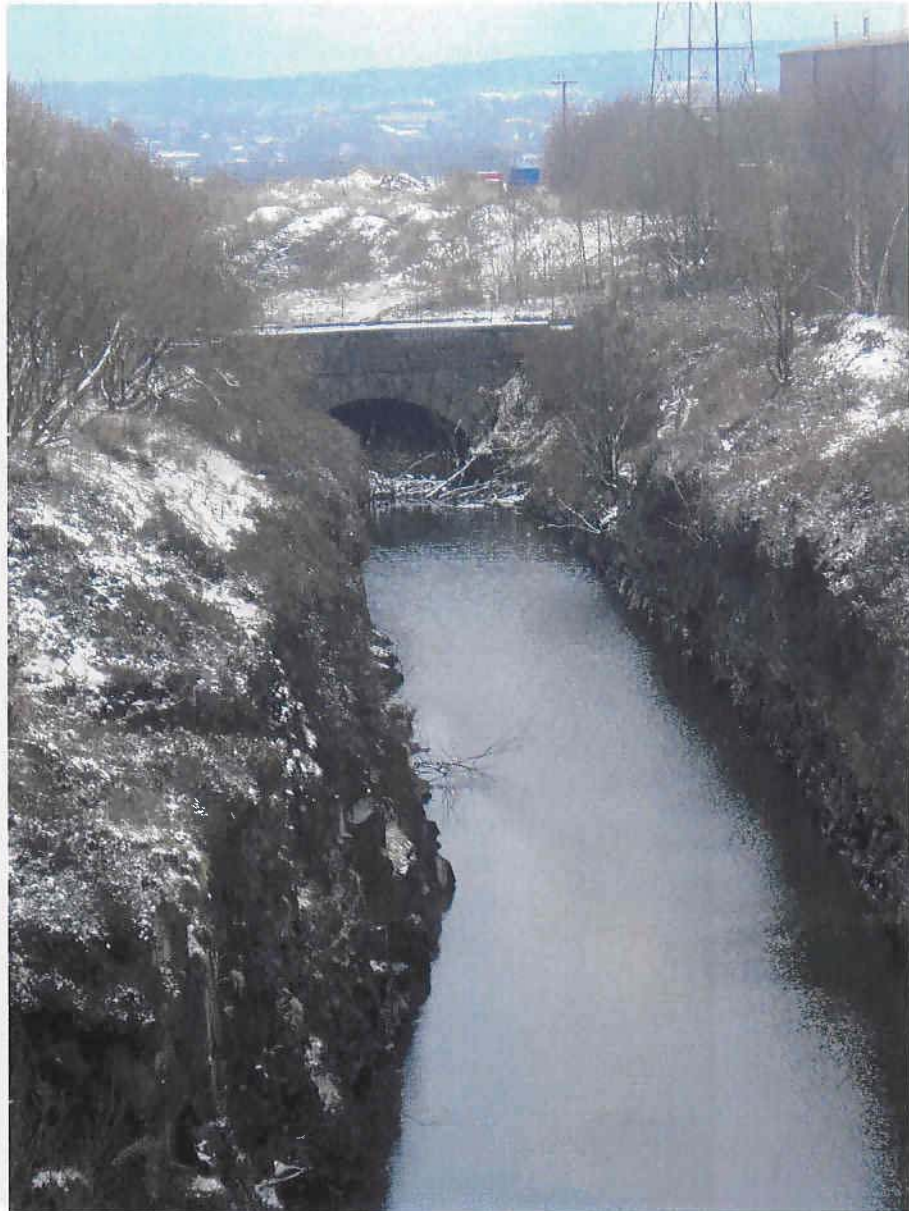
Photograph 5 Strines Beck Aqueduct – Infill material beneath.

The Holmfield (southern) portal was flooded to a depth of approximately 4 metres (Refer to Photograph no. 5). At this location the tunnel opens into a rock cutting approximately 8 metres deep. The invert level of this cutting appears to continue to fall away from the portal. Approximately 150m downstream of the tunnel portal a brick lined aqueduct conveys a watercourse, from north to south, over the cutting, (Refer to Photograph no. 4 and Figure 4.1). A small amount of leakage from the aqueduct to the cutting was observed on its western abutment. The water ingress visible on the western rock cutting immediately outside the tunnel portal suggested that the adjacent groundwater levels were approximately 2 metres higher than the retained water level (Refer to Photographs 6, 7 and 8).

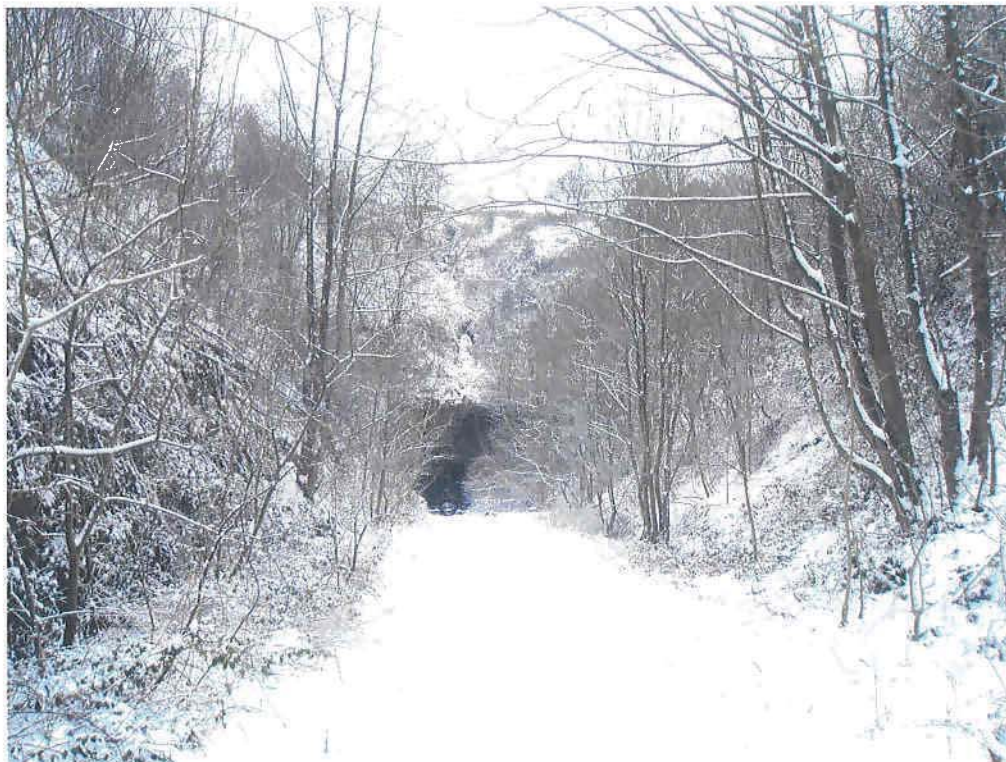
Photograph 9 View of Queensbury (north) Portal. Course of culvert running along right hand side cutting (mid height of slope)

The brick lined culvert between the northern portal and the Hole Bottom Beck serves an important function in diverting flows away from the existing tunnel portal presently. This alignment, connectivity and condition of the culvert needs to be better understood and measures taken to safeguard it's continued future operation.

1. That the connection and condition of the brick lined culvert from the northern portal to the Hole Bottom Beck is examined by CCTV survey.
2. That contact be made with the pre-cast concrete works owner adjacent to the southern portal with a view to preventing their sludge tank overflow discharge contribution to the flooding.
