Central London Cycle Grid within the City of Westminster

Camden Town to Little Venice Quietway

Stage 2 Road Safety Audit

Ref: 2602.02/001/UNC/BOR/2016

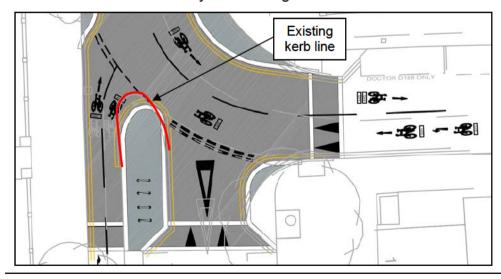
Location: A – Lyons Place junction with Aberdeen Place.

Summary: Tight turn and position of service cover for cyclists turning left from

Lyons Place into Aberdeen Place cycle lane may result in cyclists

losing control and falling from their bicycle.

The proposed route requires cyclists to turn left from Lyons Place onto Aberdeen Place. The angle of the turn is acute at approximately 50 degrees. In addition there is an existing metal service cover in the turning area. The acute turn and service cover could reduce grip and result in cyclists losing control and falling from their bicycle, especially in wet weather conditions.

The proposed design for this junction is shown below and includes a redesign of the existing island which will provide a more comfortable manoeuvre for cyclists turning left from Lyons Place into Aberdeen Place. The proposed design also increases the size of the mouth of the access into the existing bi-directional cycle track which decreases the likelihood of cyclists coming into contact with the service cover.

Adjust the alignment of the physical island to provide a less acute turn angle and / or provide an infill cover to reduce the risk of a turning cyclist losing control of their bicycle.

In response to the Road Safety Auditor's recommendation, it is proposed to adjust the alignment of the island to provide a less acute turn angle for cyclists.

There are 2 Quietway routes which join at this junction. The design of Aberdeen Place/Lyons Place junction, shown on the drawings issued for RSA, is subject to change as a higher level of intervention is proposed that is being progressed as part of another Quietway route, namely; St John's Wood to Marylebone Quietway.

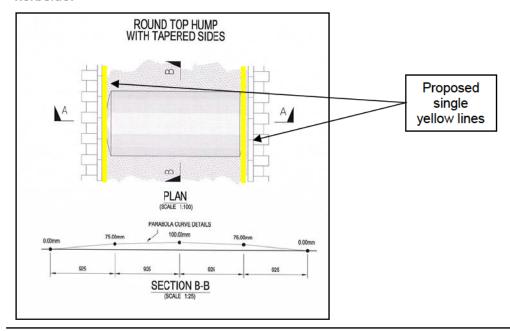
Location: General to Scheme – Blomfield Road speed humps.

It is proposed to replace the existing speed cushions with sinusoidal humps. No standard detail has been provided for the proposed sinusoidal hump, however it is assumed that the road humps will have tapered ends which terminate close to the kerb to allow water to drain around them (no additional drainage provision on Blomfield Road is detailed on the drawings). If this is the case, the yellow line markings proposed along the kerb should be deflected over the hump to guide vehicles away from the taper. It may be beneficial to realign the markings.

A typical standard detail of the type of sinusoidal speed hump which will be used is illustrated below. Please note that this is not an approved Westminster City Council standard detail but illustrates how the waiting restrictions would be installed at the kerbside.

The existing single yellow lines along Blomfield Road follow the kerb edge and will be replaced as existing following the construction of the sinusoidal speed humps.

Westminster standards to be followed for the parking and loading restrictions.

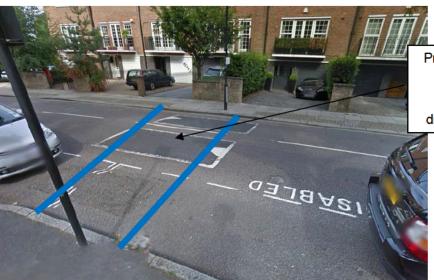
Location: 1 – Blomfield Road (opposite No. 9).

There is an existing disabled parking bay opposite number 9 Blomfield Road. The western side of the bay will be located on a proposed speed hump (it is acknowledged that the bay is currently located adjacent to the speed cushions, however these appear to have little impact on the bay itself). The hump could pose accessibility issues for mobility impaired drivers / passengers, especially those in wheelchairs. It is recommended that the hump is moved further east or west such that the disabled bay is located on a level surface.

The sinusoidal speed humps are to replace the speed cushions in their existing locations. The photograph below illustrates that it is difficult to locate the sinusoidal hump further to the north or south due to its proximity to off-street residential parking and dropped crossover which would pose build ability and functionality issues.

Proposed location of sinusoidal speed hump showing location between dropped crossovers
