GEOTECHNICAL AND GEO-ENVIRONMENTAL ASSESSMENT

**Client: West Somerset and Taunton Deane
Borough Council**

Watchet Harbour East Quay

Report No. 10501
December 2018
Version 1

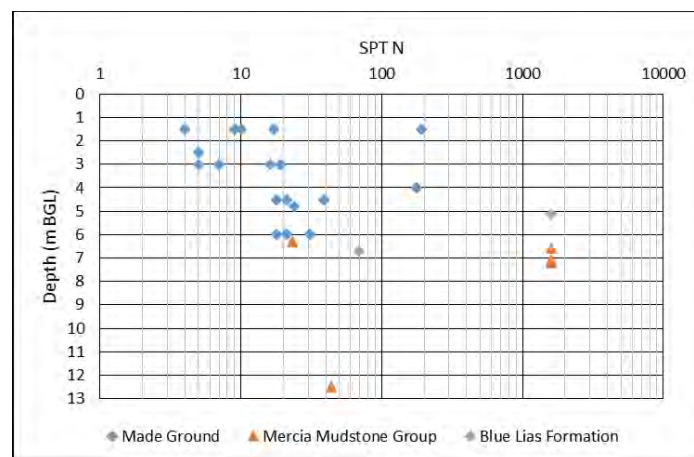
Figure 1: SPT N Vs Depth Plot

Standard Penetration Tests (SPTs) were undertaken at frequent intervals in the dynamic sample sections of the borehole to allow the relative strength / density of near surface soils to be assessed. The SPT N values have been plotted against depth in Figure 1.

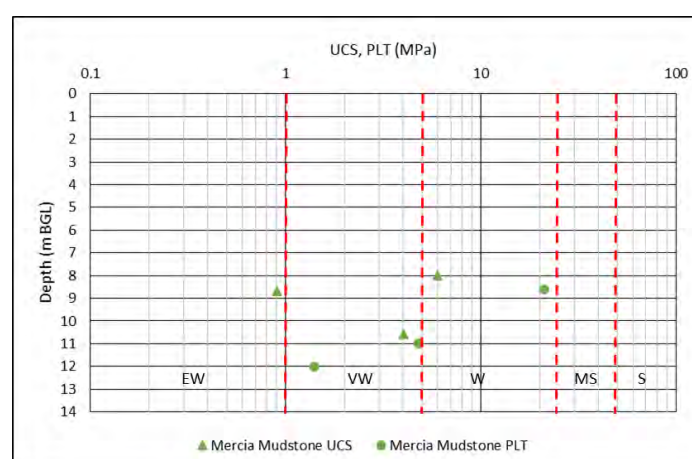
Figure 3: Laboratory Strength Test Results MMG

Laboratory strength tests undertaken on the MMG materials are summarised in Figure 3. The UCS test values (normalised) and UCS values derived from Point Load Tests confirm the range of strengths of the MMG materials with values ranging from 0.9 to 22 MPa.

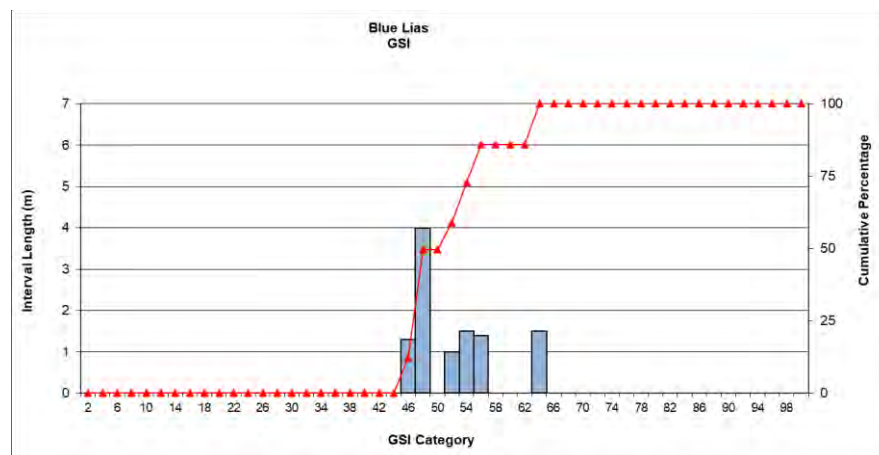
Figure 6: Histogram of GSI intervals for BLF

Geological Strength Index (GSI, Hoek and Marinos 2000) values have been determined for the materials using the logging and laboratory strength data. Figure 6 summarises the GSI values determined for the BLF per metre of core. The average GSI value is 48 with the high value (65) corresponding with the limestone.

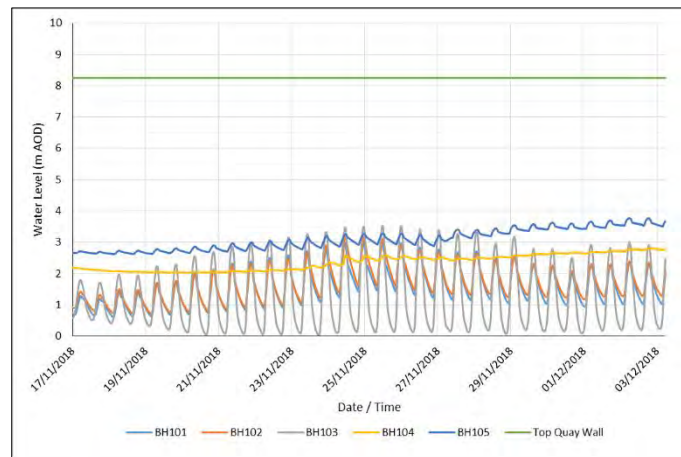
Figure 7: Barometric Logger Groundwater Level Summary

The tidal influence on boreholes 104 and 105 is much less pronounced, possibly due to the rock head levels being higher in BHs 104 and 105.

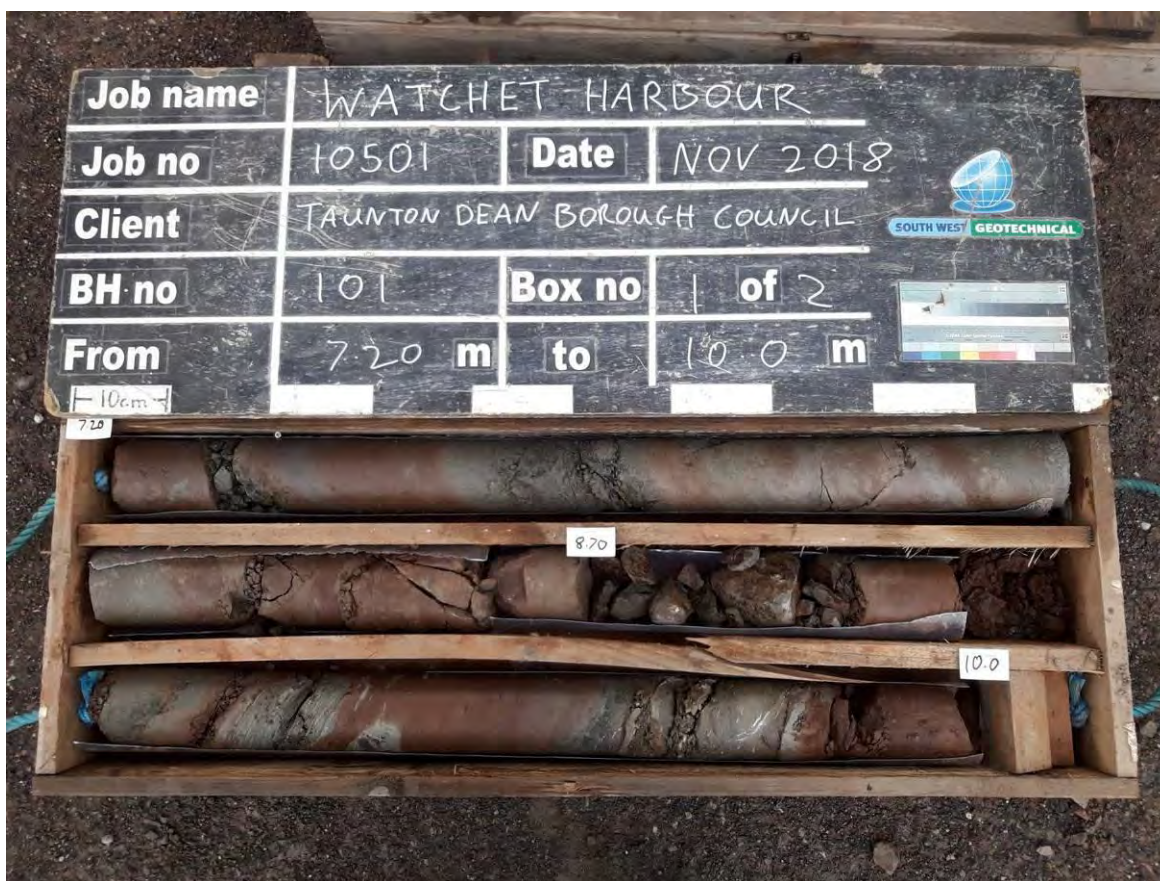
BH101: 7.20 – 10.0m

Weak to medium strong becoming weak below 12.30m, reddy brown, fresh locally slightly weathered, MUDSTONE with occasional fine gypsum veins (MERCIA MUDSTONE GROUP). Fractures are closely to widely spaced (80, 300, 750), undulating rough and smooth, dipping at 25° (J1) and 45° (J2), no infill.	11

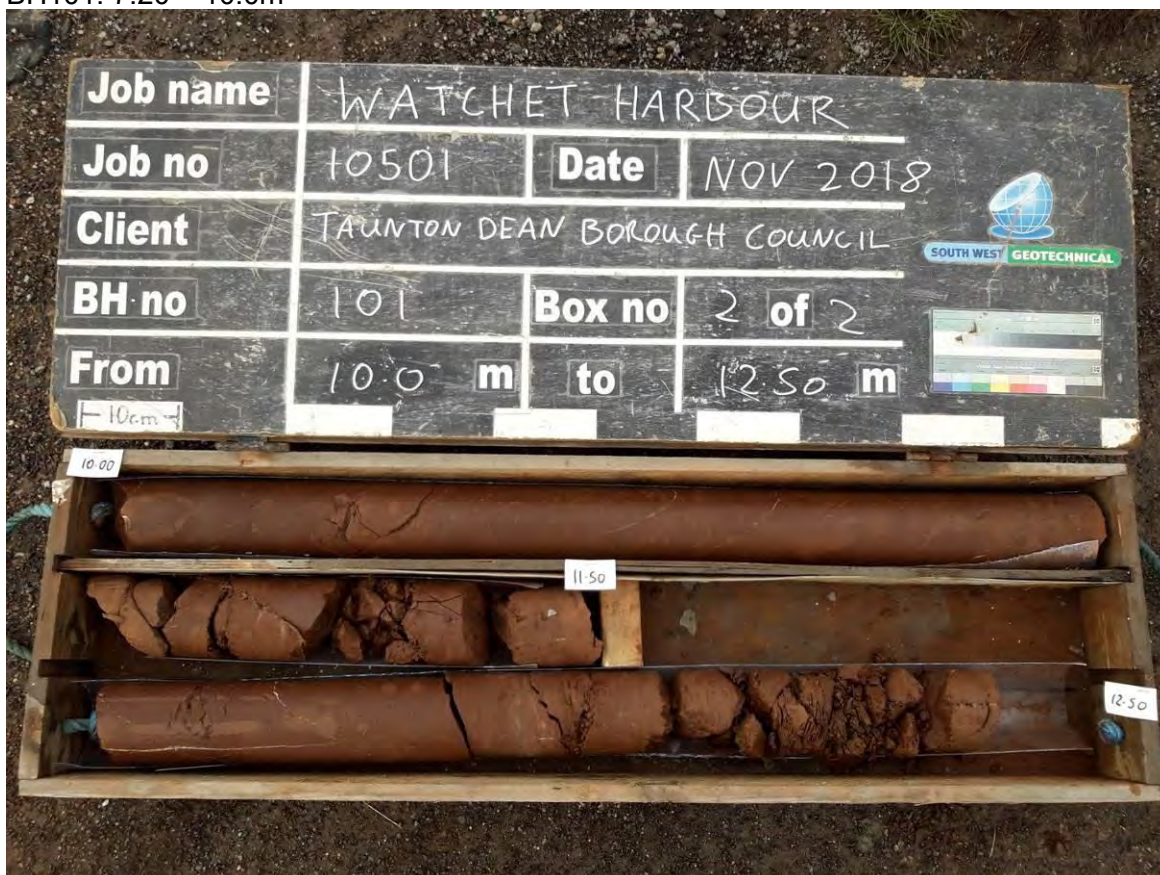
BH101: 10.0 – 12.50m

11.50 - 12.50		80	64	43					12
			13								
										End of Borehole at 12.500m	14
											15
											16
											17
											18
											19
											20
Remarks Location CAT scanned and inspection pit hand excavated to 1.2m prior to drilling. Hole drilled by dynamic sampling to 7.20mbgl, then continued by rotary coring. Monitoring well installed to base of hole.

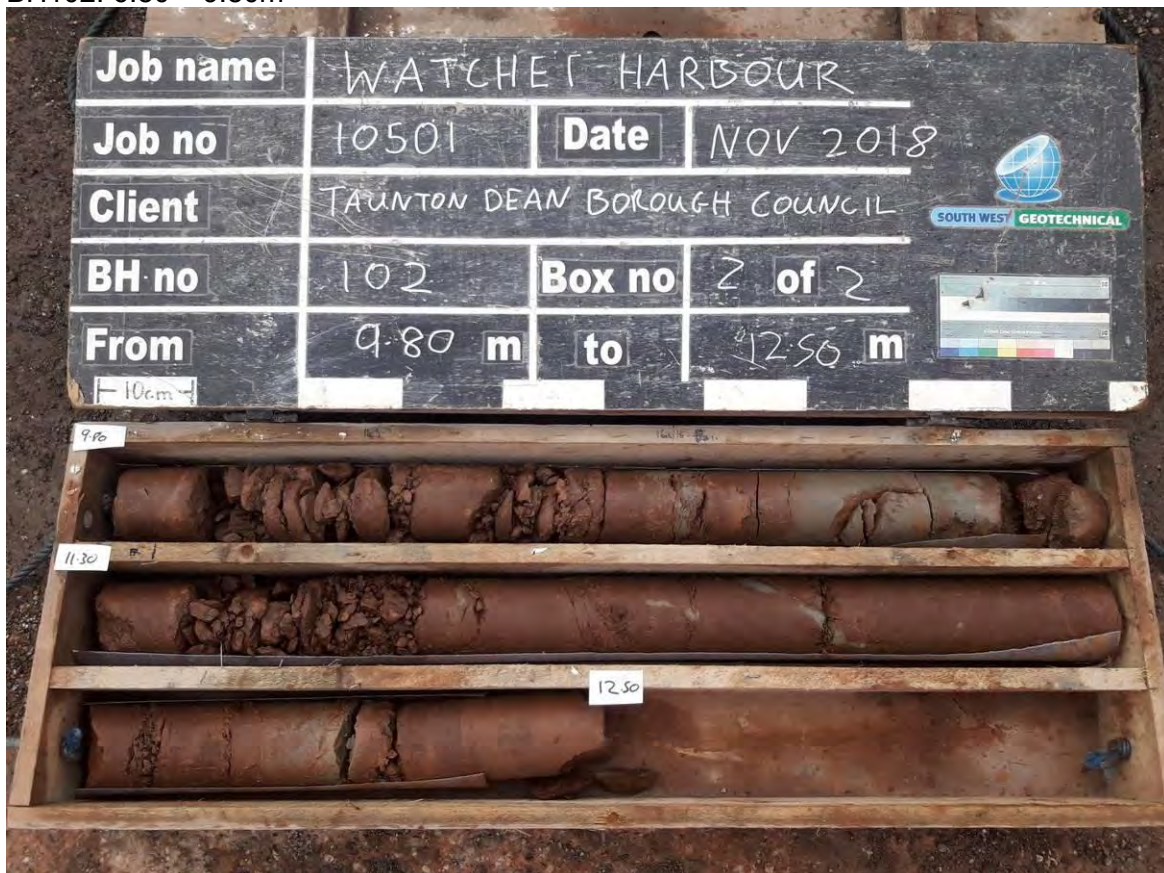
BH102: 9.80 – 12.50m

Weak locally very weak (9.3-9.8m), red brown and locally grey green slightly weathered MUDSTONE. (MERCIA MUDSTONE GROUP). Fractures are closely to medium spaced (80, 300, 520), undulating smooth, dipping at 15-20° (J1) and 50° (J2), rare 2-3mm gypsum infill.	11				
			5												12
			50

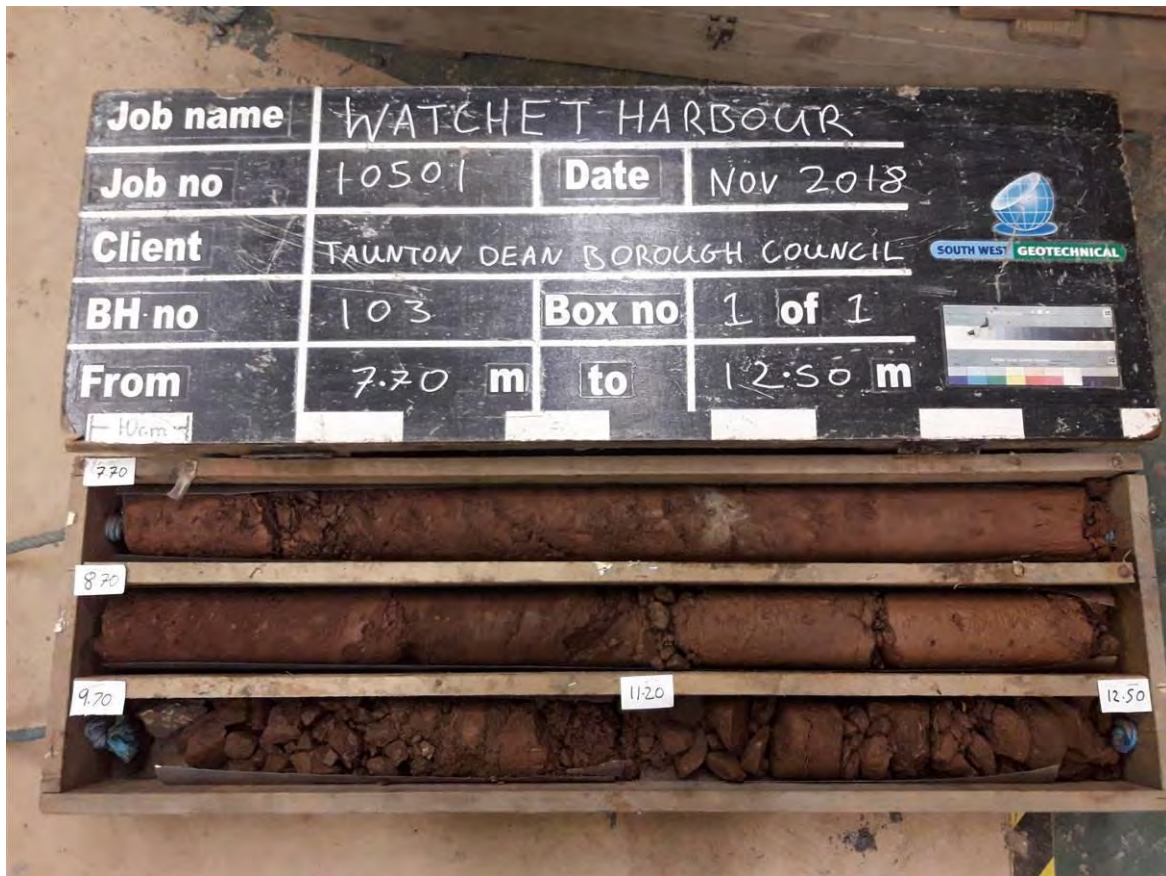
BH103: 7.70 – 12.50m

Extremely weak, locally very weak, red brown slightly weathered, MUDSTONE. Becoming moderately weathered below 9.70m with potential clay bands not recovered reflecting core lose. (MERCIA MUDSTONE GROUP). Fractures are closely to medium spaced (180, 250, 380) undulating smooth, dipping at 20-25° (J1) and 45-50° (J2), no infill. Fracture detail lost below 9.70m.	11

11.20 - 12.50		38	8	0					12
		12.50 - 12.95 N=44 (25 for 80mm/13,15,8,8)									
										End of Borehole at 12.500m	14
											15
											16
											17
											18
											19
											20
Remarks Location CAT scanned and inspection pit hand excavated to 1.2m prior to drilling. Hole drilled by dynamic sampling to 7.70mbgl, then continued by rotary coring. Monitoring well installed to base of hole.

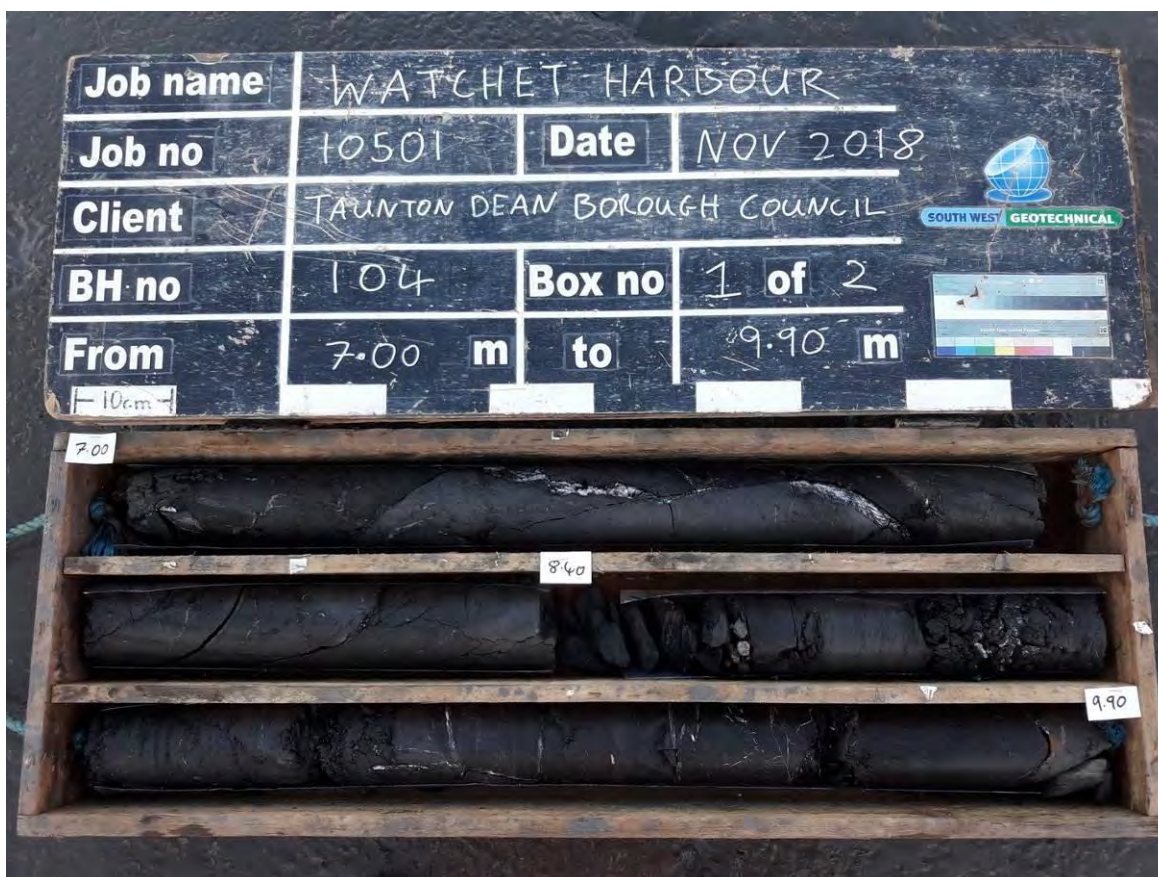
BH104: 7.00 – 9.90m

6.50	1.85			8			
							slightly to moderately weathered calcareous MUDSTONE with occasional 5-10mm thick calcite veins. (BLUE LIAS FORMATION). Fractures are medium spaced (200, 350, 600) undulating smooth, dipping at 30-40°, no infill.	9			
								10			
Remarks Location CAT scanned and inspection pit hand excavated to 1.2m prior to drilling. Hole drilled by dynamic sampling to 7.00mbgl, then continued by rotary coring. Monitoring well installed to base of hole.

Very weak, locally extremely weak and weak, grey slightly to moderately weathered calcareous MUDSTONE with occasional 5-10mm thick calcite veins. (BLUE LIAS FORMATION). Fractures are medium spaced (200, 350, 600) undulating smooth, dipping at 30-40°, no infill. Extremely weak, grey, calcareous MUDSTONE with rare calcite veins. Highly weathered and tending to very stiff clay. (BLUE LIAS FORMATION). No fractures visible

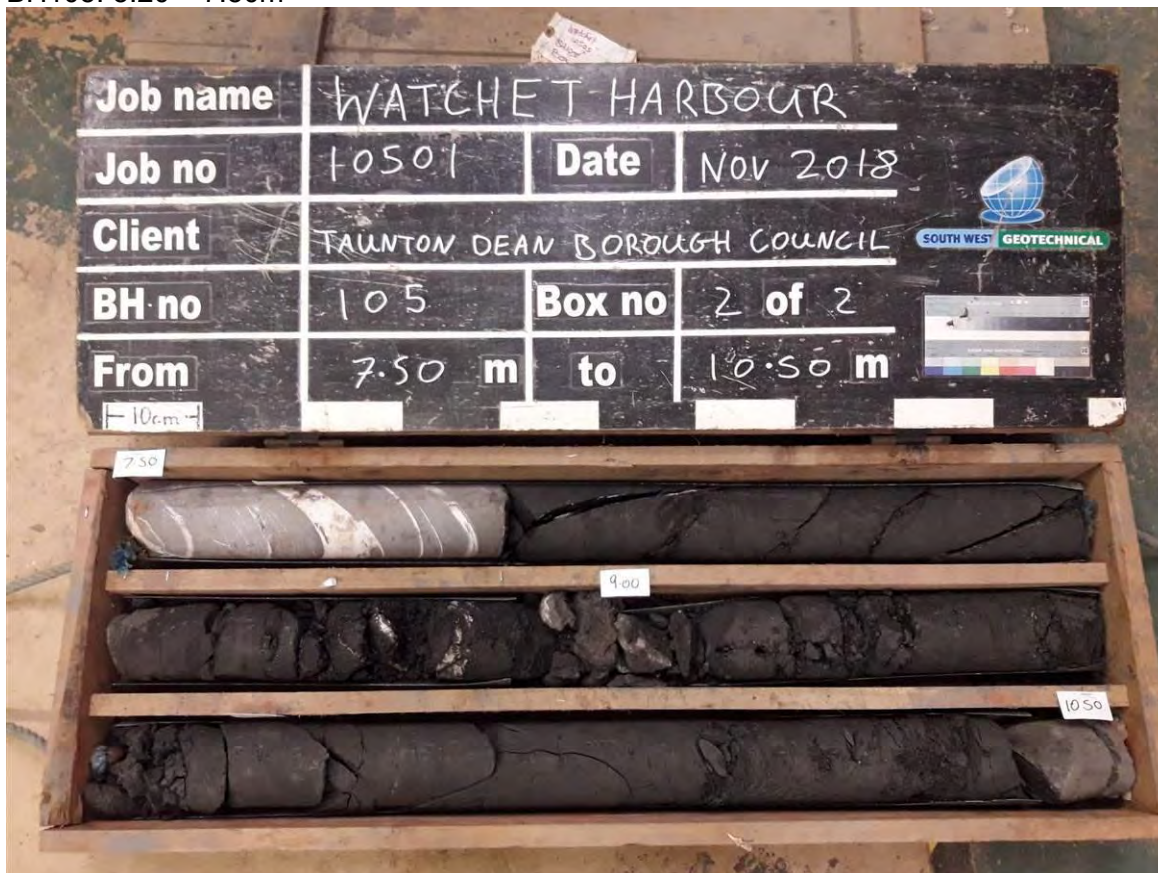
BH105: 7.50 – 10.50m

6.50 - 7.50	5	100	80	80		Fractures are closely to medium spaced (160, 200, 340), planar smooth, dipping at 30-40° (J1) and 65-70° (J2), no infill	7		
	7.50 - 9.00		100	93	65	7.50 1.00 7.90 0.60	Strong, pale, grey, fresh LIMESTONE with 1-30mm thick calcite veins. (BLUE LIAS FORMATION).	8		
		50					No fractures.

9.00 - 10.50	4	100	70	60		Very weak, locally extremely weak, dark grey, moderately locally highly weathered, calcareous MUDSTONE. (BLUE LIAS FORMATION).	9		
							Fractures are closely to medium spaced (120, 300, 400), planar smooth, dipping at 30-40° (J1) and 65-70° (J2), no infill	10
