East of England Ambulance Service NHS Trust

Incident date: 28 January 2016
Date of Final Report: 27 April 2016
Investigating Manager:
Incident Type: Equipment Failure
Incident Level: Level 1 Concise Investigation
Report approved by:

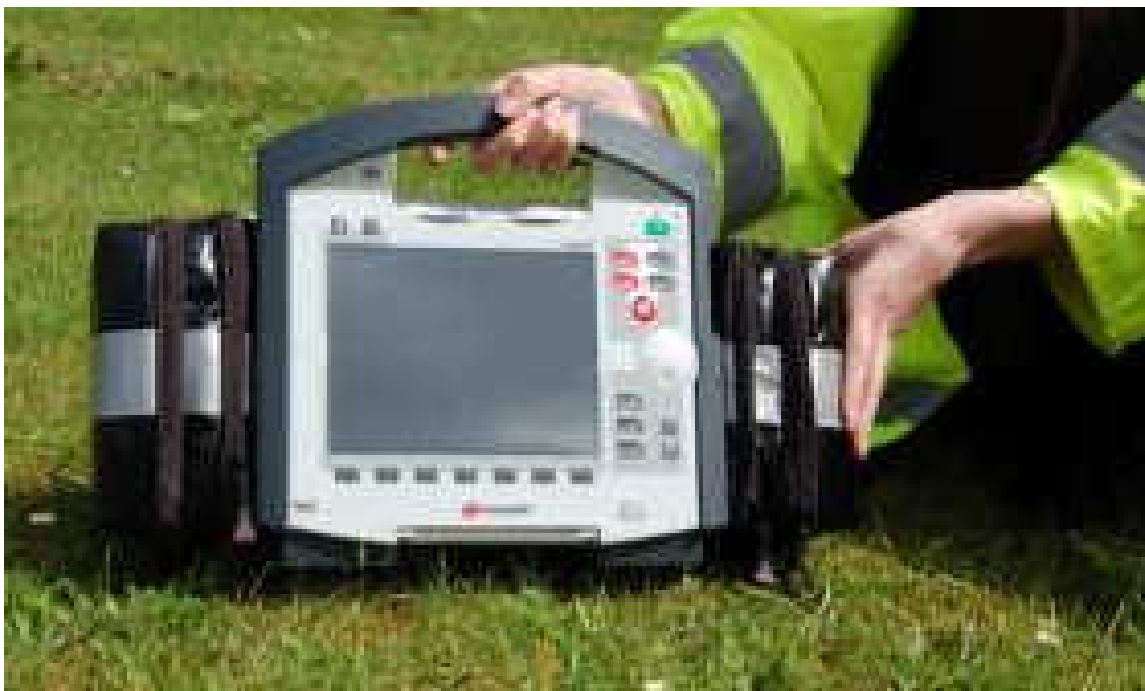
The defibrillator itself, has both adult and child pads stored within it as shown below. In addition to the pouches shown on the side of the monitor (image below) a pouch is also attached to the back of the monitor.

After consulting with one of the Trust Area Clinical Lead's (ACL), familiar with the Corpuls defibrillator, the IO has been informed that the individual Paramedics are responsible for the organisation of the defibrillator pouches. In the ACL's experience it is possible to fit the "dots", which are attached to the patient, in the left pouch with one set of adult pads in the right pouch. A spare set of adult pads and one set of paediatric pads can then be stored in the rear pouch.

By properly organising defibrillator equipment, it is possible to store a spare set of adult defibrillator pads with the Corpuls monitor
