# South Quay Hill Shelters – Design Options Technical Note

Structures Reference: 10/8080 6188

Report No: 60571547/0084/003

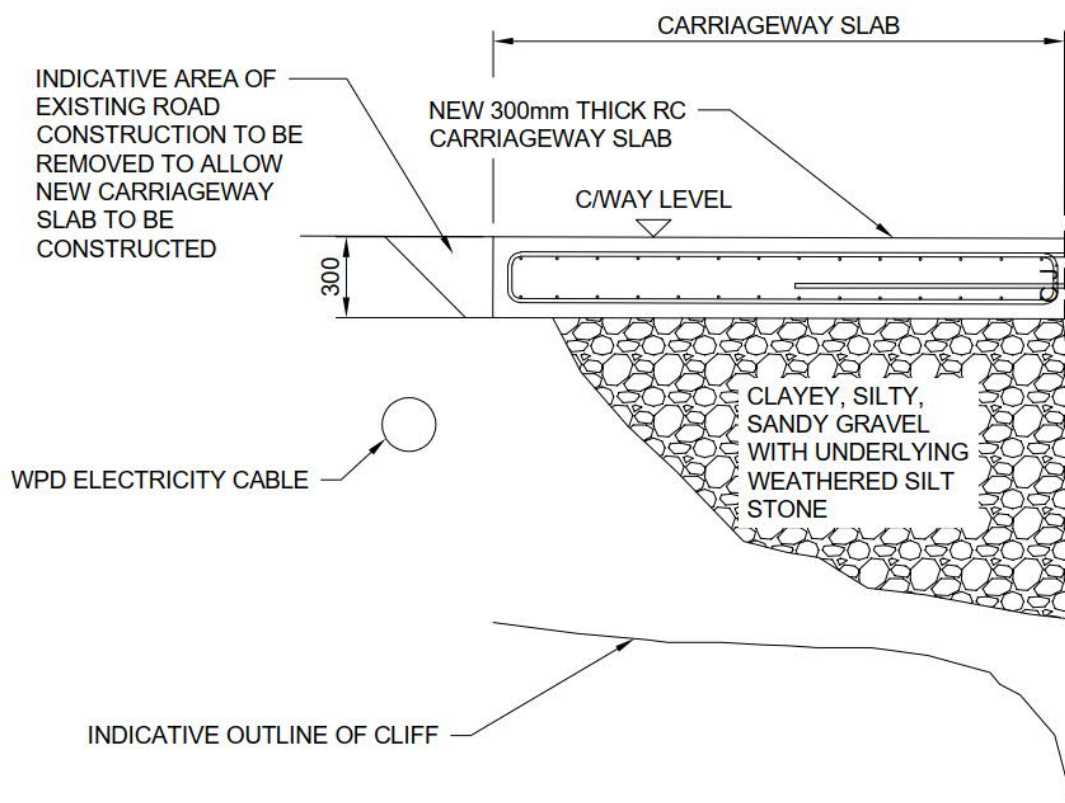
Figure 3: Option 2A - Replacement of Entire Carriageway Slab

- Option 2A – Replacement of the entire carriageway slab with a new ground bearing reinforced concrete slab that ties into the new footway slab. This option would require a complete closure of South Quay Hill to vehicular traffic for approximately four weeks, since the width required for excavation would be approximately 2.5m in width, meaning that there would only be approximately 2.0m of carriageway width available. This option would have the longest time period of road closure of the options considered. Access to Newquay Harbour would only be possible to pedestrians and cyclists for this option. This option is therefore not recommended. Further information on this option is shown in figure 3 below.

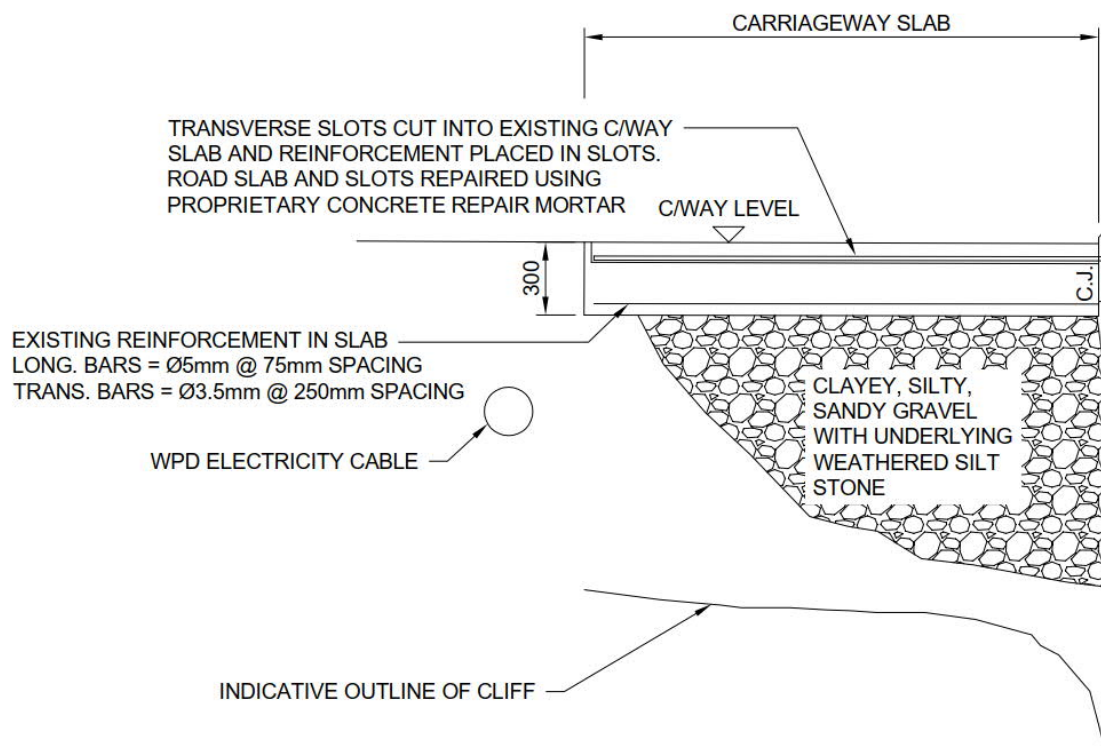
Figure 4: Option 2B - Chasing of Slots in Existing Slab for Reinforcement

- Option 2B – Chase out concrete channels or slots from the carriageway slab perpendicular to the road and insert steel reinforcement at regular intervals along the length of the slab. The reinforcement could either be stainless steel or carbon steel, depending on the option selected from section 2.1. Infill the areas of chased concrete using a rapid setting concrete mortar to minimise disruption to vehicle traffic on South Quay Hill. Apply a hard wearing, textured coating to the entire carriageway slab to improve aesthetics of the strengthened slab. This would also have the added benefit of enhancing skid resistance in wet/icy weather. Chasing of the concrete could be carried out under night-time closures and cover plates could be laid over the slab to allow the road to remain open during the day-time whilst concrete is curing. Further information on this option is shown in figure 4 below.

Construction of carriageway slab option 2B will cause much less disruption to the users of the South Quay Hill Road as the road can remain open during the day. This option also minimises the amount of concrete removal thereby reducing the overall duration of the works.

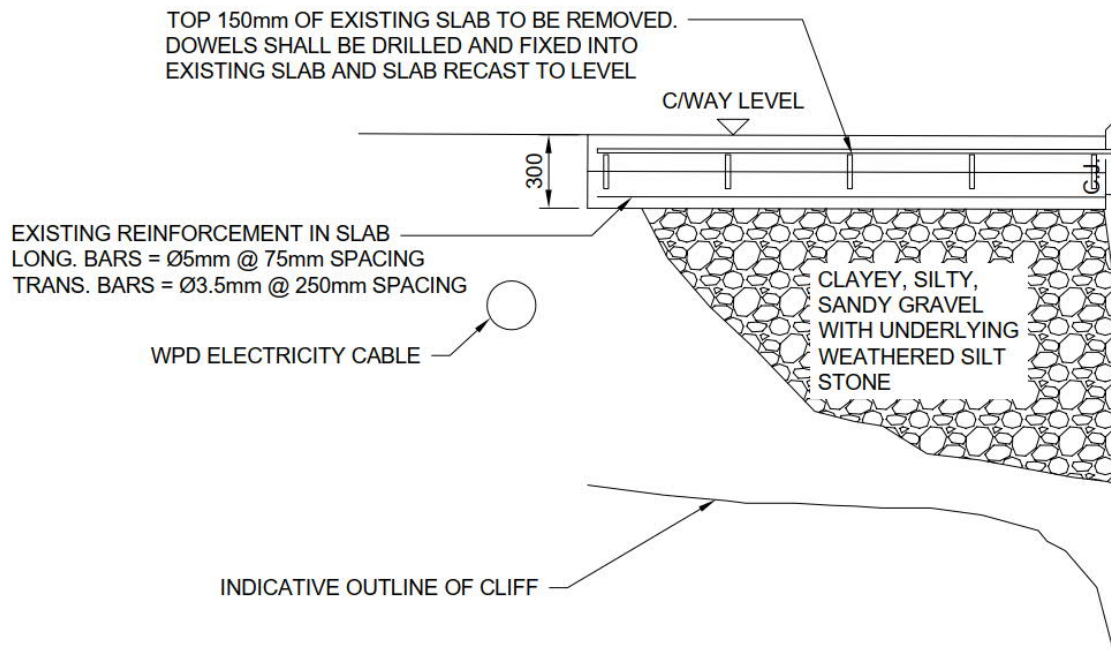
Figure 5: Option 2C – Replacement of top 150mm of existing slab

- Option 2C – Hydro-demolish the top 150mm of concrete from the existing carriageway slab. Lay a grid of horizontal reinforcement and drill and fix dowel bars to allow a shear connection between the new and existing concrete in the carriageway slab. The horizontal reinforcement is to continue through the retaining wall to the new footway slab. Recast the top 150mm of concrete. This option would require closure of South Quay Hill to vehicle traffic for approximately four weeks, with pedestrian/cyclist access to Newquay Harbour available only during construction works. Further information on this option is displayed in figure 5 below.
