# Plumpton Level Crossing Renewal GRIP3 Study

## Final Issue

28<sup>th</sup> February 2011

ATKINS

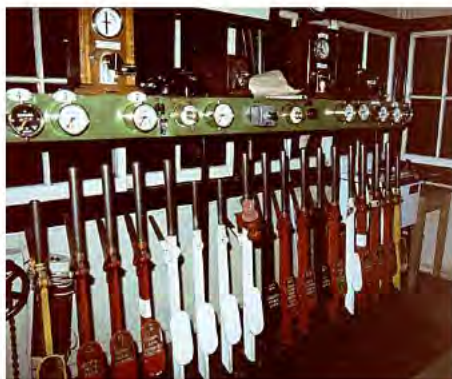
Figure 3.10. The original 21 lever frame in Plumpton signal box

Circa 1985 the majority of the signals were automated at Plumpton and as a result the majority of the levers were removed from the signal box (see figures 3.10 and 3.11); however, the signal box continued to be used to manually operate the crossing gates. At this point British Rail proposed to demolish and then to relocate the signal box but both proposals were rejected on heritage grounds and due to local opposition (see further details in section 7.4).

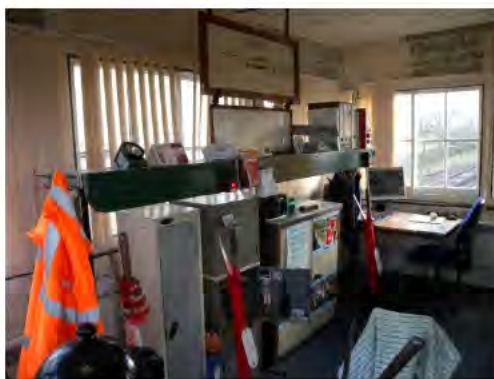
Figure 3.11. Most of the levers were removed c. 1985 and only four survive

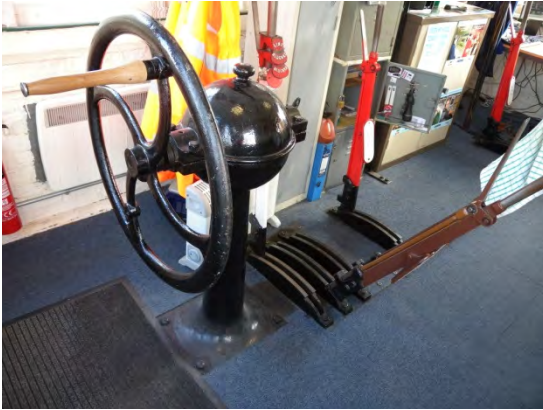
**Figure 3.12. The original 1891 capstan wheel for operating the gates survives**

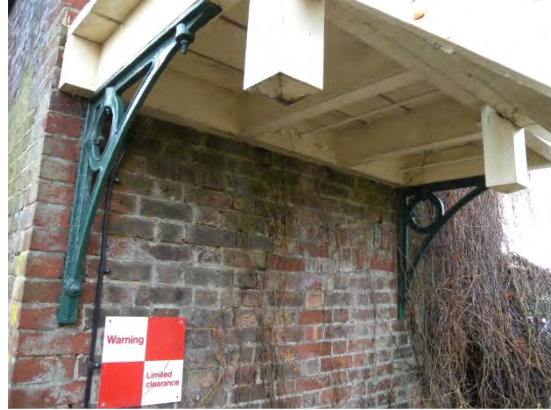
**Figure 3.13. There was originally a window at ground floor level which has been blocked, which may indicate the position of the stairs has changed.**

The signal box is two storeys, with the upper storey in weatherboarded timber on a single storey brick base. The base is constructed from stock brick with red brick quoins and lacing courses. The upper storey has sliding sash windows to three sides and is topped with a hipped roof with a decorated ventilator cowl with a pointed finial in its centre. The staircase is located on the west elevation and is in very good condition suggesting that it may have been restored, although it retains the original iron brackets. There is evidence that there was originally a window in the ground floor of the west elevation, which is now blocked. The brackets of the staircase are fixed to this blocked window (figure 3.13), which may indicate that the position

of the stair has changed. However, the OS map of 1910 (figure 3.6, which is more detailed than the earlier OS maps) indicate that the stair was in the current position at this date, so the analysis is inconclusive.

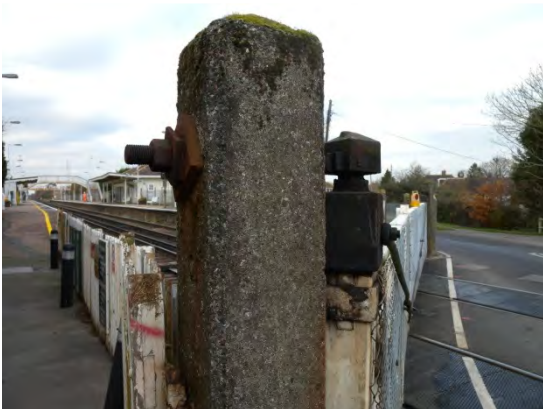
Figure 3.17. The gate posts have been replaced with reinforced concrete posts in the postwar period

A visual inspection of the gates suggests that the majority of the fabric has been replaced during repairs and restoration. The gate posts are of reinforced concrete suggesting they are postwar replacements (see figure 3.17). The ironwork on the gates appears to be original and includes heavy strap hinges; however, the timber has been replaced during repair work (see figure 3.18). A handwritten note on the timber lever frame states that all four gates were last renewed in August 2004 by RJB Engineering.

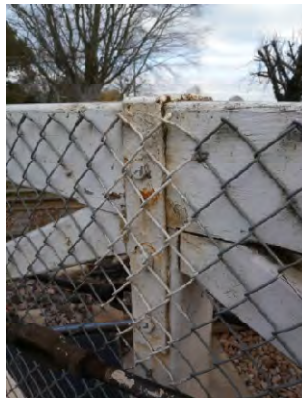
Figure 3.18. The ironwork on the gates appears to be original although the timber was replaced in 2004

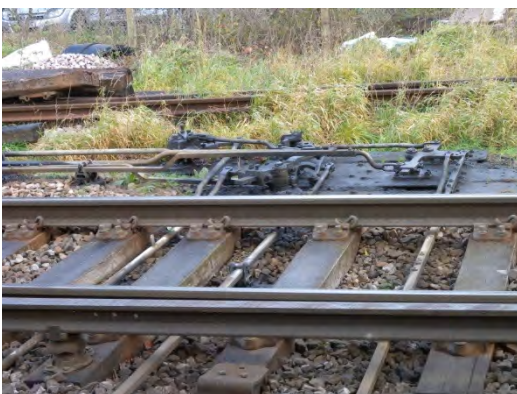
Figure 3.19. The 1891 mechanism for opening the gates survives and is still in use.

The mechanism dates from 1891 (see figures 3.19 and 3.20), although the signaller on site explained that the cog closest to the crossing keeper's house was replaced recently with a salvaged cog from another crossing. A handwritten note on the timber lever frame states that the gate equipment was renewed and refurbished in June 1997 by RJB Engineering.

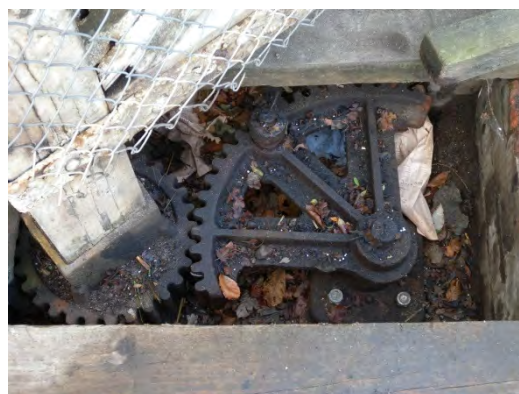
Figure 3.20. A system of cogs open the gates.

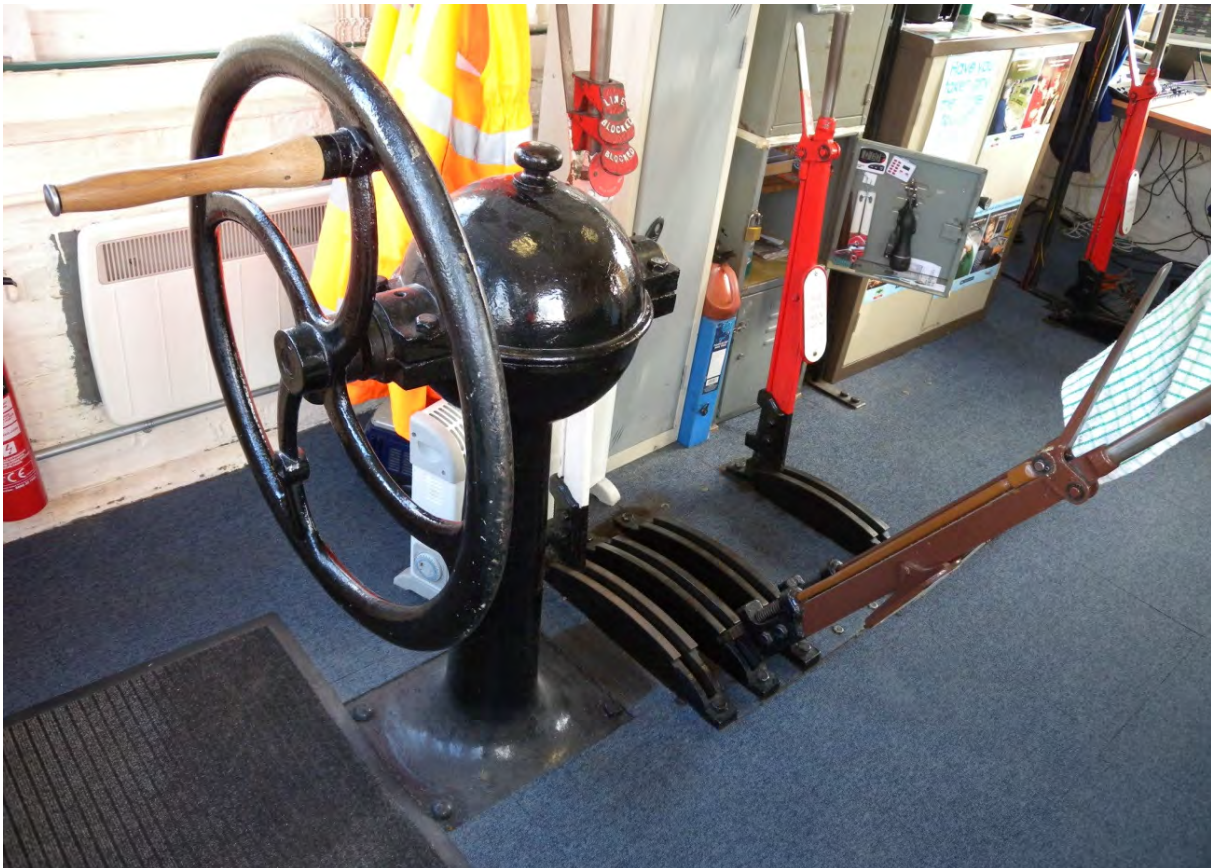
Figure 3.21. Hand Operated Gate Wheel in Plumpton Gate Box

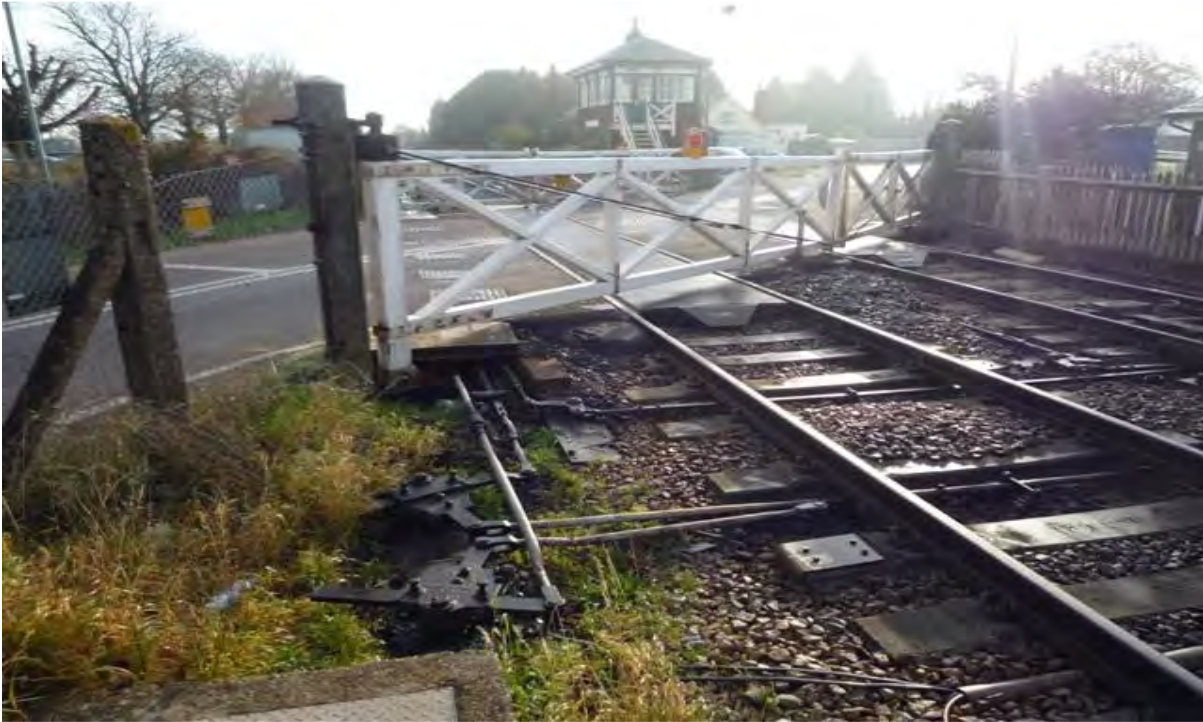
Figure 3.22. Ground Lever System on Up Side (West Side of Crossing)

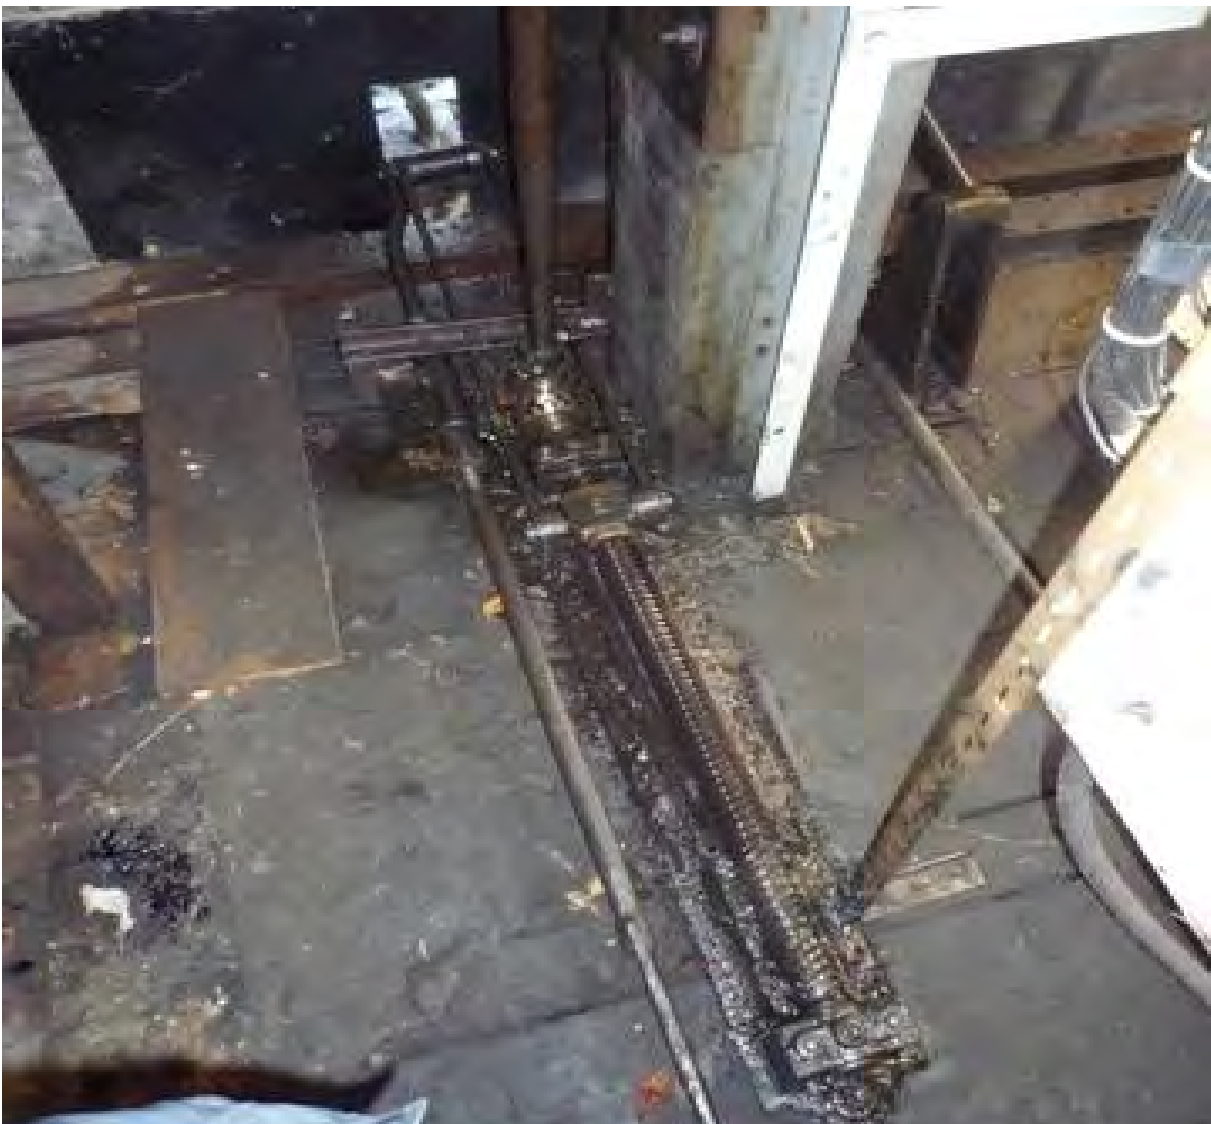
Figure 3.23. Worm Drive in undercroft of Plumpton Gate Box

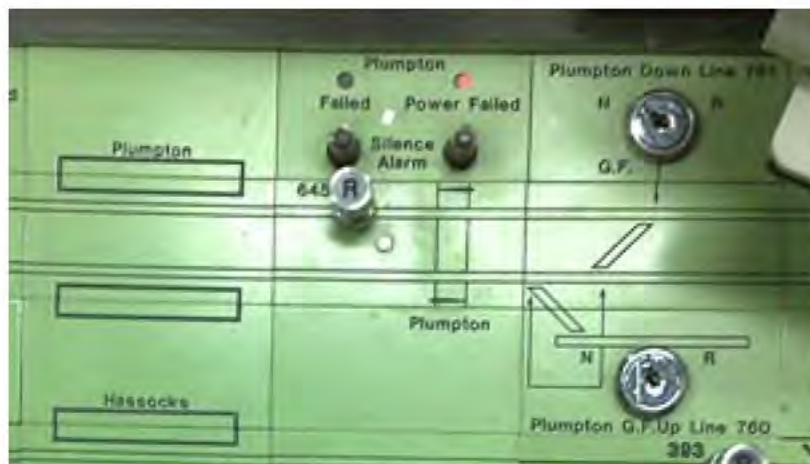
Figure 3.25 Three Bridges panel – Plumpton Crossing

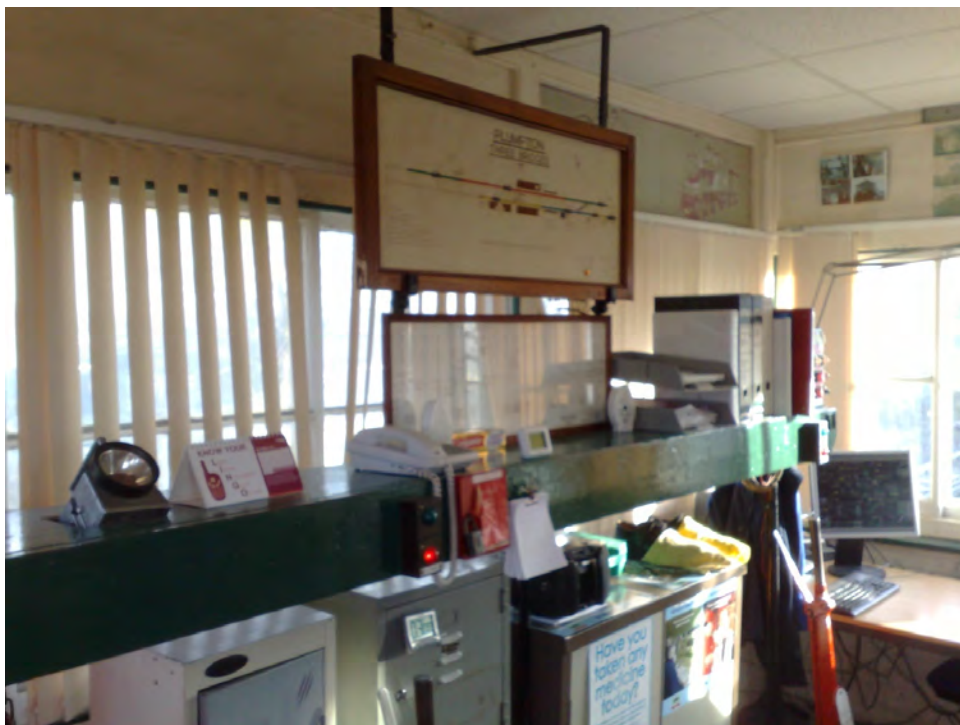
Figure 3.27 Plumpton Signal Box showing illuminated diagram

Plumpton Signal Box has a 21 level frame with 5 levers remaining in-situ. 4 remain in use and one is spare. The illuminated diagram in the signal box correctly shows the signalling arrangement with the exception of the out-of-use wicket gates which are shown as being present. The illuminated diagram also shows all three sections of Track Circuit JO separately, whereas they are shown as combined at Three Bridges.

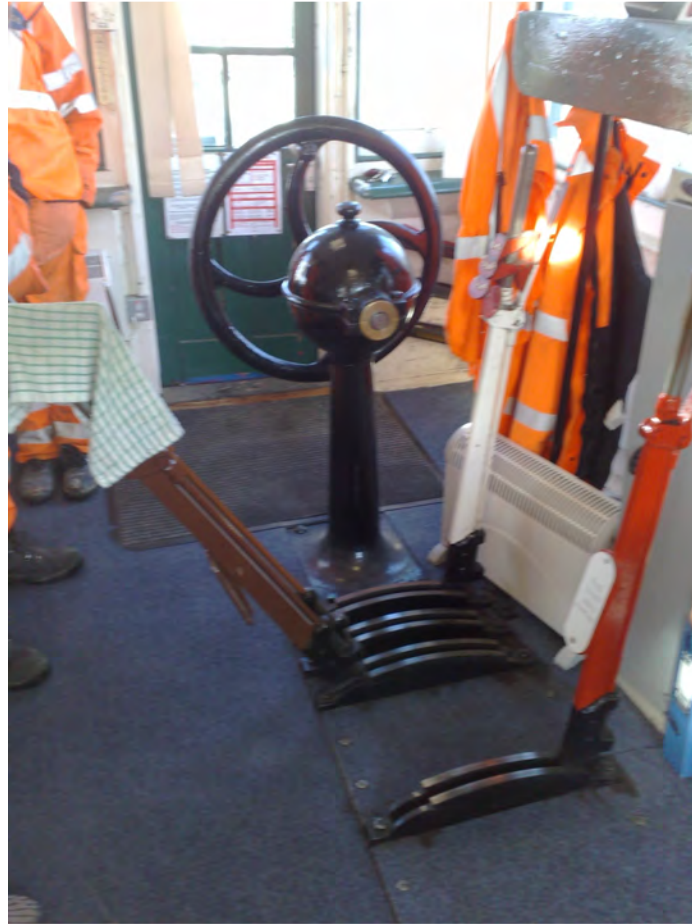
Figure 3.28 Plumpton Signal Box showing lever frame and wheel

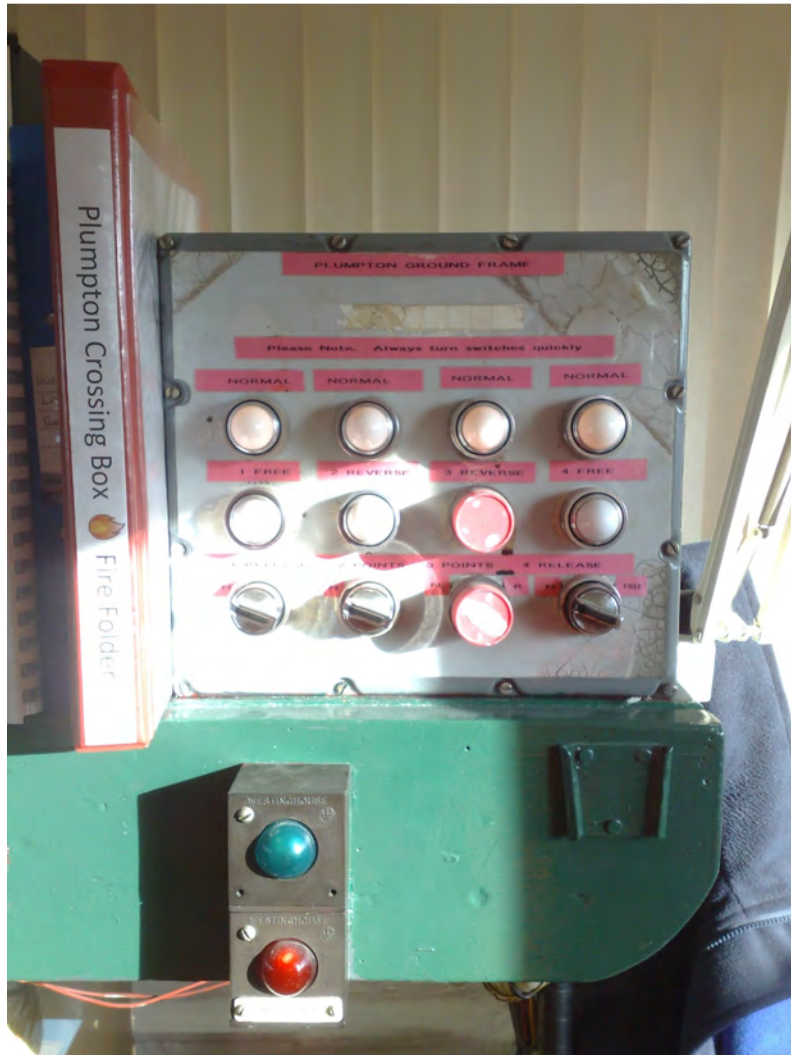
**Figure 3.30 Plumpton Signal Box Ground Frame**

The Ground Frames consist of a switch panel on the block shelf.

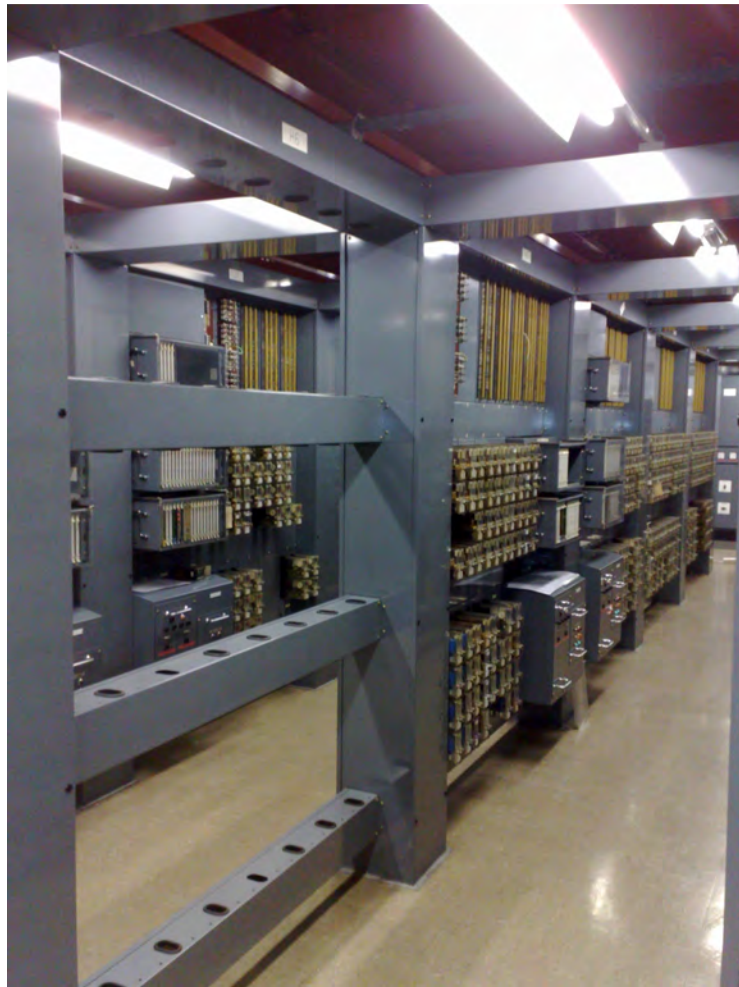
**Figure 4.1 Spare rack in Three Bridges RR**

A new free wired interlocking would be provided at Plumpton Level Crossing housed in a new REB along with the circuitry and equipment associated with the MCB crossing. A standby-battery room would be provided as part of the REB. The interlocking would require a remote control system from Three Bridges to Plumpton to carry the control and indications, there appears to be sufficient space for such a system in Three Bridges Relay Room with one suitable location being in a spare rack adjacent to Haywards Heath circuitry as shown in figure 4.1.

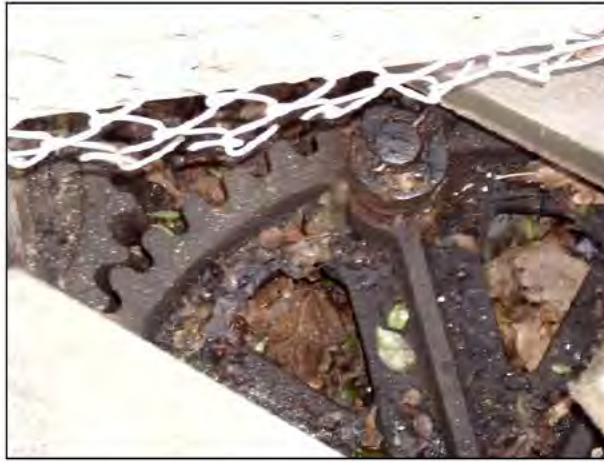
Figure 6.1 Existing Gear Drive to Gates

The proposals to install drives at each of the gates would make use of the existing gear drive to each of the gates as shown in the photograph below. These are robust parts of the existing installation and their reuse would reduce the amount of work required to the existing infrastructure.

Each gate post would be fitted with two number electronically controlled servo motors each driving a 600mm stroke in line cylinder in a push pull arrangement linked to the existing gear drives. Each cylinder would have a maximum capacity of 21kN giving more than enough force to operate the gates against the highest wind load.

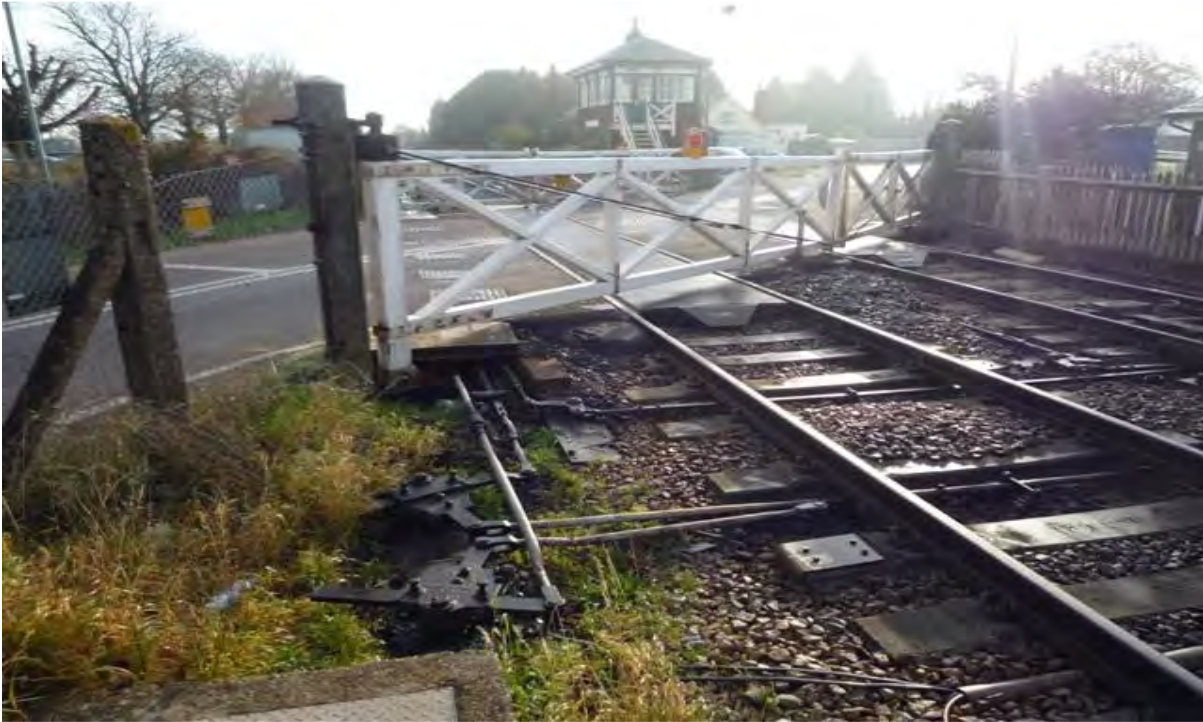
Photo H3 – Ground lever system at Up (West) side of level crossing

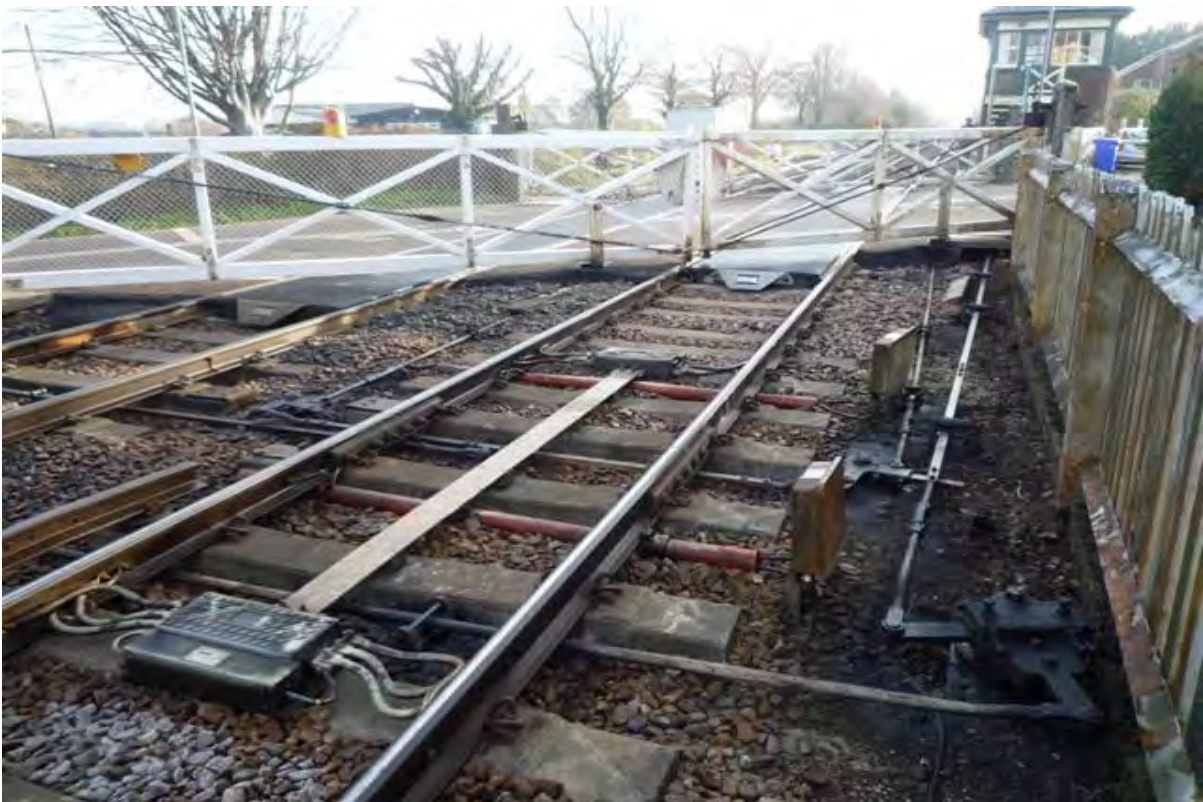
Photo H4 – Ground lever system at Up (West) side of level crossing

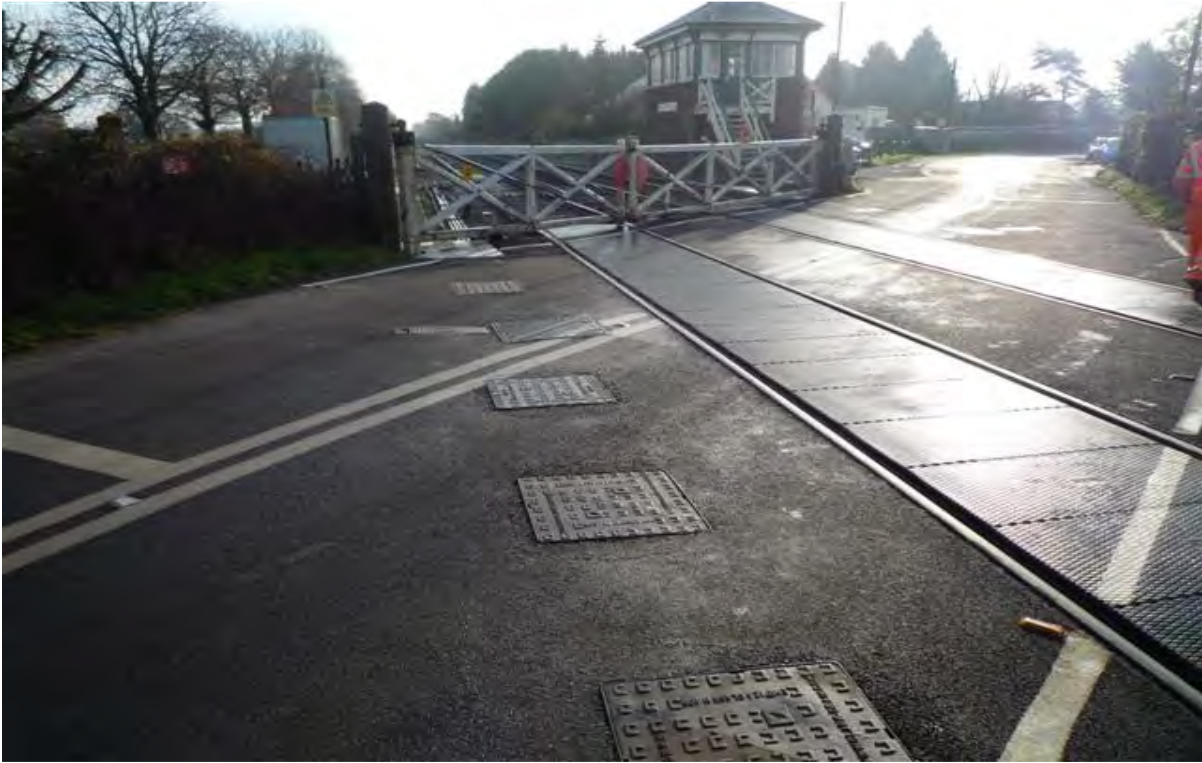
Photo H5 – North side URX access ICs and gate stop mounting plate.

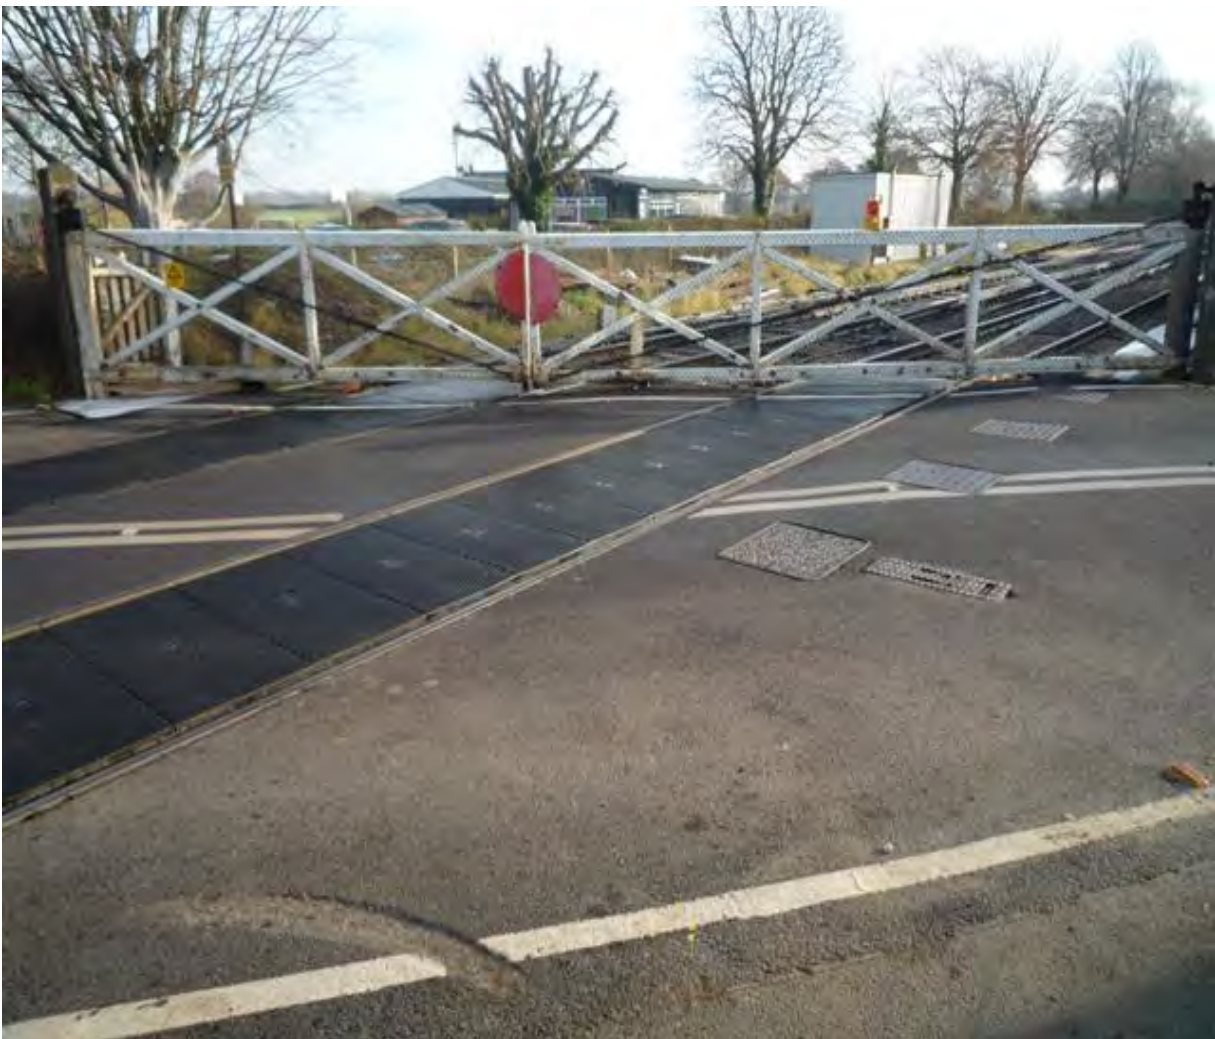
Photo H6 - Southside URX access ICs and gate stop mounting plate.

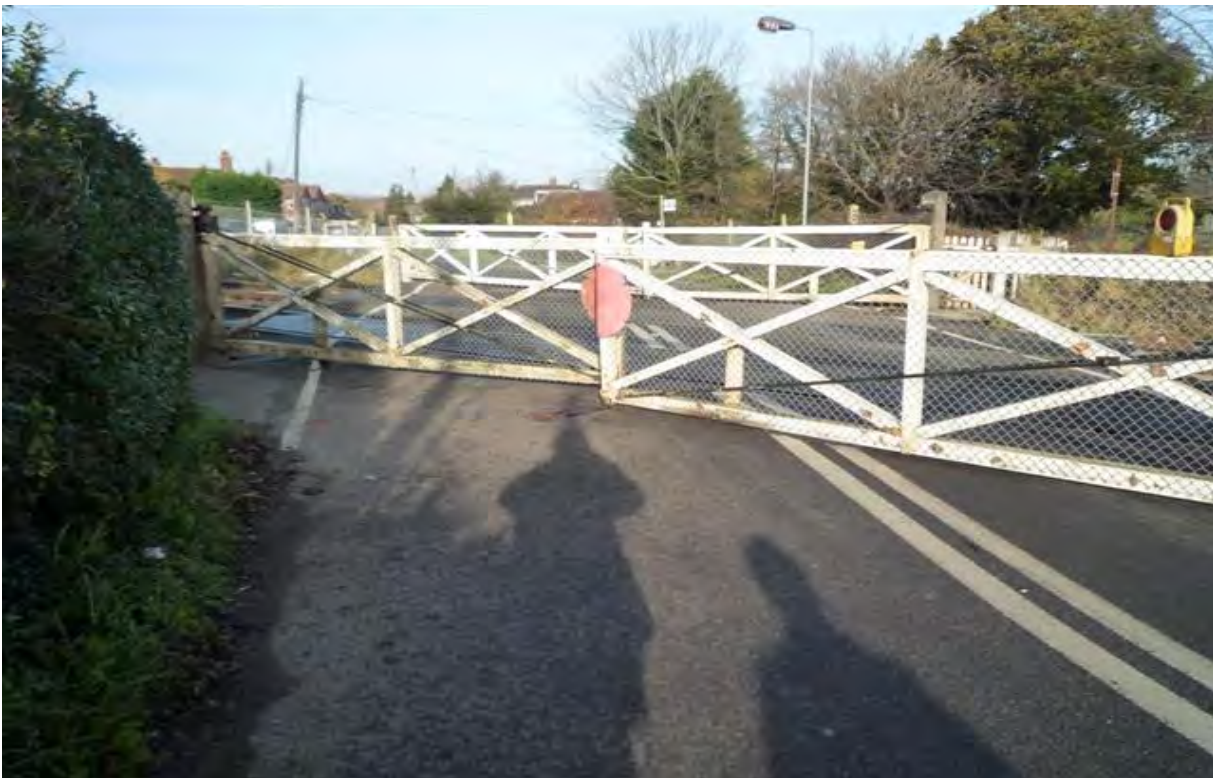
Photo H8 – Operation of gates, note gate stop raised.

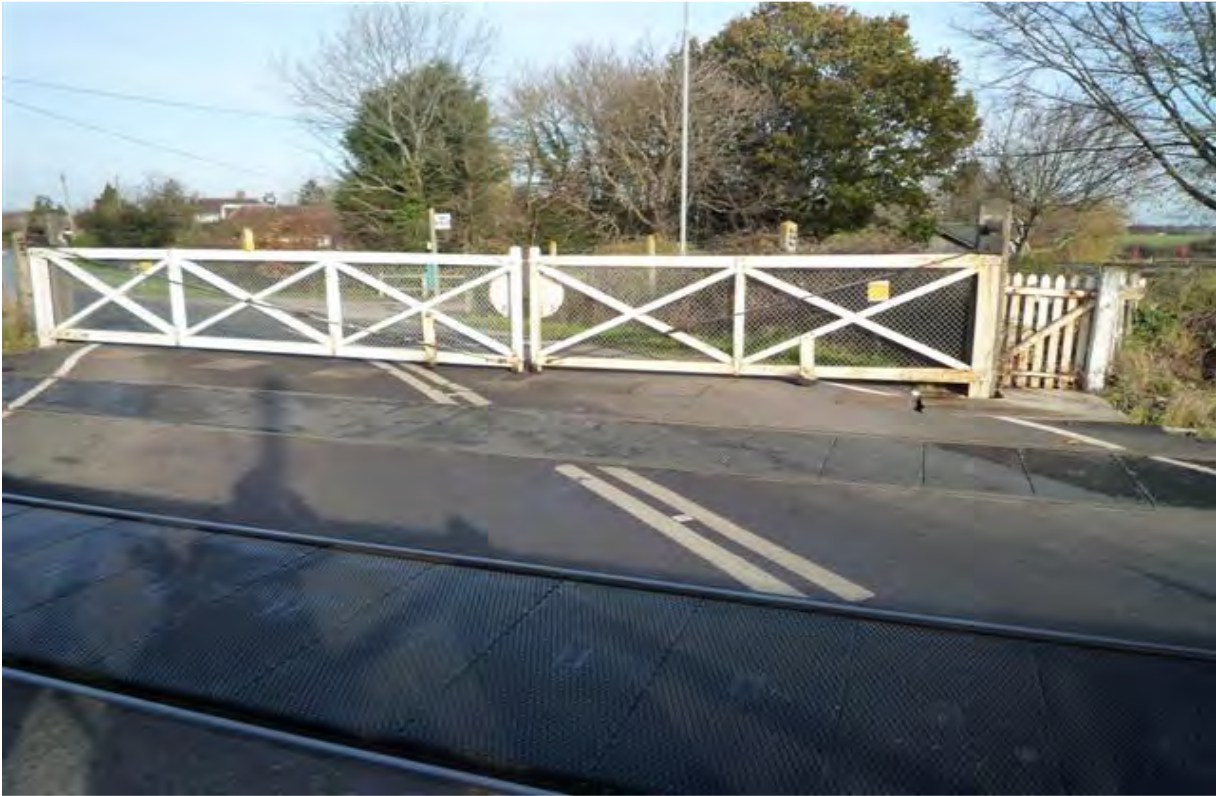
Photo H9 – Road closed, gate stop in place wicket gate locked.

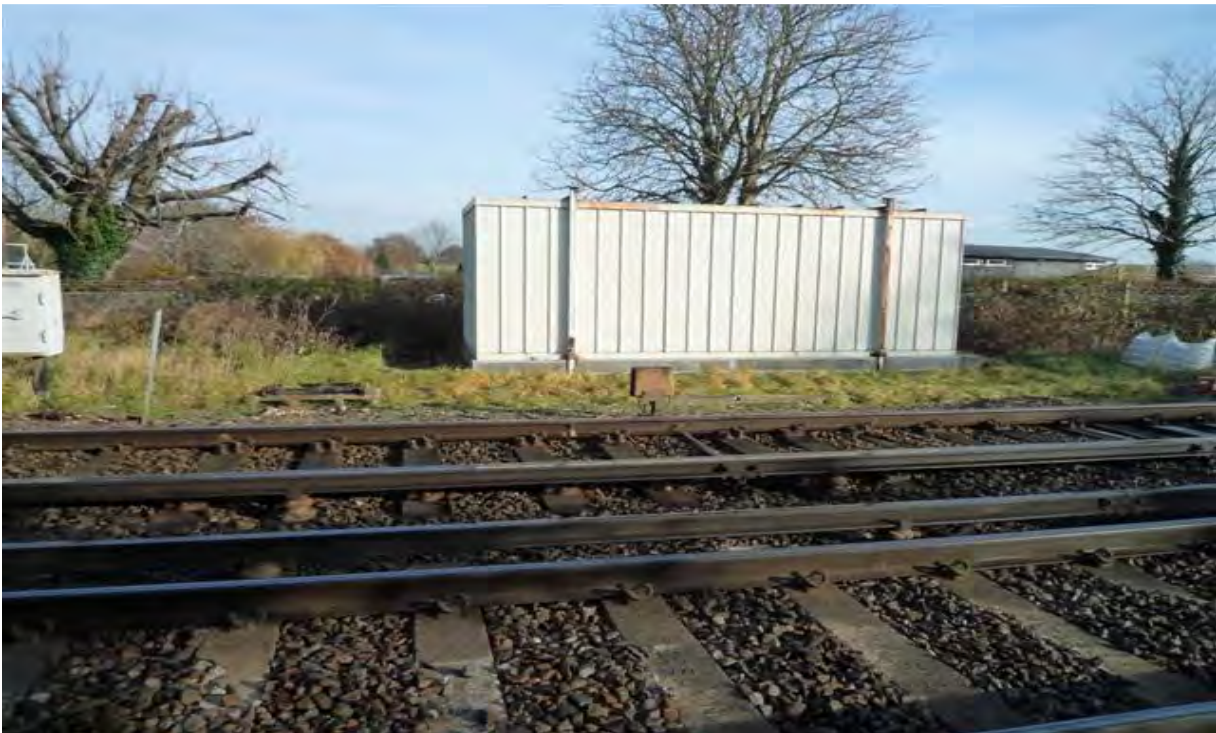
Photo H10 – Signalling REB downside cess opposite signal box

Record data held in the signalling REB in the downside cess to the East of the level crossing confirms that provision for a 650V signalling supply has also been made at the crossing. It is understood that this was for the provision of automatic half barriers that were never installed.

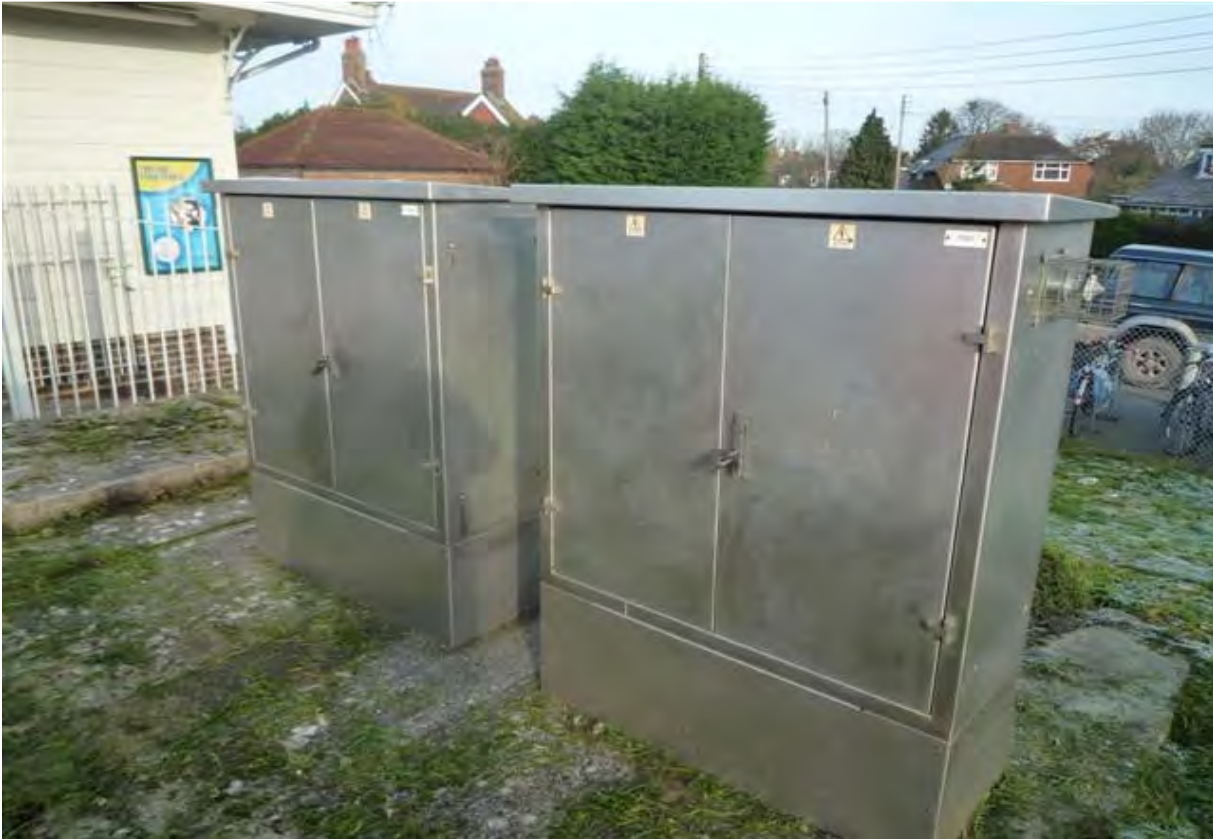
Photo H11 – DNO metering and distribution cubicles

There are currently 2 No. TP&N DNO electrical supplies to the site. These are housed in stainless steel metering/distribution cubicles on land adjacent to the railway station. One cubicle serves domestic LV electricity to the station areas and the second serves the signal box and the CSR mast. The supply to the second cubicle is a 100A TP&N metered service and there is a large percentage of spare capacity available.

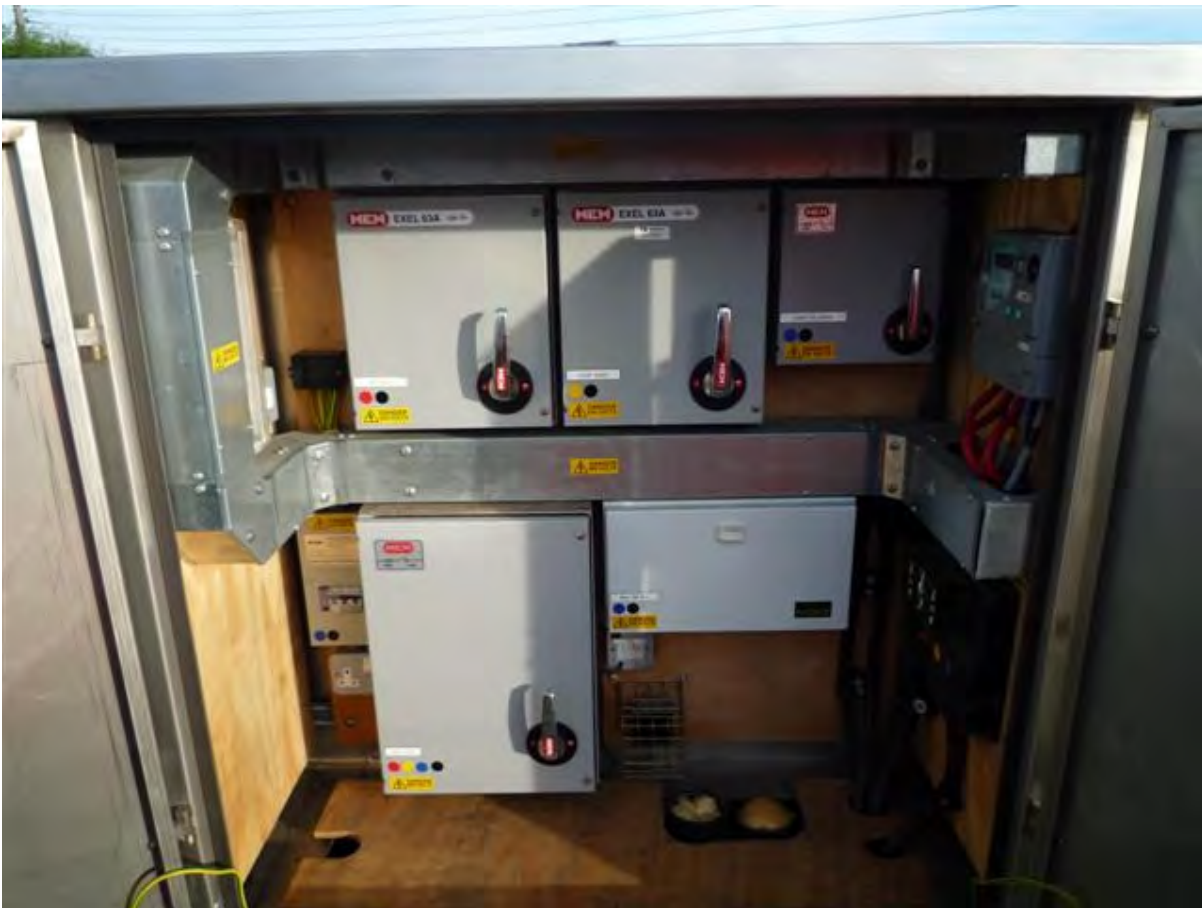
Photo H12 – LV Distribution Switchgear for signal box and CSR DNO cubicle
