REPORT ON REPAIR OF FENDERING TO BERTHING PLATFORM

LLANDUDNO PIER

Date 9 November 2009

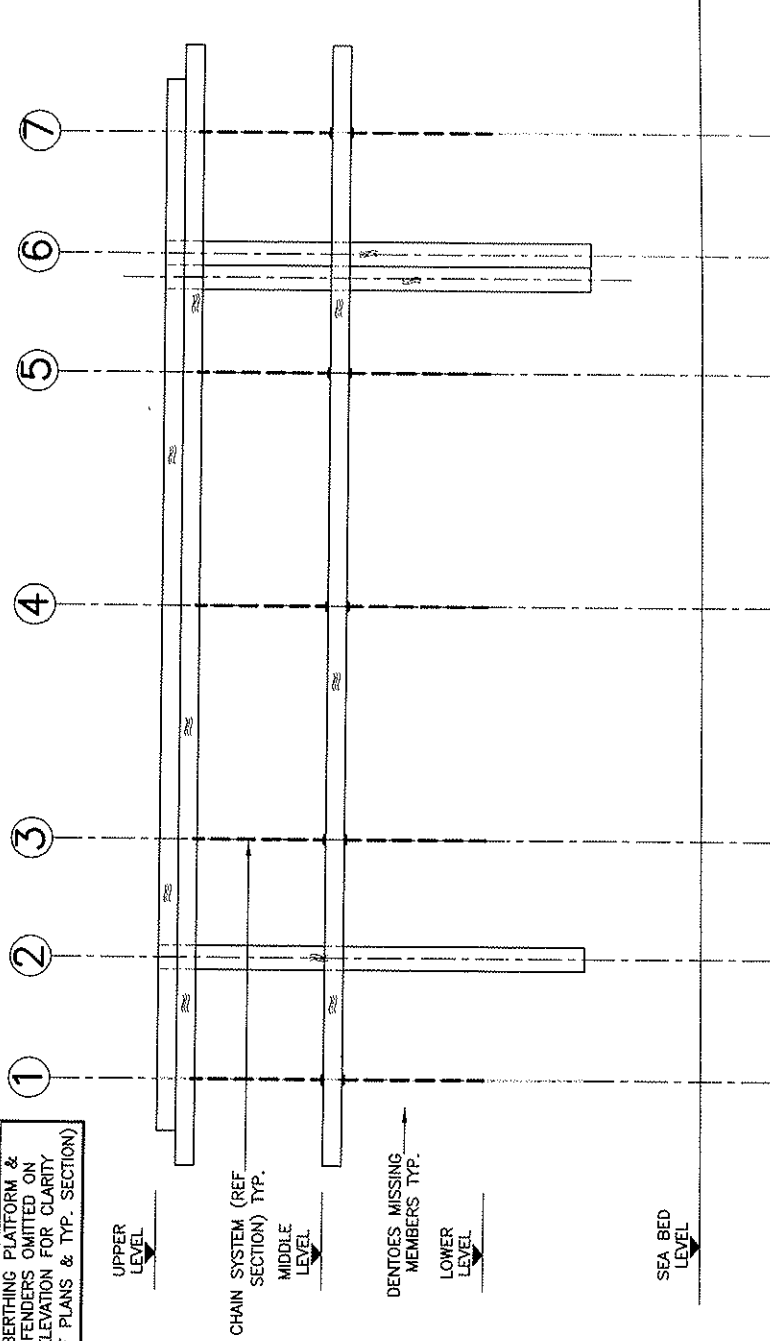
EXISTING ELEVATION
(FACING SEA)
1:100

- 5.5. Of the original framework of 3 cross-beams and 7 lines of verticals only 2 cross-beams remained whilst 5 lines of verticals were missing. The loss of the lower beam had led to the loss of the attached rubber fenders which provided a lower bearing point for the framework against the bottom slab. In its absence the framework had rotated from the vertical causing the compression of the middle rubber fenders and the loss of contact between the upper slab and the framework.

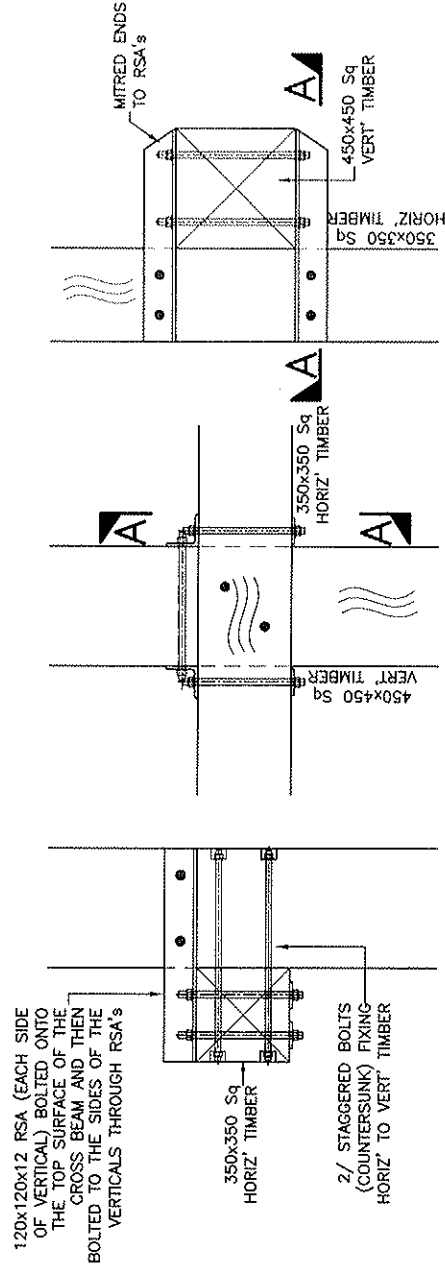
6.4 The steel bracket is considered to be particularly vulnerable to corrosion and overstress. Where the plate connects to the verticals it reduces to a pair of unstiffened steel plates subject to eccentric loading. The remains of these plates show failure of the plate due to buckling under bending.

- 7.3 The timbers that remain show signs of decay and splitting due to overstressing of bolted connections.
- 7.4 The loss of most of the vertical members is as a result of the failure of the steel bracket connecting them to the cross-beams. The detail is considered to be vulnerable to the effects of corrosion and overload.

SECTION A-A ELEVATION PLAN
ALTERNATIVE PRINCIPAL SUPPORT BETWEEN THE VERTICALS & THE CROSS-BEAMS
