INSPECTION OF THE SUPERSTRUCTURE, VICTORIA PIER, COLWYN BAY

In February 2010 Datrys was commissioned by Conwy County Borough Council (CCBC) to carry out a structural inspection and assessment of Victoria Pier, Colwyn Bay and to provide a report on our findings.

This report relates to the structural inspection that was carried out above deck level on the 27th July 2010. The inspection consisted of a visual assessment all of accessible buildings, structures and areas that were deemed safe to enter. This report follows on from our initial report which concerned the supporting steel and cast iron structure below deck level.

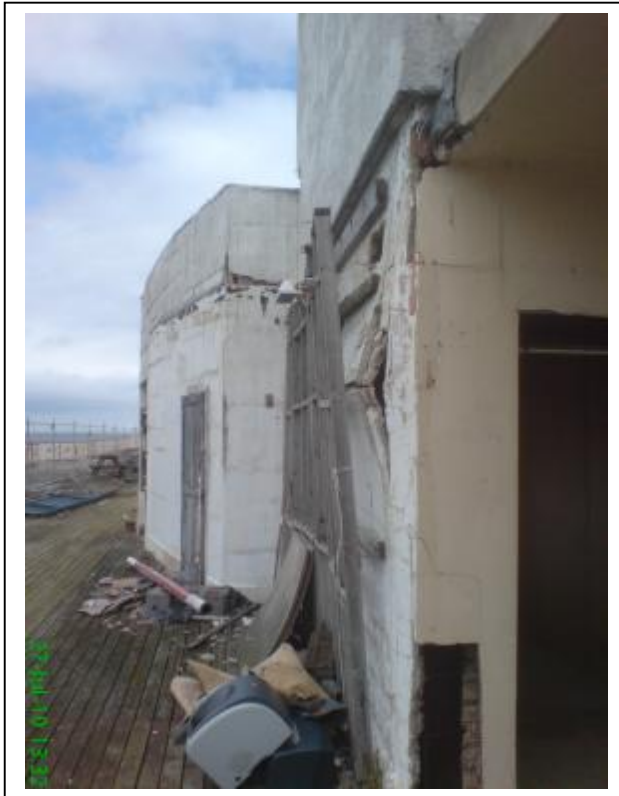
- A substantial proportion of the rendered outer wall leafs are cracked and are collapsing (photo's 12-14, 21-25, 28-29, 58-60).
- Some of the secondary steelwork supporting the fabric walls is corroding (photo's 30, 52, and 60).
- The roof of the toilet block to the north west of the main building is leaking. The floor is wet and seems to be rotten (photo's 35, 36).
- The principal structural members appeared to be in a good condition with little signs of corrosion and no signs of defects.

Most of the external wall panels have failed due to cracking and buckling; in areas they have become detached. This failure pattern is probably due to corrosion of the unrendered inner face of the steel laths as a result of condensation. The expansion of the corroding steel would cause the render to crack allowing exposure to the aggressive external environment. This in turn would lead to accelerated corrosion and expansion resulting in the buckling of the wall panel and its becoming detached from the supporting structure.

Lath & plaster boarding to the pavilion

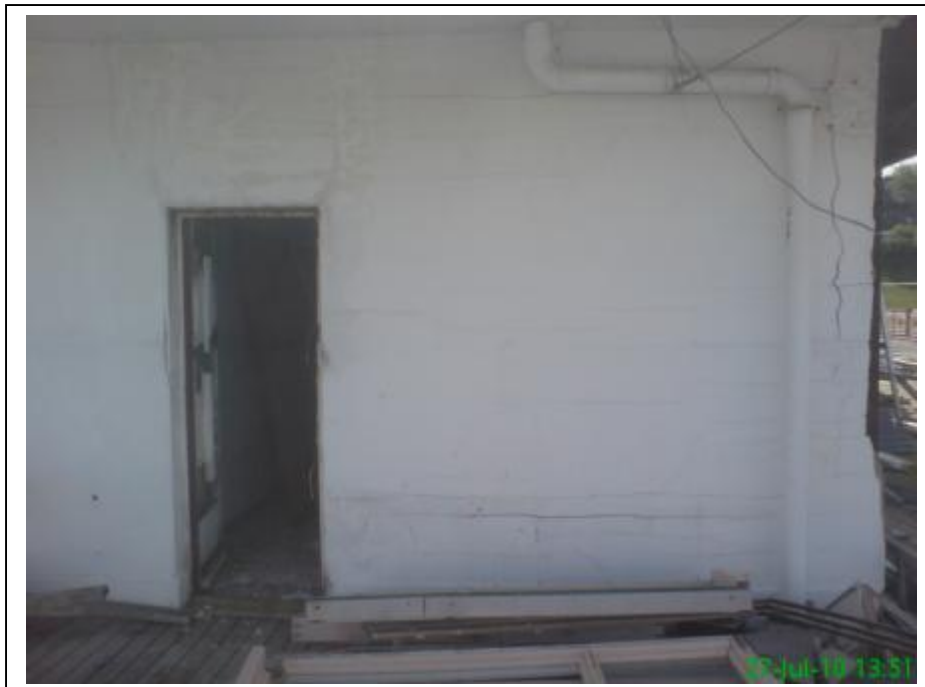
Photo 31: View from the north west corner
showing the toilets

It is clear that there have been problems with the roofs leaking in the past which may be why the majority of the sheeting has been replaced on the lower annexes. The roof to the toilet area continues to leak which will be causing corrosion of the supporting steelwork.

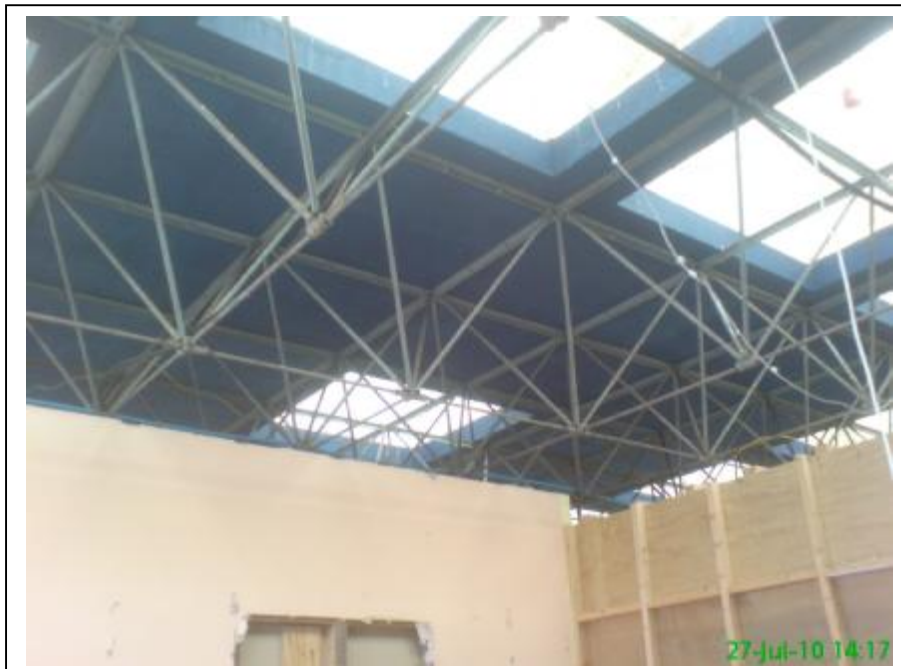
Photo 48: Roof over the entrance building

There were no significant structural defects observed. The roof had leaked at some point in the past and may need to be repaired. The space frame will need to be treated to prevent ongoing corrosion. Whilst the buildings are structurally adequate, they are unlikely to comply with the current Building Regulations.

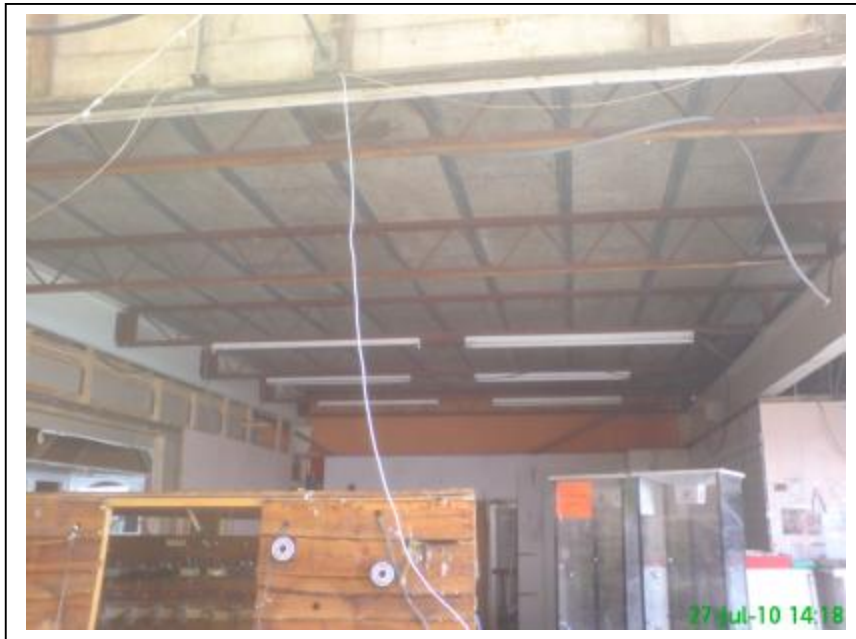
Photo 49: Roof over the south room of the entrance building

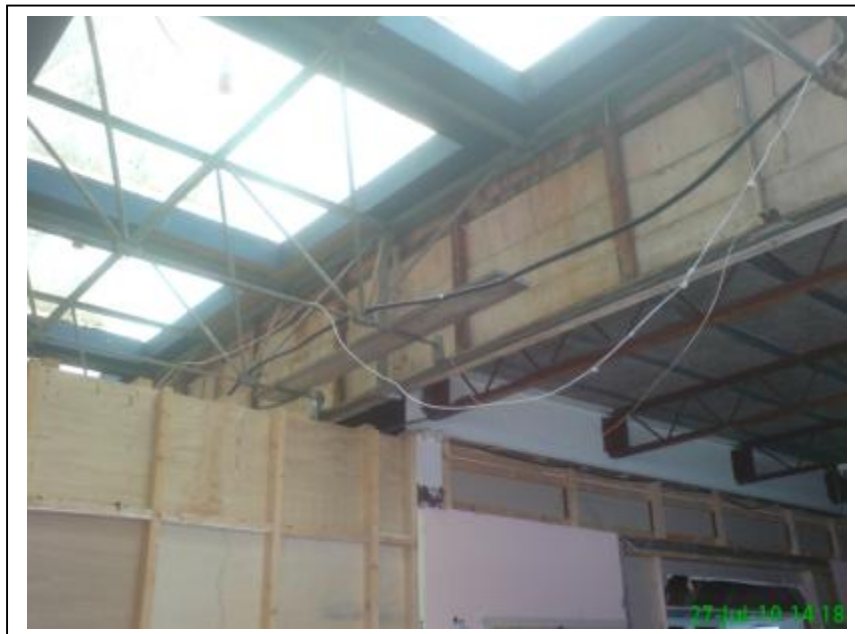
Photo 50: Roof over the south room of the entrance building
