STRUCTURAL APPRAISAL

VICTORIA PIER, COLWYN BAY

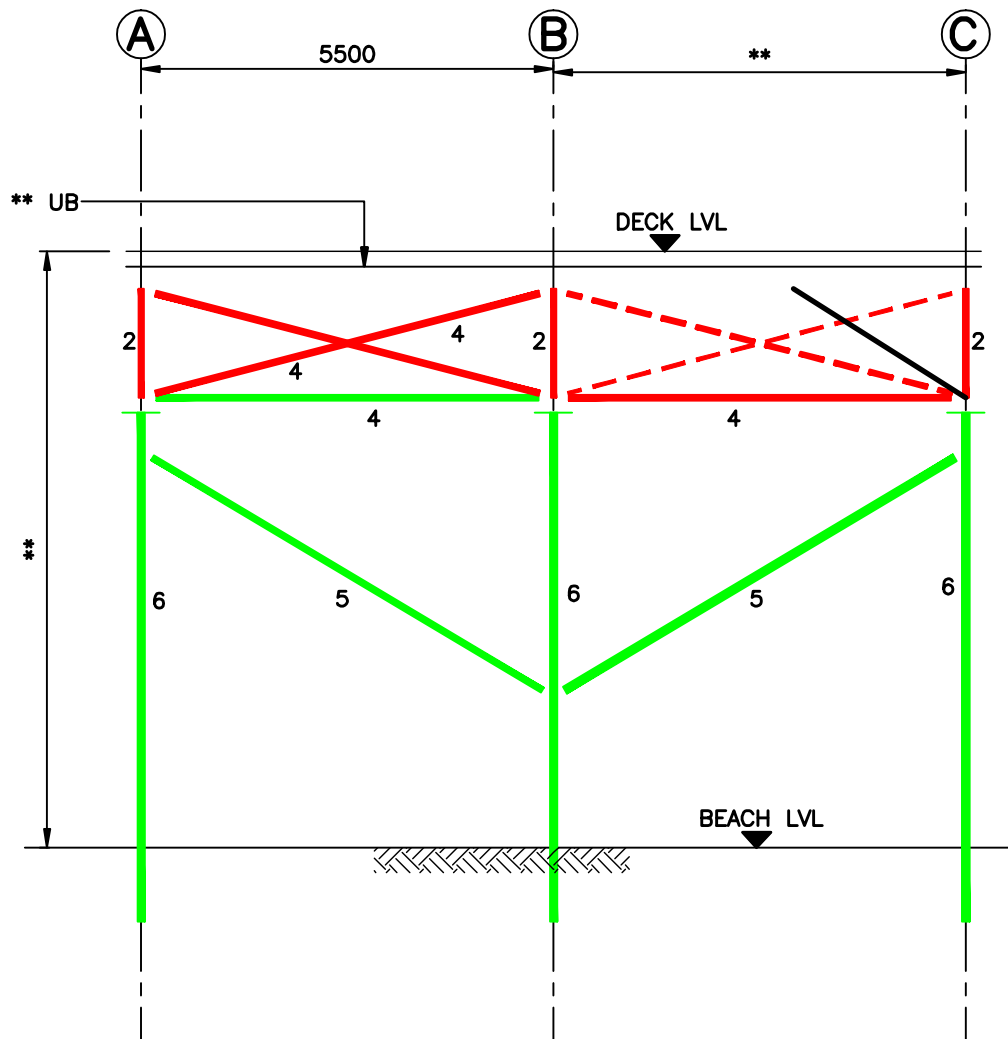
MEMBER	MEMBER TYPE	SECTION	NUMBER OF	NO# FAILED MEMBERS	ACTION
2	T SECTION	250x150mm	3	3	REPLACE
4	RSA	100x100mm	6	1	REPLACE
5	UC	203x203	2	0	BLAST & PAINT
6	CHS (COLUMN)	300x25mm	3	0	BLAST & PAINT

**OVERALL VERDICT : REPLACE GIRDER
(FAILURE PREDOMINANTLY OBSERVED DURING VISUAL INSPECTION)**

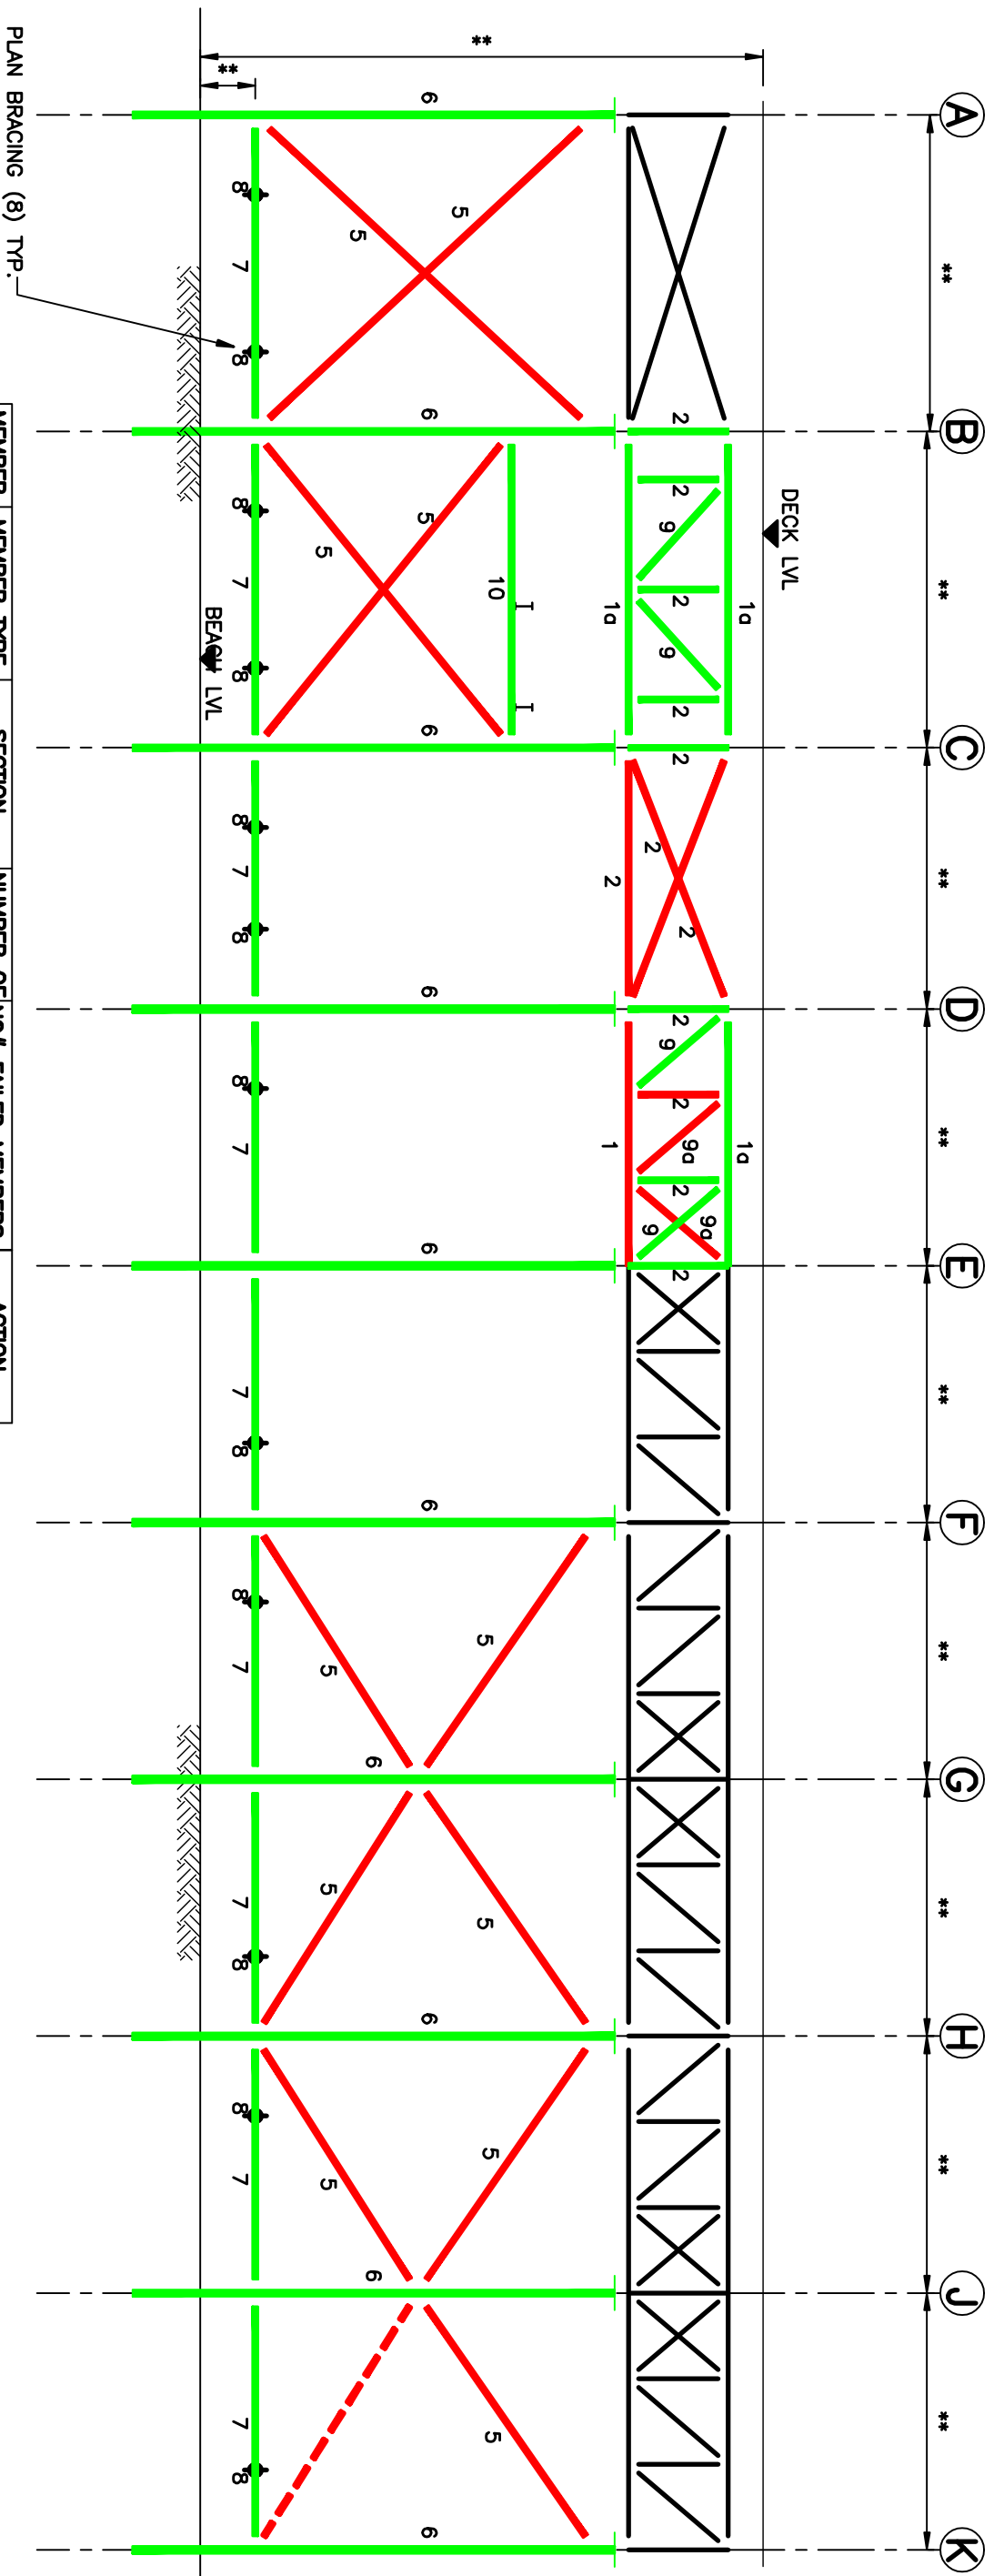
MEMBER	MEMBER TYPE	SECTION	NUMBER OF	NO#	FAILED	MEMBERS	ACTION
1	T SECTION	155x50mm	1		1		REPLACE
1a	T SECTION	155x50mm	3		3		BLAST & PAINT
2	RSA (VERT')	70x70x4mm	12		4		REPLACE
5	BAR	50mm Ø	12		12		REPLACE
6	CHS (COLUMN)	300x25mm	10		0		BLAST & PAINT
7	RAIL	135x65mm	9		0		BLAST & PAINT
8	BAR	38x63mm	12		0		BLAST & PAINT
9	FLAT (DIAG')	75x10mm	4		0		BLAST & PAINT
9a	FLAT (DIAG')	75x10mm	2		2		REPLACE
10	UB	203x133	1		0		BLAST & PAINT

**OVERALL VERDICT : KEEP GIRDER B-C, REPLACE GIRDER C-E
(FAILURE PREDOMINANTLY OBSERVED DURING VISUAL INSPECTION)**

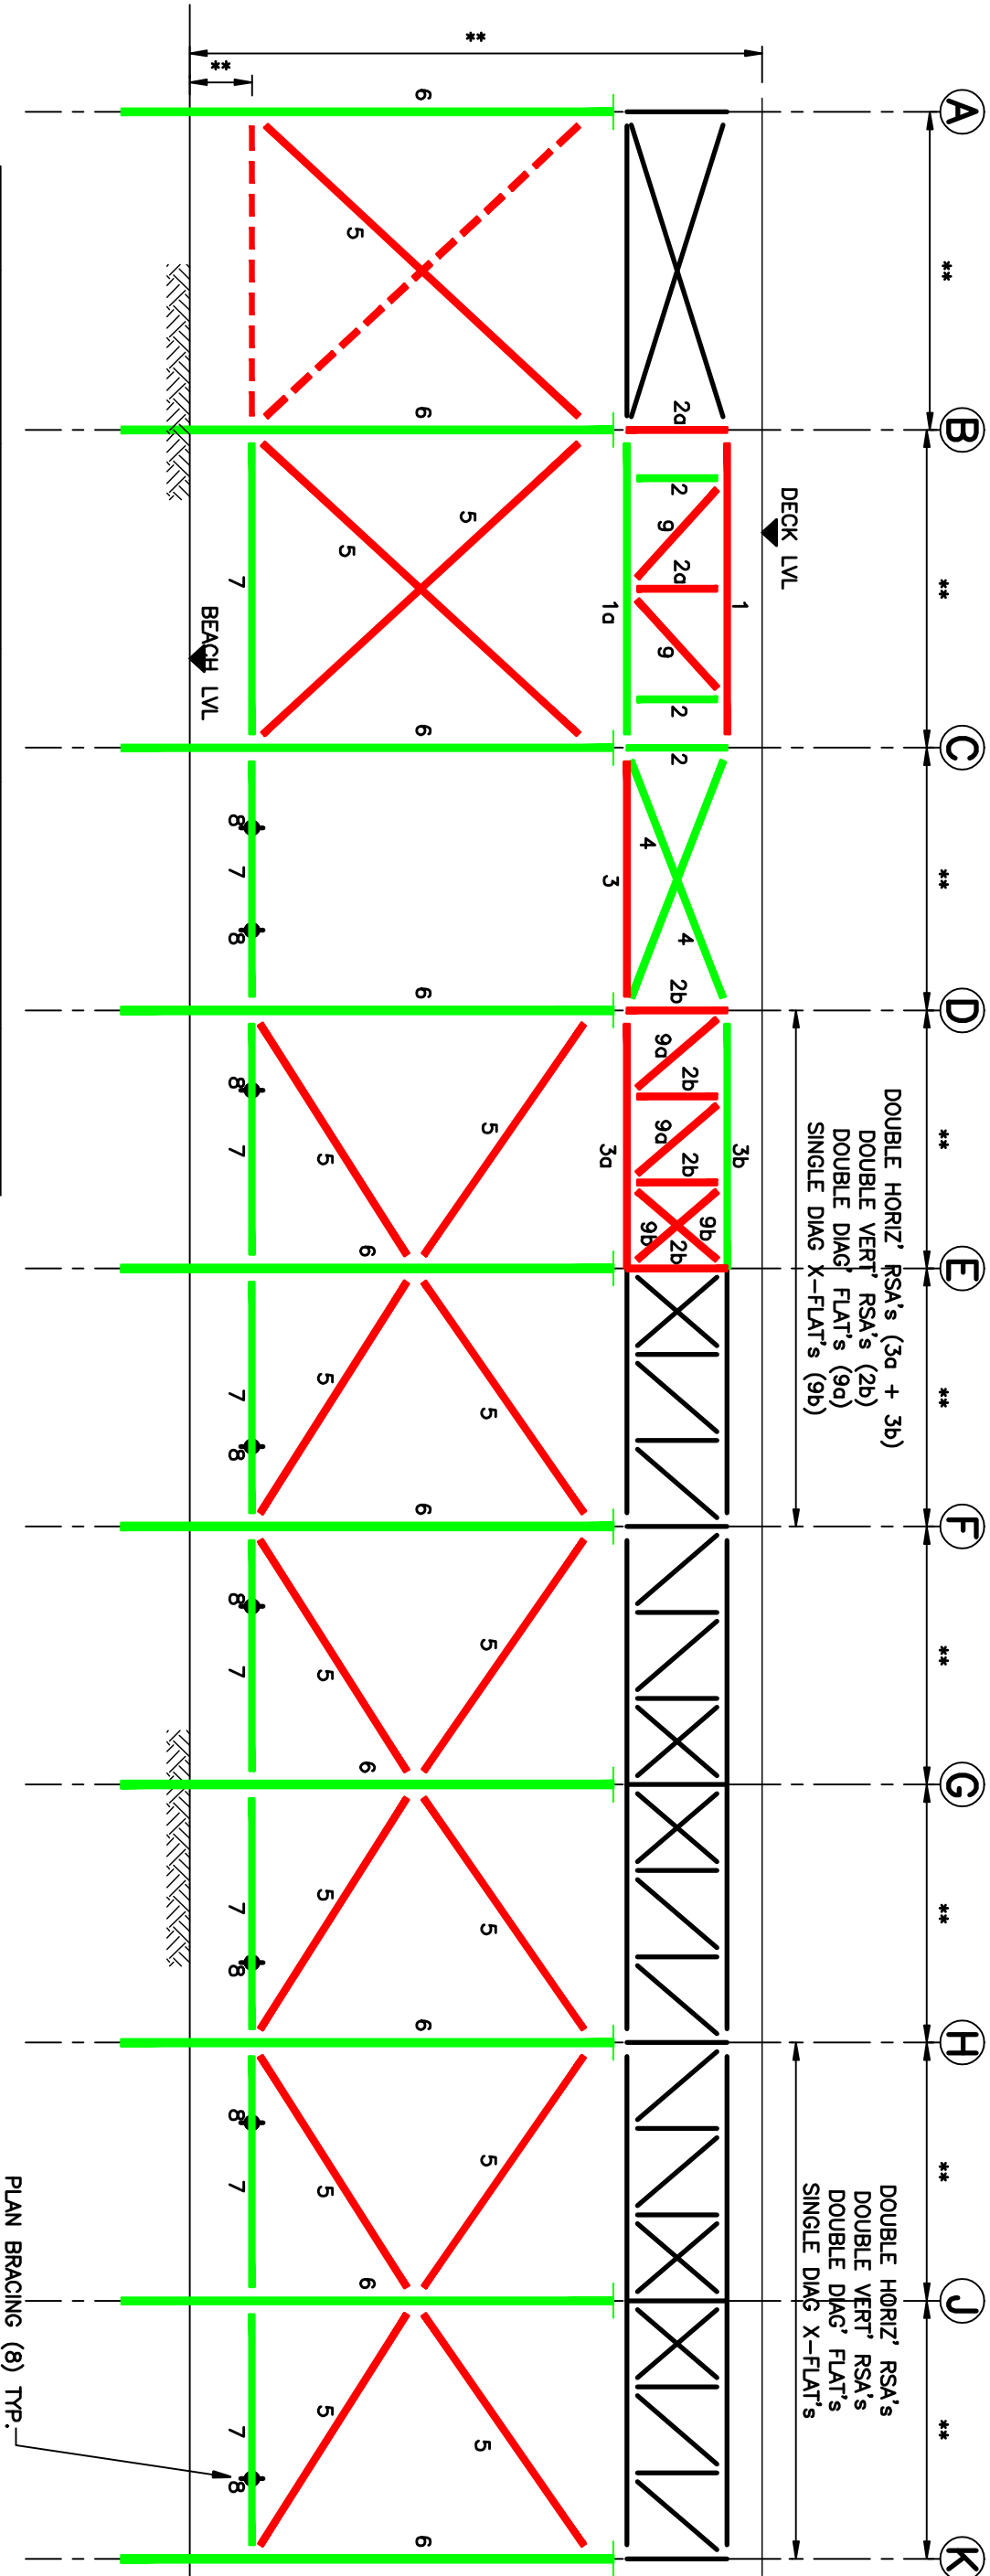
MEMBER	MEMBER TYPE	SECTION	NUMBER OF	NO# FAILED MEMBERS	ACTION
1	T SECTION	165x60x4mm	1	1	REPLACE
1a	T SECTION	150x70x3mm	1	0	BLAST & PAINT
2	RSA (VERT')	75x75x6mm	3	0	BLAST & PAINT
2a	RSA (VERT')	75x75x6mm	2	2	REPLACE
2b	RSA (VERT')	2/ 75x75x7mm	4	4	REPLACE
3	RSA (HORIZ')	100x75mm	1	1	REPLACE
3a	RSA (HORIZ')	2/ 140x130x7mm	1	1	REPLACE
3b	RSA (HORIZ')	2/ 140x130x7mm	1	0	BLAST & PAINT
4	RSA (DIAG')	75x75mm	2	0	BLAST & PAINT
5	BRACING	50mm ø	16	16	REPLACE
6	CHS (COLUMN)	300x25mm	10	0	BLAST & PAINT
7	RAIL	135x65mm	9	0	BLAST & PAINT
8	BAR	38x63mm	8	0	BLAST & PAINT
9	PLATES	100x10mm	2	2	REPLACE
9a	PLATES	150x8mm	2	2	REPLACE
9b	PLATES	150x8mm	2	2	REPLACE

OVERALL VERDICT : REPLACE GIRDER B-C & D-E, REPAIR GIRDER C-D IN-SITU
(FAILURE PREDOMINANTLY OBSERVED DURING VISUAL INSPECTION)

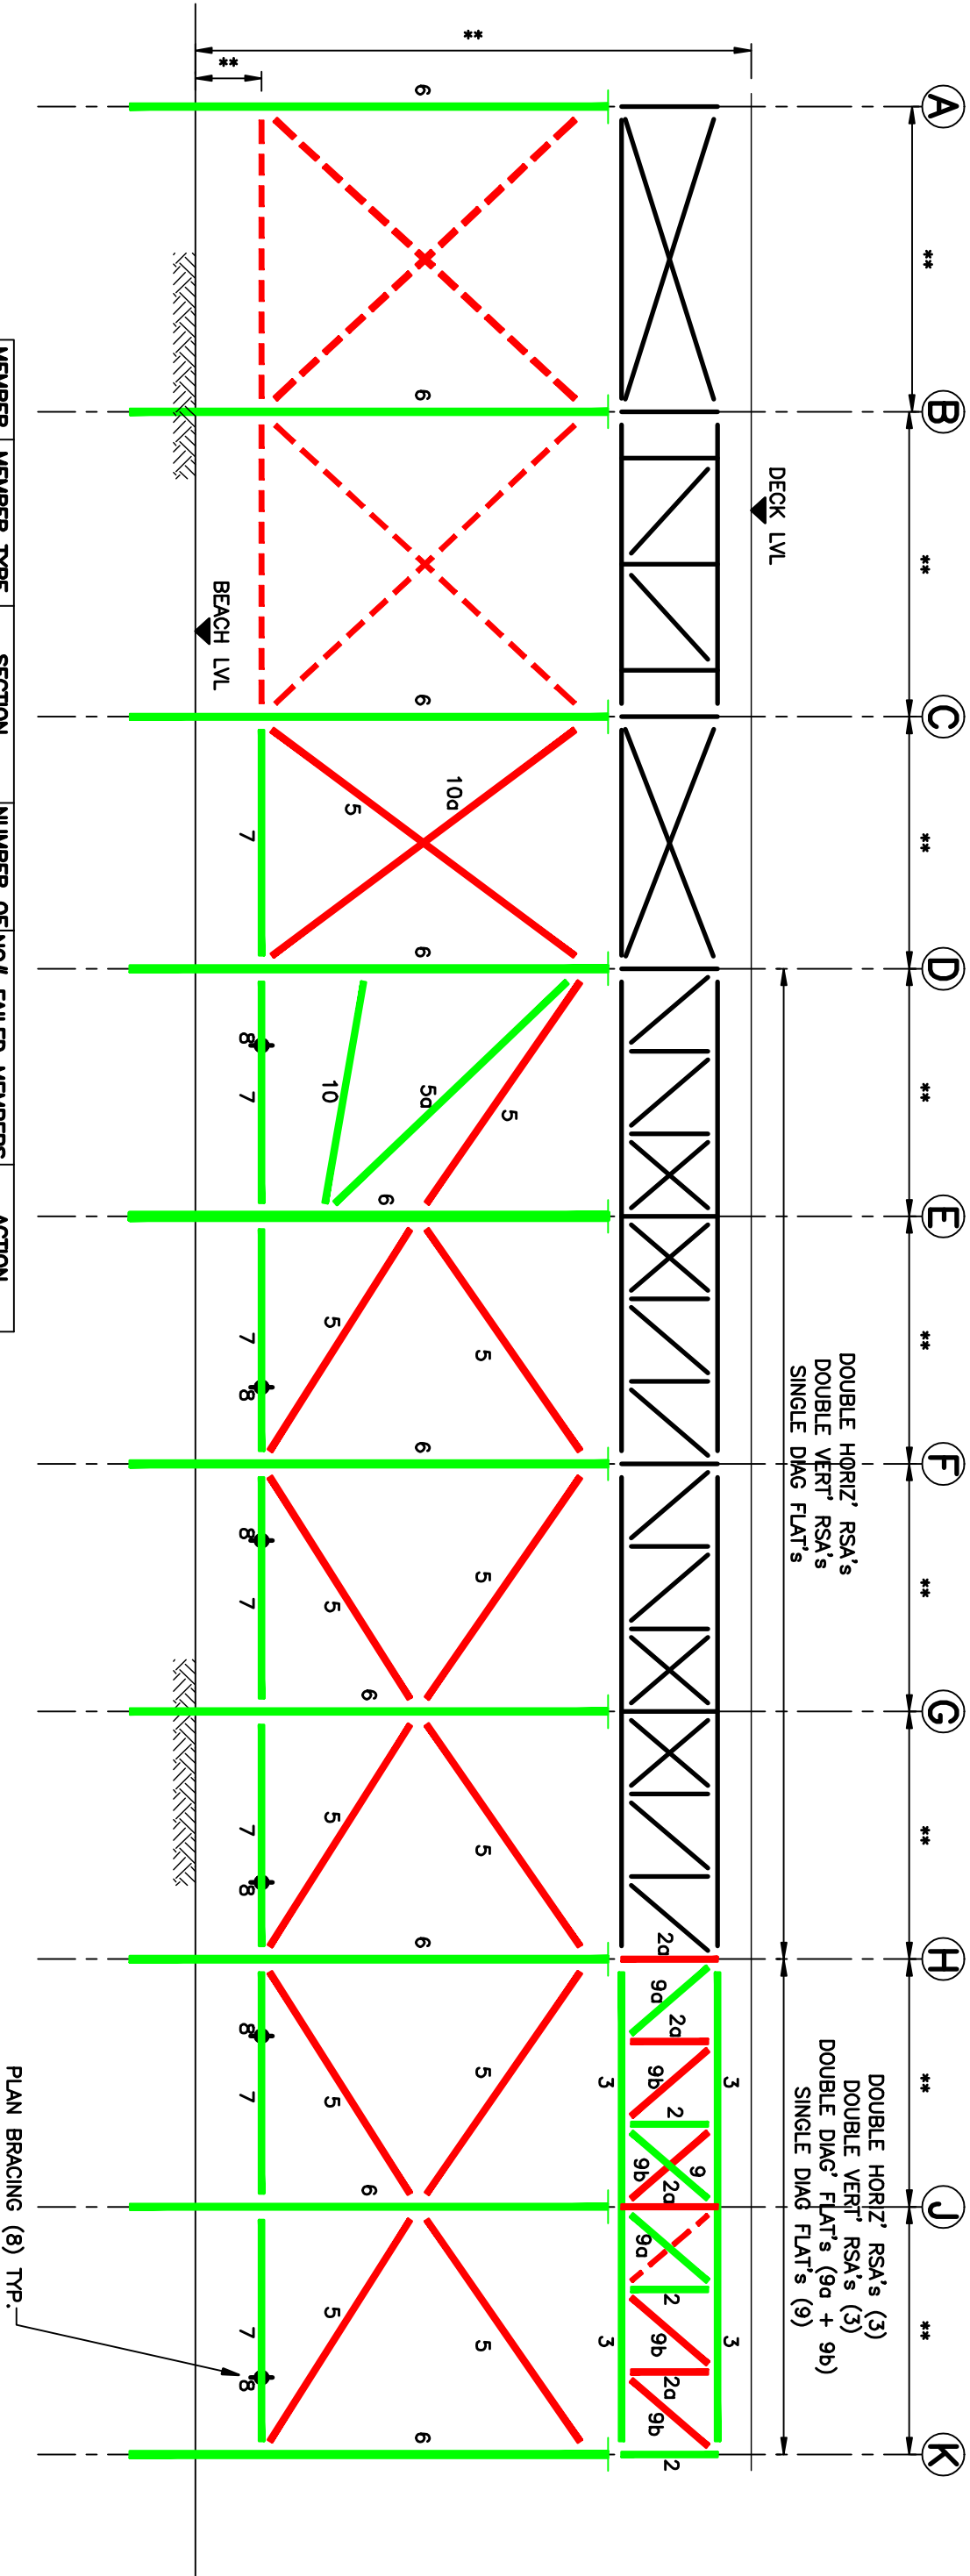
MEMBER	MEMBER TYPE	SECTION	NUMBER OF NO#	FAILED MEMBERS	ACTION
2	RSA (VERT')	2 / 75x75x10mm	3	0	BLAST & PAINT
2a	RSA (VERT')	2 / 75x75x10mm	4	4	REPLACE
3	RSA (HORIZ')	2 / 140x130x8mm	4	0	BLAST & PAINT
5	BRACING	50mm Ø	16	16	REPLACE
5d	BRACING	50mm Ø	1	0	BLAST & PAINT
6	CHS (COLUMN)	300x25mm	10	0	BLAST & PAINT
7	RAIL	135x65mm	7	0	BLAST & PAINT
8	BAR	38x63mm	6	0	BLAST & PAINT
9	FLAT (DIAG')	155x8mm	1	0	BLAST & PAINT
9a	FLAT (DIAG')	2 / 155x8mm	2	0	BLAST & PAINT
9b	FLAT (DIAG')	2 / 155x8mm	4	4	REPLACE
10	PFC	2 / 200x75mm	1	0	BLAST & PAINT
10a	PFC	2 / 200x75mm	1	1	REPLACE

OVERALL VERDICT : REPLACE GIRDER IN-SITU
(FAILURE PREDOMINANTLY OBSERVED DURING VISUAL INSPECTION)

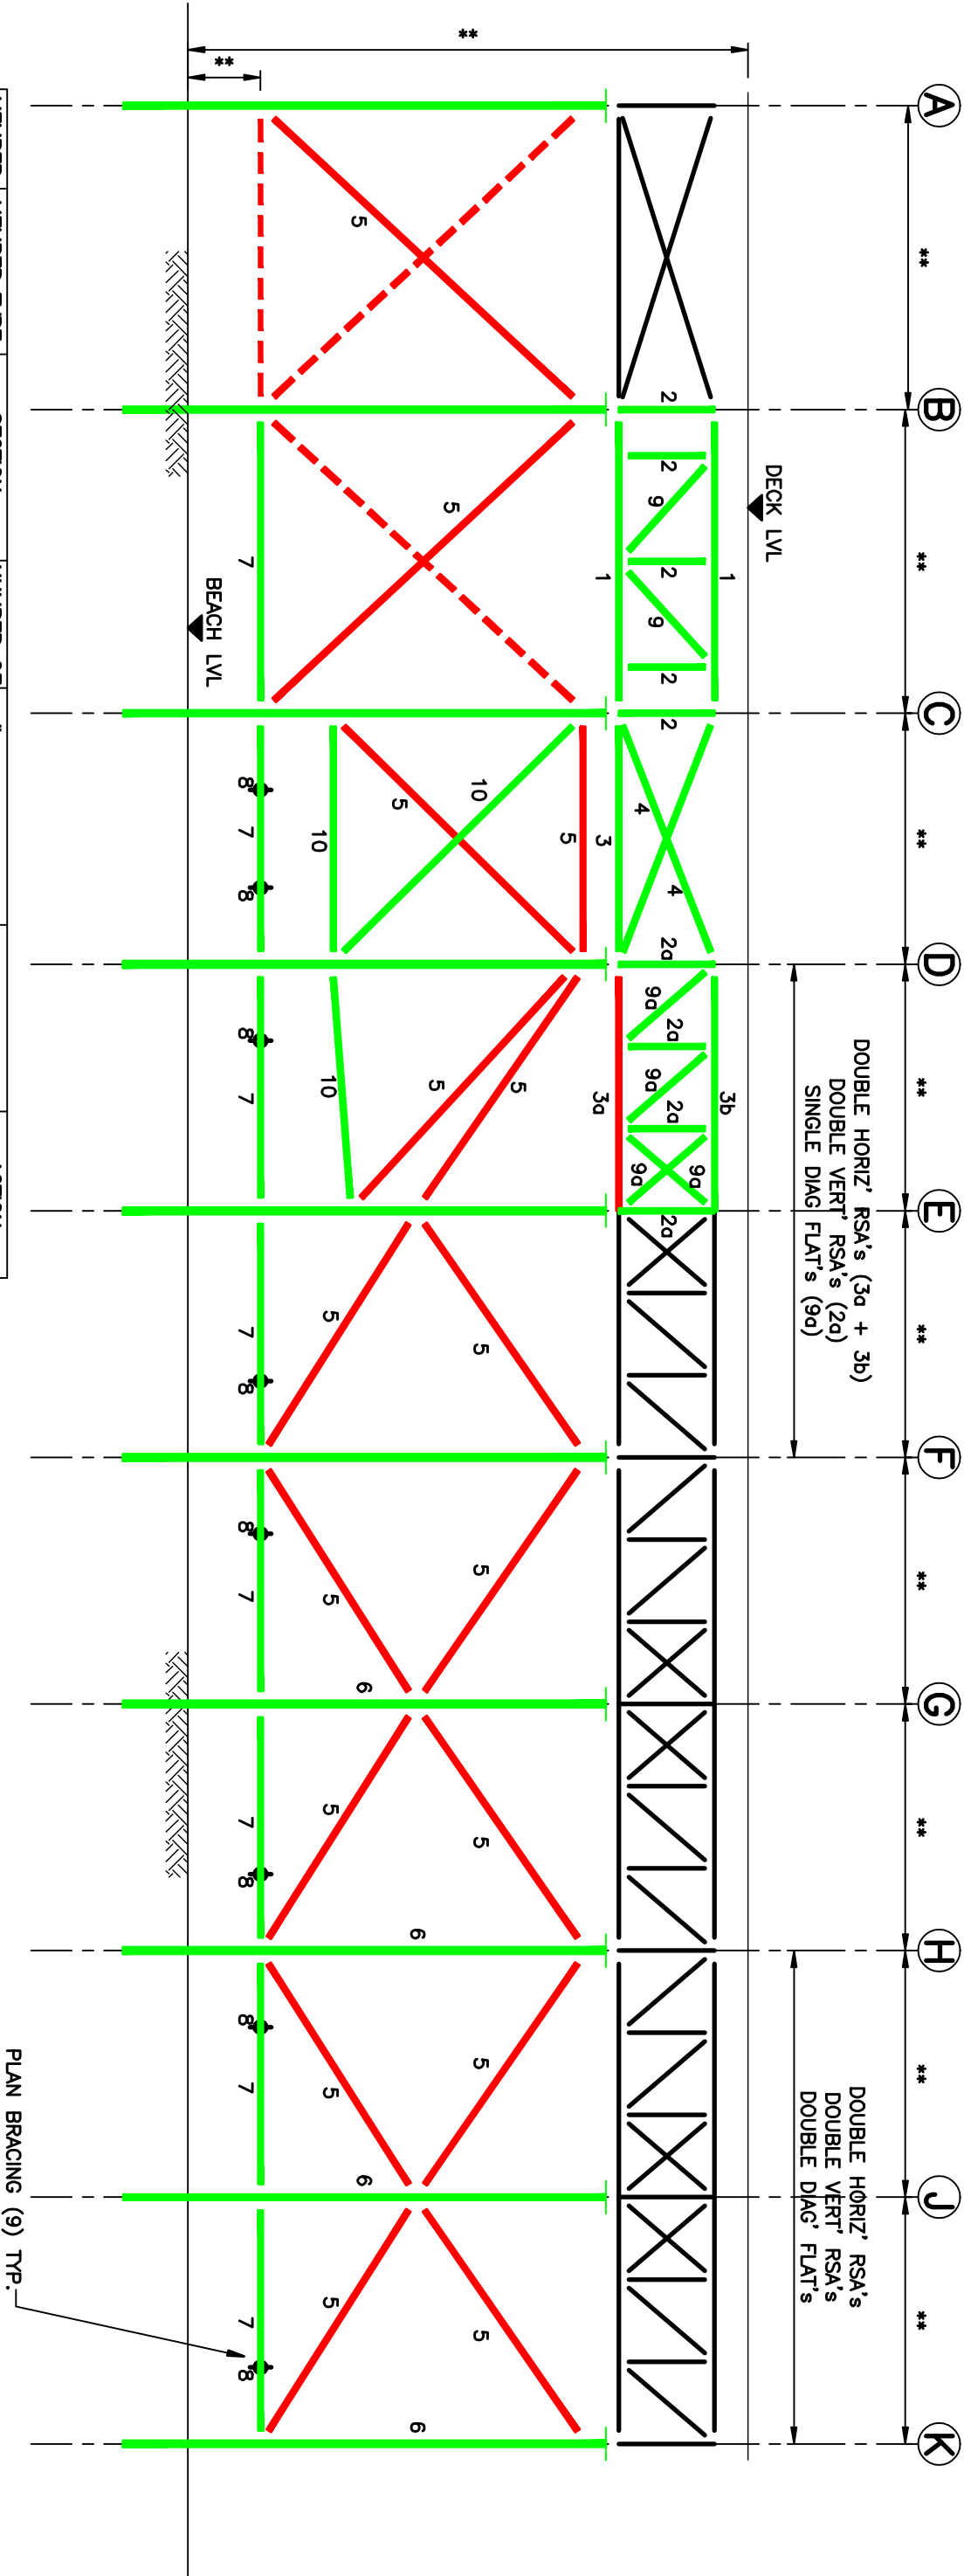
MEMBER	MEMBER TYPE	SECTION	NUMBER OF	NO# FAILED	MEMBERS			ACTION
1	T SECTION	150x100x8mm	2	0				BLAST & PAINT
2	RSA (VERT')	75x75x10mm	5	0				BLAST & PAINT
2a	RSA (VERT')	2/ 75x75x6mm	4	0				BLAST & PAINT
3	RSA (HORIZ')	75x75x8mm	1	0				BLAST & PAINT
3a	RSA (HORIZ')	2/ 100x100x10mm	1	1				REPLACE
3b	RSA (HORIZ')	2/ 100x100x10mm	1	0				BLAST & PAINT
4	RSA (DIAG')	75x75x10mm	2	0				BLAST & PAINT
5	BAR	50mm ø	18	18				REPLACE
6	CHS (COLUMN)	300x25mm	10	0				BLAST & PAINT
7	RAIL	135x65mm	8	0				BLAST & PAINT
8	BAR	38x63mm	8	0				BLAST & PAINT
9	FLAT (DIAG')	100x10mm	2	0				BLAST & PAINT
9a	FLAT (DIAG')	155x12mm	4	0				BLAST & PAINT
10	PFC	2/ 200x75mm	3	0				BLAST & PAINT

OVERALL VERDICT : KEEP GIRDER
(FAILURE PREDOMINANTLY OBSERVED DURING VISUAL INSPECTION)

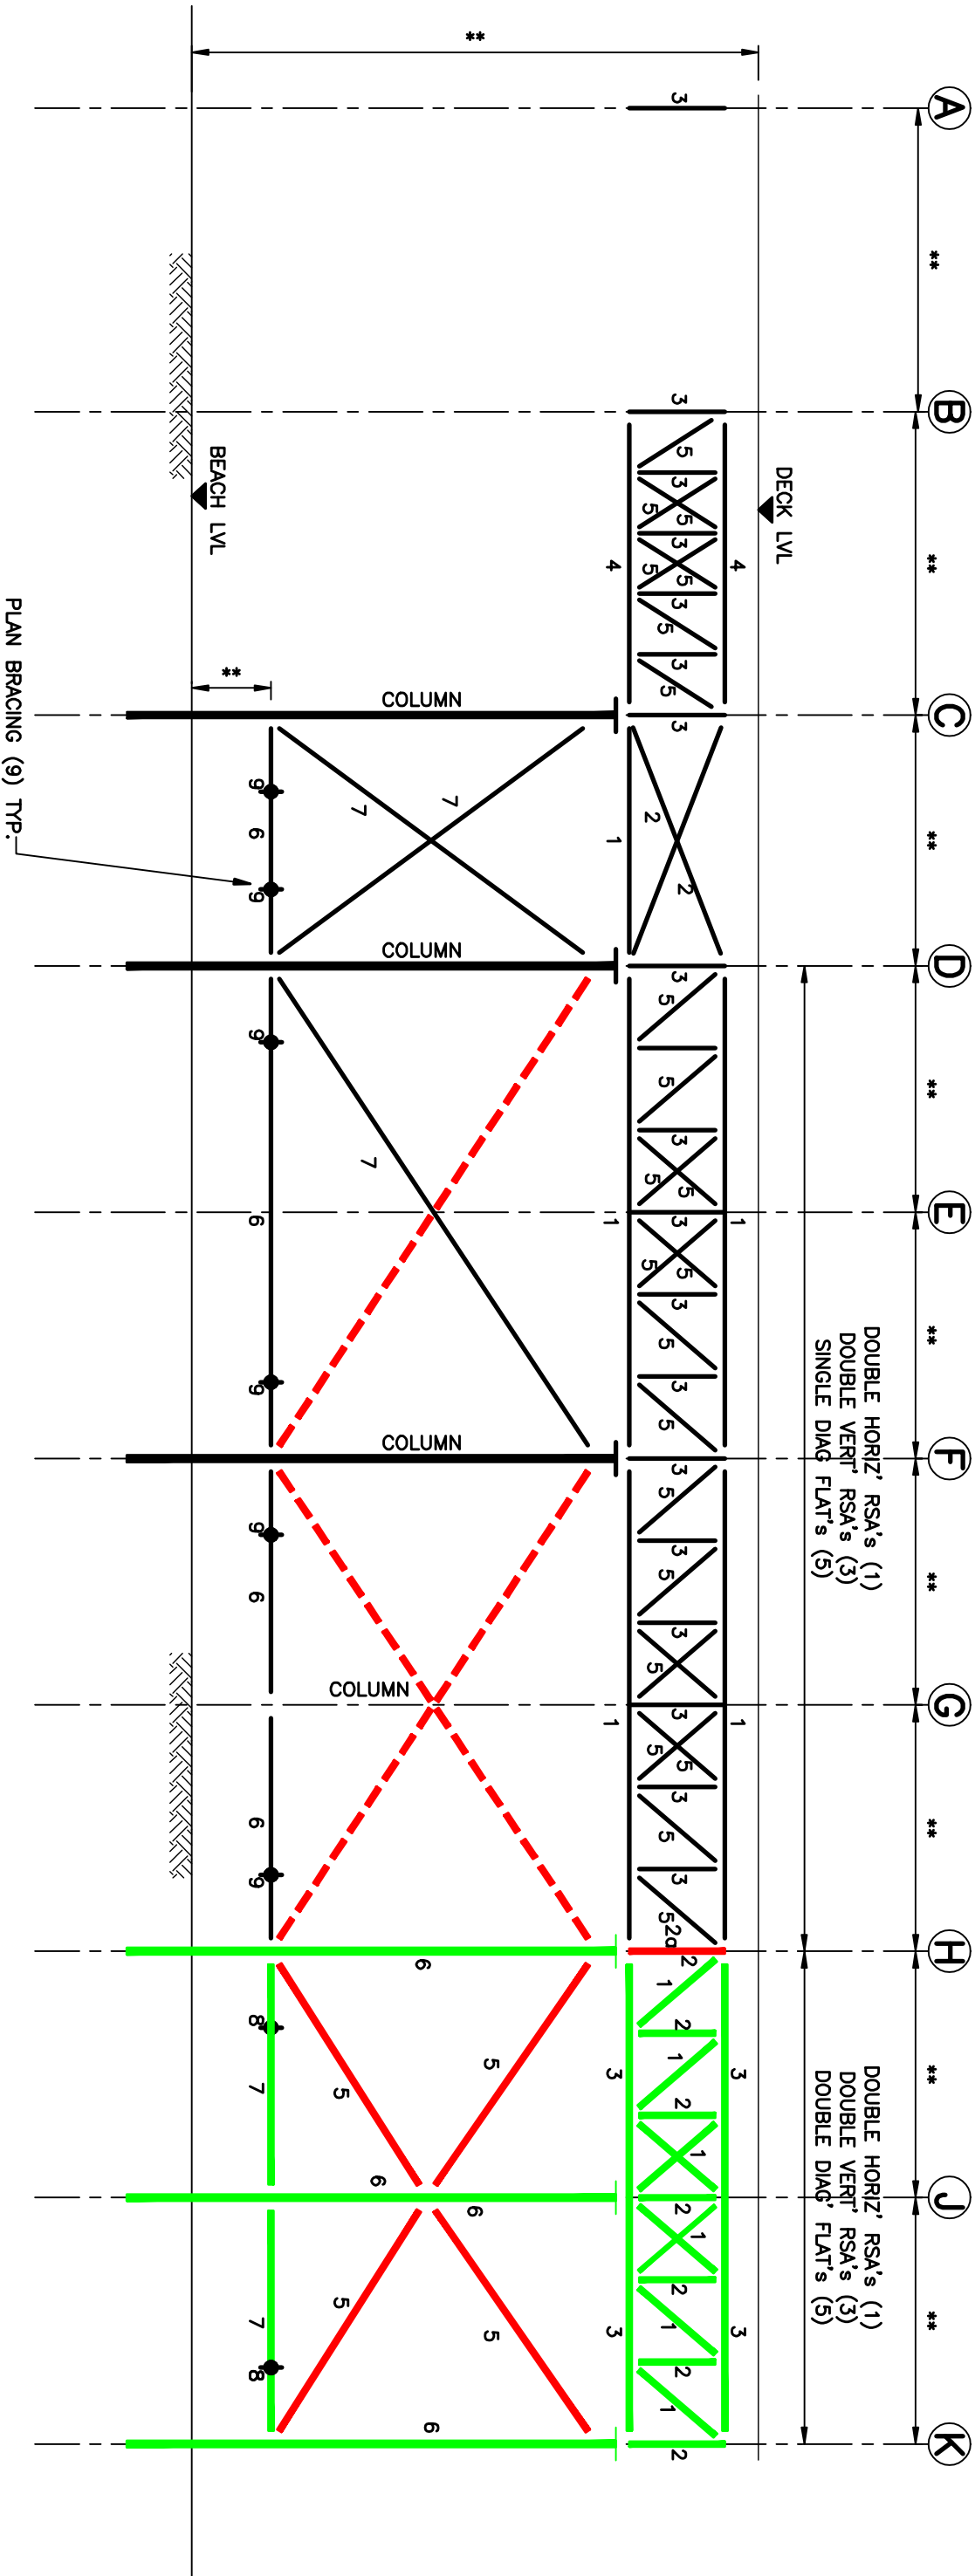
MEMBER	MEMBER TYPE	SECTION	NUMBER OF NO# FAILED MEMBERS	ACTION
1	T SECTION	150x75x10mm	8	BLAST & PAINT
2	RSA (2)	90x75mm	7	REPLACE
3	RSA (2)	100x125mm	4	BLAST & PAINT
5	BRACING	50mm Ø	4	REPLACE
6	CHS (COLUMN)	300x25mm	3	BLAST & PAINT
7	RAIL	135x65mm	2	BLAST & PAINT
8	BAR	38x63mm	2	BLAST & PAINT

OVERALL VERDICT : REPLACE GIRDER
(FAILURE PREDOMINANTLY OBSERVED DURING VISUAL INSPECTION)

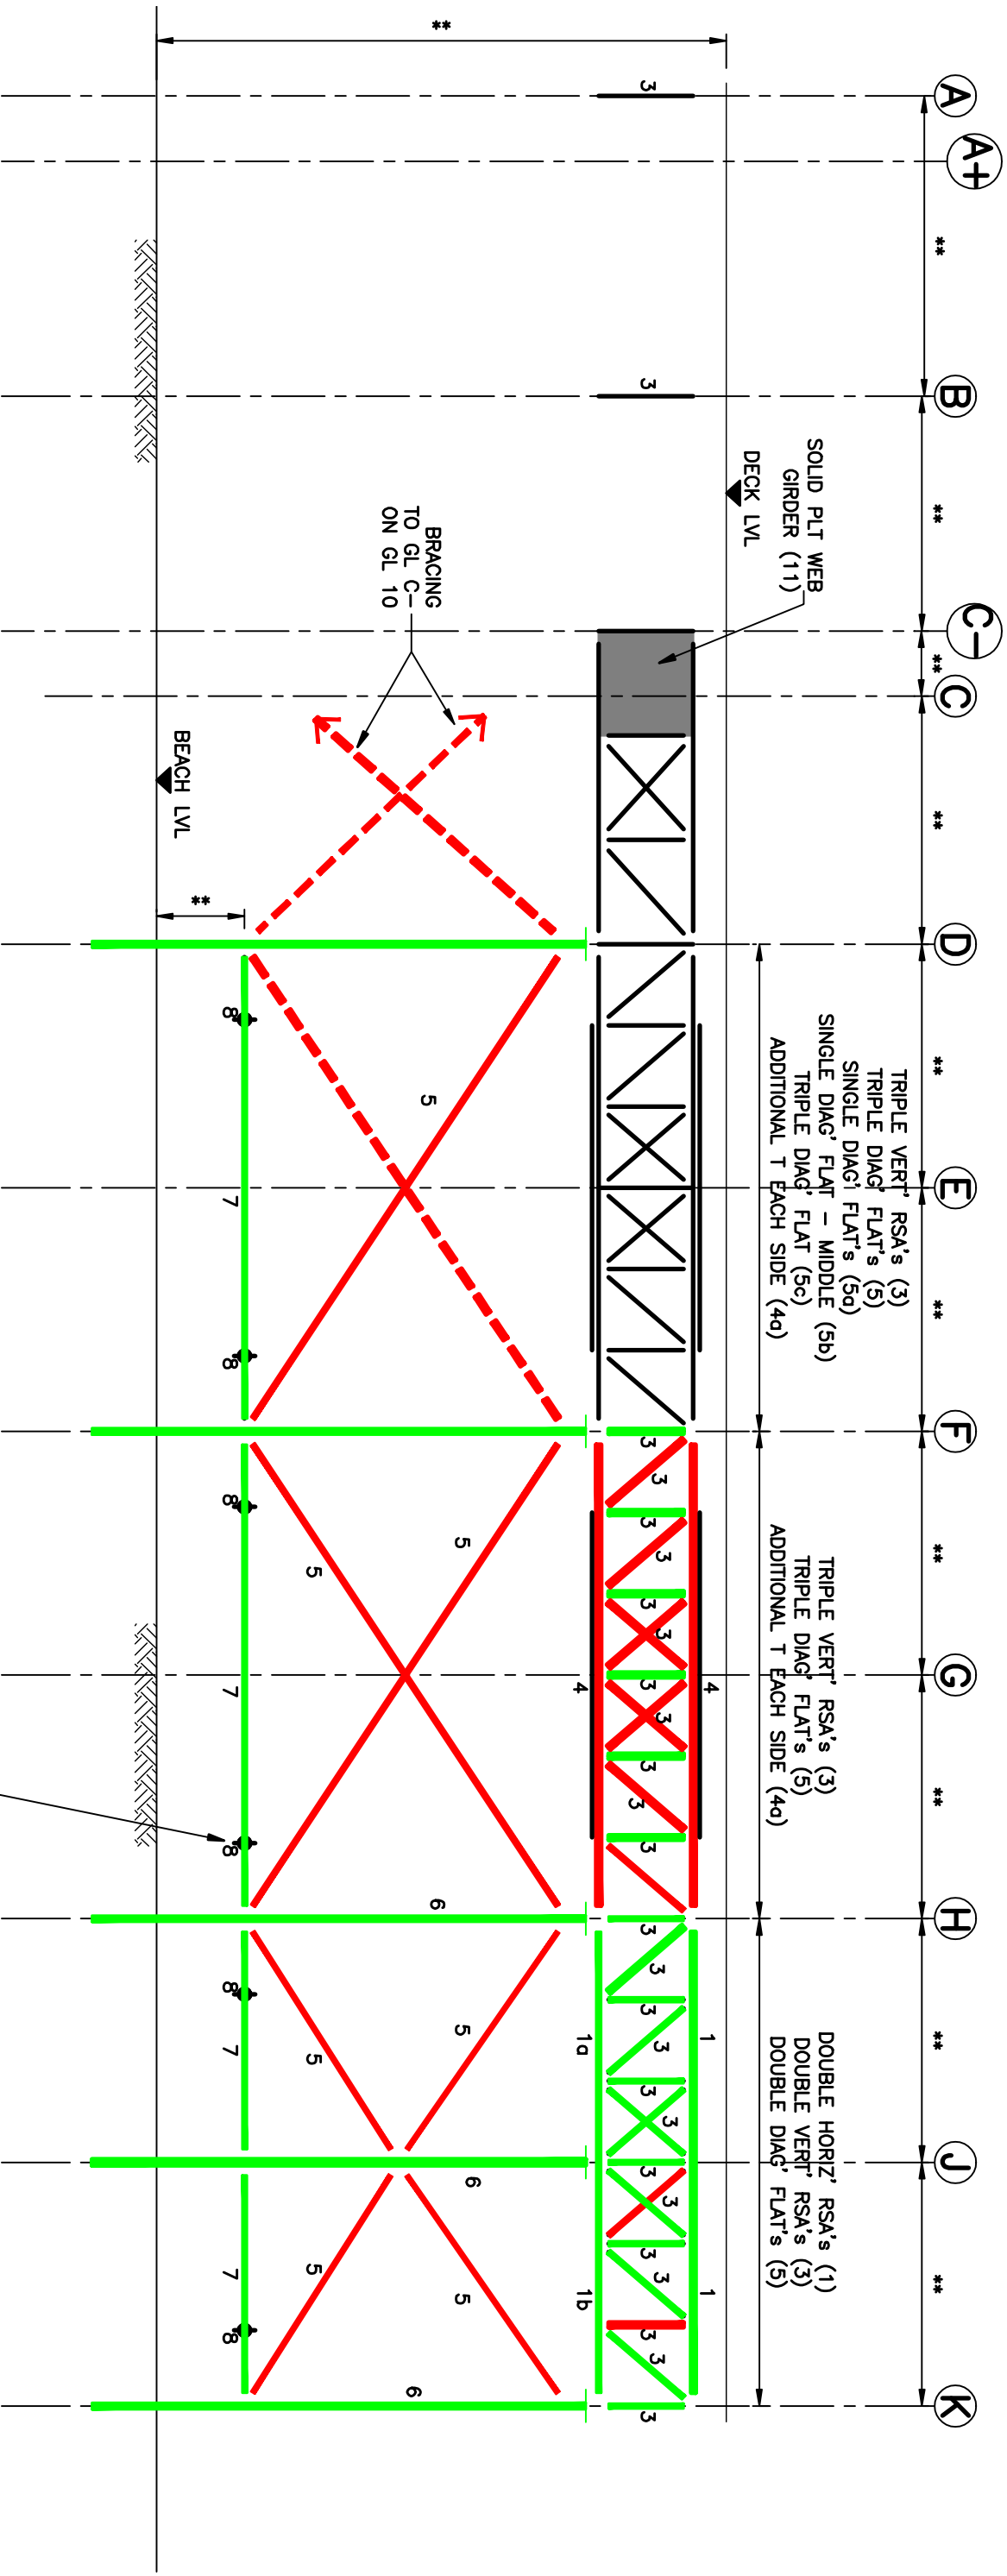
MEMBER	MEMBER TYPE	SECTION	NUMBER OF NO#	FAILED MEMBERS	ACTION
1	RSA	100x100mm	1	0	BLAST & PAINT
1a	RSA	150x10mm	1	0	BLAST & PAINT
1b	RSA	125x75x10mm	1	0	BLAST & PAINT
3	RSA (2)	75x65x5mm	29	10	REPLACE
5	BRACING	50mm ø	4	4	REPLACE
6	CHS (COLUMN)	300x25mm	3	0	BLAST & PAINT
7	RAIL	135x65mm	2	2	REPLACE

OVERALL VERDICT : REPAIR GIRDER H-K, REPLACE GIRDER F-H
(FAILURE PREDOMINANTLY OBSERVED DURING VISUAL INSPECTION)

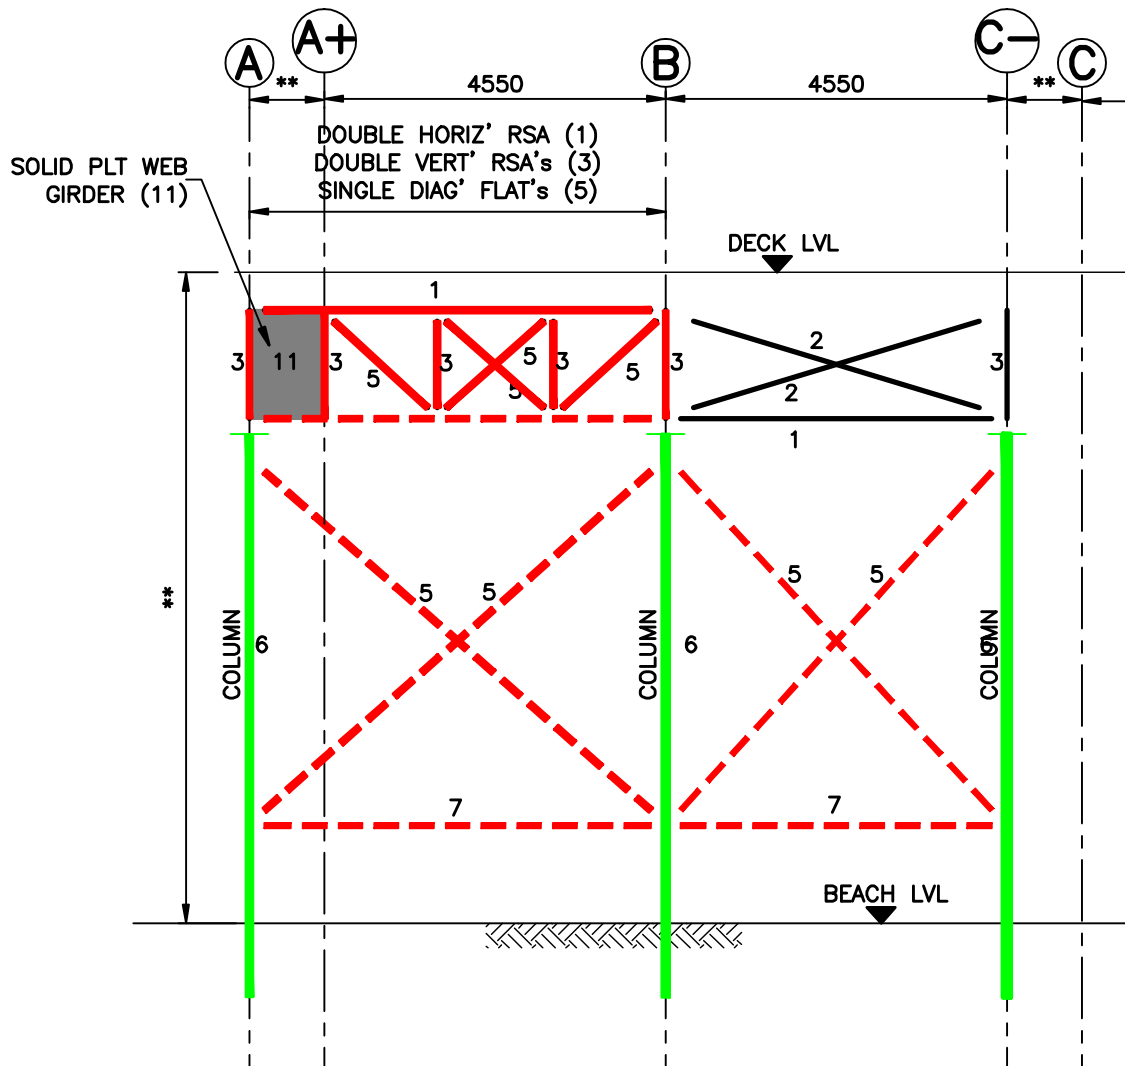
MEMBER	MEMBER TYPE	SECTION	NUMBER OF	NO# FAILED MEMBERS	ACTION
1	RSA	90x90mm	1	0	BLAST & PAINT
2	RSA	100x100mm	2	0	BLAST & PAINT
3	RSA	75x65x10mm	5	5	REPLACE
5	BRACING	50mm Ø	4	4	REPLACE
6	CHS (COLUMN)	300x25mm	3	0	BLAST & PAINT
7	RAIL	135x65mm	2	2	REPLACE

**OVERALL VERDICT : REPLACE GIRDER
(MEMBERS GENERALLY IN TACT DURING VISUAL INSPECTION BUT
FAILED DURING ANALYSIS)**

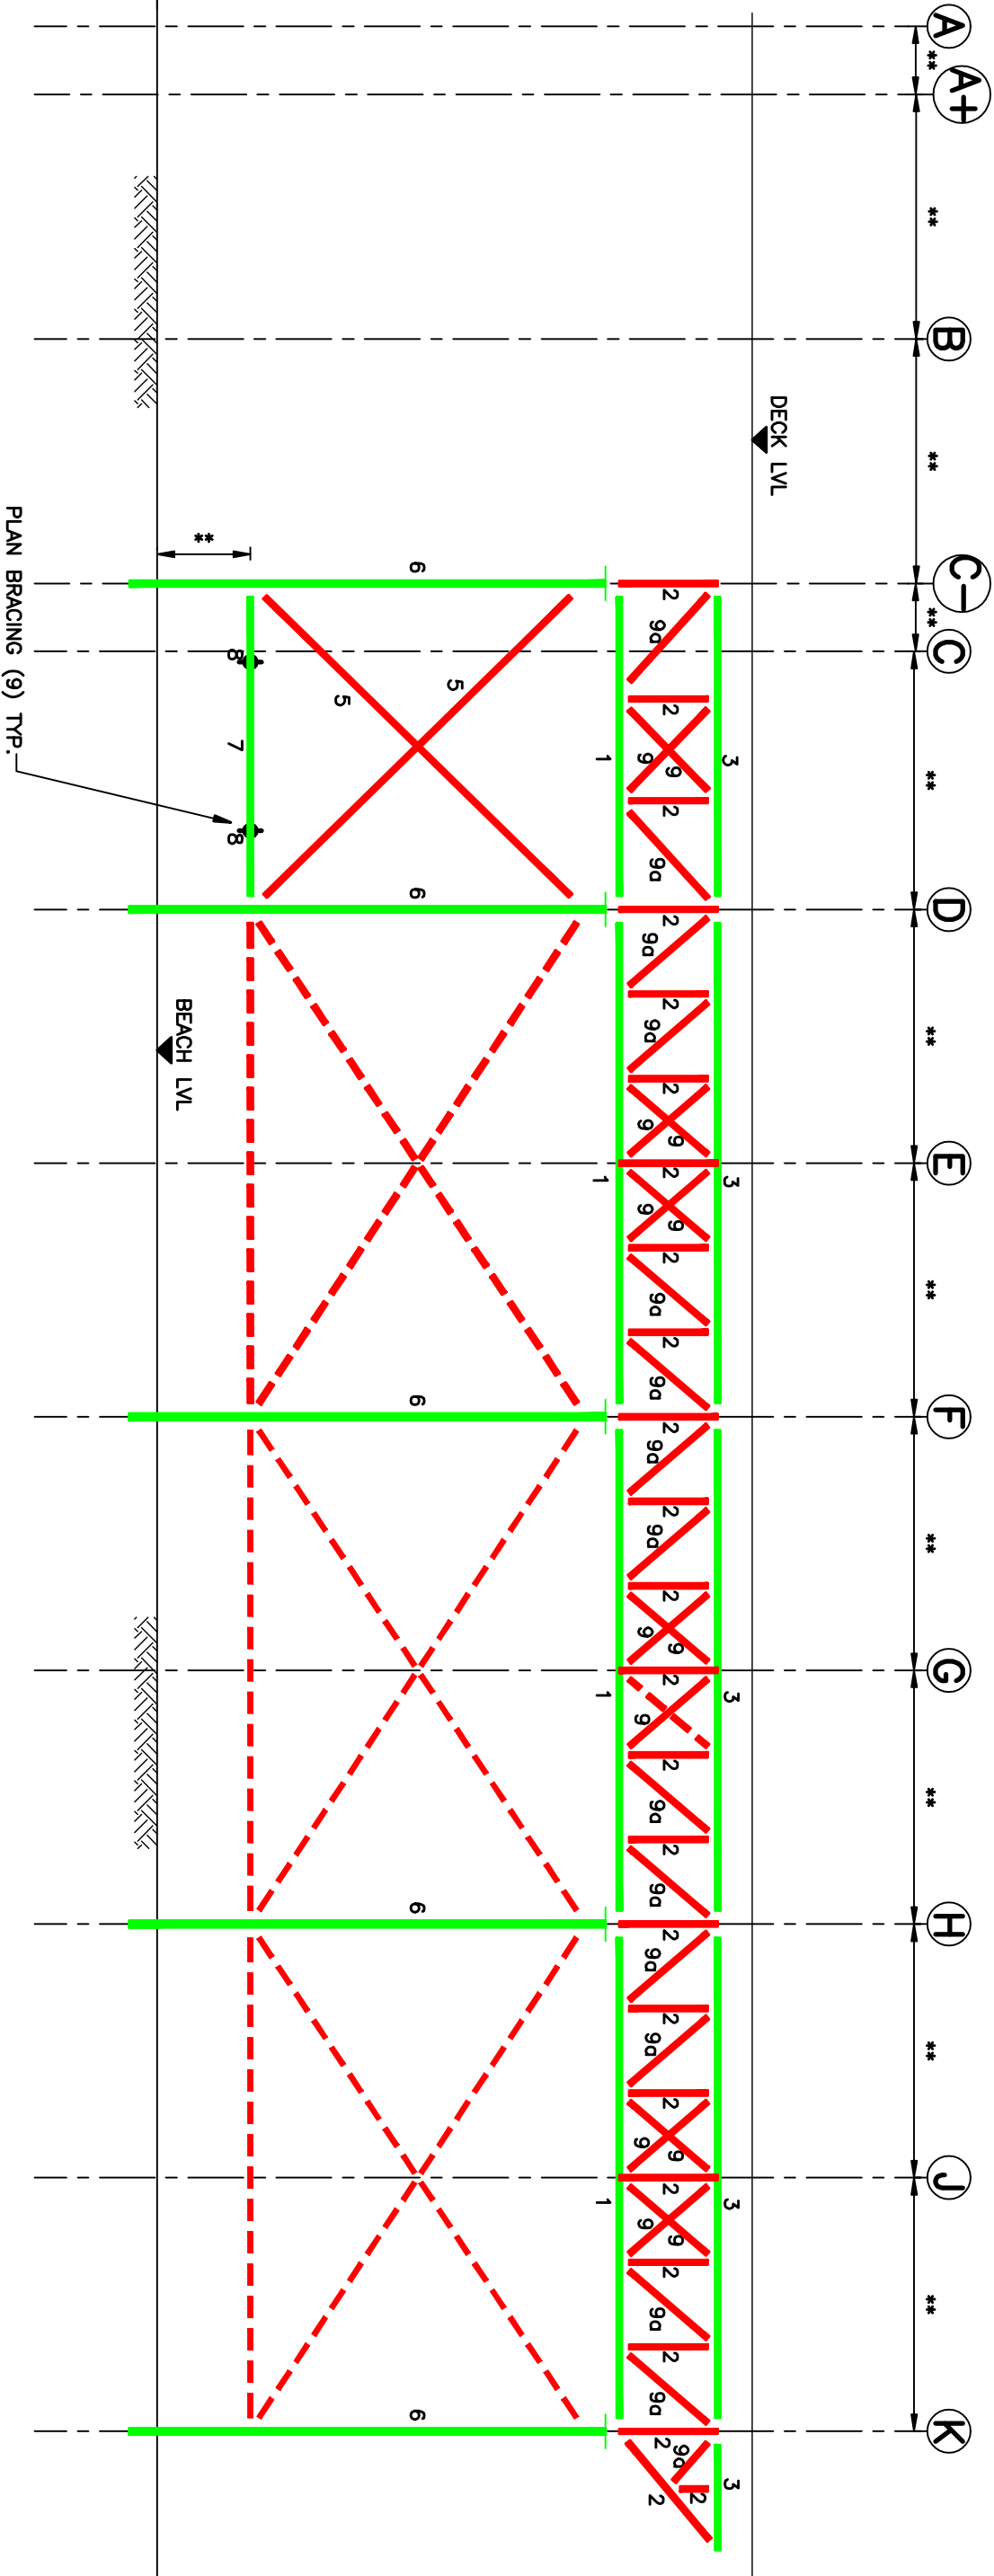
MEMBER	MEMBER TYPE	SECTION	NUMBER OF	NO# FAILED MEMBERS	ACTION
3	RSA (2)	90x90mm	5	0	BLAST & PAINT
9	PLATES	125x10mm	14	14	REPLACE
9a	PLATES	75x10mm	14	14	REPLACE
2	T SECTION	155x110mm	4	0	BLAST & PAINT
2a	RSA	75x65mm	23	23	REPLACE
5	BRACING	50mm Ø	8	8	REPLACE
6	CHS (COLUMN)	300x25mm	5	0	BLAST & PAINT
7	RAIL	135x65mm	4	3	REPLACE

OVERALL VERDICT : REPLACE GIRDER
(FAILURE PREDOMINANTLY OBSERVED DURING VISUAL INSPECTION)

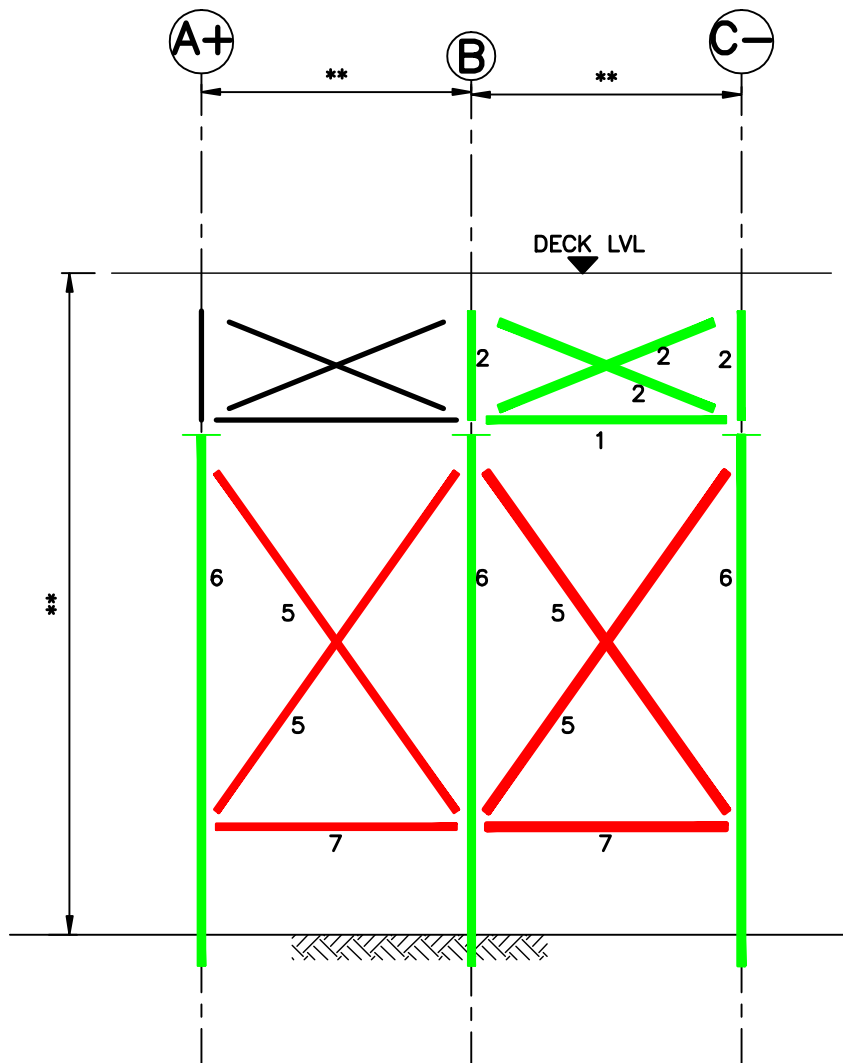
MEMBER	MEMBER TYPE	SECTION	NUMBER OF	NO# FAILED MEMBERS	ACTION
1	RSA	90x90mm	1	0	BLAST & PAINT
2	RSA	100x100mm	2	0	BLAST & PAINT
5	BRACING	50mm ϕ	2	2	REPLACE
6	CHS (COLUMN)	300x25mm	2	0	BLAST & PAINT
7	RAIL	135x65mm	2	2	REPLACE

**OVERALL VERDICT : REPLACE GIRDER
(MEMBERS GENERALLY IN TACT DURING VISUAL INSPECTION BUT
FAILED DURING ANALYSIS)**
