STRUCTURAL APPRAISAL

VICTORIA PIER, COLWYN BAY

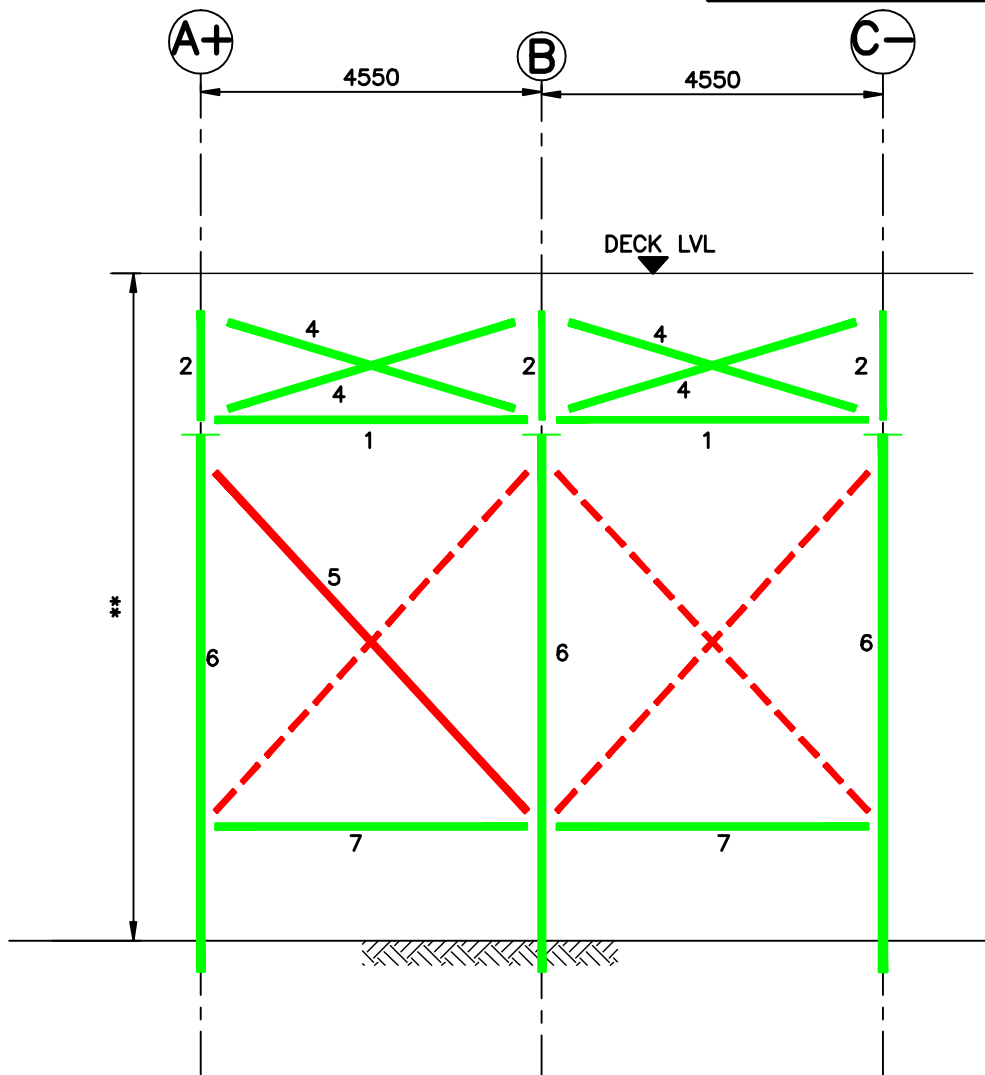
MEMBER	MEMBER TYPE	SECTION	NUMBER OF	INSPECTION RESULT	ANALYSIS RESULT	ACTION
1	T SECTION	100x100x6mm	2	ALL OK		BLAST & PAINT
2	RSA (VERT')	100x100mm	3	ALL OK		BLAST & PAINT
4	RSA (DIAG')	100x100x8mm	4	ALL OK		BLAST & PAINT
5	BAR	50mm ϕ	4	FAILED		REPLACE
6	CHS (COLUMN)	300x25mm	3	ALL OK		BLAST & PAINT
7	RAIL	135x65mm	2	OK		BLAST & PAINT

OVERALL VERDICT : REPAIR IN-SITU

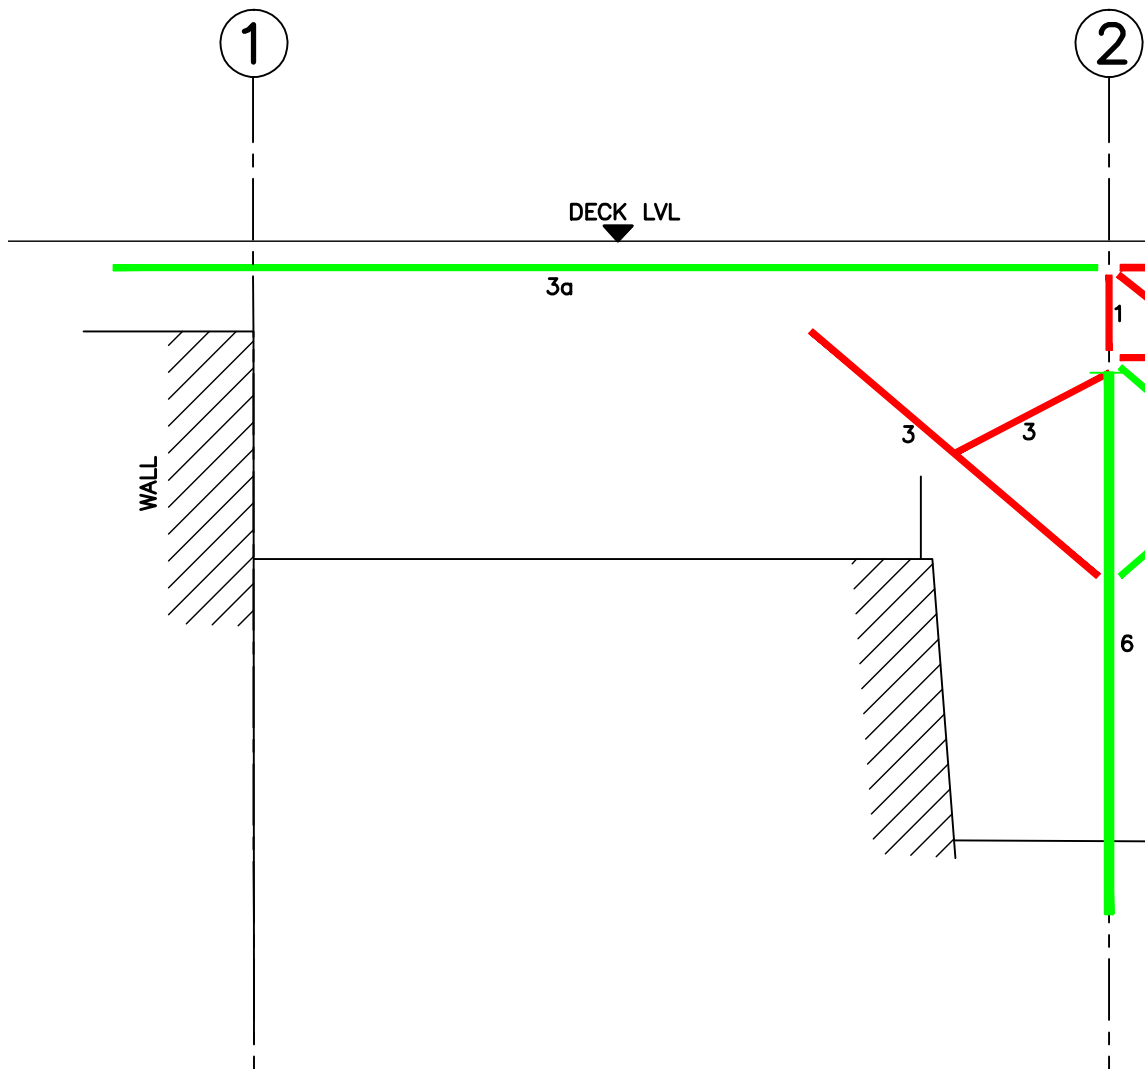
MEMBER	MEMBER TYPE	SECTION	NUMBER OF	NO# FAILED MEMBERS	ACTION
3	UB	152x152mm	2	2	REPLACE
3a	UB	456x191mm	1	0	BLAST & PAINT
6	CHS (COLUMN)	300x25mm	1	0	BLAST & PAINT

**OVERALL VERDICT : REPLACE GIRDER
(MEMBERS GENERALLY IN TACT DURING VISUAL INSPECTION BUT
FAILED DURING ANALYSIS)**

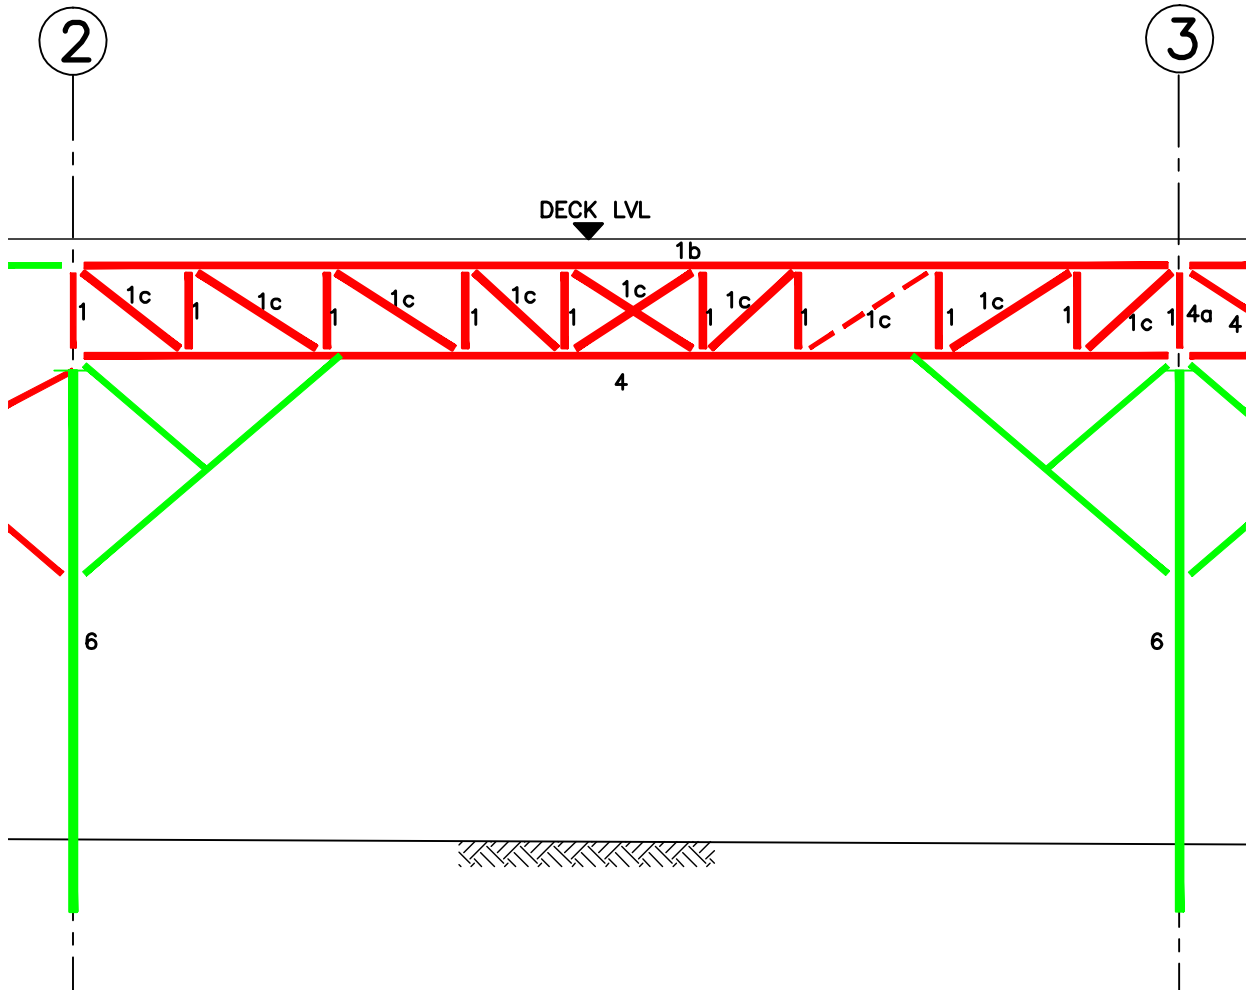
MEMBER	MEMBER TYPE	SECTION	NUMBER OF	NO# FAILED MEMBERS	ACTION
1	T SECTION	100x60mm	1	1	REPLACE
1b	T SECTION	380x160mm	1	1	REPLACE
1c	T SECTION	100x80mm	10	10	REPLACE
4	RSA (DIAG')	180x90x10mm	1	1	REPLACE
6	CHS (COLUMN)	300x25mm	1	0	BLAST & PAINT

**OVERALL VERDICT : REPLACE GIRDER
(FAILURE PREDOMINANTLY OBSERVED DURING VISUAL INSPECTION)**

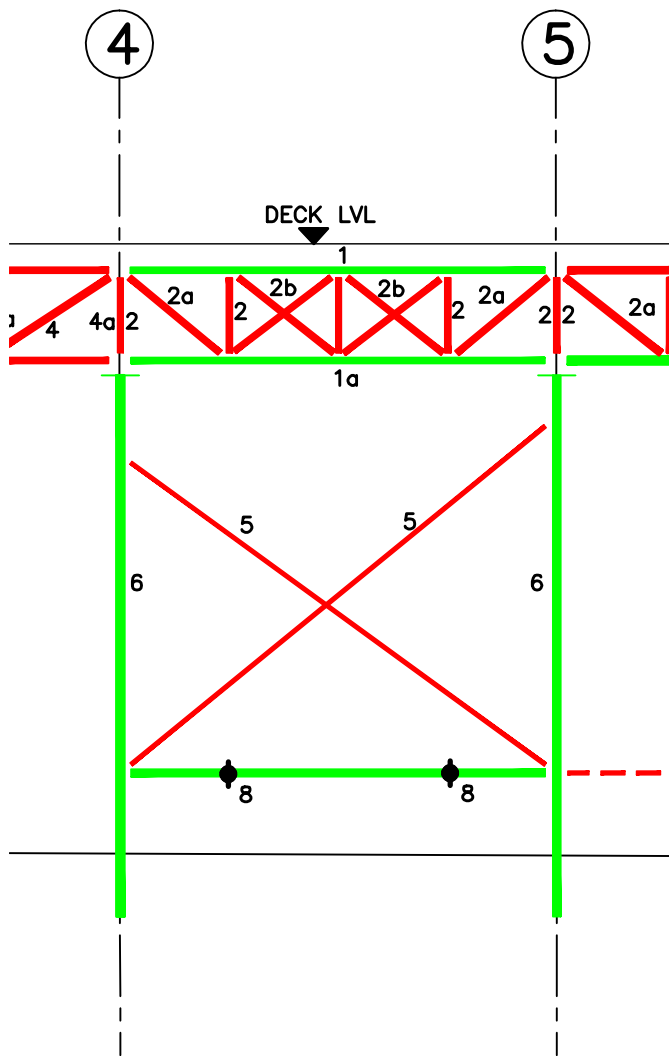
MEMBER	MEMBER TYPE	SECTION	NUMBER OF	NO# FAILED MEMBERS	ACTION
1	T SECTION	130x100mm	1	0	BLAST & PAINT
1a	T SECTION	100x100mm	1	0	BLAST & PAINT
2	RSA (2)	80x80mm	5	5	BLAST & PAINT
2a	PLATES	150x8mm	5	5	BLAST & PAINT
2b	PLATES	75x6mm	4	4	BLAST & PAINT
5	BRACING	50mm ϕ	2	2	REPLACE
6	CHS (COLUMN)	300x25mm	2	0	BLAST & PAINT
7	RAIL	135x65mm	1	0	BLAST & PAINT
8	BARS	38x63mm	2	0	BLAST & PAINT

OVERALL VERDICT : REPLACE GIRDER
(MEMBERS GENERALLY IN TACT DURING VISUAL INSPECTION BUT
FAILED DURING ANALYSIS)

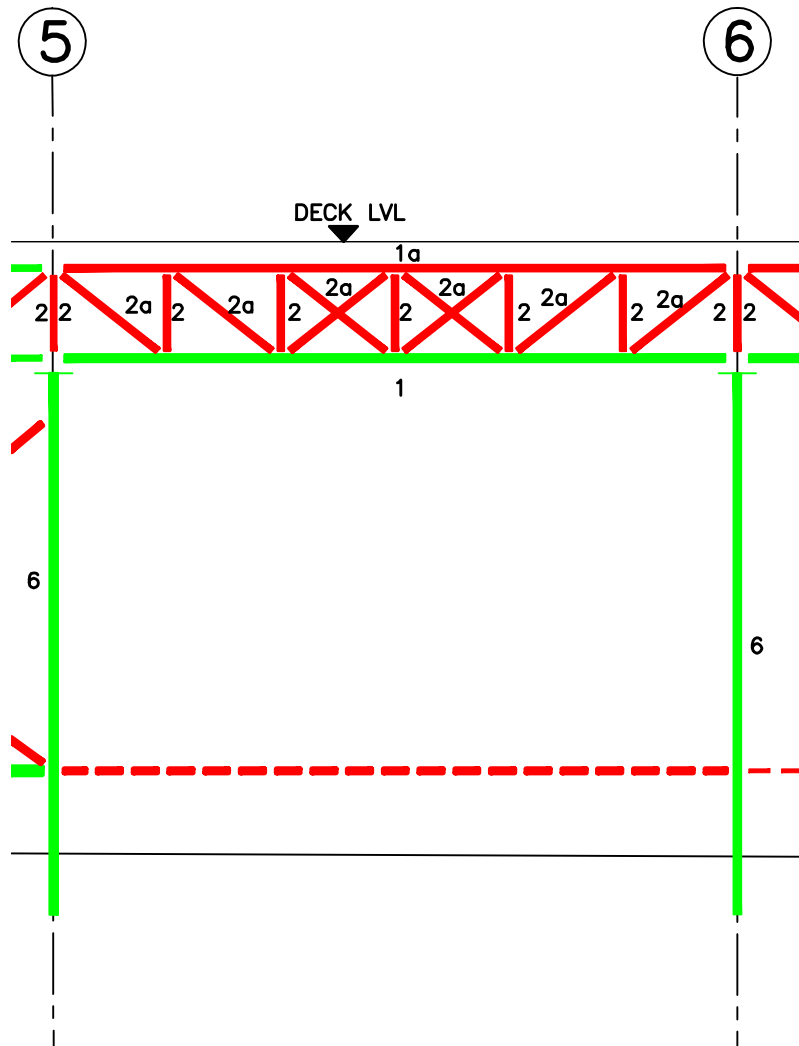
MEMBER	MEMBER TYPE	SECTION	NUMBER OF	NO# FAILED MEMBERS	ACTION
1	T SECTION	100x100mm	1	0	BLAST & PAINT
1a	T SECTION	155x110mm	1	1	REPLACE
2	RSA (2)	75x50mm	7	7	REPLACE
2a	PLATES	75x6mm	8	8	REPLACE
6	CHS (COLUMN)	300x25mm	2	0	BLAST & PAINT

**OVERALL VERDICT : REPLACE GIRDER
(FAILURE PREDOMINANTLY OBSERVED DURING VISUAL INSPECTION)**

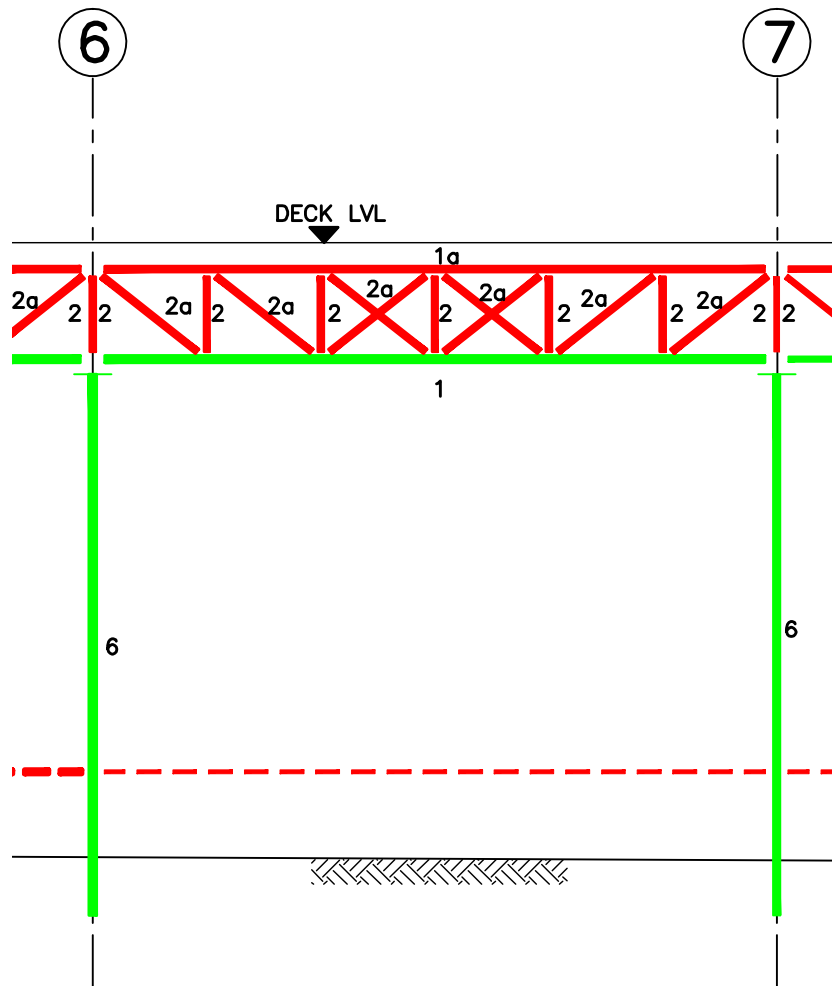
MEMBER	MEMBER TYPE	SECTION	NUMBER OF	NO# FAILED MEMBERS	ACTION
1	T SECTION	100x100mm	1	0	REPLACE
1a	T SECTION	155x110mm	1	1	REPLACE
2	RSA (2)	75x50mm	7	7	REPLACE
2a	PLATES	75x6mm	8	8	REPLACE
6	CHS (COLUMN)	300x25mm	2	0	BLAST & PAINT

**OVERALL VERDICT : REPLACE GIRDER
(FAILURE PREDOMINANTLY OBSERVED DURING VISUAL INSPECTION)**

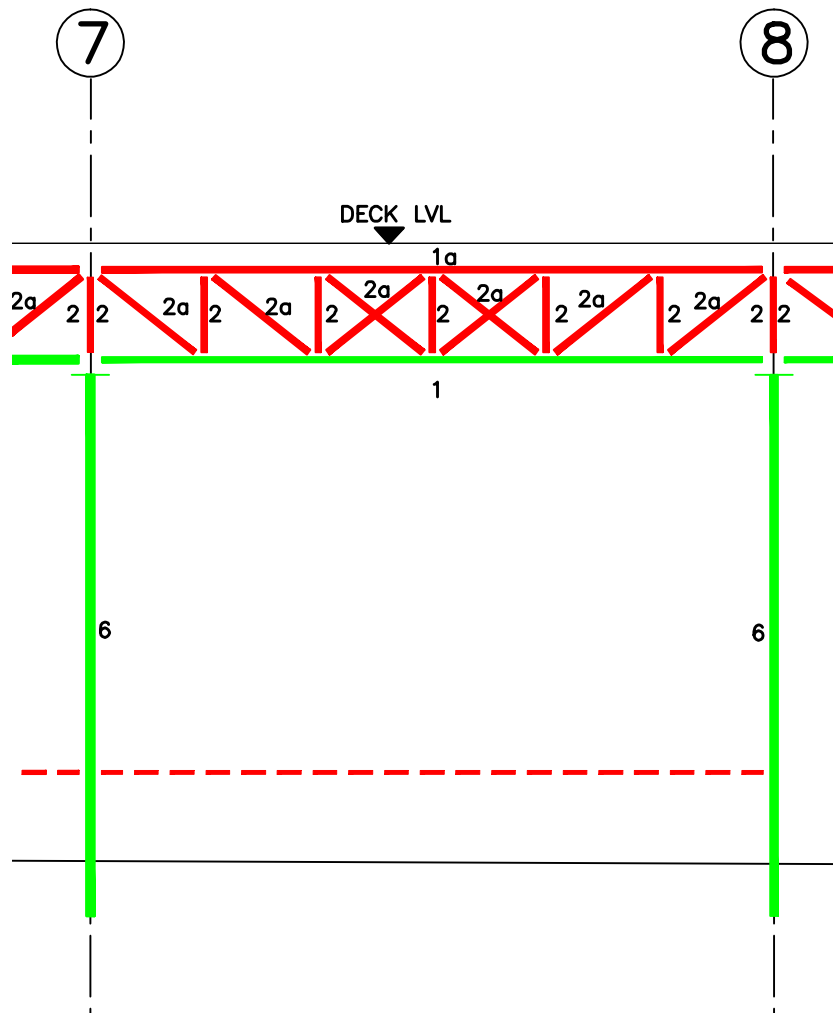
MEMBER	MEMBER TYPE	SECTION	NUMBER OF	NO# FAILED MEMBERS	ACTION
1	T SECTION	310x125mm	1	0	REPLACE
1a	T SECTION	100x60mm	1	1	REPLACE
2	RSA (2)	80x80mm	7	7	REPLACE
2a	RSA	80x80mm	8	8	REPLACE
6	CHS (COLUMN)	300x25mm	2	0	BLAST & PAINT

**OVERALL VERDICT : REPLACE GIRDER
(FAILURE PREDOMINANTLY OBSERVED DURING VISUAL INSPECTION)**

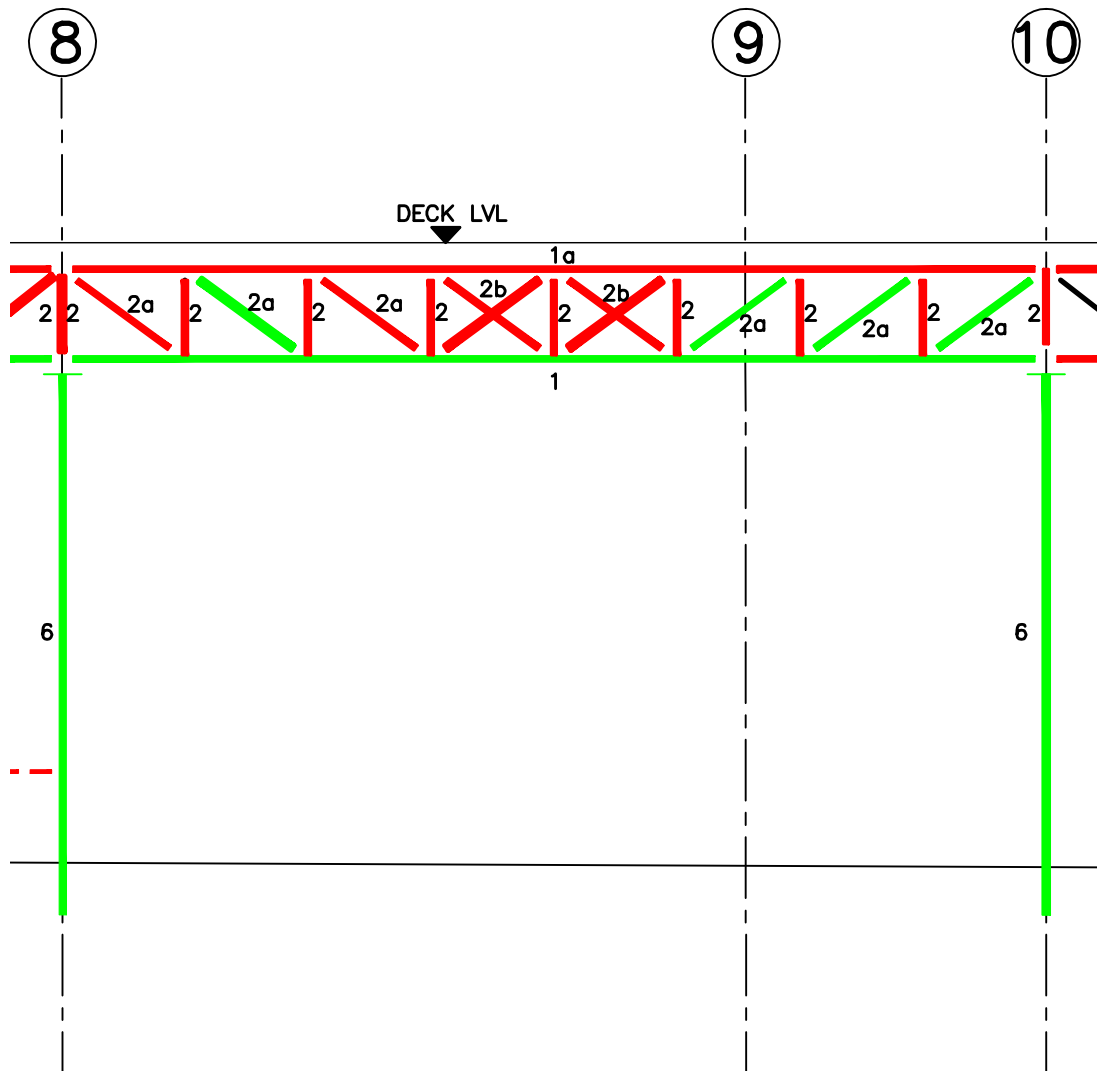
MEMBER	MEMBER TYPE	SECTION	NUMBER OF	NO# FAILED MEMBERS	ACTION
1	RSA	90x75mm	1	0	BLAST & PAINT
1a	RSA	100x100mm	1	1	REPLACE
2	RSA	70x70mm	9	9	REPLACE
2a	PLATES	100x10mm	6	2	REPLACE
2b	PLATES	75x10mm	6	2	REPLACE
6	CHS (COLUMN)	300x25mm	4	4	REPLACE

**OVERALL VERDICT : REPLACE GIRDER
(FAILURE PREDOMINANTLY OBSERVED DURING VISUAL INSPECTION)**

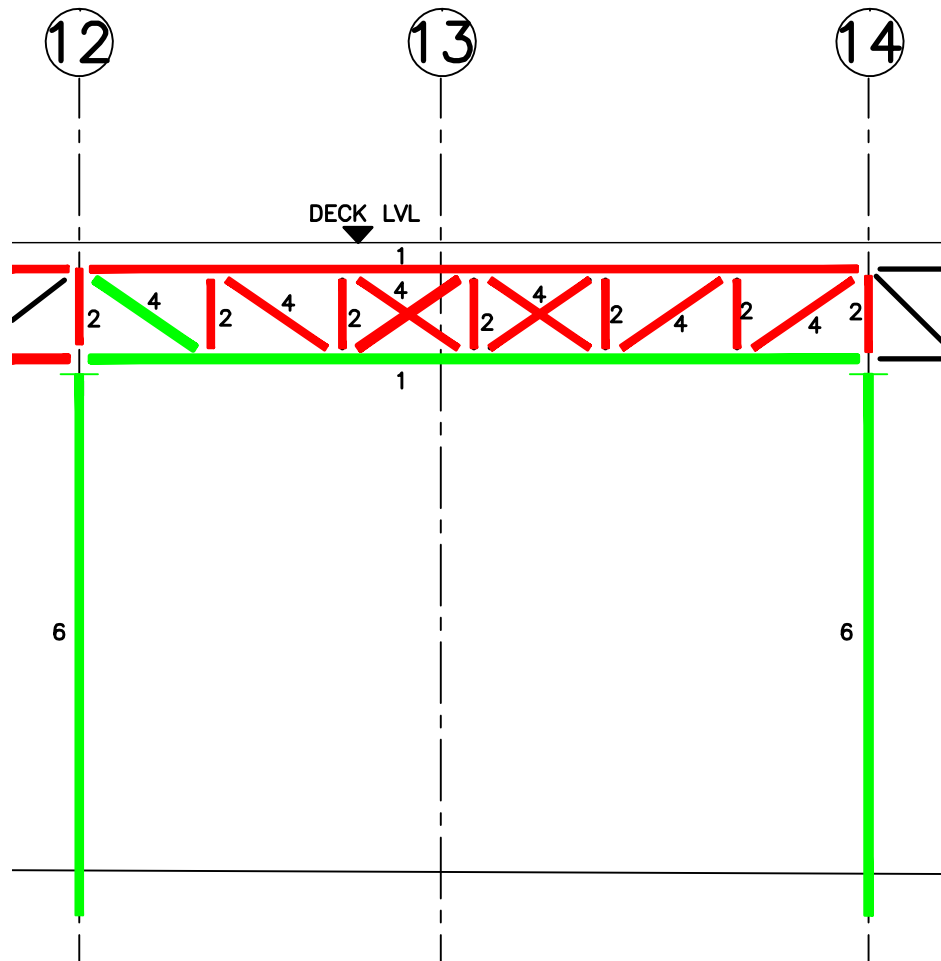
MEMBER	MEMBER TYPE	SECTION	NUMBER OF	NO# FAILED MEMBERS	ACTION
1	RSA	140x130mm	2	1	REPLACE
2	RSA (2)	90x75mm	7	7	REPLACE
4	PLATES	75x10mm	8	7	REPLACE
6	CHS (COLUMN)	300x25mm	2	0	BLAST & PAINT

**OVERALL VERDICT : REPLACE GIRDER
(MEMBERS GENERALLY IN TACT DURING VISUAL INSPECTION BUT
FAILED DURING ANALYSIS)**

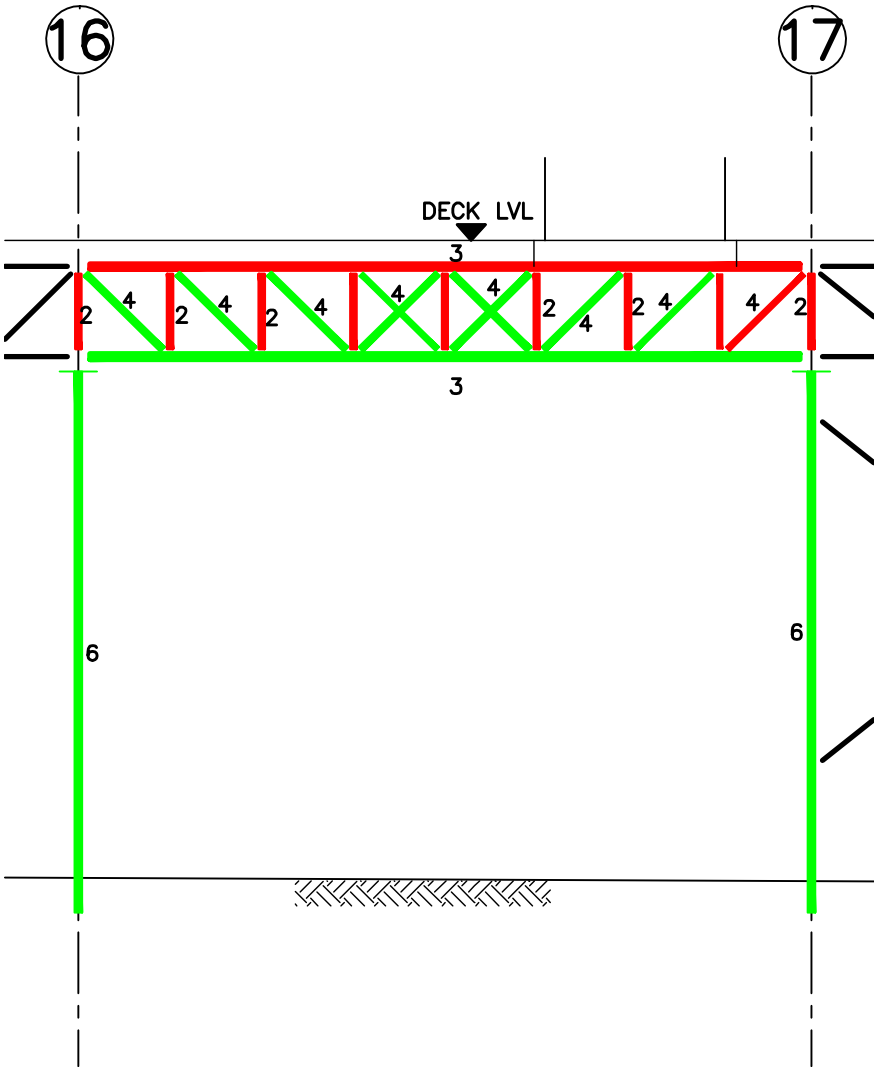
MEMBER	MEMBER TYPE	SECTION	NUMBER OF	NO# FAILED MEMBERS	ACTION
3	RSA	152x152mm	2	1	REPLACE
2	RSA (VERT'S)	75x65x5mm	8	8	REPLACE
4	PLATES	100x15mm	10	1	REPLACE
6	CHS (COLUMN)	300x25mm	2	0	BLAST & PAINT

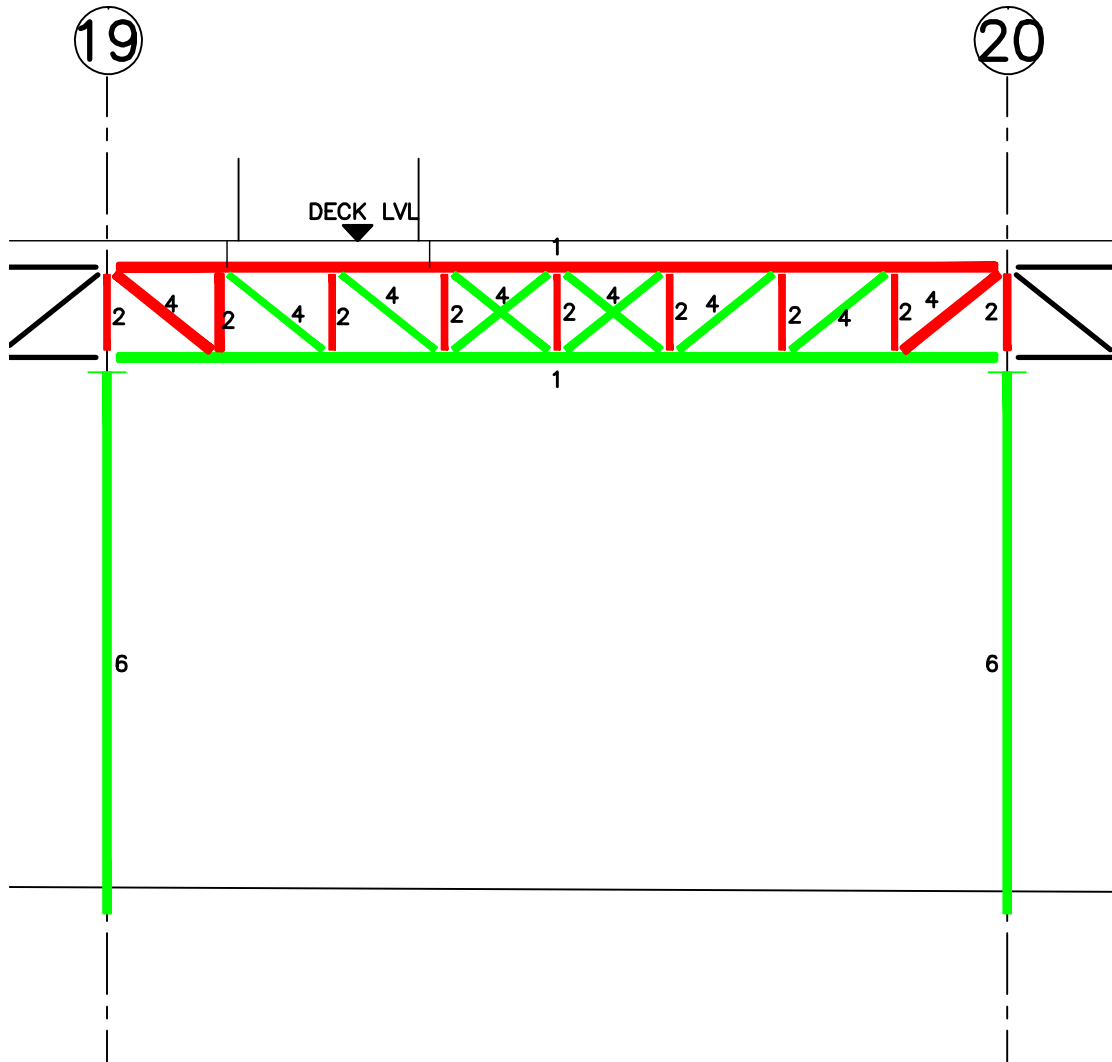
MEMBER	MEMBER TYPE	SECTION	NUMBER OF	NO# FAILED MEMBERS	ACTION
1	RSA	100x100mm	2	1	REPLACE
2	RSA (VERT'S)	75x65x5mm	9	4	REPLACE
4	PLATES	75x10mm	10	2	REPLACE
6	CHS (COLUMN)	300x25mm	2	0	BLAST & PAINT

OVERALL VERDICT : REPLACE GIRDER
(MEMBERS GENERALLY IN TACT DURING VISUAL INSPECTION BUT
FAILED DURING ANALYSIS)

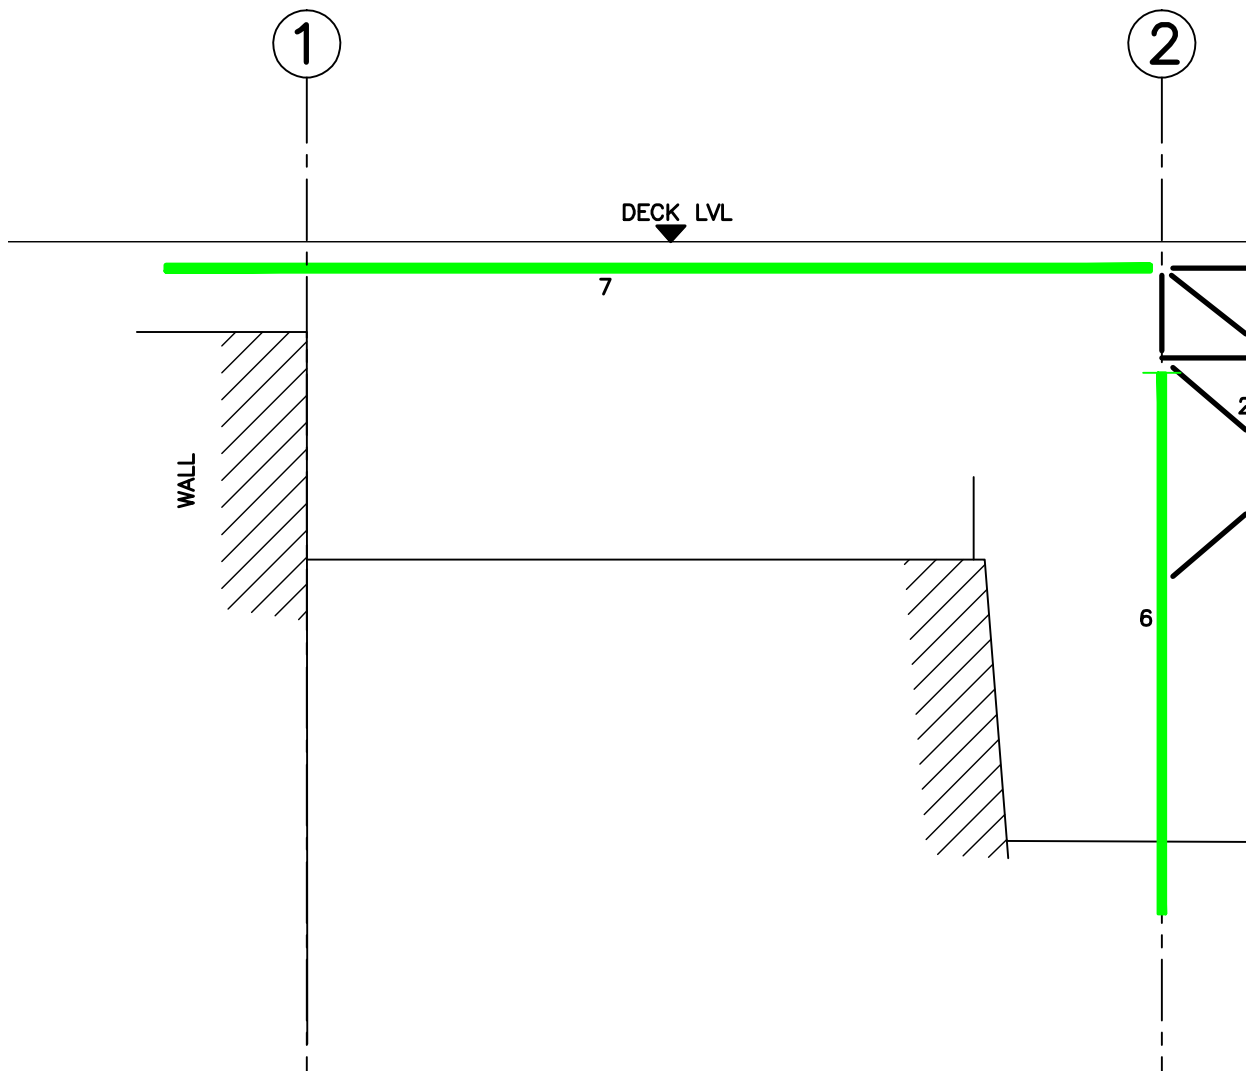
MEMBER	MEMBER TYPE	SECTION	NUMBER OF	NO# FAILED MEMBERS	ACTION
6	CHS (COLUMN)	300x25mm	1	0	BLAST & PAINT
7	CAST BEAM	930x225mm	1	1	REPLACE

**OVERALL VERDICT : REPLACE GIRDER
(MEMBERS GENERALLY IN TACT DURING VISUAL INSPECTION BUT
FAILED DURING ANALYSIS)**

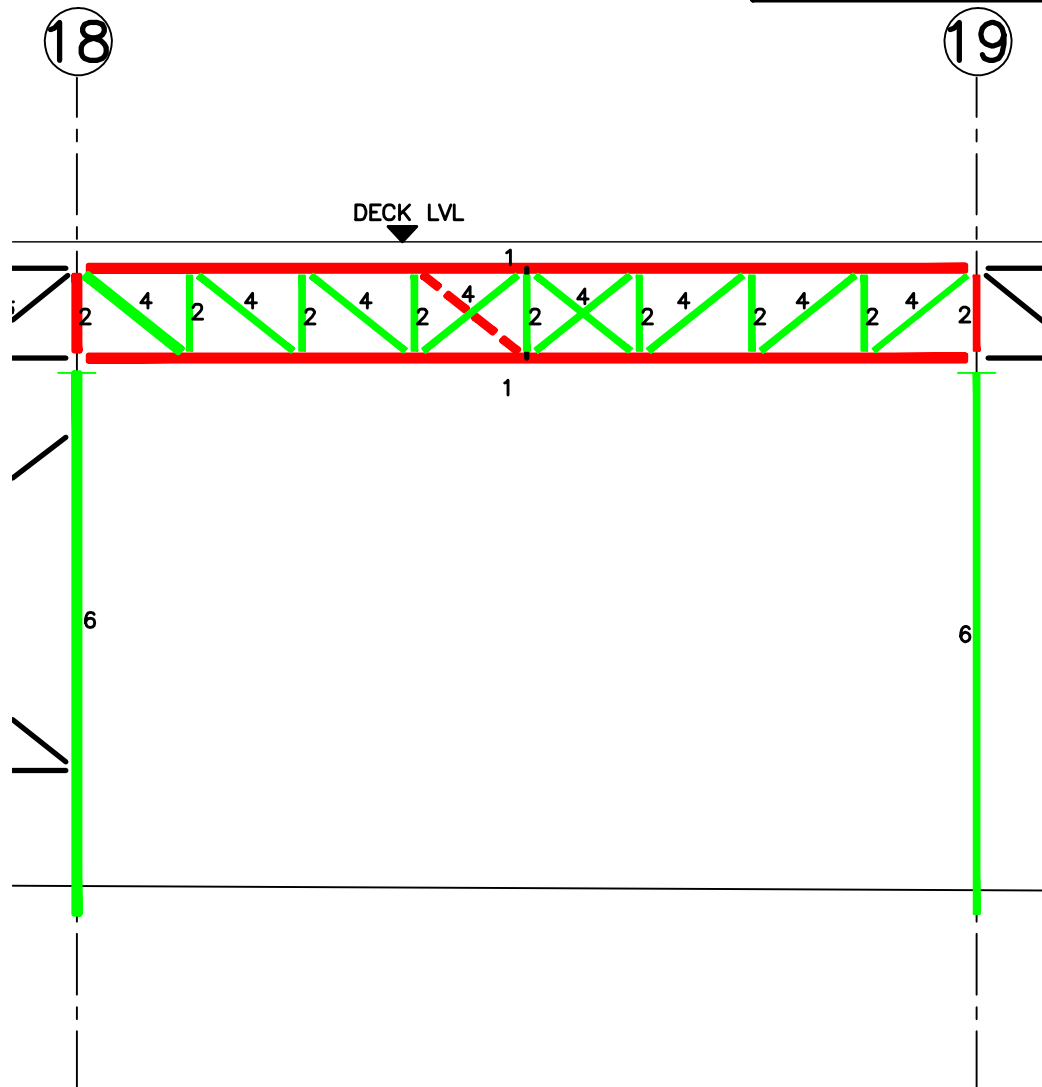
MEMBER	MEMBER TYPE	SECTION	NUMBER OF	NO# FAILED MEMBERS	ACTION
1	RSA	150x100mm	2	2	REPLACE
2	RSA	75x65x5mm	9	2	REPLACE
4	PLATES	125x10mm	10	1	REPLACE
6	CHS (COLUMN)	300x25mm	2	0	BLAST & PAINT

**OVERALL VERDICT : REPLACE GIRDER
(FAILURE PREDOMINANTLY OBSERVED DURING VISUAL INSPECTION)**

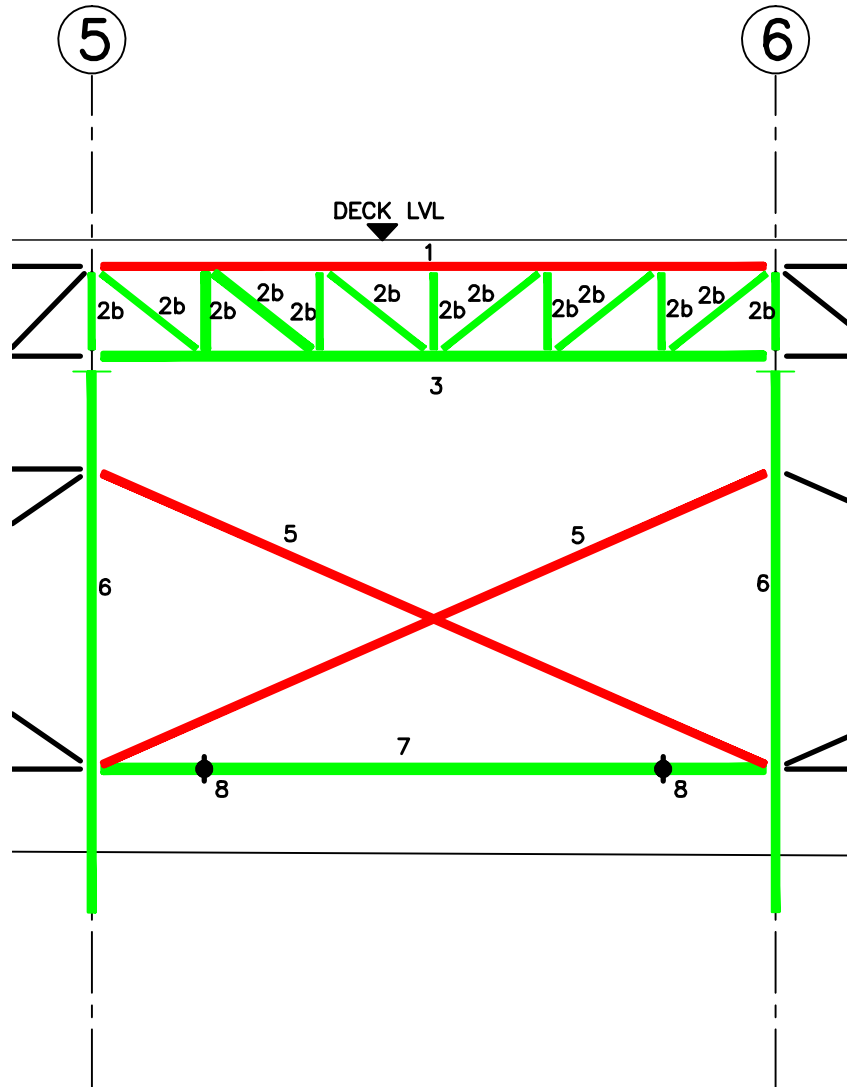
MEMBER	MEMBER TYPE	SECTION	NUMBER OF	NO# FAILED MEMBERS	ACTION
1	T SECTION	310x160mm	1	1	REPLACE
2b	RSA SECTIONS	125x75x10mm	13	0	BLAST & PAINT
3	UB SECTIONS	152x152mm	1	0	BLAST & PAINT
5	BRACING	50mm ϕ	2	2	REPLACE
6	CHS (COLUMN)	300x25mm	2	0	BLAST & PAINT
7	RAIL	135x65mm	1	0	BLAST & PAINT
8	BARS	38x63mm	2	0	BLAST & PAINT

**OVERALL VERDICT : REPLACE GIRDER
(MEMBERS GENERALLY IN TACT DURING VISUAL INSPECTION BUT
FAILED DURING ANALYSIS)**

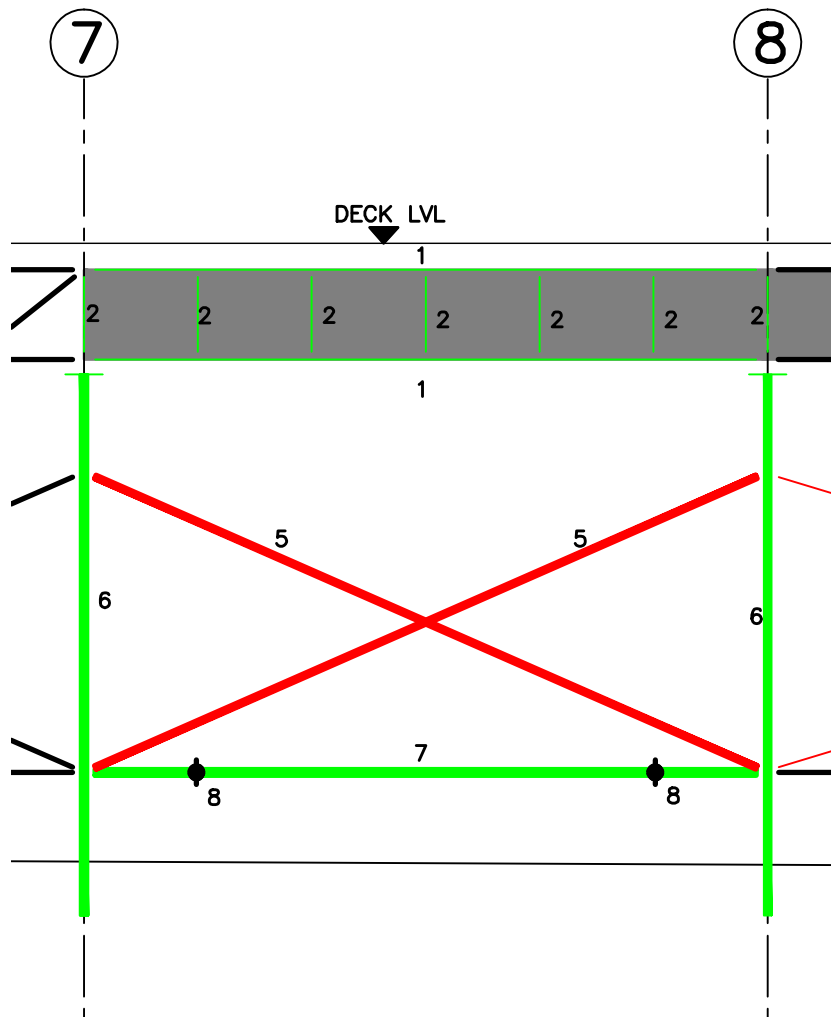
MEMBER	MEMBER TYPE	SECTION	NUMBER OF	NO# FAILED MEMBERS	ACTION
1	RSA SECTION	130x90mm	2	0	BLAST & PAINT
2	RSA SECTIONS	90x75mm	7	0	BLAST & PAINT
5	BRACING	50mm Ø	2	2	REPLACE
6	CHS (COLUMN)	300x25mm	2	0	BLAST & PAINT
7	RAIL	135x65mm	1	0	BLAST & PAINT
8	BARS	38x63mm	2	0	BLAST & PAINT

OVERALL VERDICT : RETAIN

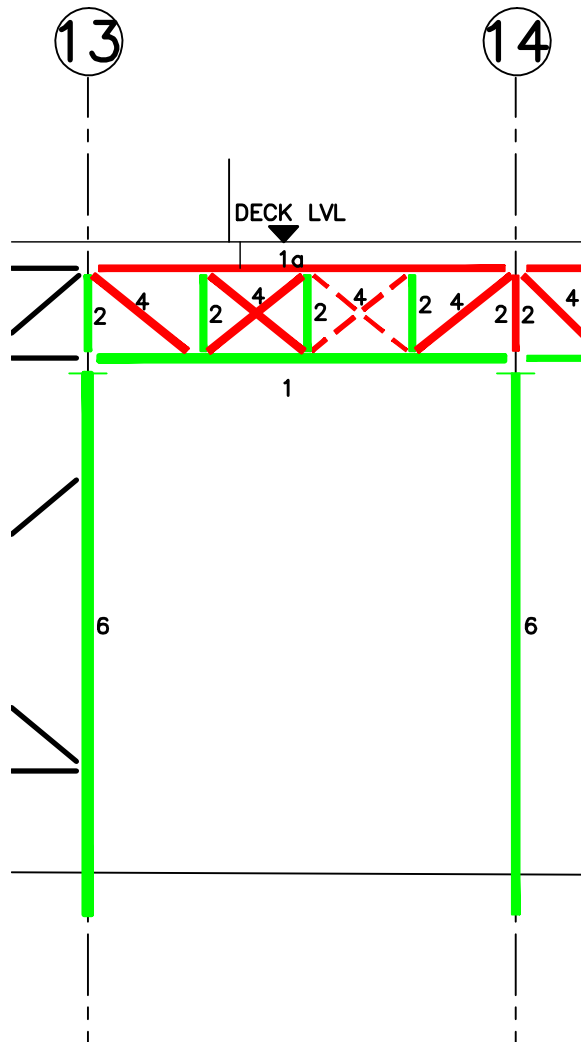
MEMBER	MEMBER TYPE	SECTION	NUMBER OF	NO# FAILED MEMBERS	ACTION
1	T SECTIONS	130x100mm	1	1	REPLACE
1a	T SECTIONS	100x100mm	1	0	BLAST & PAINT
2	RSA	75x65x10mm	5	4	REPLACE
4	PLATES	75x10mm	6	6	REPLACE
6	CHS (COLUMN)	300x25mm	2	0	BLAST & PAINT

OVERALL VERDICT : REPLACE GIRDER
(FAILURE PREDOMINANTLY OBSERVED DURING VISUAL INSPECTION)

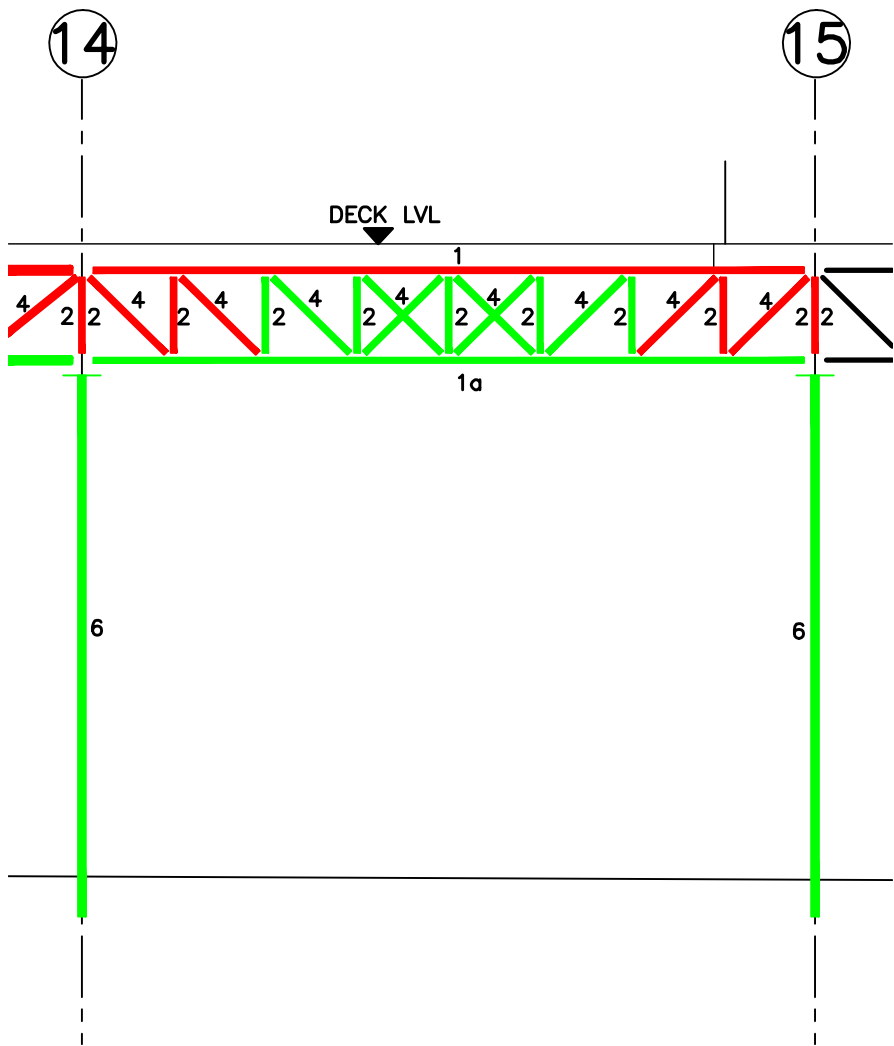
MEMBER	MEMBER TYPE	SECTION	NUMBER OF	NO# FAILED MEMBERS	ACTION
1	RSA	100x100mm	1	1	REPLACE
1a	RSA	90x75mm	1	0	REPLACE
2	RSA	75x65x10mm	9	4	REPLACE
4	PLATES	100x15mm	10	4	REPLACE
6	CHS (COLUMN)	300x25mm	2	0	BLAST & PAINT

OVERALL VERDICT : REPLACE GIRDER
(FAILURE PREDOMINANTLY OBSERVED DURING VISUAL INSPECTION)

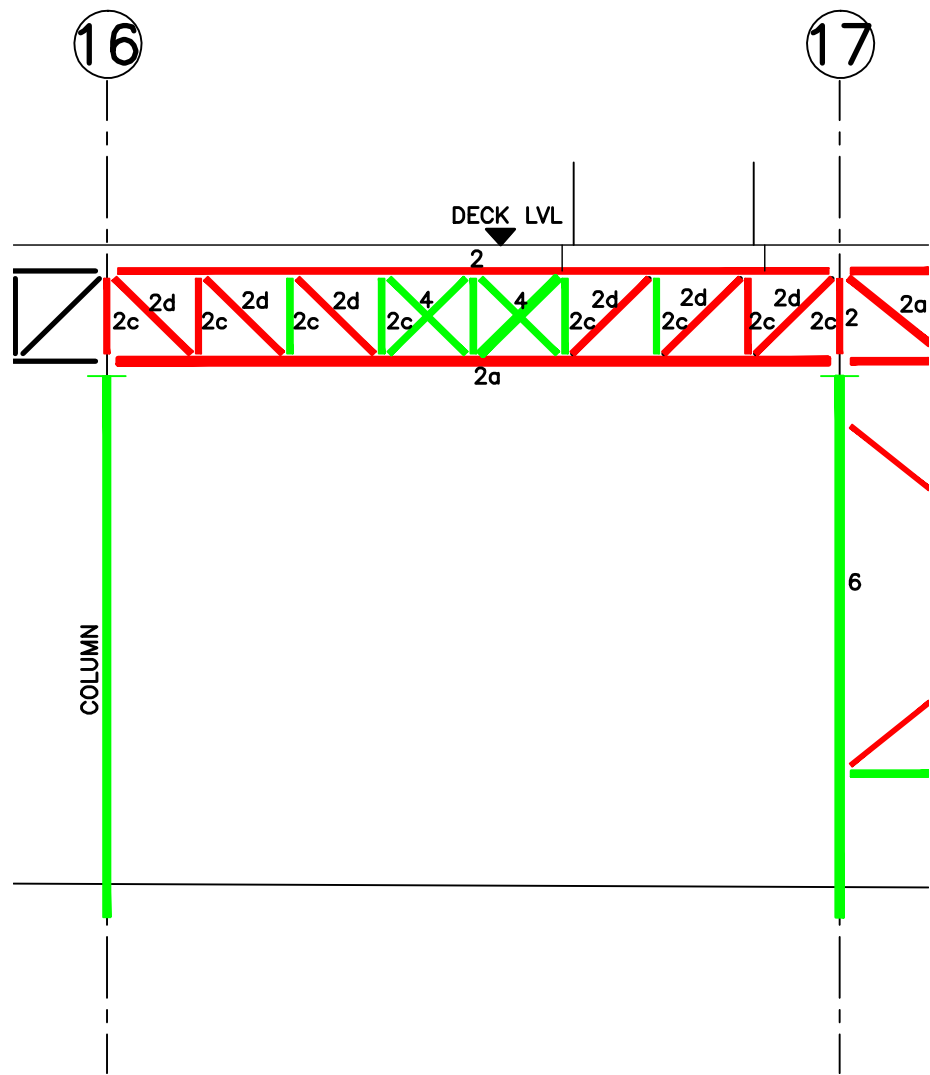
MEMBER	MEMBER TYPE	SECTION	NUMBER OF	NO# FAILED MEMBERS	ACTION
2	RSA SECTION	100x100mm	1	1	REPLACE
2a	RSA SECTION	90x75mm	1	1	REPLACE
2c	RSA SECTIONS	75x75x10mm	9	4	REPLACE
2d	PLATES	100x10mm	6	6	REPLACE
4	PLATES	75x10mm	4	0	BLAST & PAINT
6	CHS (COLUMN)	300x25mm	2	0	BLAST & PAINT

OVERALL VERDICT : REPLACE GIRDER
(FAILURE PREDOMINANTLY OBSERVED DURING VISUAL INSPECTION)

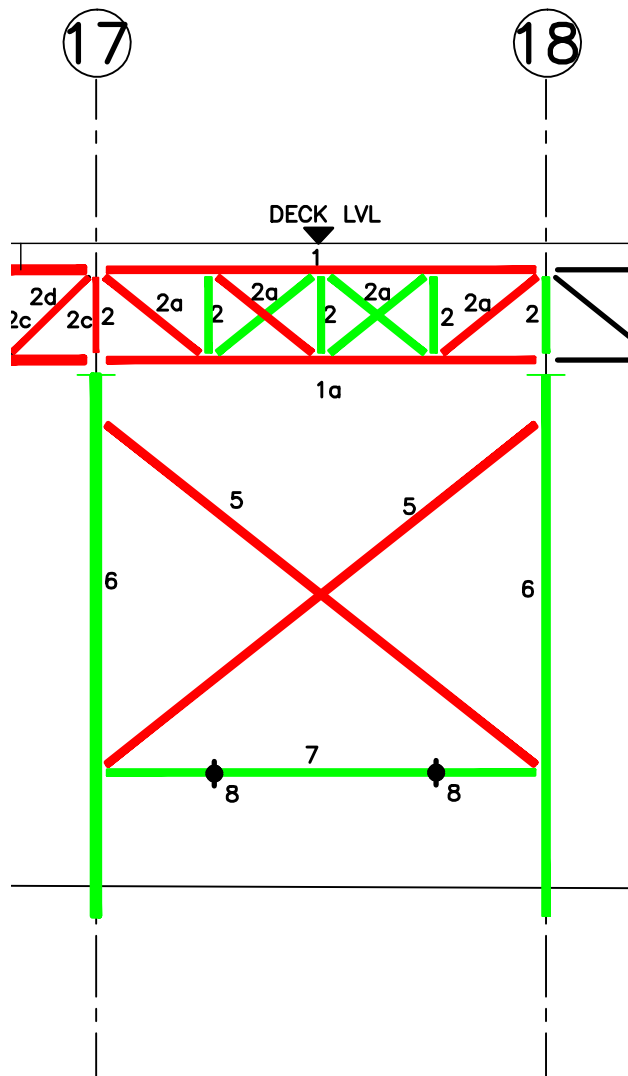
MEMBER	MEMBER TYPE	SECTION	NUMBER OF	NO# FAILED MEMBERS	ACTION
1	T SECTION	210x125mm	1	1	REPLACE
1a	T SECTION	100x100mm	13	0	BLAST & PAINT
2	RSA	75x75mm	5	1	BLAST & PAINT
2a	PLATES	75x6mm	6	3	BLAST & PAINT
5	BRACING	50mm Ø	2	2	REPLACE
6	CHS (COLUMN)	300x25mm	2	0	BLAST & PAINT
7	RAIL	135x65mm	1	0	BLAST & PAINT
8	BARS	38x63mm	2	0	BLAST & PAINT

OVERALL VERDICT : REPLACE GIRDER
(FAILURE PREDOMINANTLY OBSERVED DURING VISUAL INSPECTION)

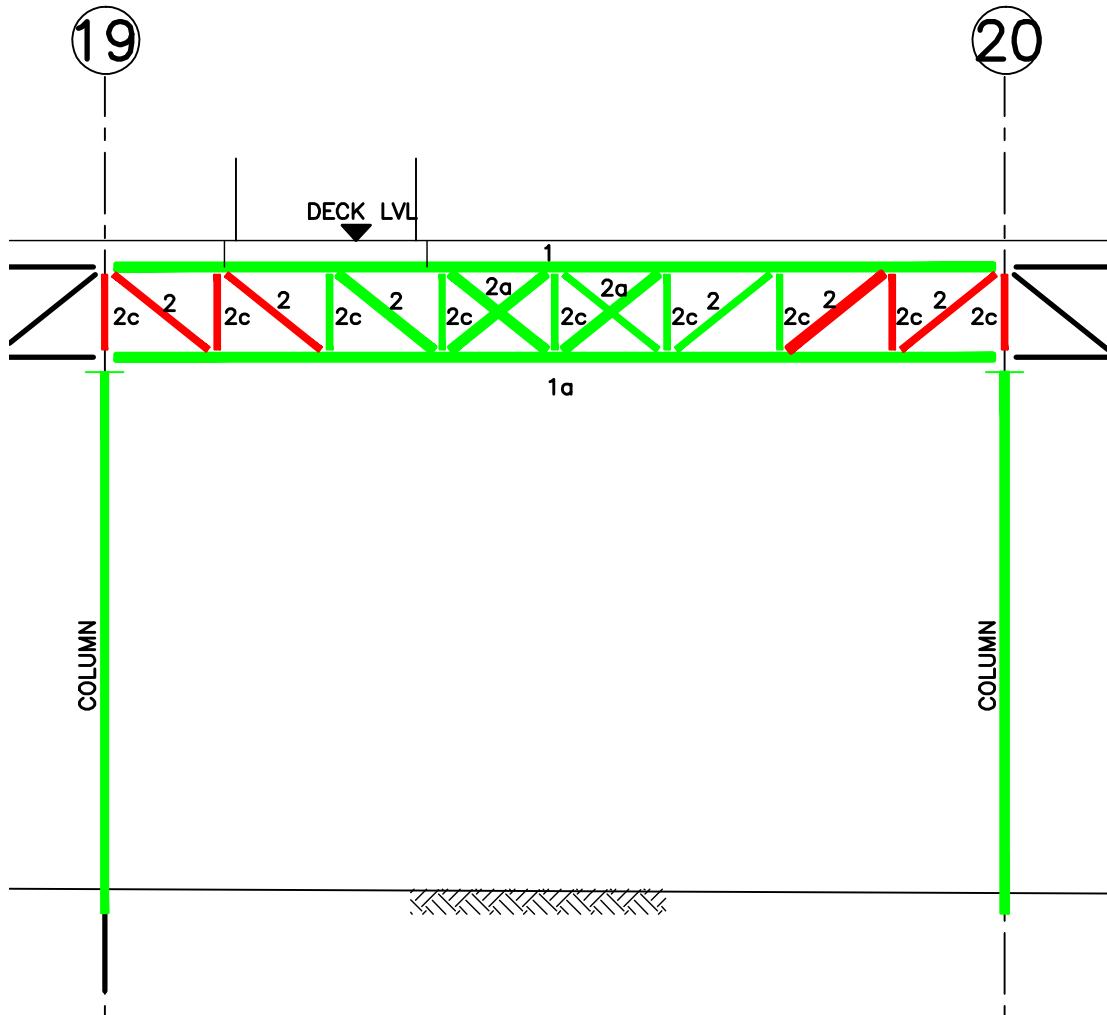
MEMBER	MEMBER TYPE	SECTION	NUMBER OF	NO# FAILED MEMBERS	ACTION
1	RSA SECTION	100x100mm	1	0	REPLACE
1a	RSA SECTION	90x75mm	1	0	REPLACE
2	PLATES	100x10mm	6	4	REPLACE
2a	PLATES	75x10mm	4	0	BLAST & PAINT
2c	RSA SECTIONS	75x75x10mm	9	4	REPLACE
6	CHS (COLUMN)	300x25mm	2	0	BLAST & PAINT

**OVERALL VERDICT : REPLACE GIRDER
(MEMBERS GENERALLY IN TACT DURING VISUAL INSPECTION BUT
FAILED DURING ANALYSIS)**

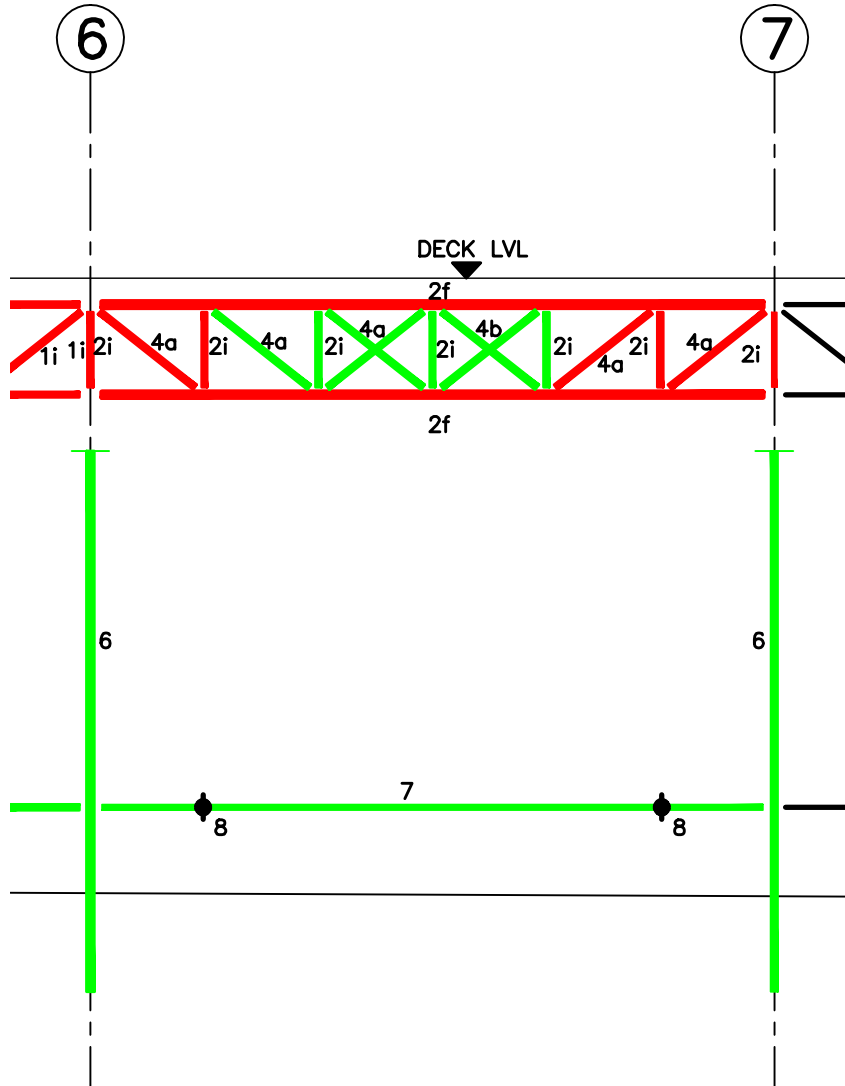
MEMBER	MEMBER TYPE	SECTION	NUMBER OF	NO# FAILED MEMBERS	ACTION
2f	RSA SECTIONS	100x100mm	2	2	REPLACE
2i	RSA (VERT'S)	90x90mm	7	5	REPLACE
4a	PLATES	125x10mm	6	6	REPLACE
4b	PLATES	75x10mm	2	0	BLAST & PAINT
6	CHS (COLUMN)	300x25mm	2	0	BLAST & PAINT
7	RAIL	135x65mm	1	0	BLAST & PAINT
8	BARS	38x63mm	2	0	BLAST & PAINT

**OVERALL VERDICT : REPLACE GIRDER
(MEMBERS GENERALLY IN TACT DURING VISUAL INSPECTION BUT
FAILED DURING ANALYSIS)**
