STRUCTURAL APPRAISAL

VICTORIA PIER, COLWYN BAY

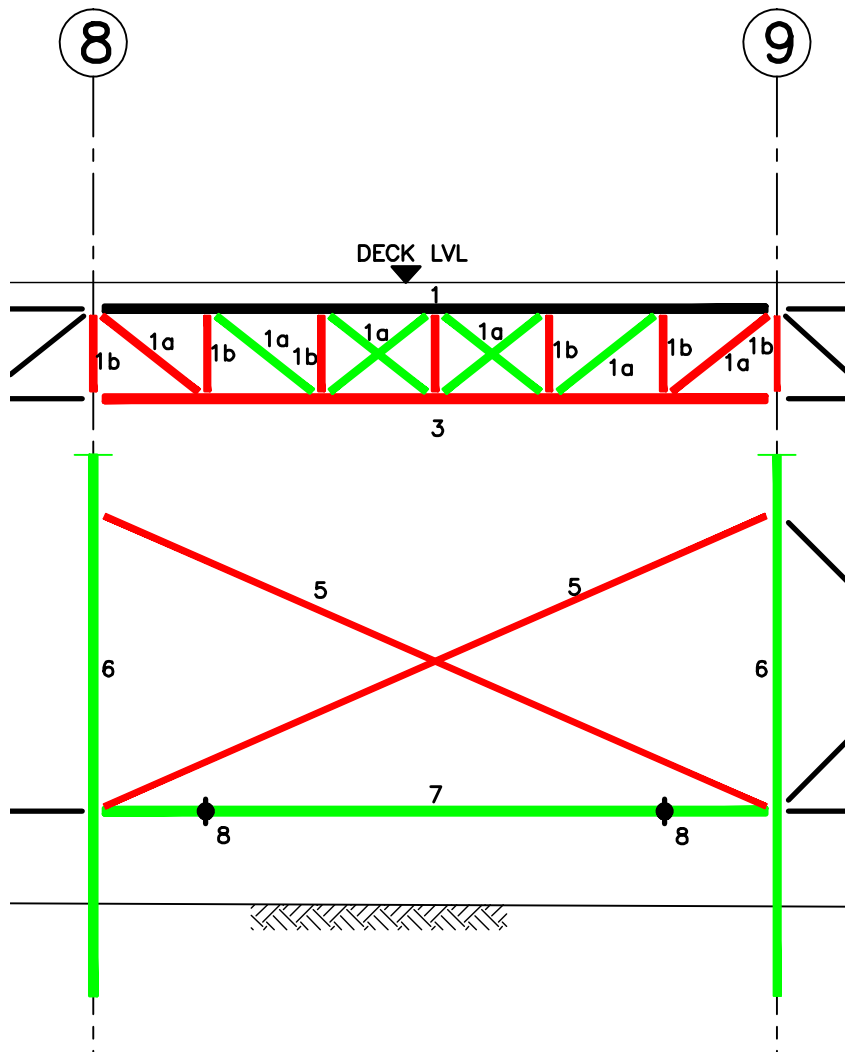
MEMBER	MEMBER TYPE	SECTION	NUMBER OF	NO# FAILED MEMBERS	ACTION
1	T SECTION	310x160mm	1	1	REPLACE
1b	T SECTION	60x60mm	7	7	REPLACE
1a	T SECTION	78x60mm	8	2	REPLACE
5	BRACING	50mm ϕ	2	2	REPLACE
6	CHS (COLUMN)	300x25mm	2	0	BLAST & PAINT
7	RAIL	135x65mm	1	0	BLAST & PAINT
8	BARS	38x63mm	2	0	BLAST & PAINT

**OVERALL VERDICT : REPLACE GIRDER
(FAILURE PREDOMINANTLY OBSERVED DURING VISUAL INSPECTION)**

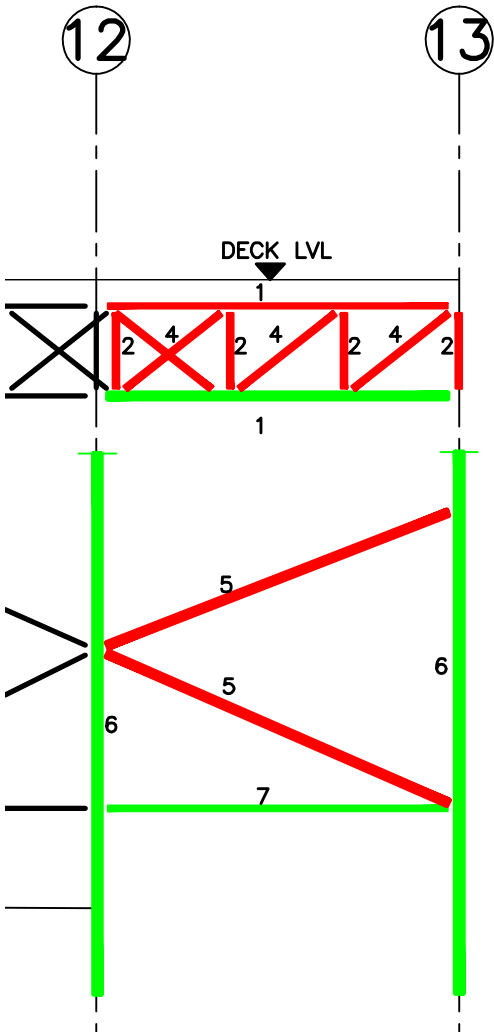
MEMBER	MEMBER TYPE	SECTION	NUMBER OF	NO# FAILED MEMBERS	ACTION
1	T SECTION	150x100mm	2	1	REPLACE
2	RSA	75x65x5mm	4	4	REPLACE
4	PLATES	75x10m	4	4	REPLACE
5	BRACING	50mm ϕ	2	2	REPLACE
6	CHS (COLUMN)	300x25mm	2	0	BLAST & PAINT

OVERALL VERDICT : REPLACE GIRDER
(MEMBERS GENERALLY IN TACT DURING VISUAL INSPECTION BUT
FAILED DURING ANALYSIS)

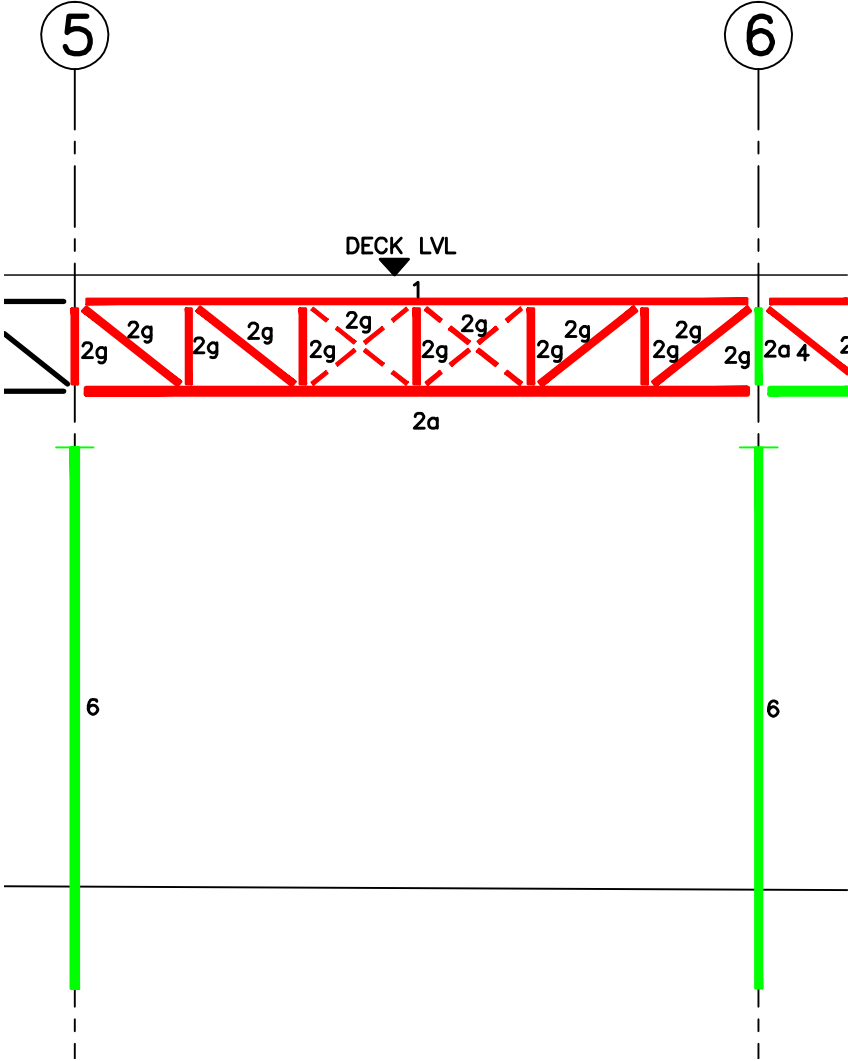
MEMBER	MEMBER TYPE	SECTION	NUMBER OF	NO# FAILED MEMBERS	ACTION
1	T SECTION	150x75mm	1	1	REPLACE
2	RSA	75x65x5mm	7	7	REPLACE
4c	PLATES	75x6m	2	2	REPLACE
4e	PLATES	100x10m	2	2	REPLACE
6	CHS (COLUMN)	300x25mm	2	0	BLAST & PAINT

OVERALL VERDICT : REPLACE GIRDER
(FAILURE PREDOMINANTLY OBSERVED DURING VISUAL INSPECTION)

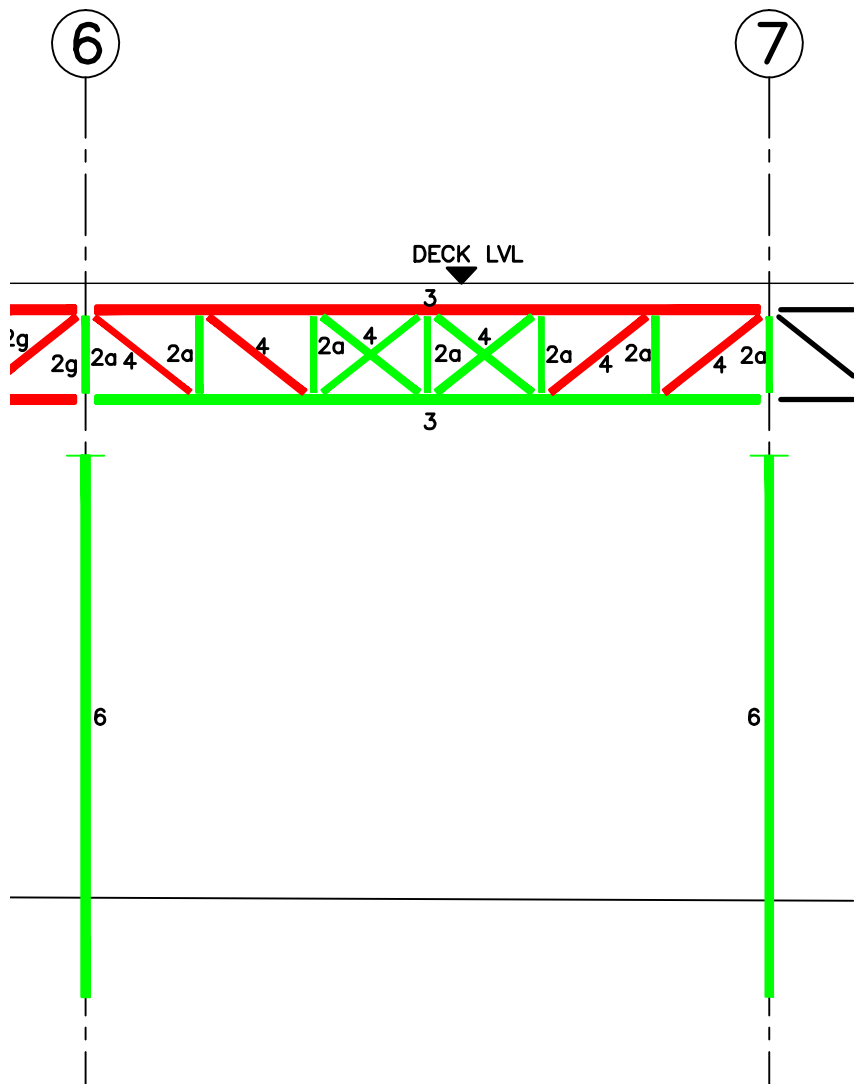
DRG No. GL E5-E6

MEMBER	MEMBER TYPE	SECTION	NUMBER OF	NO# FAILED MEMBERS	ACTION
3	UB	152x152mm	2	1	REPLACE
2a	RSA (VERT'S)	80x125x10mm	7	0	REPLACE
4	PLATES	100x15mm	8	4	REPLACE
6	CHS (COLUMN)	300x25mm	2	0	BLAST & PAINT

OVERALL VERDICT : REPLACE GIRDER
(MEMBERS GENERALLY IN TACT DURING VISUAL INSPECTION BUT
FAILED DURING ANALYSIS)

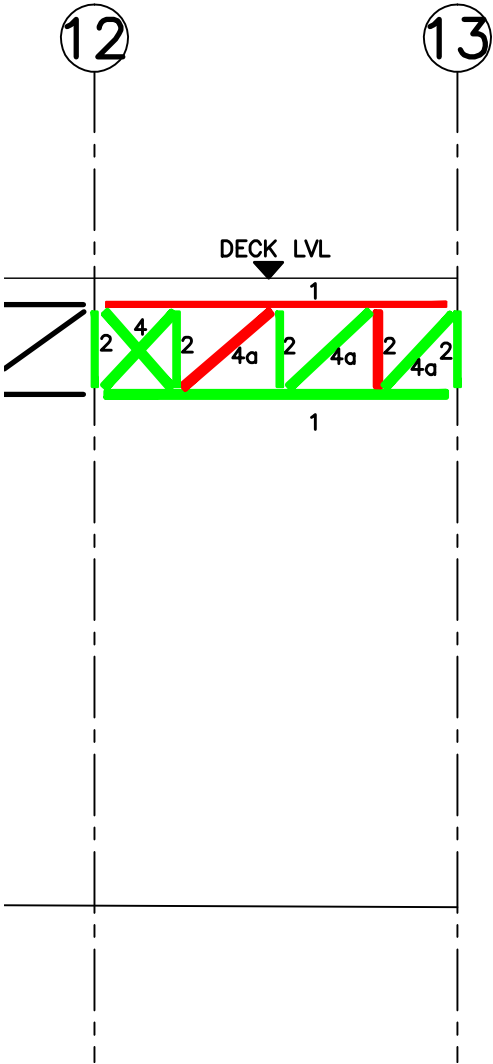
MEMBER	MEMBER TYPE	SECTION	NUMBER OF	NO# FAILED MEMBERS	ACTION
1	T SECTION	150x100mm	2	1	REPLACE
2	RSA (VERT'S)	75x65mm	5	0	BLAST & PAINT
4	PLATES	75x10mm	2	0	BLAST & PAINT
4a	PLATES	100x10mm	3	1	REPLACE

OVERALL VERDICT : REPLACE GIRDER
(MEMBERS GENERALLY IN TACT DURING VISUAL INSPECTION BUT
FAILED DURING ANALYSIS)

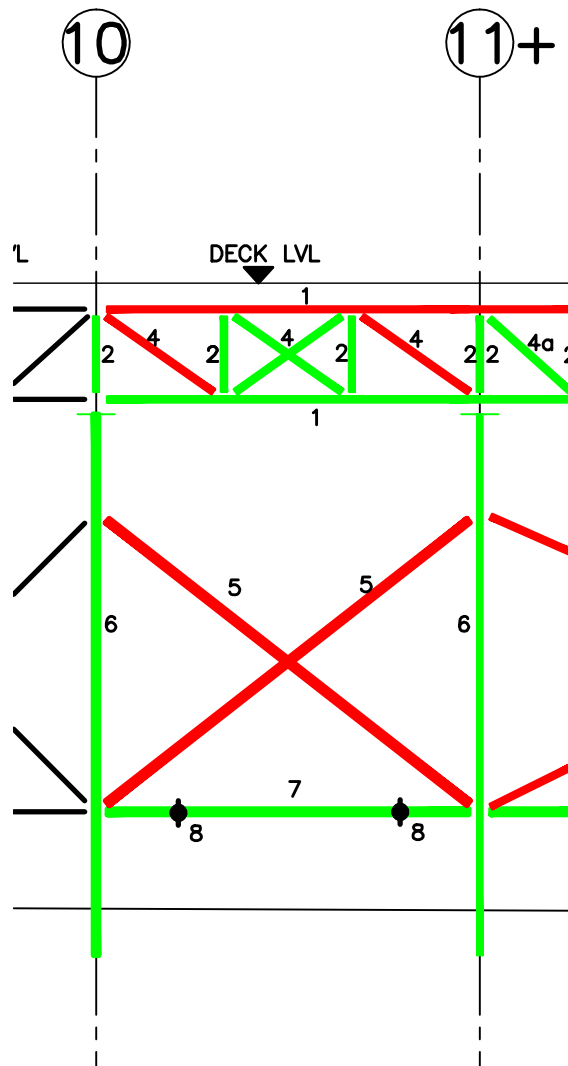
MEMBER	MEMBER TYPE	SECTION	NUMBER OF	NO# FAILED MEMBERS	ACTION
1	T SECTION	150x100mm	2	1	REPLACE
2	RSA	75x65x5mm	4	0	BLAST & PAINT
4	PLATES	60x8mm	4	2	REPLACE
5	BRACING	50mm ϕ	2	2	REPLACE
6	CHS (COLUMN)	300x25mm	2	0	BLAST & PAINT
7	RAIL	135x65mm	1	0	BLAST & PAINT
8	BARS	38x63mm	2	0	BLAST & PAINT

OVERALL VERDICT : REPLACE GIRDER
(MEMBERS GENERALLY IN TACT DURING VISUAL INSPECTION BUT
FAILED DURING ANALYSIS)

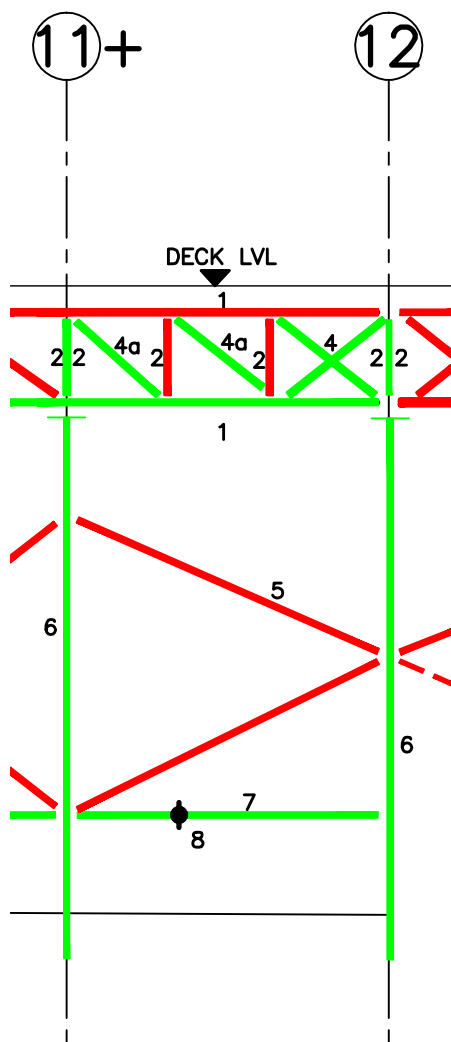
MEMBER	MEMBER TYPE	SECTION	NUMBER OF	NO# FAILED MEMBERS	ACTION
1	T SECTION	150x100mm	2	1	REPLACE
2	RSA	75x65x5mm	4	2	BLAST & PAINT
4	PLATES	100x5mm	2	0	BLAST & PAINT
4a	PLATES	155x12mm	2	1	REPLACE
5	BRACING	50mm ϕ	2	2	REPLACE
6	CHS (COLUMN)	300x25mm	2	0	BLAST & PAINT
7	RAIL	135x65mm	1	0	BLAST & PAINT
8	BARS	38x63mm	1	0	BLAST & PAINT

OVERALL VERDICT : REPLACE GIRDER
(MEMBERS GENERALLY IN TACT DURING VISUAL INSPECTION BUT
FAILED DURING ANALYSIS)

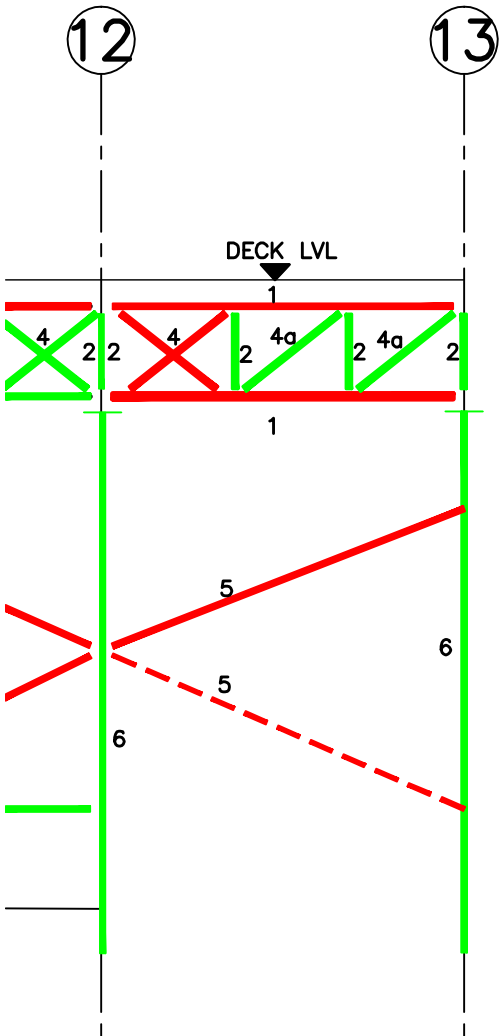
MEMBER	MEMBER TYPE	SECTION	NUMBER OF	NO# FAILED MEMBERS	ACTION
1	T SECTION	150x100mm	2	2	REPLACE
2	RSA	75x65x5mm	4	0	BLAST & PAINT
4	PLATES	100x5mm	2	2	REPLACE
4a	PLATES	155x12mm	2	0	BLAST & PAINT
5	BRACING	50mm ϕ	2	2	REPLACE
6	CHS (COLUMN)	300x25mm	2	0	BLAST & PAINT

OVERALL VERDICT : REPLACE GIRDER
(MEMBERS GENERALLY IN TACT DURING VISUAL INSPECTION BUT
FAILED DURING ANALYSIS)

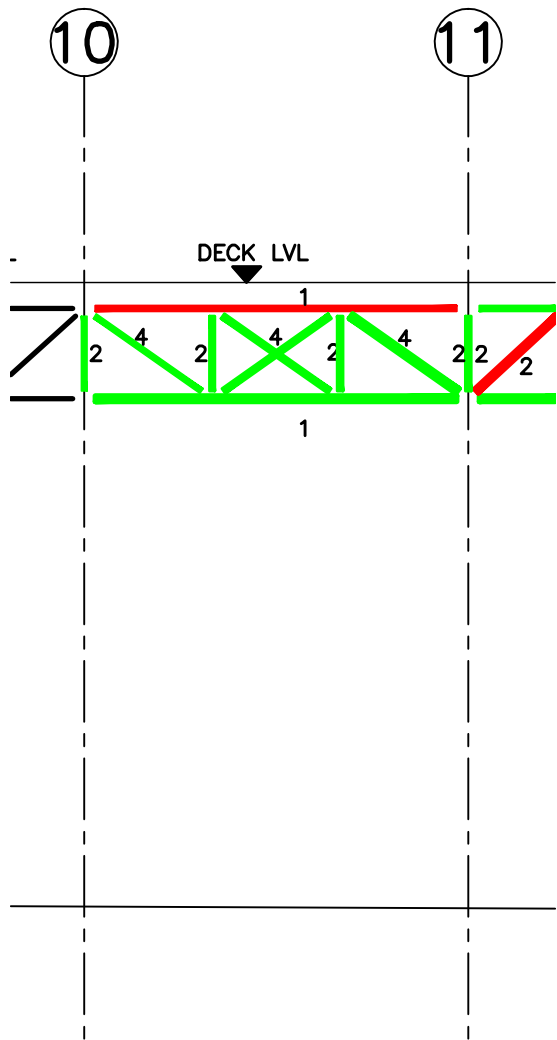
MEMBER	MEMBER TYPE	SECTION	NUMBER OF	NO# FAILED MEMBERS	ACTION
1	T SECTION	150x100mm	2	0	BLAST & PAINT
2	RSA (VERT'S)	75x65mm	4	0	BLAST & PAINT
4	PLATES	60x8mm	4	0	BLAST & PAINT

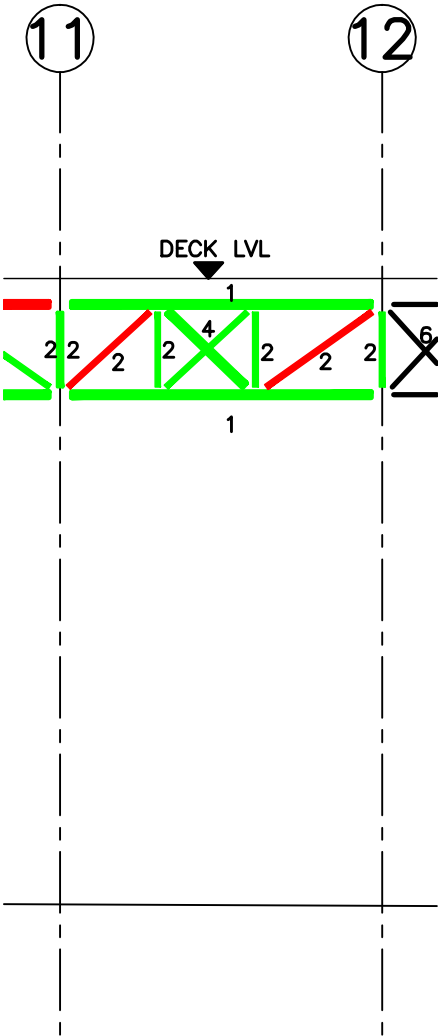
MEMBER	MEMBER TYPE	SECTION	NUMBER OF	NO# FAILED MEMBERS	ACTION
1	T SECTION	150x100mm	2	0	BLAST & PAINT
2	RSA (VERT'S)	75x65mm	6	2	REPLACE
4	PLATES	100x10mm	2	0	BLAST & PAINT

OVERALL VERDICT : REPLACE GIRDER
(MEMBERS GENERALLY IN TACT DURING VISUAL INSPECTION BUT
FAILED DURING ANALYSIS)

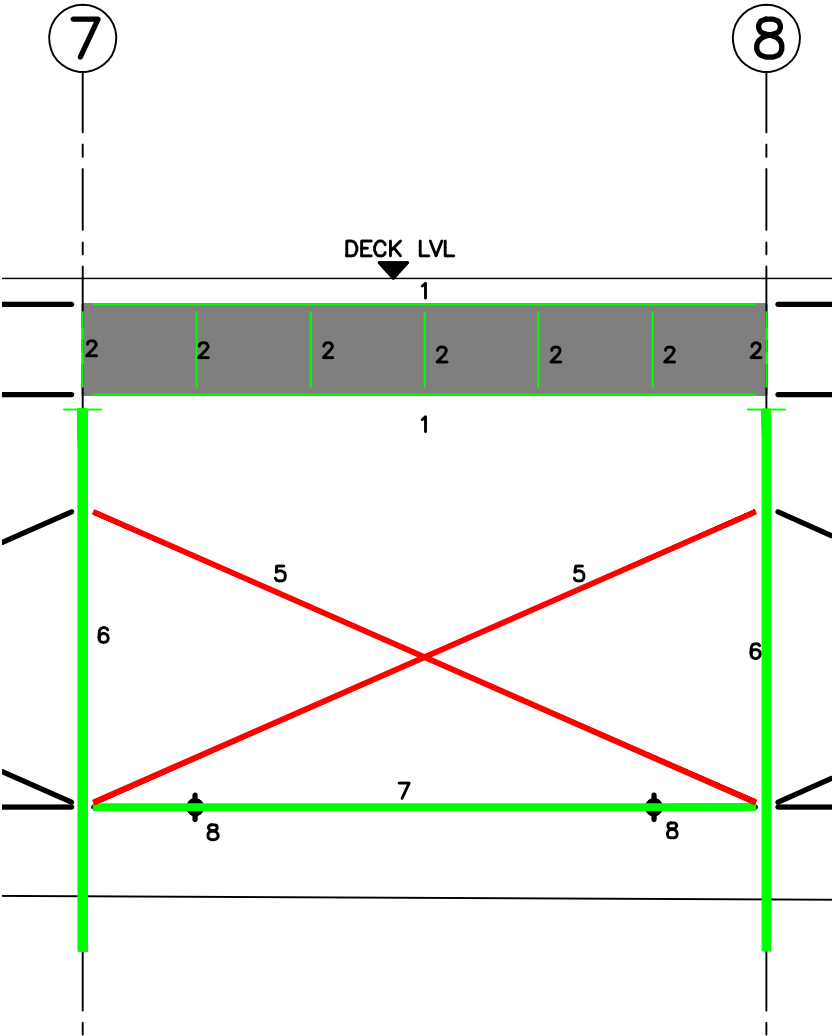
MEMBER	MEMBER TYPE	SECTION	NUMBER OF	NO# FAILED MEMBERS	ACTION
1	RSA SECTION	130x90mm	2	0	BLAST & PAINT
2	RSA SECTIONS	90x75mm	7	0	BLAST & PAINT
5	BRACING	50mm ϕ	2	2	REPLACE
6	CHS (COLUMN)	300x25mm	2	0	BLAST & PAINT
7	RAIL	135x65mm	1	0	BLAST & PAINT
8	BARS	38x63mm	2	0	BLAST & PAINT

OVERALL VERDICT : RETAIN

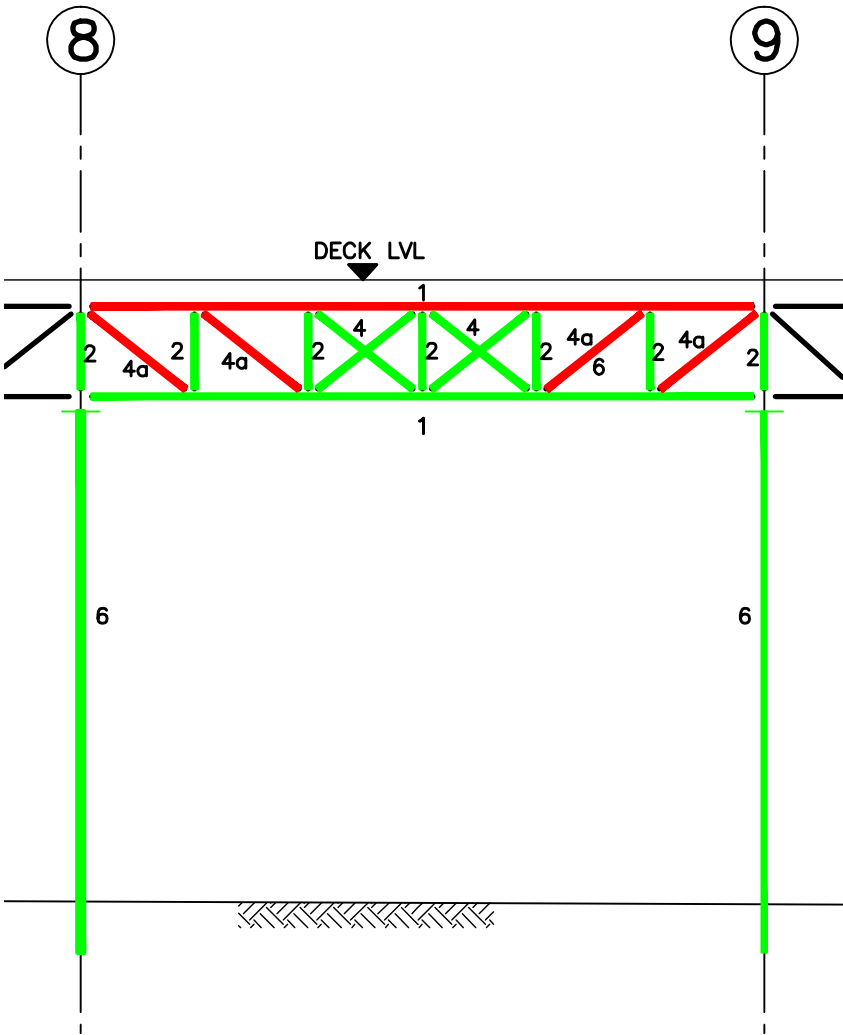
MEMBER	MEMBER TYPE	SECTION	NUMBER OF	NO# FAILED MEMBERS	ACTION
1	T SECTION	150x100mm	2	1	REPLACE
2	RSA	75x65x5mm	7	0	BLAST & PAINT
4	PLATES	75x6mm	4	0	BLAST & PAINT
4a	PLATES	100x10mm	4	4	REPLACE
6	CHS (COLUMN)	300x25mm	2	0	BLAST & PAINT

OVERALL VERDICT : REPLACE GIRDER
(FAILURE PREDOMINANTLY OBSERVED DURING VISUAL INSPECTION)

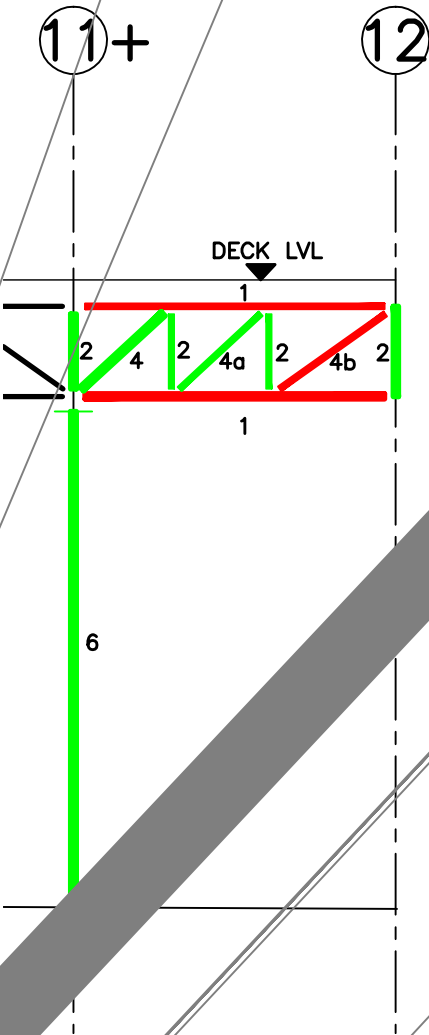
MEMBER	MEM TYPE	SECTION	NUMBER OF	NO# FAILED MEMBERS	ACTION
1	CHS (COLUMN)	150x100mm	2	0	BLAST & PAINT
2	CHS (COLUMN)	75x65x5mm	4	0	BLAST & PAINT
4	PLATES	150x8mm	1	0	BLAST & PAINT
	PLATES	100x10mm	1	0	BLAST & PAINT
	PLATES	75x6mm	1	1	REPLACE
	CHS (COLUMN)	300x25mm	1	0	BLAST & PAINT

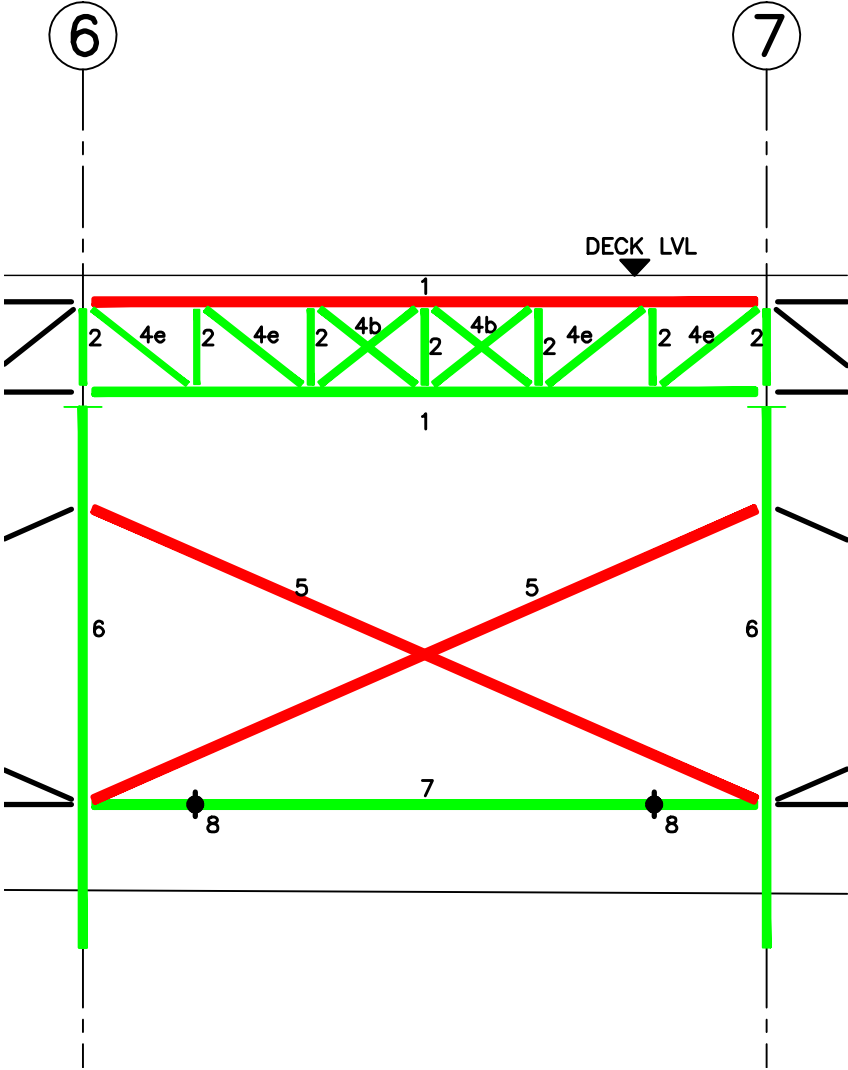
MEMBER	MEMBER TYPE	SECTION	NUMBER OF	NO# FAILED MEMBERS	ACTION
1	T SECTION	155x110mm	2	1	REPLACE
2	RSA	75x65x5mm	7	0	REPLACE
4b	PLATES	75x10mm	4	0	REPLACE
4e	PLATES	100x10mm	4	0	REPLACE
5	BRACING	50mm ϕ	2	2	REPLACE
6	CHS (COLUMN)	300x25mm	2	0	BLAST & PAINT
7	RAIL	135x65mm	1	0	BLAST & PAINT
8	BARS	38x63mm	2	0	BLAST & PAINT

OVERALL VERDICT : REPLACE GIRDER
(MEMBERS GENERALLY IN TACT DURING VISUAL INSPECTION BUT
FAILED DURING ANALYSIS)

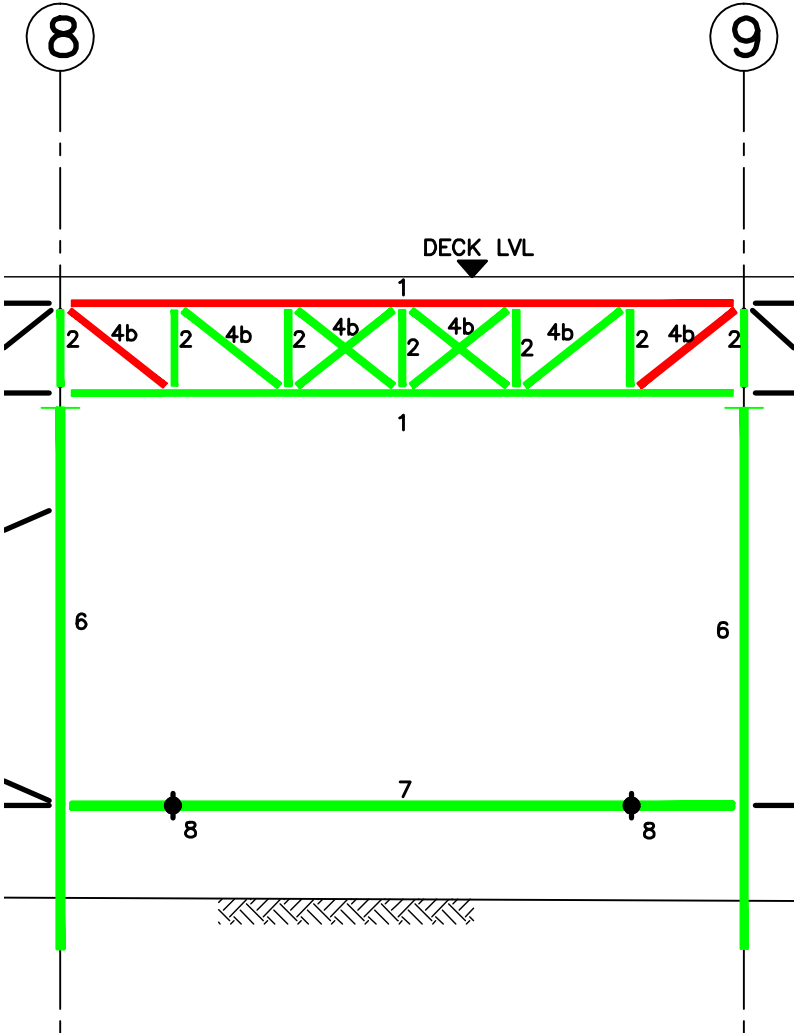
MEMBER	MEMBER TYPE	SECTION	NUMBER OF	NO# FAILED MEMBERS	ACTION
1	T SECTION	150x100mm	2	1	BLAST & PAINT
2	RSA	75x75x5mm	7	0	BLAST & PAINT
4	PLATES	75x10mm	8	2	REPLACE
6	CHS (COLUMN)	300x25mm	2	0	BLAST & PAINT
7	RAIL	135x65mm	1	0	BLAST & PAINT
8	BARS	38x63mm	2	0	BLAST & PAINT

OVERALL VERDICT : REPLACE GIRDER
(MEMBERS GENERALLY IN TACT DURING VISUAL INSPECTION BUT
FAILED DURING ANALYSIS)

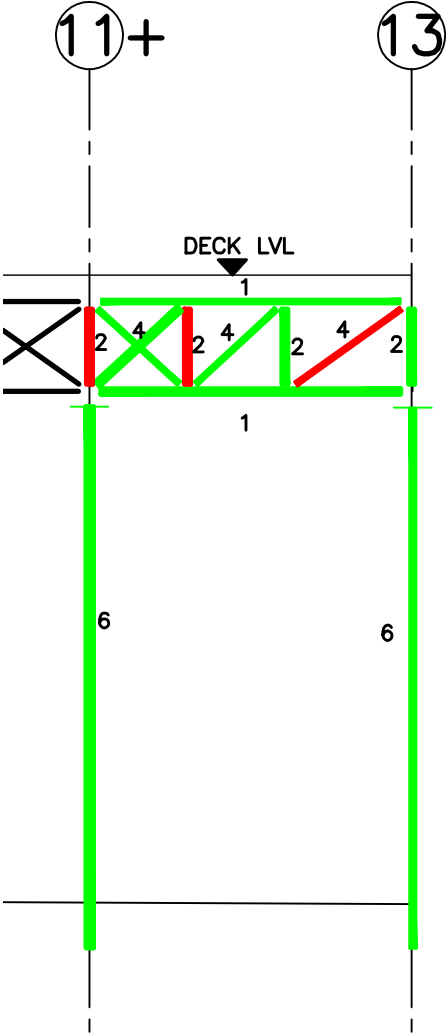
MEMBER	MEMBER TYPE	SECTION	NUMBER OF	NO# FAILED MEMBERS	ACTION
1	T SECTION	150x100mm	2	0	BLAST & PAINT
2	RSA	75x65x5mm	4	2	REPLACE
4	PLATES	75x10mm	4	1	REPLACE
6	CHS (COLUMN)	300x25mm	2	0	BLAST & PAINT

OVERALL VERDICT: REPLACE TRUSS
