**ASBESTOS SURVEYING TRAINING & REMOVAL ASSOCIATION**  
**ASTRA HOUSE WHITEHART MEADOW MIDDLETON MANCHESTER M24 2GA**

<b>SURVEY DATE</b>	13.02.12 – 15.02.12
<b>SURVEYOR(S)</b>	Adam Roche
<b>CLIENT</b>	ARTEZ LIMITED
<b>SURVEY REF</b>	Report ref: AR/BROD/AR/1
<b>ADDRESS</b>	Bradford Odeon Cinema, Quebec Street, Bradford, BD1 2ER
<b>SURVEY TYPE</b>	<u>UPDATE TO THE MAJOR REFURBISHMENT/PRE-DEMOLITION SURVEY</u> <u>CARRIED OUT IN MAY 2008 REF:RWB/A1/24162N</u>

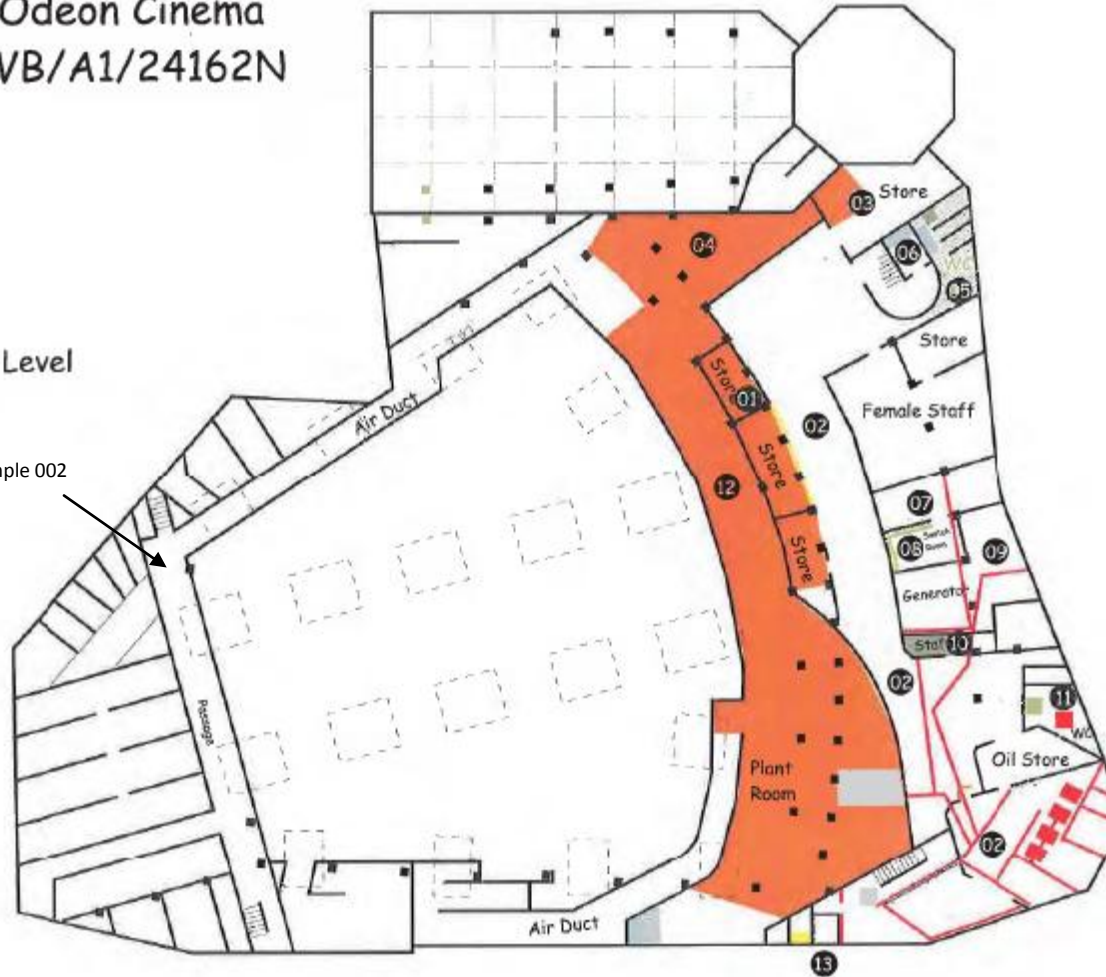
Project No:	AR/BROD/AR/1
Plan No:	1 of 7
Floor Level:	Basement
Client:	ARTEZ LTD
Site Address:	Bradford Odeon Cinema, Quebec Street, Bradford, BD1 2ER
Asbestos Shading Colours:

The basement level is highly contaminated as per previous report. The Asbestos Insulating Board Ceiling Panels to various areas throughout the basement identified within the previous asbestos report are in a poor condition many are damaged and debris noted to the floor area directly beneath. Some panels have been removed and are strewn on the floor.

It is recommended that the building be sealed and asbestos warning signage displayed to prevent further unauthorised access. All asbestos removal works should be carried out as a matter of urgency due to the condition of the identified materials.

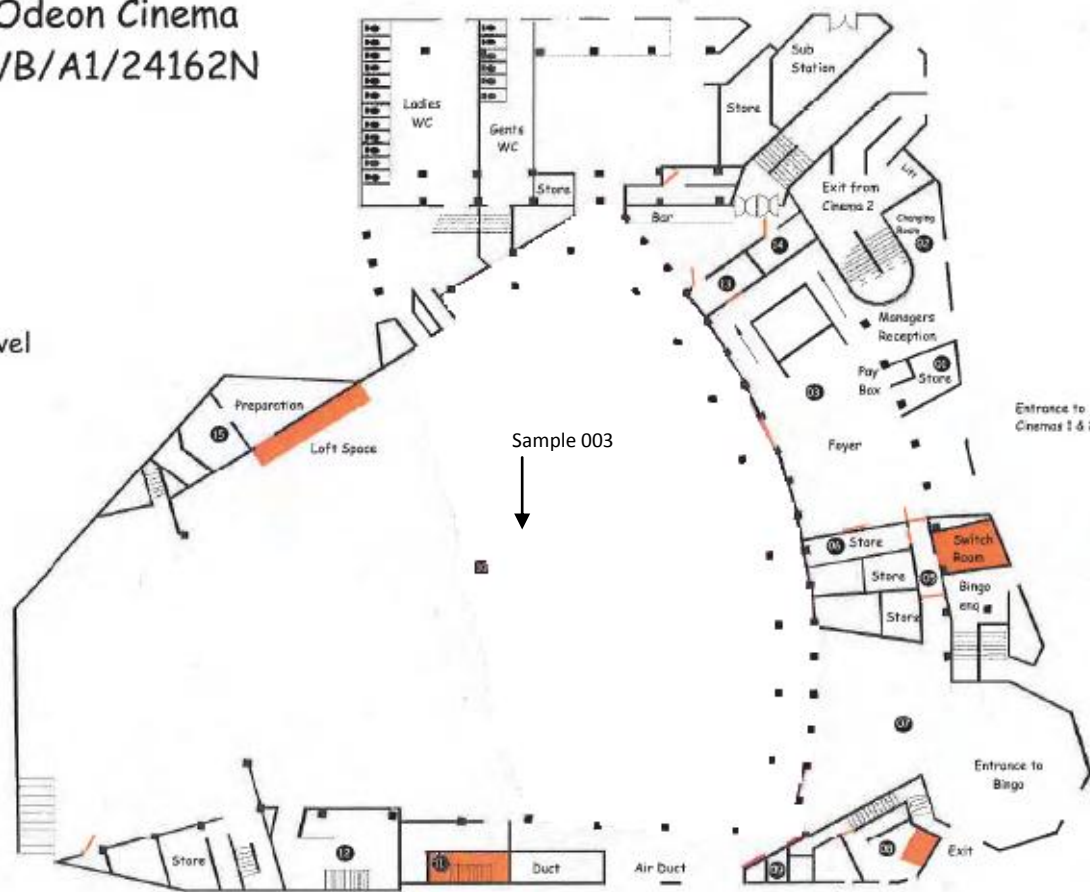
Ground Level

The ground floor level the asbestos insulation board ceiling panelling to the switch room 0/004/02 has been damaged due to vandalism. As you carry on through the sprayed coating to the ceiling 0/010/01 within the bingo hall has been penetrated in various areas to access above this was re-sampled and proven to be negative for asbestos content.
