STAGE 1 ROAD SAFETY AUDIT REPORT FOR 111644: FOOTBALL STADIUM AND TRAINING FACILITIES AT KINGSFORD, ABERDEEN

Report Ref 40817(1) Rev C

111644: Football Stadium & Training Facilities, Kingsford, Aberdeen.
Road Safety Audit Stage 1

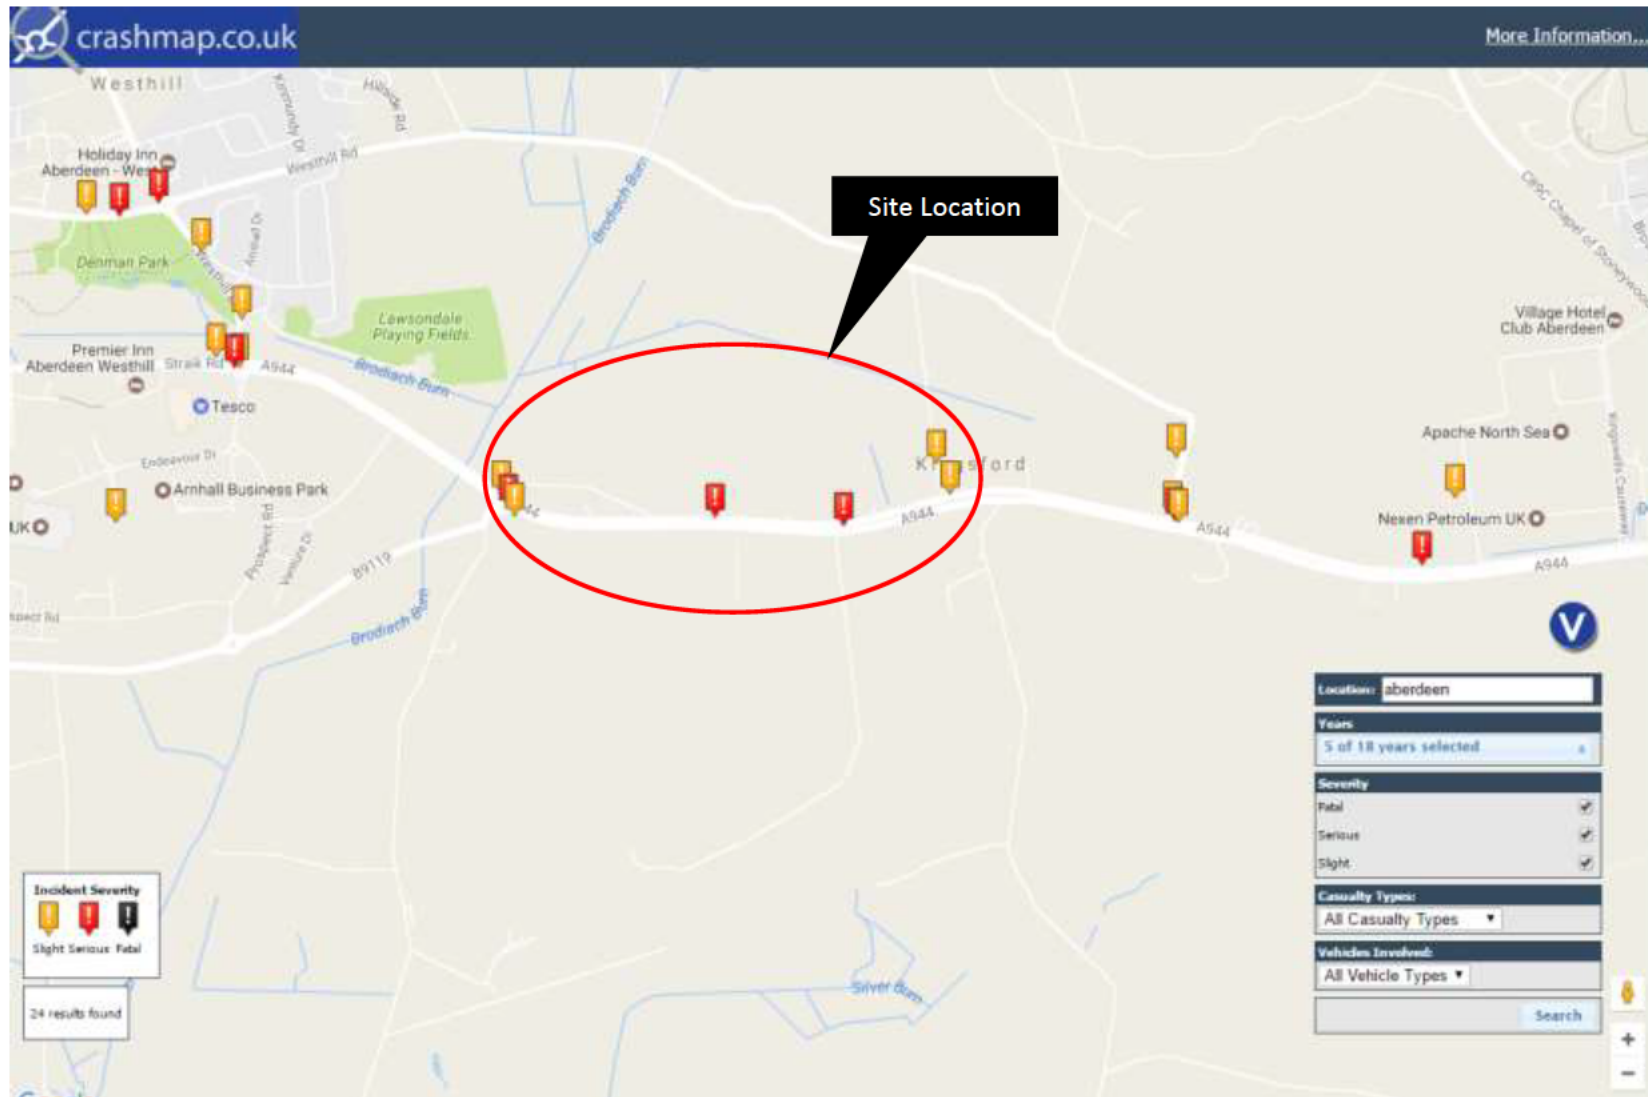
Appendix B. Location of Recorded Collisions.

2.3 Road traffic collision information has also been retrieved from Crashmap.co.uk . It should be noted that the A944 and B9119 junction has changed from a roundabout to a signalised junction during the period of the collision search, and the AWPR Kingswell south junction is under construction to the east of the site.
