FACTUAL REPORT

Duty Holder Details: Merlin Attractions Operations Ltd			
Name of Duty Holder	Merlin Attractions Operations Ltd. Trading as: Alton Towers Resort	Role	Theme / Amusement Park
Address	Farley Ln, Alton, Staffordshire, ST10 4DB.	Registered Office	3 Market Close, Poole, Dorset, BH15 1NQ.
Duty Holder Status	Private limited company	Companies House No.	06272935

Introduction / accident summary

The accident happened at around 13:51 on 02/06/15.

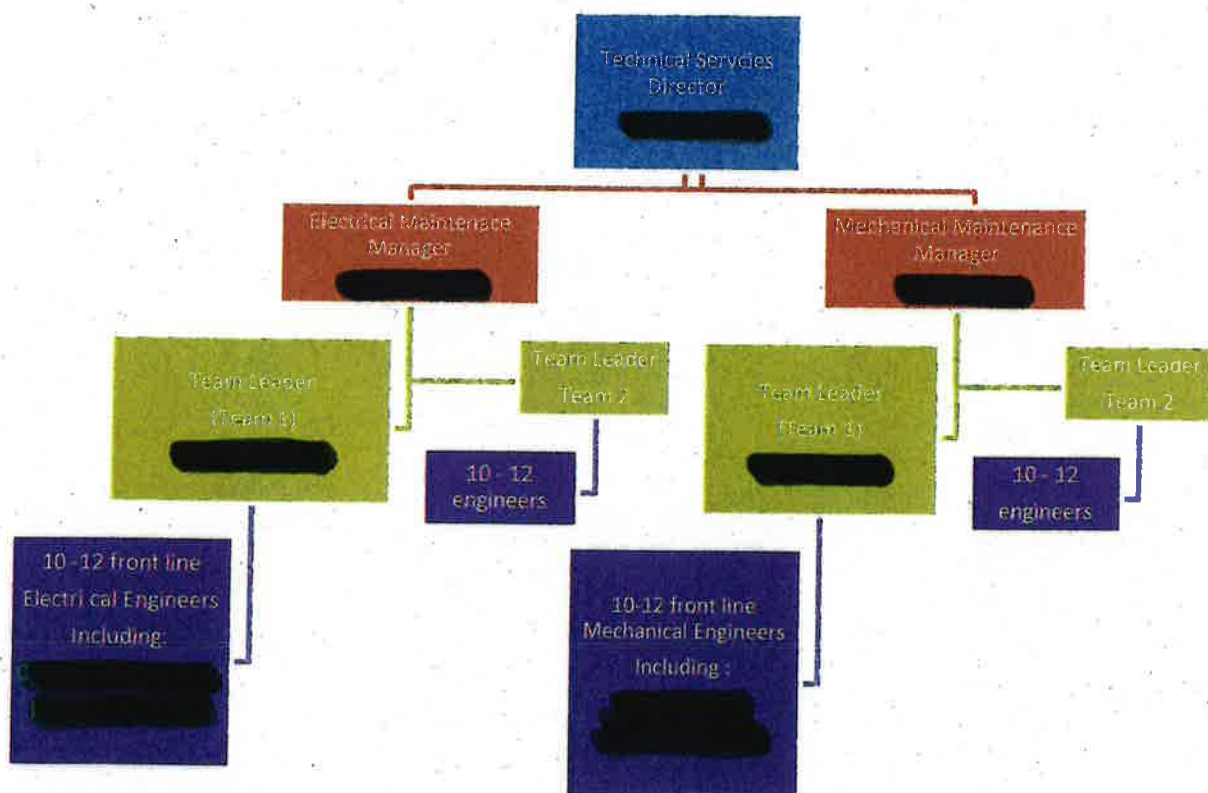
Figure 5 - Organizational Chart for Alton Towers Technical Services Department

6. There are two teams of electrical & mechanical engineers at the Alton Towers resort. 'Team 1' consists of around 10 to 12 front line engineers. Team 1 covers one half of the Alton Towers Resort (i.e. the half which contains the Smiler ride). All ride engineers belong to the Technical Services Department. Team 1 only covers their half of the park – they do not cross over. See Figure 5, below, for a basic organizational chart showing the structure of the Technical Services Department. Four front line engineers attended the Smiler ride on the day of the incident, [REDACTED] and [REDACTED]. Prior to the incident, two mechanical engineers had added a fifth train to the ride, these were [REDACTED] and [REDACTED]. Shortly after this, they were joined by two electrical engineers, [REDACTED] and [REDACTED] to assist in dealing with a breakdown situation. Through the process of dealing with the breakdown and trying to get the ride back into operational use, two of the trains incorrectly entered the same block of track and a collision occurred. One of the trains was empty (the one in front), the other contained passengers. Some of the passengers (members of the public) who were occupying the train which impacted the stationary train suffered severe, life-changing injuries. The immediate and underlying causes for the incident will be discussed further, in the following report.
