QMUL  
**Francis Bancroft Building**  
Engineering Review

02/2017

Issue | 2 November 2017

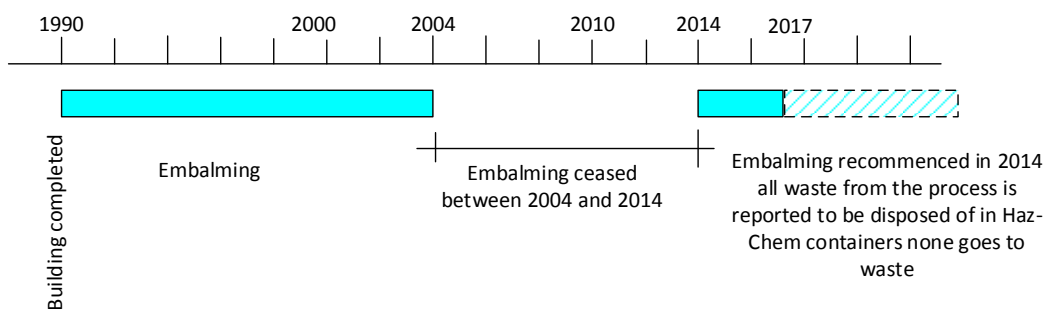
Figure 3.2 Embalming Activities in the Turnbull Centre

It was reported by the Department Manager that embalming activities ceased during the period 2004-2014 and recommenced in 2014, see Figure 3.2. The quantities of formaldehyde that are used in these activities are small - typical concentrations in TC were recorded at 0.4 to 0.5 ppm compared a WEL standard of 2ppm.

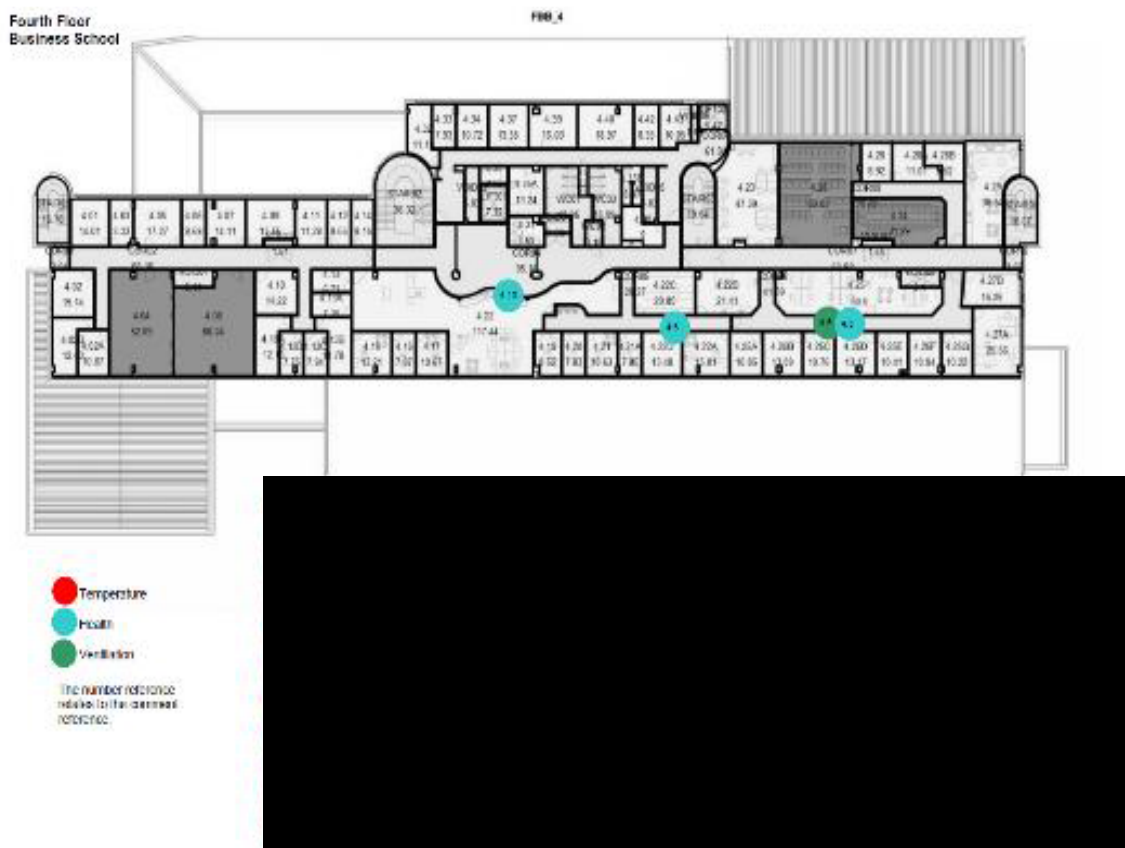
Figure 3.6 4<sup>th</sup> Floor School of Business and Management – Complaints Map

The general malaise of poor thermal comfort and poor ventilation is evident but there was also a greater concentration of complaints of poor health too - complaints of headaches and respiratory problems are commonplace, see Figure 3.6.

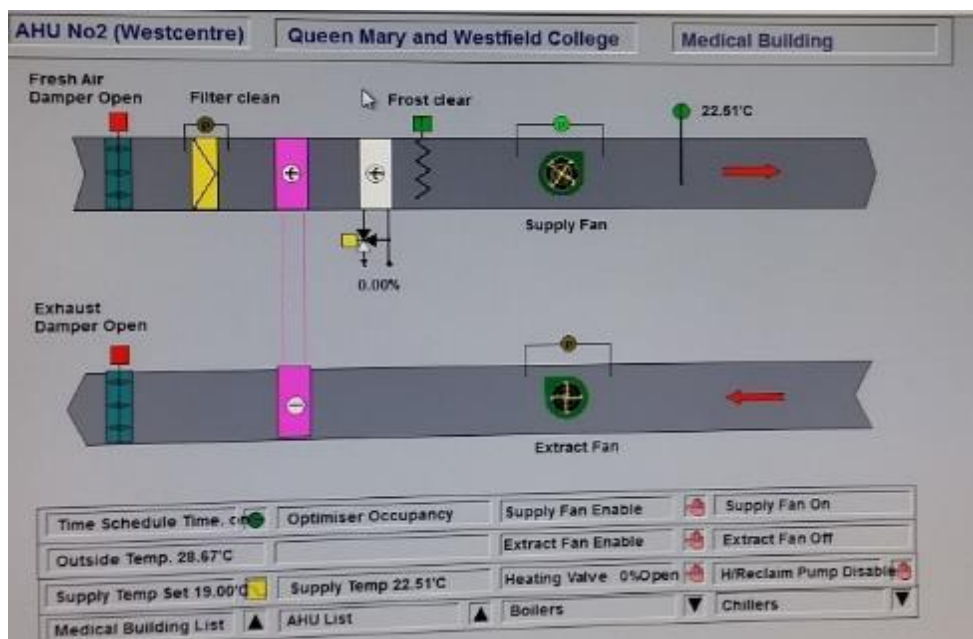
Figure 6.5 Schematic of AHU02

There were general complaints of poor thermal conditions throughout the building and throughout the year. In essence, the majority of the AHUs are delivering full fresh air and warm air heating to the occupied spaces. The principal AHUs providing general ventilation do not have mechanical cooling fitted – the typical arrangement is shown in Figure 6.5.

The AHU is controlled with two stages of heating to maintain a supply air temperature set point by initially starting the run-around coils pump to recover heat from the exhaust air then modulating the LTHW heating coil control valve if further heat is required. This is controlled by a P+I action to eliminate any offset in the controlled condition.

This arrangement means that there is no feedback from the occupied space and the system can only provide tempered air relying on the sill –line perimeter heating to carry-out the main modulation of heat in the room

For example the external air temperature was indicating a temperature of 28.67°C when the actual temperature was 14°C, see the BMS graphic for AHU02 in Figure 6.5.. The poor calibration of this sensor results in the 3 heating weather compensated circuits operating at a considerably lower temperature than it should leading to underheating of the building.

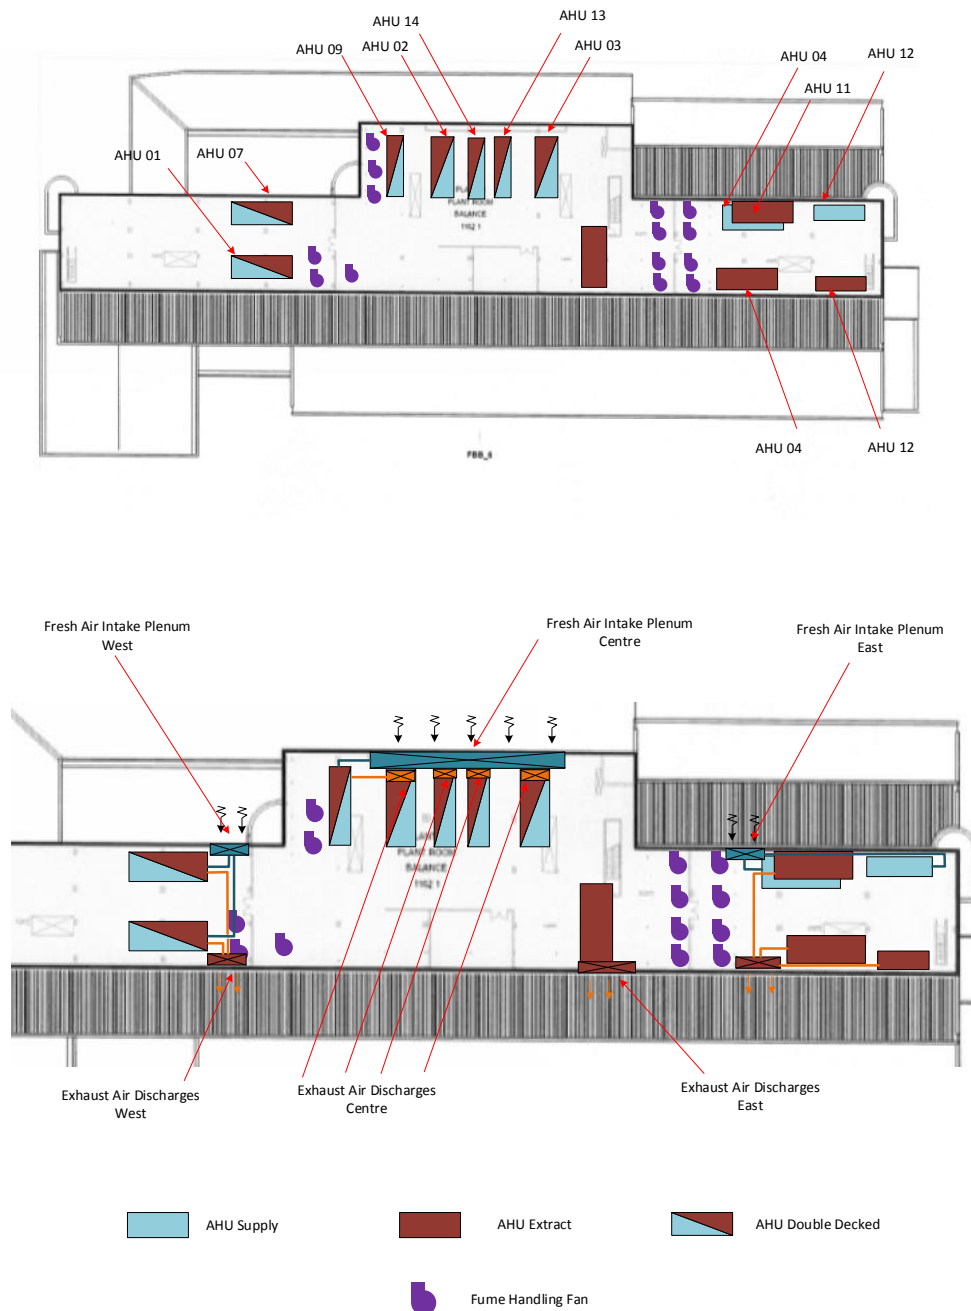
Figure 6.6 Roof Plantroom General Arrangement

There are numerous complaints of poor air quality that affect the majority of the building. The arrangement of AHUs, fresh air intakes and exhaust discharges are shown in Figure 6.6.

Generally, the fresh air intakes are arranged on the north façade of the building with the discharges on the south. The exception to this is the centre zone where the fresh air intake plenum is in close proximity to the discharges from the General Ventilation from AHU02 & 03 and AHU13 & 14 as well as that from the toilet extract discharge of AHU09 - these are shown in aerial views of the building in Figures 6.7 and 6.8

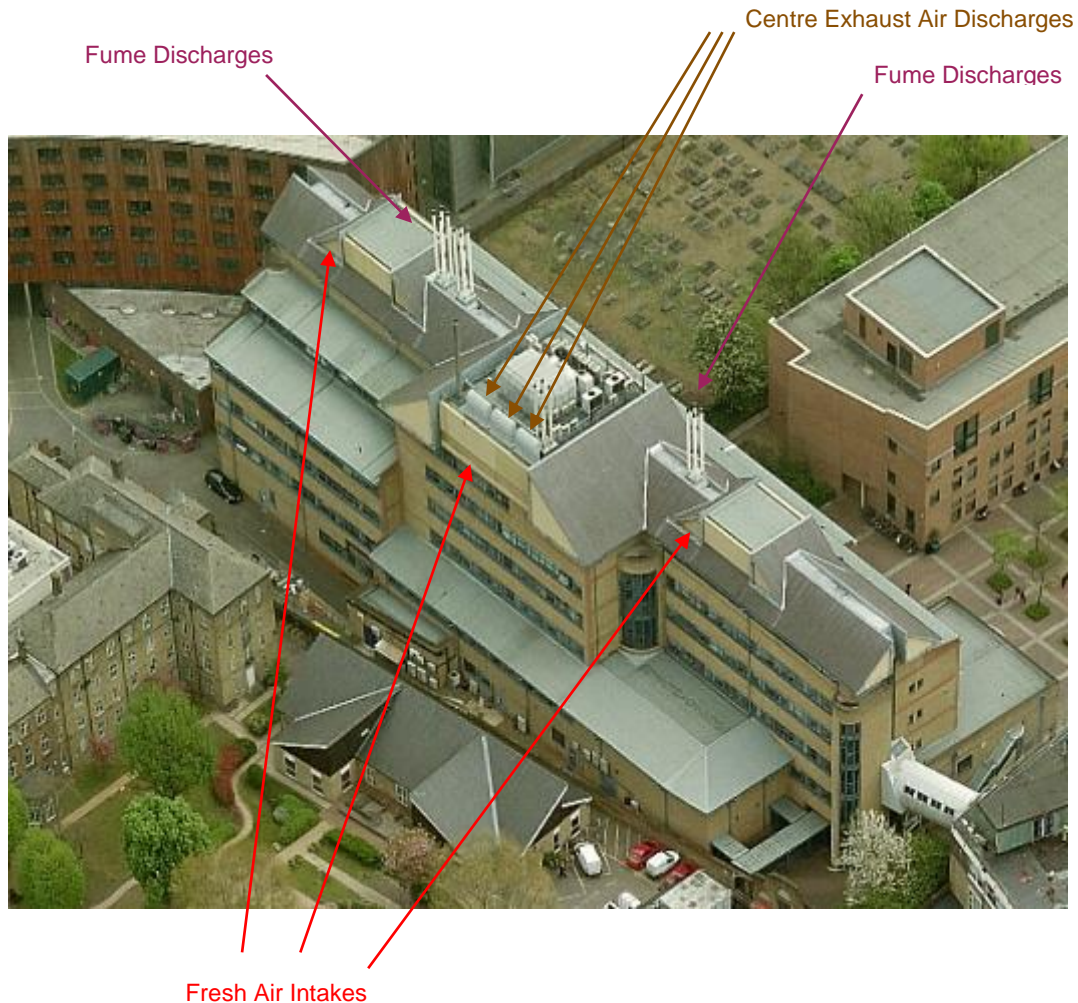
Figure 6.7 FBB North Façade – Air Intakes and Exhausts

The proximity of the centre exhaust discharges to the centre fresh air intake is a possible route for air to short-circuit back into fresh air supply of AHUs 02 & 03 which serve the general ventilation of a large proportion of the building.

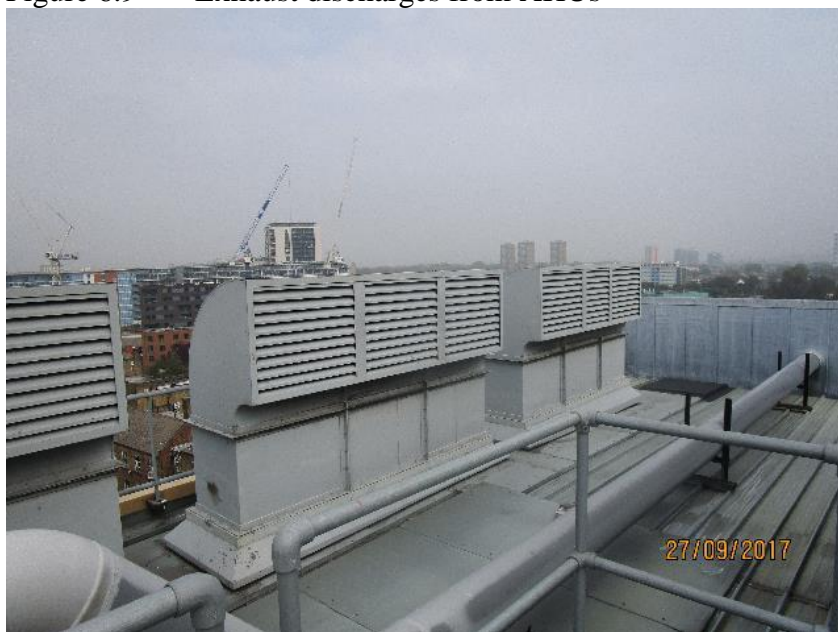
Figure 6.9 Exhaust discharges from AHUs

The detail of the central exhaust discharges are shown in Figure 6.9

Figure 6.10 is a section through the fresh air intake and exhaust air discharge and indicates how the discharge may possibly short circuit into the fresh air inlet plenum. The discharges from AHU13 & 14, located in the centre of the bank of three will have exhaust air from the 5th floor.

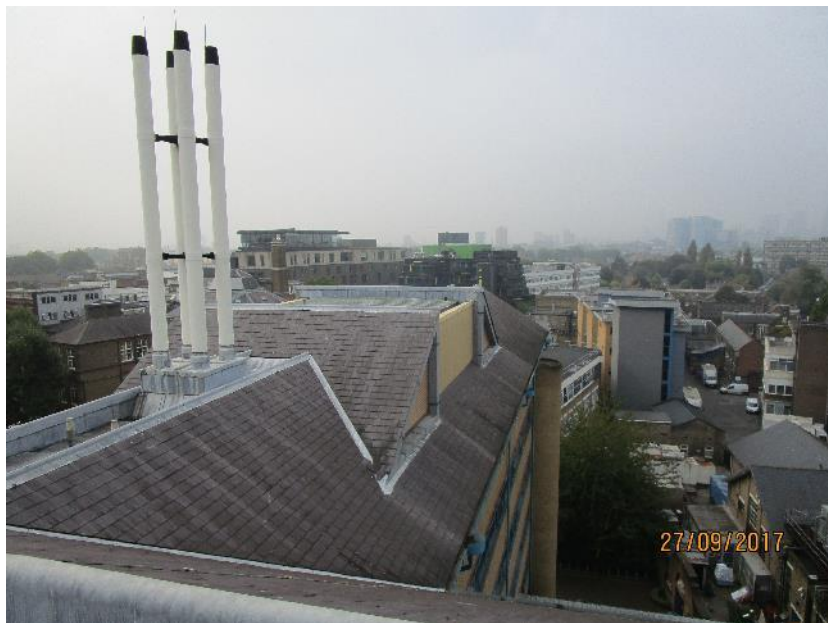
Figure 6.16 Fume cupboard individual discharge flues (centre zone)

The building has several fume handling systems which tend to have a decentralised arrangement in that 1 fan serves 1 fume cupboard and flue discharges are taken up 6m above the roof line, see Figure 6.16.

We noted that on a number of these fume discharge ducts there were air leakage paths to the plantroom where, for example traverse point test plugs had been removed leading to a transmission path for contaminants into the plantroom areas.

The sections of ductwork under positive pressure need to be leak tested and any breaches appropriately sealed.

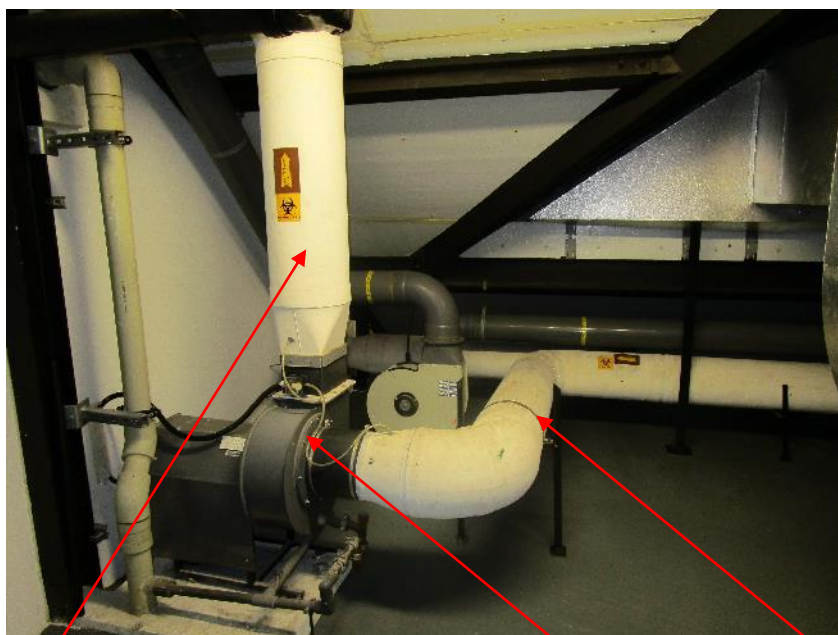
Figure 6.17 Typical fume cupboard arrangement

An example of the fan arrangement is shown in Figure 6.17 which are all located in the roof plantroom space (6<sup>th</sup> floor), see plantroom layout in Figure 6.6.

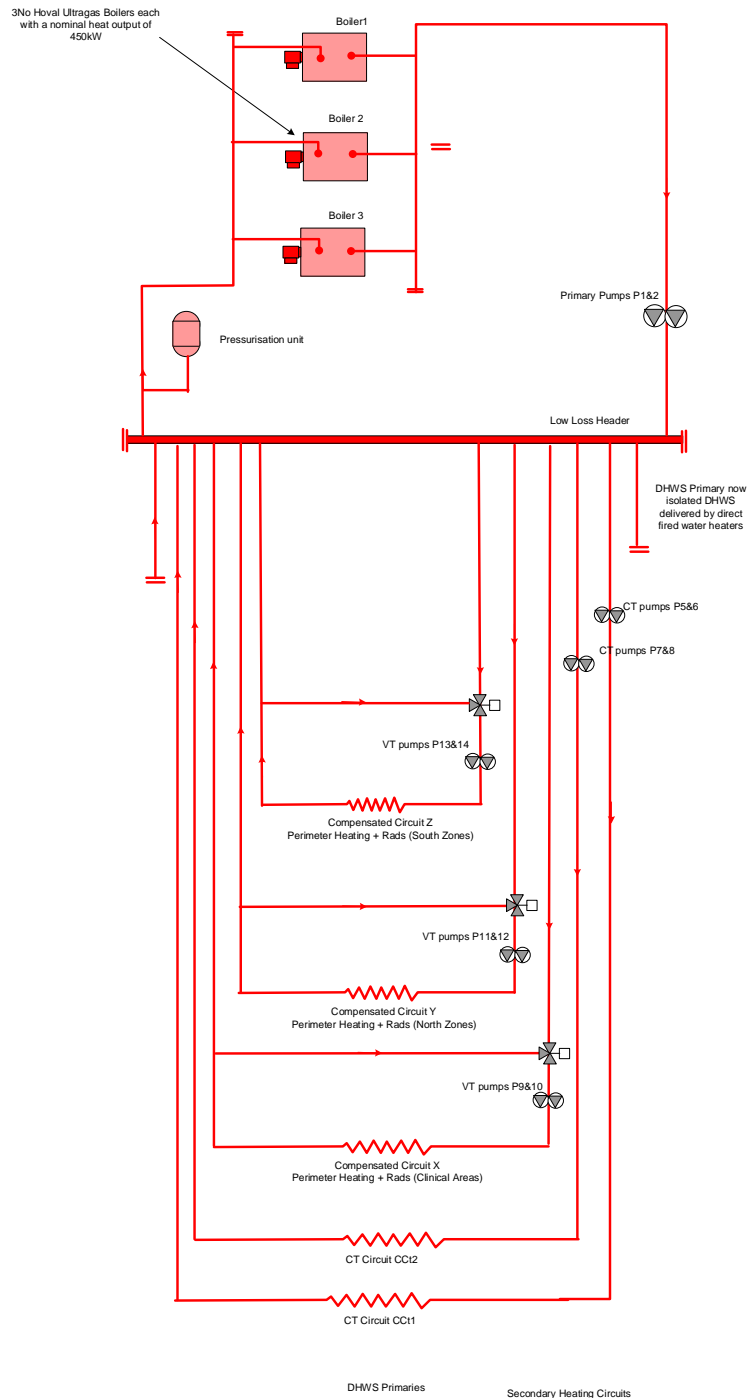
Figure 6.18 LTHW Boiler Simplified Schematic

The building is heated with an LTHW distribution system serving the heating coils in the AHUs and the perimeter finned tube sill line heaters. A simplified schematic is shown in Figure 6.18 showing the primary and secondary circuits

It will be necessary modify the heating system so it is better equipped to match the local requirements of individual spaces. The existing sill line perimeter heating has no local control of heating water temperature this is achieved centrally through weather compensated control of 3 secondary circuits, see Figure 6.18. The colder the outside weather, the higher flow temperature set point.

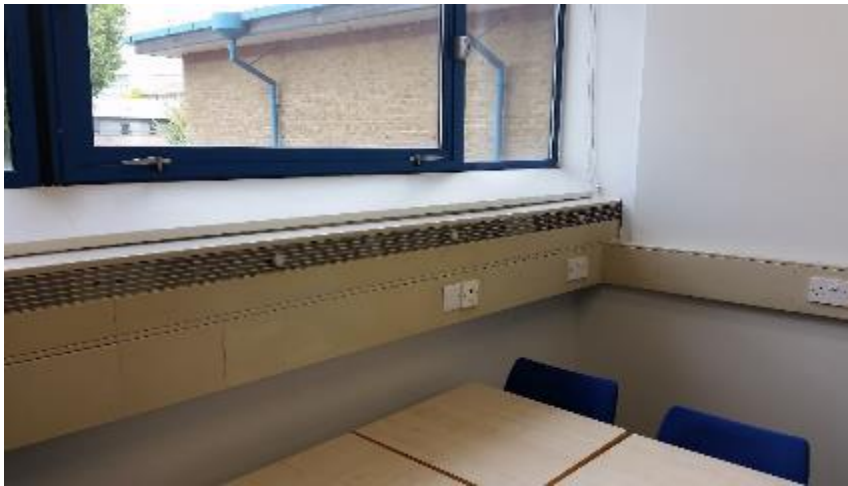
Figure 6.19 Sill Line heaters

The occupied spaces are heated by the LTHW compensated circuits with predominately sill line fin tube natural convectors, see Figure 6.17. A view from below shows that the coils are connected in series without any control valves, see Figure 6.18.

The heating temperature of the LTHW circulating in the compensated circuit is set according to the outside weather - there is no feedback from the space. The only

control that is provided is the air damper button for manual control of output. This would have been adequate for larger open plan spaces where occupancy is relatively uniform but is not ideal for cellular spaces where occupation and hence thermal loads can vary.

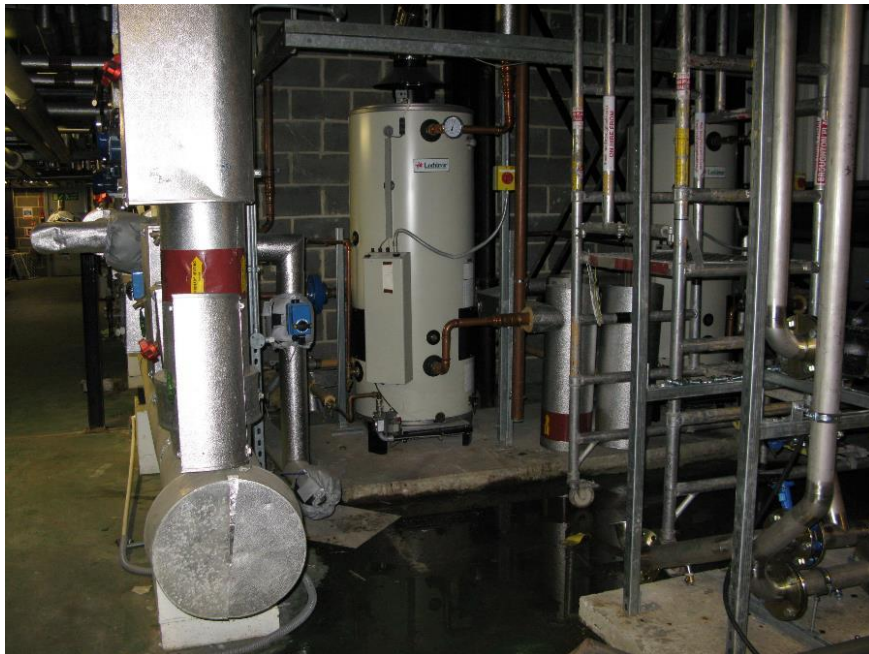
Figure 6.21 DHWS Direct Fired Gas Water Heaters

The DHWS was raised by the main LTHW primaries which have been subsequently isolated on the main plant. It is now delivered from two Lochinvar direct fired gas water heaters see Figure 6.21.

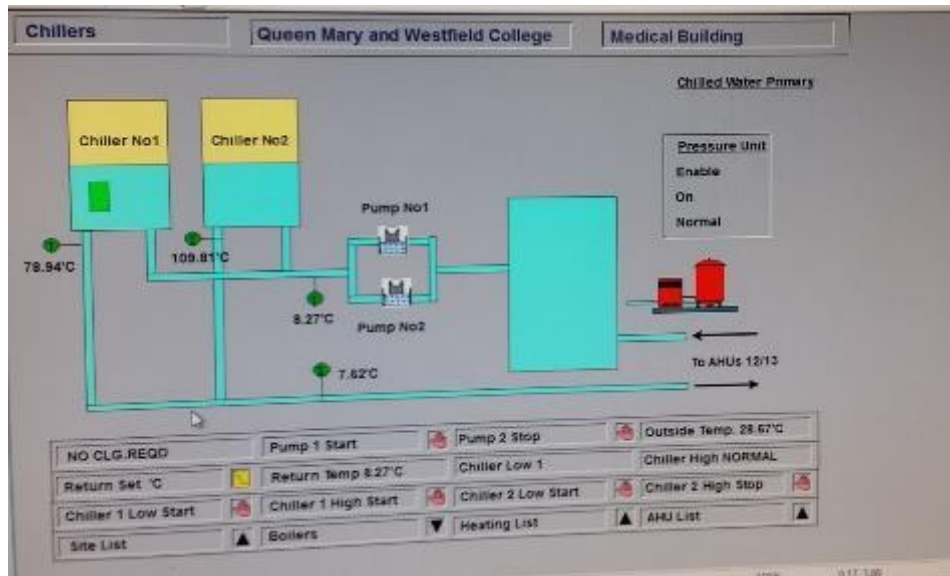
Figure 6.22 Chilled Water System Schematic (BMS Graphic)

The chilled water system essentially serves the cooling requirements of the 5<sup>th</sup> floor in AHUs 12 & 13, the BMS graphic is shown in Figure 6.22. There are two water cooled water chillers located in the roof plantroom that operate to maintain a chilled water flow temperature of 6°C. A buffer vessel has been installed to the circuit to increase the water content of this small circuit to minimise cycling of the chiller compressors.

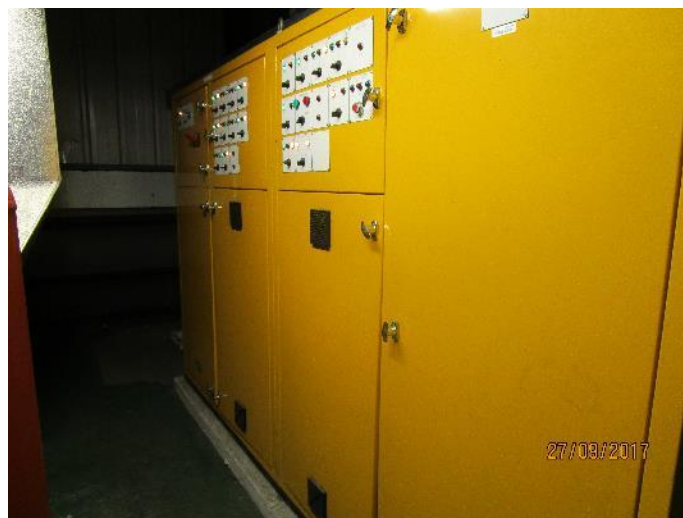
Figure 6.23 Existing MCC and Control Panel Sections

The HVAC are controlled by a building management system that was originally a Satchwell BAS 2000 which were acquired latterly by TAC systems. An example of an existing MCCP and controls section is shown in Figures 6.23 and 6.24.

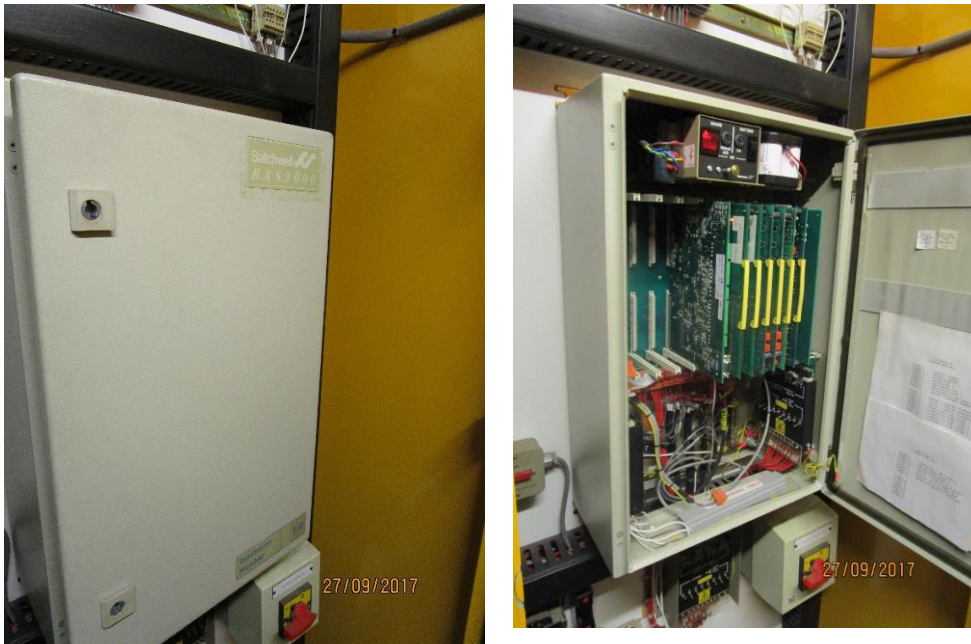
Figure 6.24 Controls Enclosure showing original Satchwell BAS 2000 badge

The existing BMS has a number of defects which impact upon the way in which the HVAC systems perform and in turn on the comfort and well-being of the occupant.

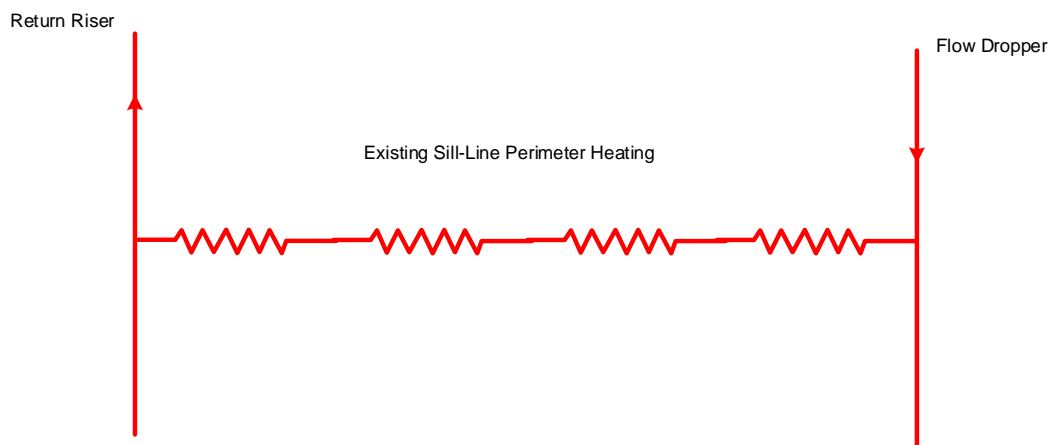
Figure 6.25 Perimeter Heating System – Existing Ladder Arrangement

The existing perimeter heating finned tubes are served in a ladder pipework arrangement, see Figure 6.25. Local control could be introduced by converting the system into a two pipe arrangement with a local direct acting control valve for each space, Figure 6.26.

A two pipe feed is proposed so that a local direct acting thermostatic valve can be introduced with a remote sensor located in the room air. A lock shield valve will be introduced for flow balancing.

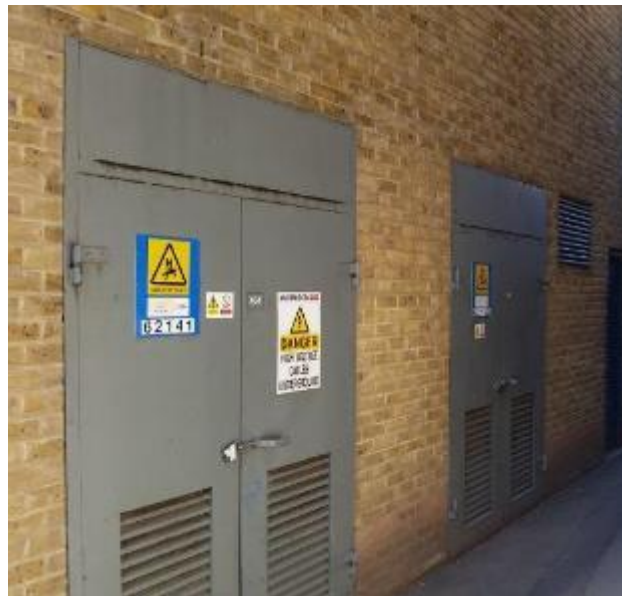
Figure 7.1 UKPN Substations

The Francis Bancroft Building is served from two separate UKPN Substations located at Ground level at the north eastern end of the building with the associated LV Switchgear directly above. The LV Schematics indicate that two UKPN services are connected (assumed to be one from each substation) each terminating on an 800A Moulded Case Circuit Breaker in the LV switchgear. It should not be inferred that the UKPN supplies are rated at 800A, see Figure 7.1.
