Birmingham and Solihull
Mental Health NHS Foundation Trust

Management Asbestos Registers for Properties Containing
Asbestos Materials
2016.

Report type: Assessment of Asbestos Containing Materials

Report Date: 20th December 2016

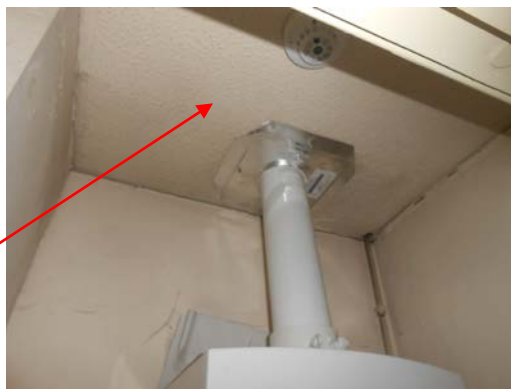
Location: House No.3, first floor, boiler Cupboard.

Lab result: Chrysotile

Material Risk Score: 3

Product Type: 1
Damage/deterioration: 0
Surface treatment 1
Asbestos type: 1

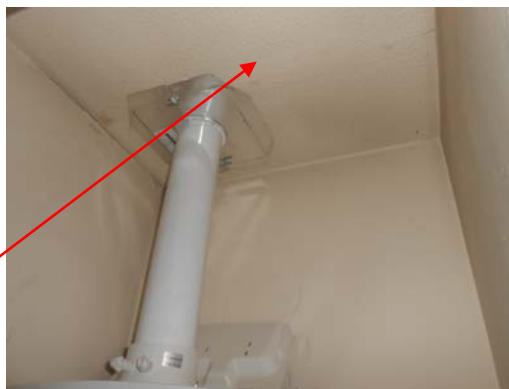
Location: House No.4, first floor, boiler Cupboard.

Lab result: Chrysotile

Material Risk Score: 3

Product Type: 1
Damage/deterioration: 0
Surface treatment 1
Asbestos type: 1

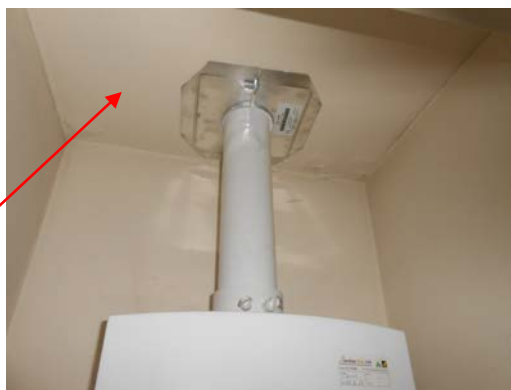
Location: House No.11, first floor, boiler Cupboard.

Lab result: Chrysotile

Material Risk Score: 3
Product Type: 1
Damage/deterioration: 0
Surface treatment 1
Asbestos type: 1

Total Risk Score: 3 – Very low risk

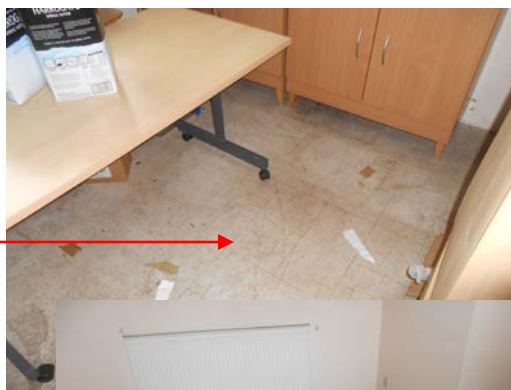
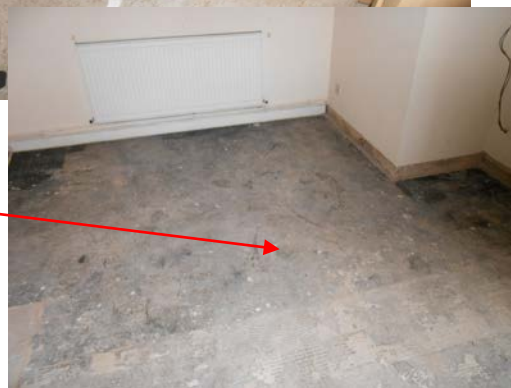
Location: House No.13 & 14.

Lab result: Chrysotile

Reviewed November 2016

The vinyl floor tiles throughout the house have been removed; there is still bitumen adhesive on the floor, this is presumed to contain very low levels of asbestos, a modern flooring material can be laid over the top.

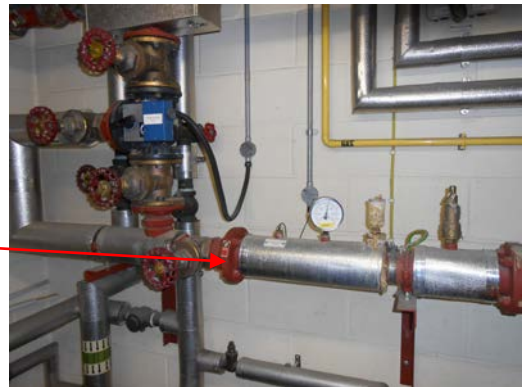
Location: Basement boiler room.

Lab result: Chrysotile

Material Risk Score: 3
Product Type: 2
Damage/deterioration: 0
Surface treatment: 0
Asbestos type: 1

Total Risk Score: 3 – Very Low Risk

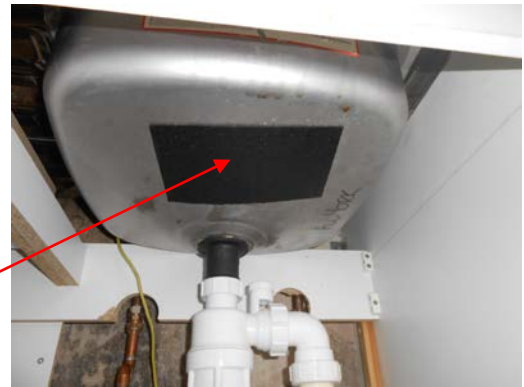
Location: Ground floor, main kitchen.

Item: Sink pad.

Lab result: Chrysotile

Material Risk Score: 3

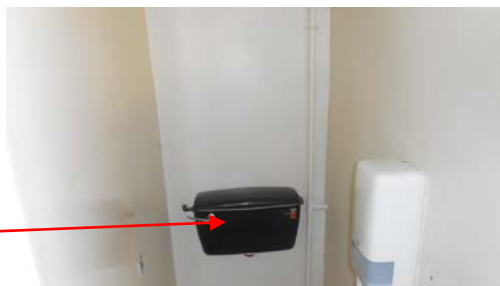
Location: First floor, Gents toilets
Room F73,

Lab result: Amosite

Reviewed November 2016
The Bakelite asbestos toilet
cistern has been removed

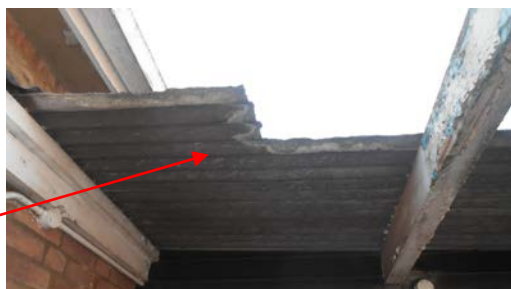
Location: Smoking area.

Lab result: Chrysotile.

Reviewed November 2016
The corrugated cement roof sheets are still in situ. These cement sheets should be removed with advice from a licensed asbestos removal contractor

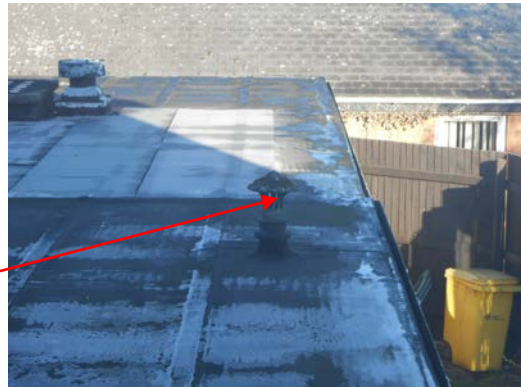
Material Risk Score: 4

Product Type: 1
Damage/deterioration: 1
Surface treatment: 1
Asbestos type: 1

Total Risk Score: 4 – Very low risk

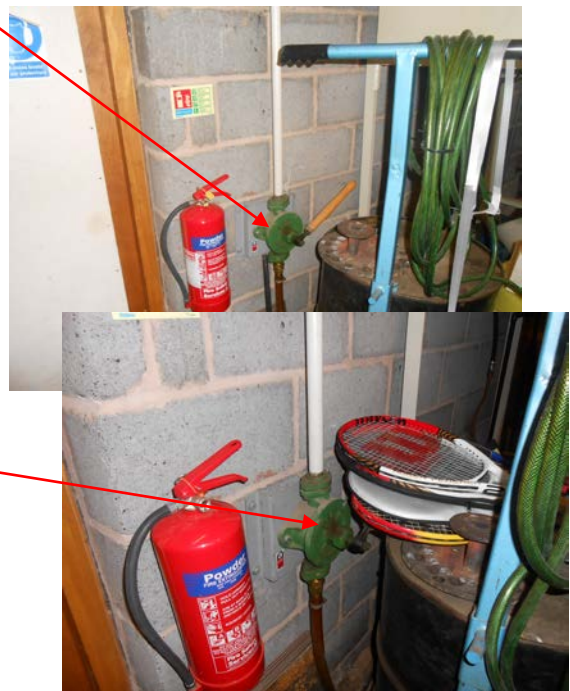
Material Risk Score: 3

Product Type: 2
Damage/deterioration: 0
Surface treatment: 0
Asbestos type: 1

Total Risk Score: 3 – Very Low Risk

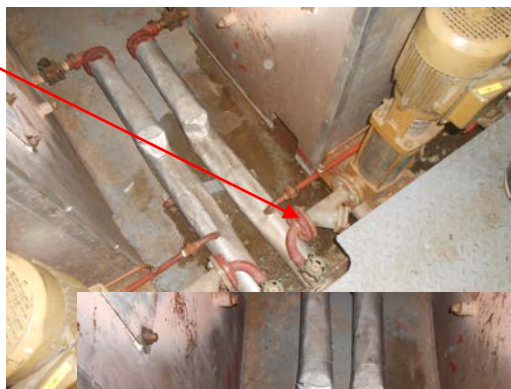
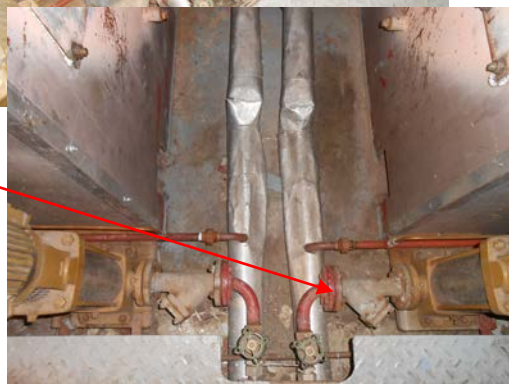
Material Risk Score: 3

Product Type: 2
Damage/deterioration: 0
Surface treatment: 0
Asbestos type: 1

Total Risk Score: 3 – Very Low Risk

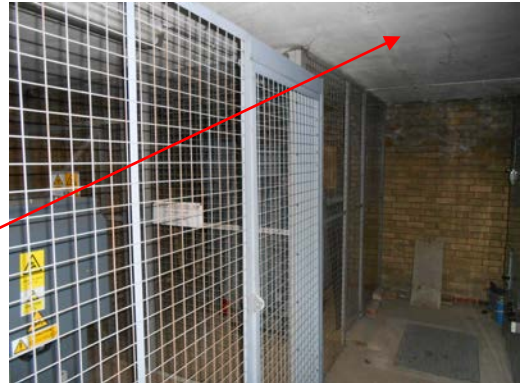
Location: Substation by old generating House.

Lab result: Amosite & Chrysotile

Material Risk Score: 8
Product Type: 2
Damage/deterioration: 1
Surface treatment: 3
Asbestos type: 2

Total Risk Score: 8 - Medium risk

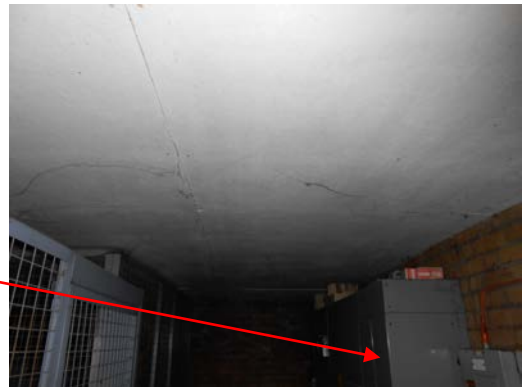
Location: Substation by old generating House.

Lab result: Chrysotile

Material Risk Score: 7

Product Type: 2
Damage/deterioration: 2
Surface treatment: 2
Asbestos type: 1

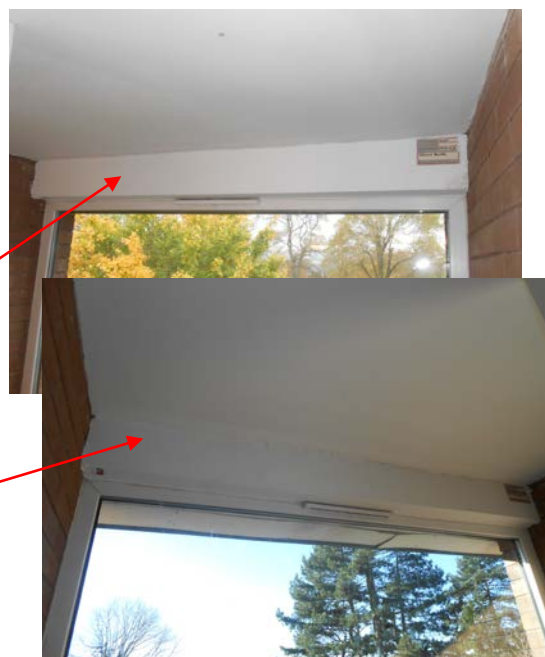
Material Risk Score: 6

Product Type: 2
Damage/deterioration: 1
Surface treatment 1
Asbestos type: 2

Total Risk Score: 6 – Medium Risk

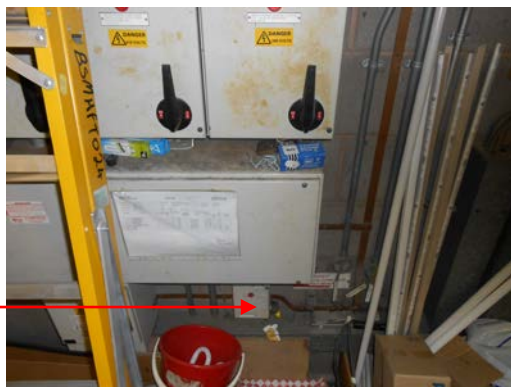
Location: Plant room, old electrics.

Lab result: Chrysotile

Material Risk Score: 7 Product Type: 2
Damage/deterioration: 2
Surface treatment: 2
Asbestos type: 1

Total Risk Score: 7 - Medium risk

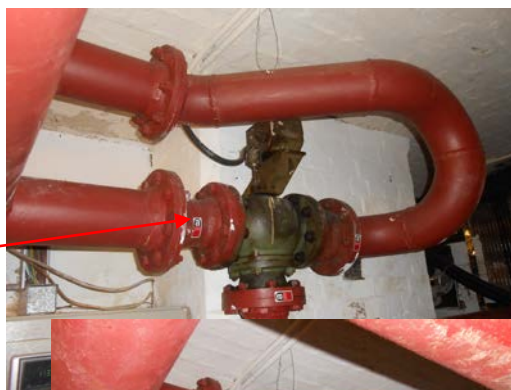
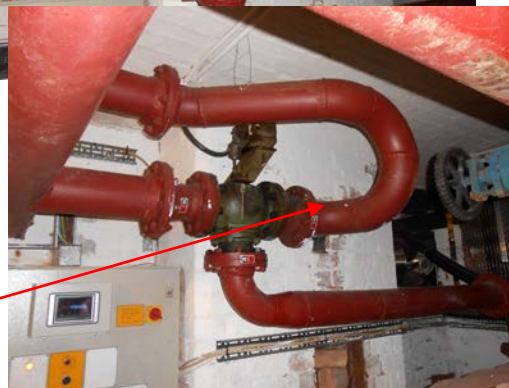
Location: Basement boiler room.

Lab result: Chrysotile

Reviewed November 2016

There are both modern and asbestos containing flange gaskets to the pipe work. They are all in good condition. All gaskets should be treated as asbestos materials unless it can be proved that they have been replaced with a modern gasket material

Product Type: 2
Damage/deterioration: 0
Surface treatment: 0
Asbestos type: 1

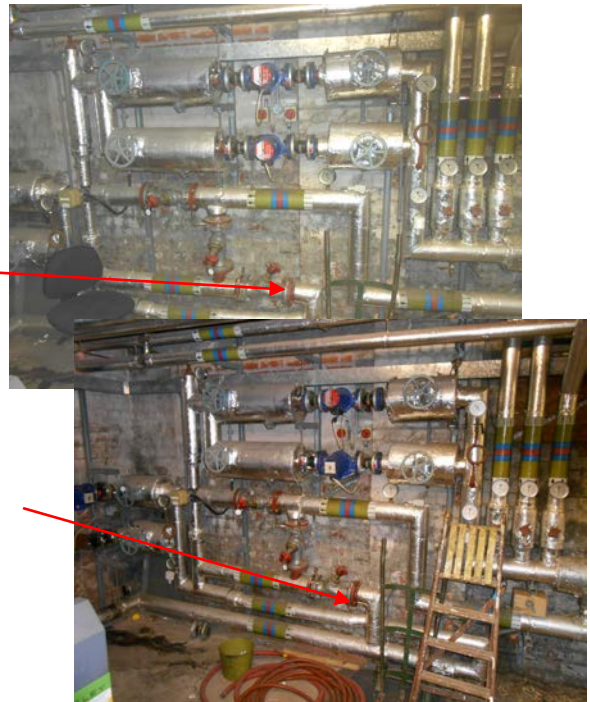
Material Risk Score: 3

Product Type: 2
Damage/deterioration: 0
Surface treatment: 0
Asbestos type: 1

Total Risk Score: 3 – Very Low Risk

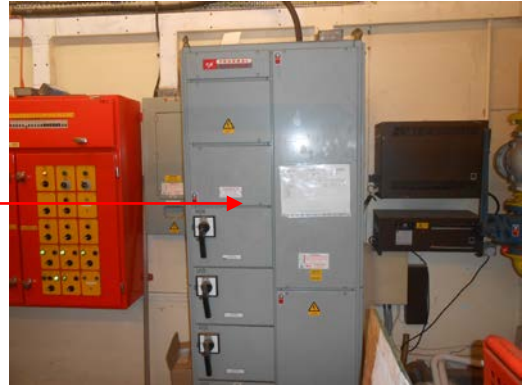
Location: Plant room, electrical switch box.

Lab result: Chrysotile

Material Risk Score: 7 Product Type: 2
Damage/deterioration: 2
Surface treatment: 2
Asbestos type: 1

Total Risk Score: 7 - Medium risk

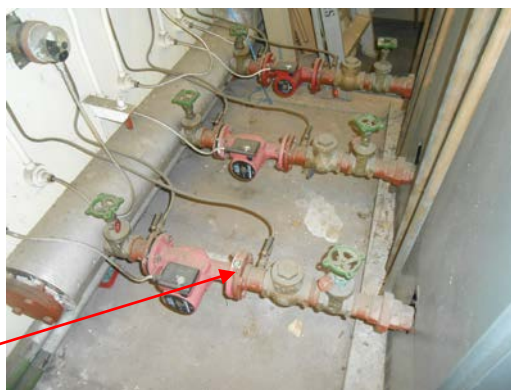
Location: Plant room.

Lab result: Chrysotile

Material Risk Score: 3

Product Type: 2
Damage/deterioration: 0
Surface treatment: 0
Asbestos type: 1

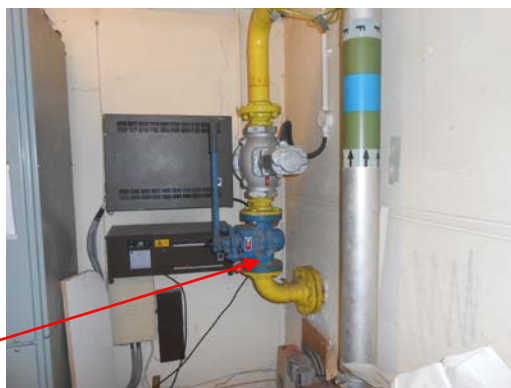
Location: Plant room.

Lab result: Chrysotile

Material Risk Score: 3

Product Type: 2
Damage/deterioration: 0
Surface treatment: 0
Asbestos type: 1
