TYPE 2
SURVEY, SAMPLING AND ASSESSMENT
OF ASBESTOS CONTAINING
MATERIALS

BRYNMAWR MARKET HALL (CINEMA)
(MO4112) BLOCK 1
MARKET SQUARE
BRYNMAWR
NP23 4AJ

REPORT REFERENCE NUMBER: 1304197 (Block 1) - Issue 2

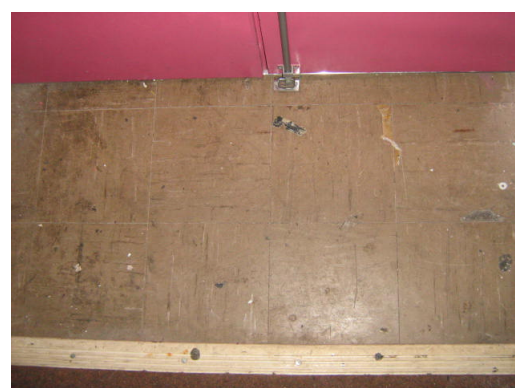
Sample Information		Material Risk Assessment	
Date:	08/07/2008	Product:	2
Surveyor:	Geraint Warlow	Damage/Deterioration:	Low
Building:	Brynmawr Market Hall (Cinema), Block 1	Surface Treatment:	Unsealed Board
Location:	Internal	Asbestos Type:	Amosite
Floor:	0	Material Score:	7
Room/Location:	016	Material Risk:	Medium
Position:	Back wall	Priority Risk Assessment*	
Description:	Grey strip panel	Normal Occupant Activity:	1
Product Type:	Insulating Board	Likelihood of Disturbance:	1
Extent:	=< 10m run	Human Exposure Potential:	1
Identification:	Sampled	Maintenance Activity:	0
Samples Ref:	1304197/0002	Priority Risk/Score:	3
Visually Similar to Sample:		Total Risk:	10

Control Actions	Timescale	Completed	Date of Completion
Encapsulate under controlled conditions	1 Months	No

Encapsulate under controlled conditions.
Note that there are 2 instances of the board in this location.

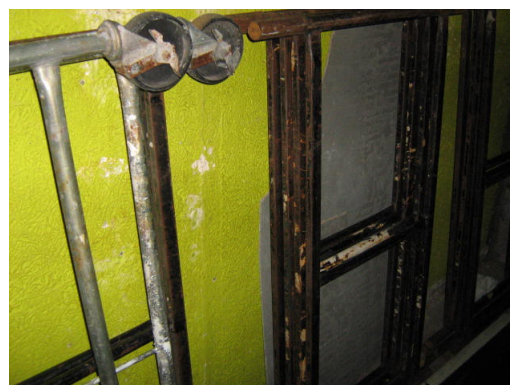
Sample Information Date: 08/07/2008 Surveyor: Geraint Warlow Building: Brynmawr Market Hall (Cinema), Block 1 Location: Internal Floor: 0 Room/Location: 016 Position: Loose by steps to fire exit Description: Grey boards Product Type: Insulating Board Extent: =< 10 m2 Identification: Sampled Samples Ref: 1304197/0003 Visually Similar to Sample:	Material Risk Assessment Product: 2 Damage/Deterioration: High Surface Treatment: Unsealed Board Asbestos Type: No Asbestos Detected Material Score: 0 Material Risk: Non Asbestos
Priority Risk Assessment* Normal Occupant Activity: Likelihood of Disturbance: Human Exposure Potential: Maintenance Activity: Priority Risk/Score:	
Total Risk: 0

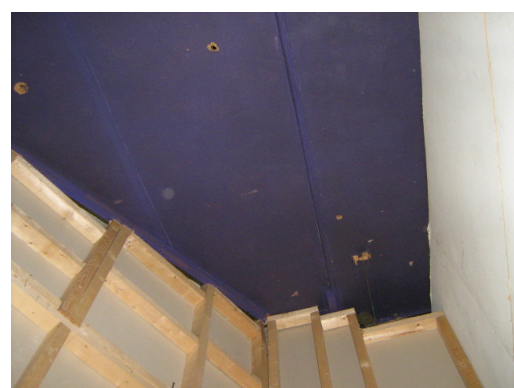
Sample Information		Material Risk Assessment	
Date:	17/04/2009	Product:	2
Surveyor:	Andrew Thomson	Damage/Deterioration:	Low
Building:	Brynmawr Market Hall (Cinema), Block 1	Surface Treatment:	Unsealed Board
Location:	Internal	Asbestos Type:	Non Asbestos
Floor:	0	Material Score:	
Room/Location:	019	Material Risk:	Non Asbestos
Position:	Ceiling of Ceiling Void	Priority Risk Assessment*	
Description:	Panels	Normal Occupant Activity:	
Product Type:	Insulating Board	Likelihood of Disturbance:	
Extent:	< 10m2 or < 10m run	Human Exposure Potential:	
Identification:	Str. Presumed	Maintenance Activity:	
Samples Ref:		Priority Risk/Score:	0
Visually Similar to Sample:	1304197/0079	Total Risk:	0

Area now fully accessed using triple ladders and crawl boards during re-visit.

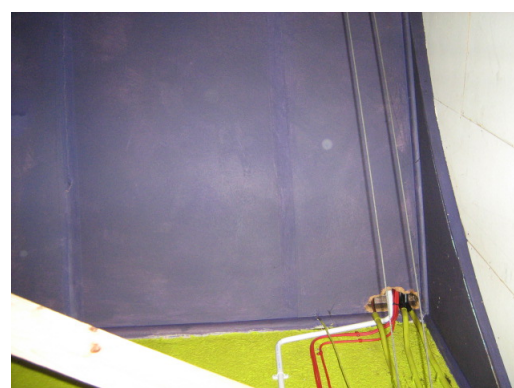
Sample Information Date: 17/04/2009 Surveyor: Andrew Thomson Building: Brynmawr Market Hall (Cinema), Block 1 Location: Internal Floor: 0 Room/Location: 018 Position: Ceiling Within Ceiling Void Description: Panels Product Type: Insulating Board Extent: < 10m2 or < 10m run Identification: Str. Presumed Samples Ref: Visually Similar to Sample: 1304197/0079	Material Risk Assessment Product: 2 Damage/Deterioration: Low Surface Treatment: Painted/Encapsulated Board Asbestos Type: Non Asbestos Material Score: Material Risk: Non Asbestos
Priority Risk Assessment* Normal Occupant Activity: Likelihood of Disturbance: Human Exposure Potential: Maintenance Activity: Priority Risk/Score: 0 Total Risk: 0

Area now fully accessed using triple ladders during re-visit.

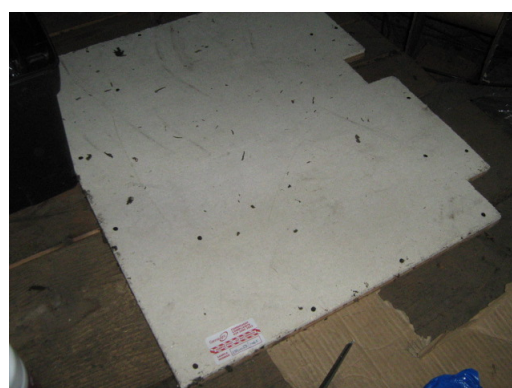
Sample Information		Material Risk Assessment	
Date:	17/04/2009	Product:	2
Surveyor:	Andrew Thomson	Damage/Deterioration:	Low
Building:	Brynmawr Market Hall (Cinema), Block 1	Surface Treatment:	Unsealed Board
Location:	Internal	Asbestos Type:	Non Asbestos
Floor:	0	Material Score:	0
Room/Location:	015	Material Risk:	Non Asbestos
Position:	Back of Hatch in Roof Void	Priority Risk Assessment*	
Description:	Panel	Normal Occupant Activity:	
Product Type:	Insulating Board	Likelihood of Disturbance:	
Extent:	< 10m2 or < 10m run	Human Exposure Potential:	
Identification:	Sampled	Maintenance Activity:	
Samples Ref:	1304197/0012	Priority Risk/Score:	0
Visually Similar to Sample:		Total Risk:	0

Area now fully accessed using triple ladders during re-visit.

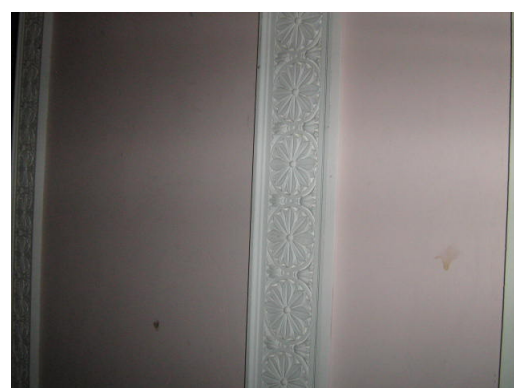
Sample Information Date: 08/07/2008 Surveyor: Geraint Warlow Building: Brynmawr Market Hall (Cinema), Block 1 Location: Internal Floor: 0 Room/Location: 015 Position: Wall throughout room Description: Decorative plaster Product Type: Textured Coating Extent: >= 50m run Identification: Sampled Samples Ref: 1304197/0013 Visually Similar to Sample:		Material Risk Assessment Product: 1 Damage/Deterioration: Medium Surface Treatment: Reinforced Composite Materials Asbestos Type: No Asbestos Detected Material Score: 0 Material Risk: Non Asbestos	
		Priority Risk Assessment* Normal Occupant Activity: Likelihood of Disturbance: Human Exposure Potential: Maintenance Activity: Priority Risk/Score:	
		Total Risk: 0

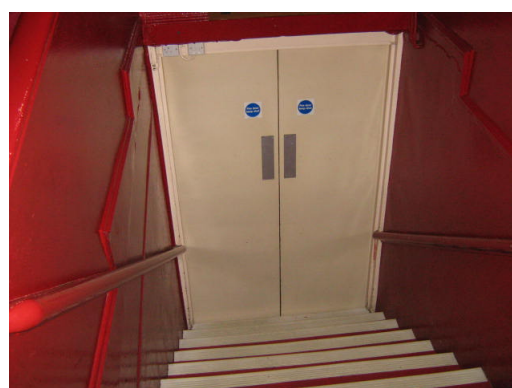
Sample Information Date: 08/07/2008 Surveyor: Geraint Warlow Building: Brynmawr Market Hall (Cinema), Block 1 Location: Internal Floor: 0 Room/Location: 012 Position: Description: No Suspect ACM Observed Product Type: Extent: Identification: No Suspect ACM Observed Samples Ref: Visually Similar to Sample:		Material Risk Assessment Product: Damage/Deterioration: Surface Treatment: Asbestos Type: Material Score: 0 Material Risk: Non Asbestos	
		Priority Risk Assessment* Normal Occupant Activity: Likelihood of Disturbance: Human Exposure Potential: Maintenance Activity: Priority Risk/Score:	
		Total Risk: 0

Room refurbished within last two years.

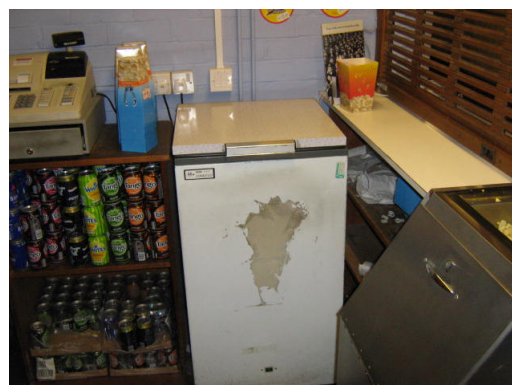
Sample Information Date: 08/07/2008 Surveyor: Geraint Warlow Building: Brynmawr Market Hall (Cinema), Block 1 Location: Internal Floor: 0 Room/Location: 013 Position: Description: No Suspect ACM Observed Product Type: Extent: Identification: No Suspect ACM Observed Samples Ref: Visually Similar to Sample:	Material Risk Assessment Product: Damage/Deterioration: Surface Treatment: Asbestos Type: Material Score: 0 Material Risk: Non Asbestos
Priority Risk Assessment* Normal Occupant Activity: Likelihood of Disturbance: Human Exposure Potential: Maintenance Activity: Priority Risk/Score:	
Total Risk: 0

Room refurbished within the last two years

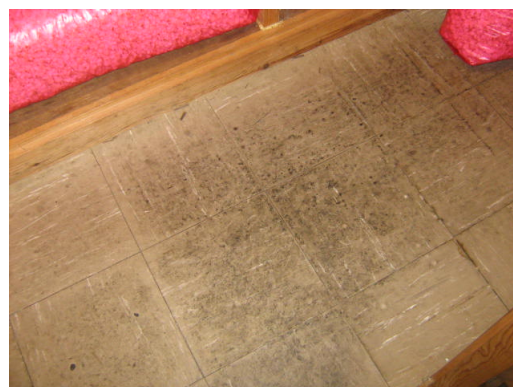
Number: 1304197-0017

Sample Information		Material Risk Assessment	
Date:	08/07/2008	Product:	1
Surveyor:	Geraint Warlow	Damage/Deterioration:	Low
Building:	Brynmawr Market Hall (Cinema), Block 1	Surface Treatment:	Reinforced Composite Materials
Location:	Internal	Asbestos Type:	No Asbestos Detected
Floor:	0	Material Score:	0
Room/Location:	009	Material Risk:	Non Asbestos
Position:	Floor in store	Priority Risk Assessment*	
Description:	Beige tiles	Normal Occupant Activity:	
Product Type:	Vinyl	Likelihood of Disturbance:	
Extent:	=< 10 m2	Human Exposure Potential:	
Identification:	Strongly Presumed	Maintenance Activity:	
Samples Ref:		Priority Risk/Score:	
Visually Similar to Sample:	1304197/0001	Total Risk: 0

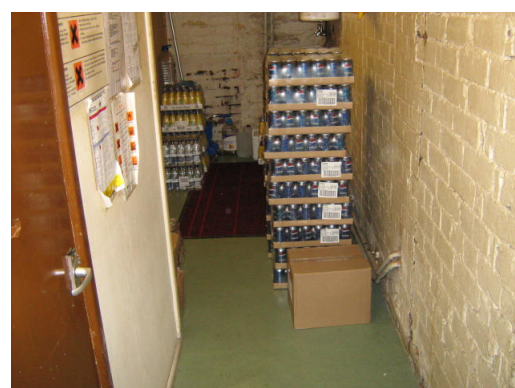
Sample Information Date: 08/07/2008 Surveyor: Geraint Warlow Building: Brynmawr Market Hall (Cinema), Block 1 Location: Internal Floor: 0 Room/Location: 010 Position: Description: No Suspect ACM Observed Product Type: Extent: Identification: No Suspect ACM Observed Samples Ref: Visually Similar to Sample:		Material Risk Assessment Product: Damage/Deterioration: Surface Treatment: Asbestos Type: Material Score: 0 Material Risk: Non Asbestos	
		Priority Risk Assessment* Normal Occupant Activity: Likelihood of Disturbance: Human Exposure Potential: Maintenance Activity: Priority Risk/Score:	
		Total Risk: 0

New floor covering less than two years old.
