**Report No: AR/09/3388 (update 02)**

**CRAGSIDE PRIMARY SCHOOL,  
WEST LOCK ROAD,  
CRAMLINGTON, NE23 6LW  
MANAGEMENT ASBESTOS SURVEY**

**UPDATED ASBESTOS REGISTER FROM VEGA REPORT  
AR/09/3388**

**Issue Date: 09 July 2015**

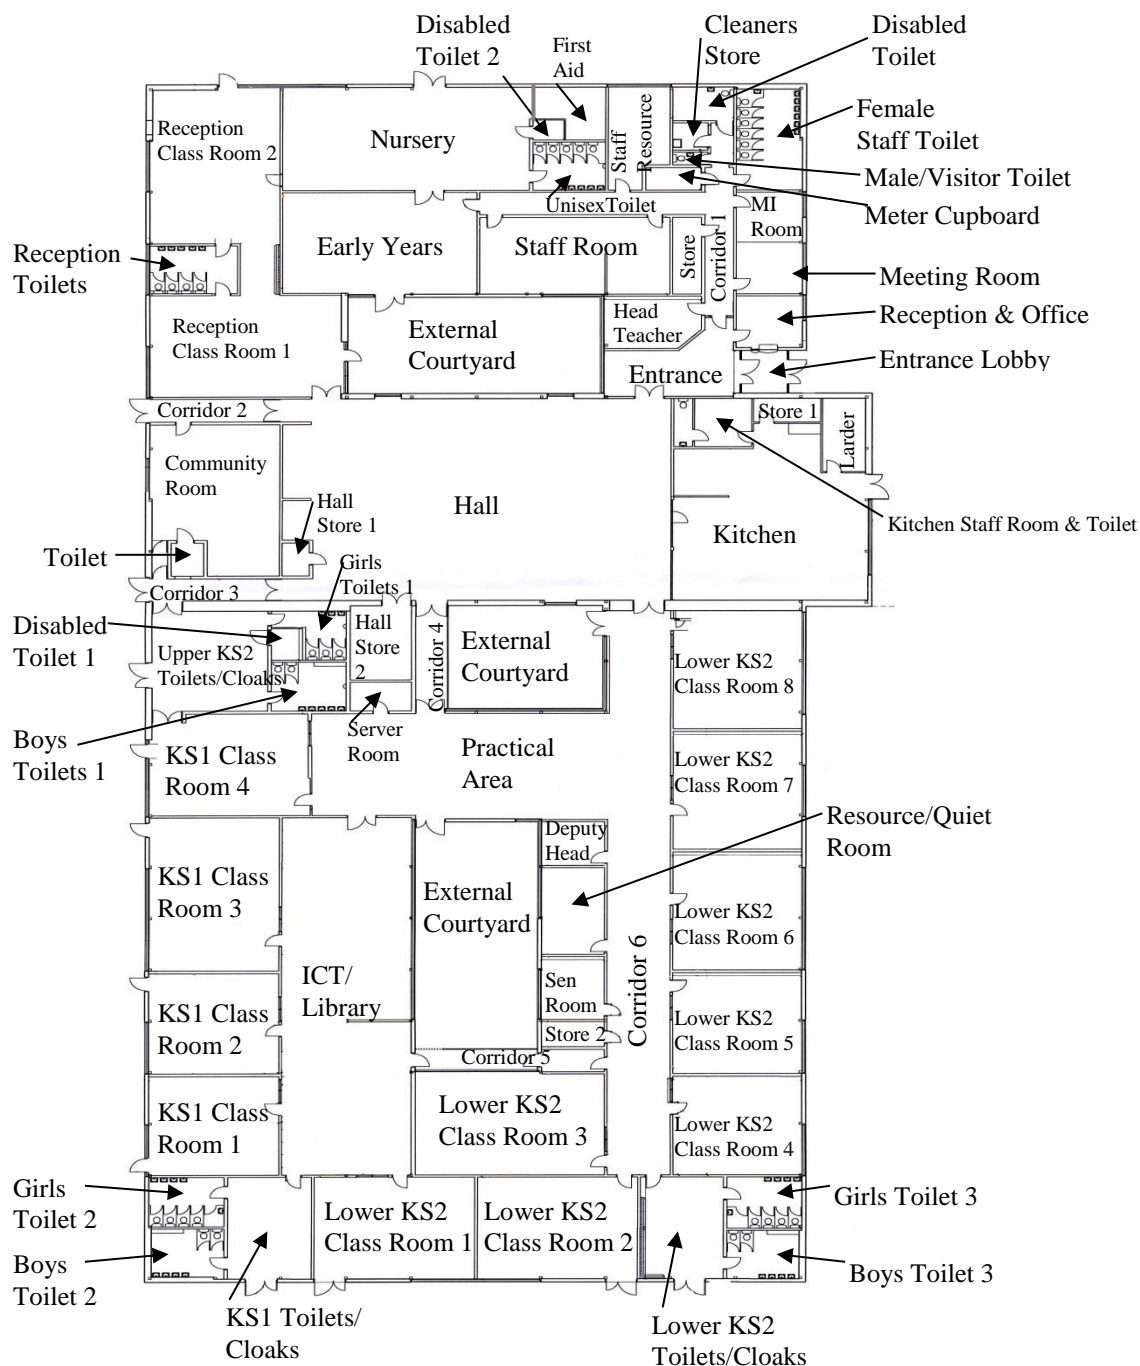
**Cragside Primary School**

Kitchen Staff Room & Toilet - toilet cistern is an asbestos containing material (ACM sample BS/01). It is in good condition and recommended it be left undisturbed and monitored.

Boiler Room - residual debris to roof joists is an ACM (as BS/02). It is recommended that the roof joists are cleaned and decontaminated by a licenced asbestos removal contractor.

Tank Room - residual debris to roof joists is an ACM (as BS/02). It is recommended that the roof joists are cleaned and decontaminated by a licenced asbestos removal contractor.

Tank Room - floor debris is an ACM (sample BS/02). It is recommended that the floor space is cleaned and decontaminated by a licenced asbestos removal contractor.

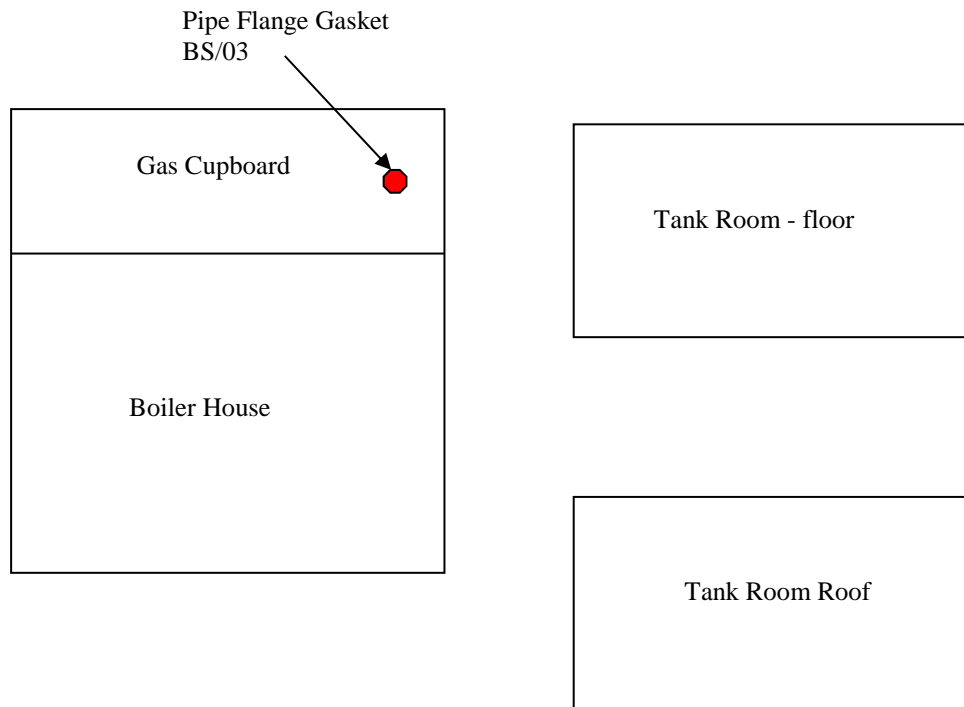
**External Buildings**

Gas Cupboard - pipe flange gaskets are an ACM (sample BS/03). They are in good condition and recommended they be left undisturbed and monitored.

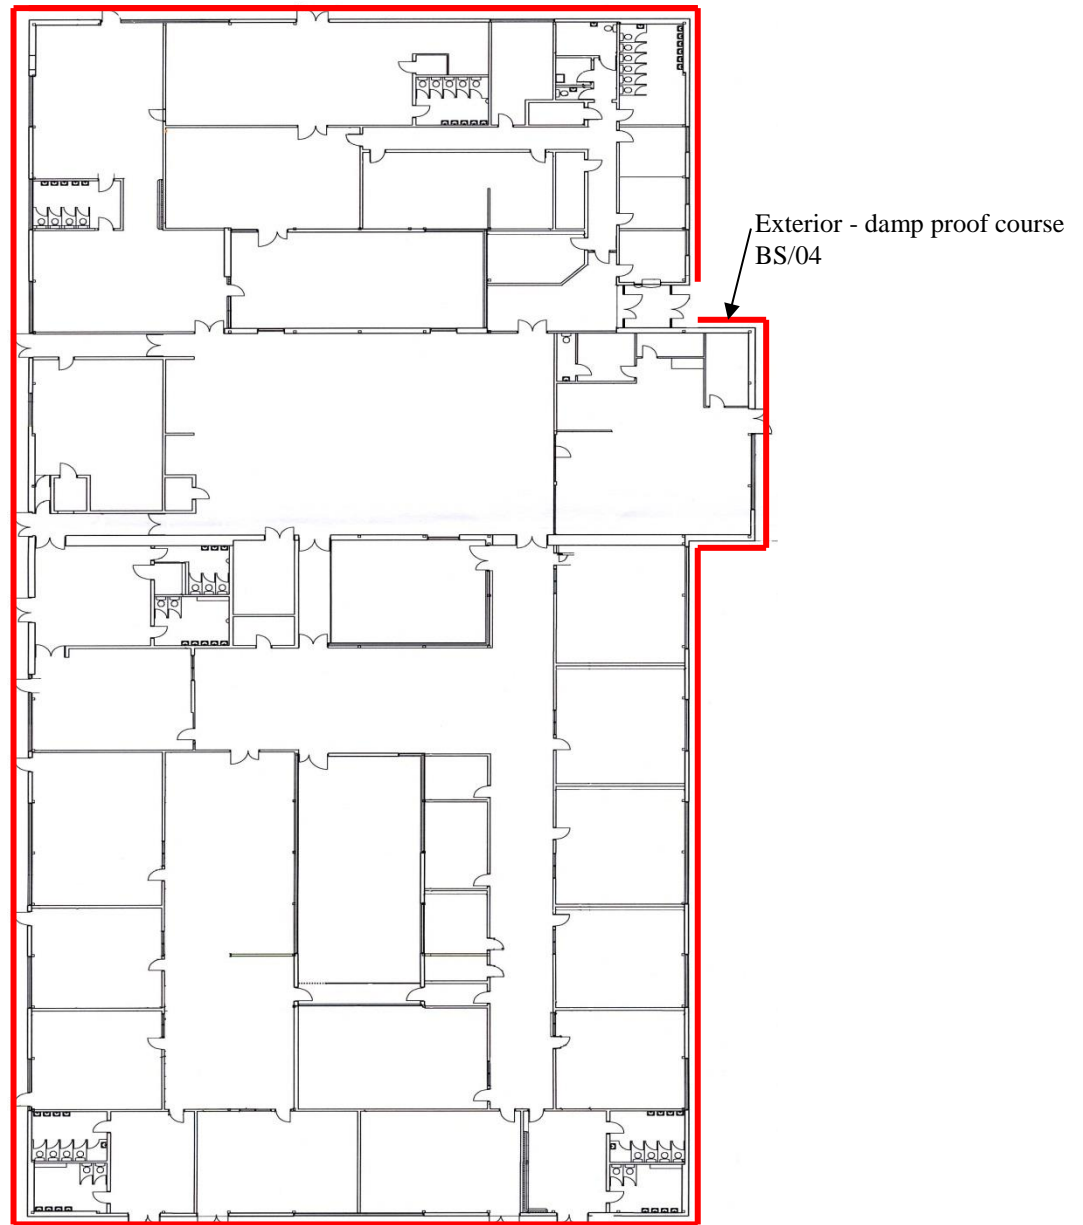
**Exterior**

Exterior - damp proof course is an ACM (BS/04). It is in good condition and recommended it be left undisturbed and monitored.
