**Report No: AR/04/1677 (Update 06)**

**CRAMLINGTON HILLCREST SCHOOL,  
EAST VIEW AVENUE  
CRAMLINGTON, NE23 9DY**

**UPDATED ASBESTOS REGISTER FROM VEGA REPORT  
AR/04/1677  
UPDATED BY ASBESTOS MANAGER – RON BROWN  
UPDATE NUMBER 06**

**ASBESTOS SURVEY REPORT**

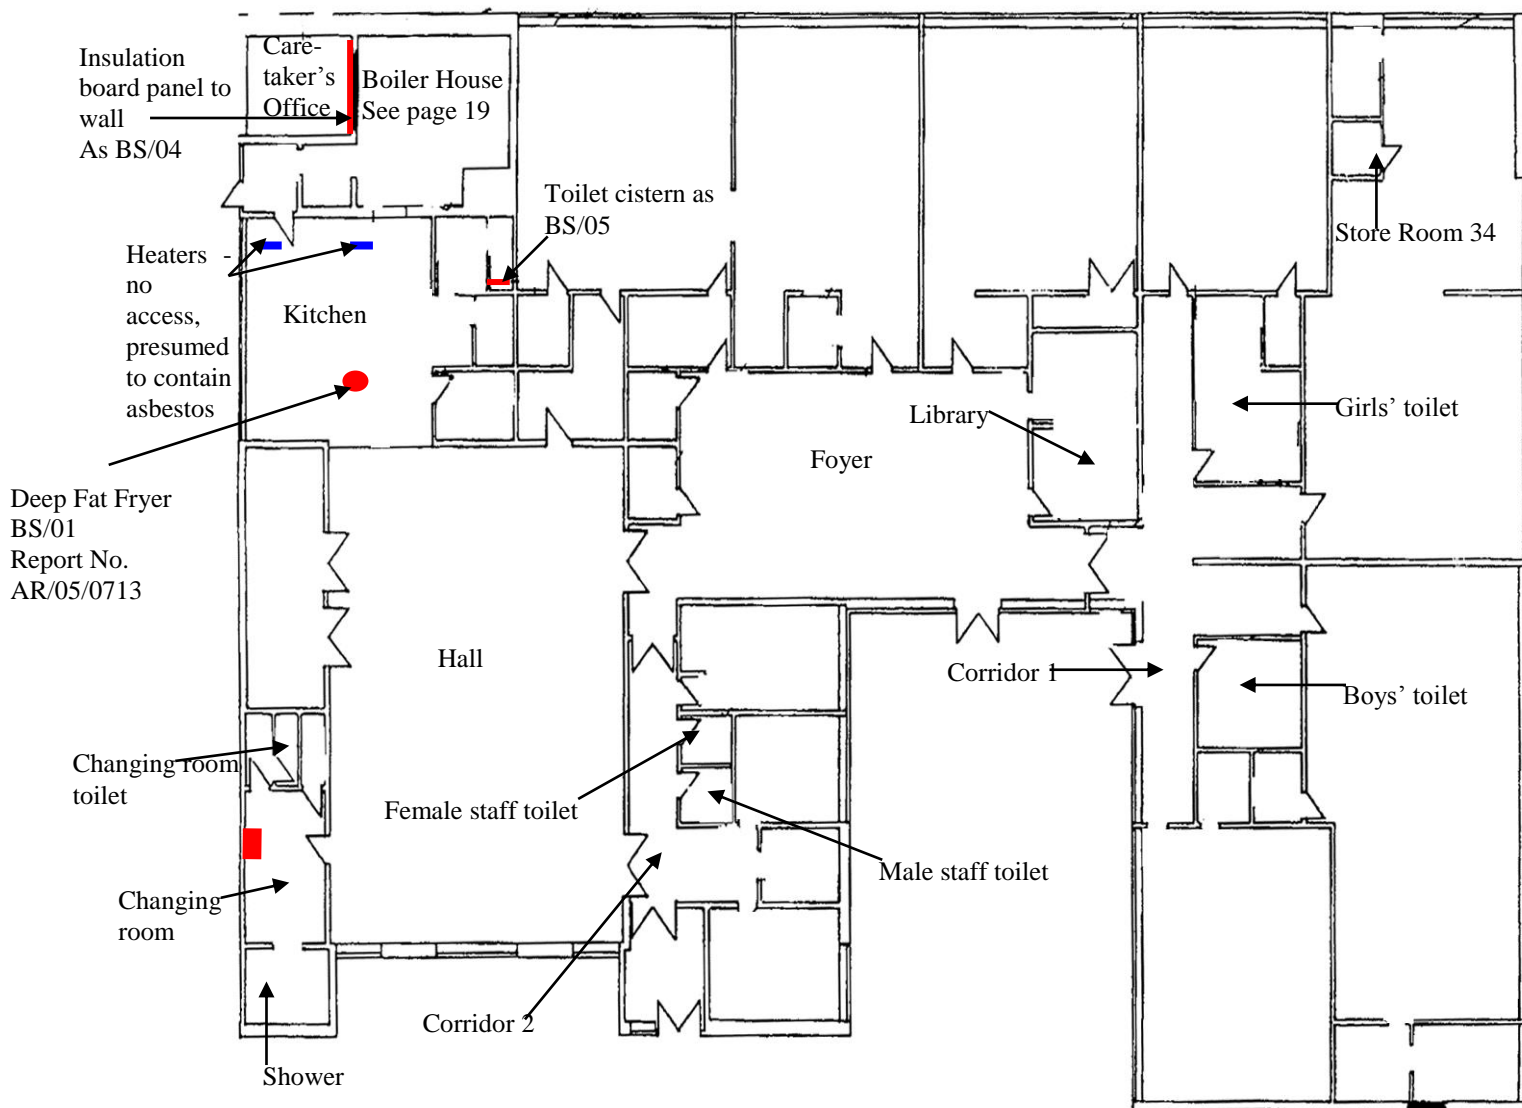
**GROUND FLOOR**

**DRAWING TO DEPICT ASBESTOS CONTAINING MATERIALS  
AND ASBESTOS SAMPLE POINT LOCATIONS**

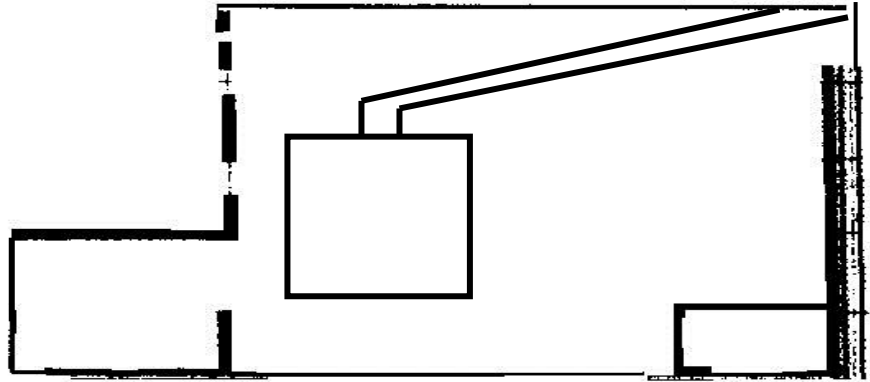
**GROUND FLOOR, BOILER ROOM**

**DRAWING TO DEPICT ASBESTOS CONTAINING MATERIALS  
AND ASBESTOS SAMPLE POINT LOCATIONS**

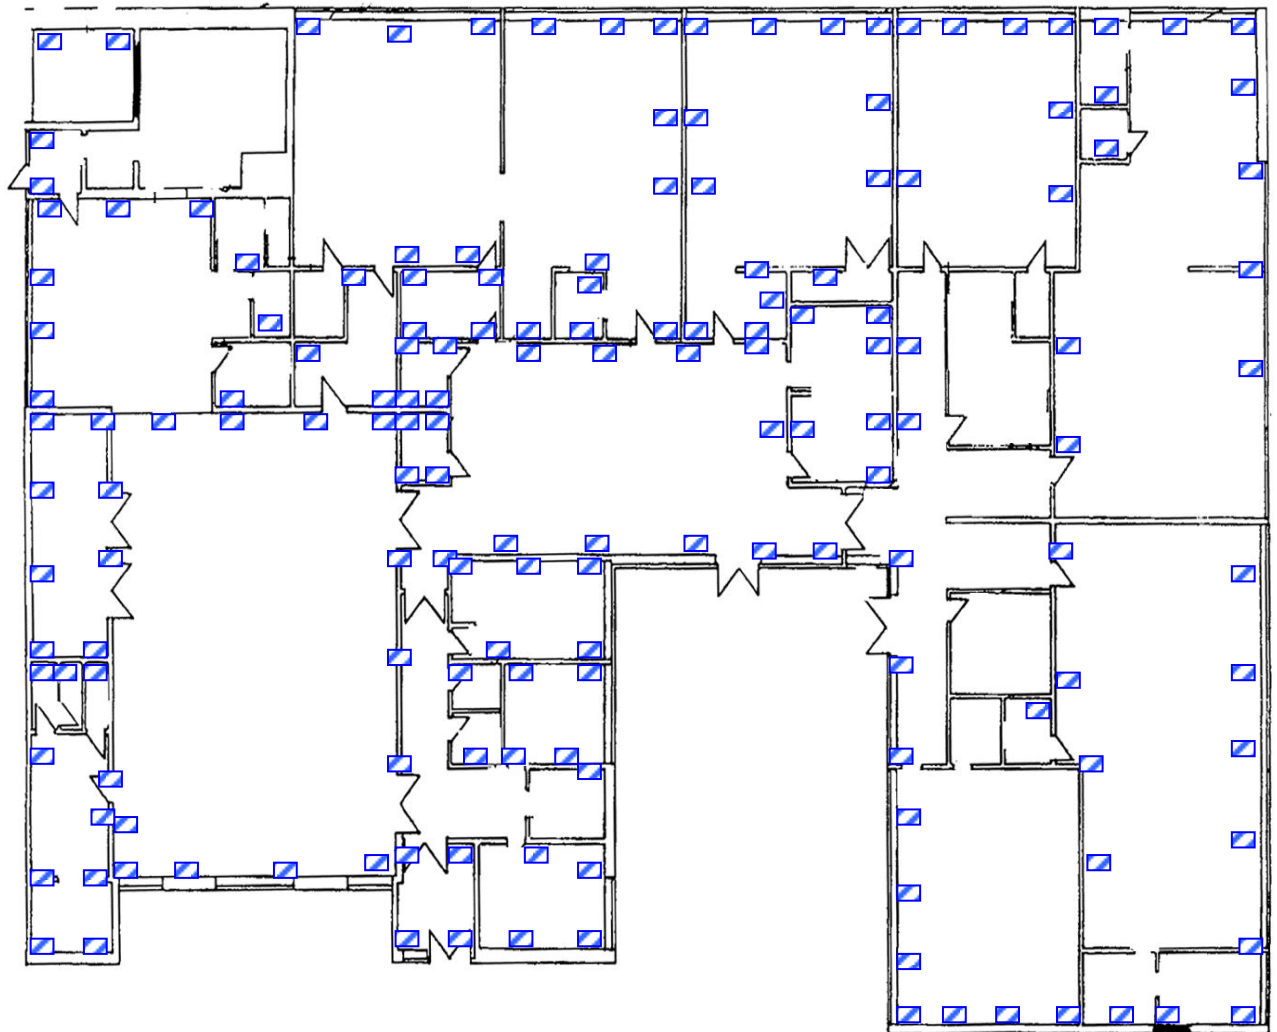
**GROUND FLOOR  
Diagram to depict metal columns**

**DRAWING TO DEPICT ASBESTOS CONTAINING MATERIALS  
AND ASBESTOS SAMPLE POINT LOCATIONS**
