Report No: AR/10/00215

**SEAFIELD TOILETS
SEAHOUSES
TYPE 2 ASBESTOS SURVEY**

Survey to identify asbestos based materials
carried out on behalf of Northumberland County Council

Issue Date: 6 February 2010

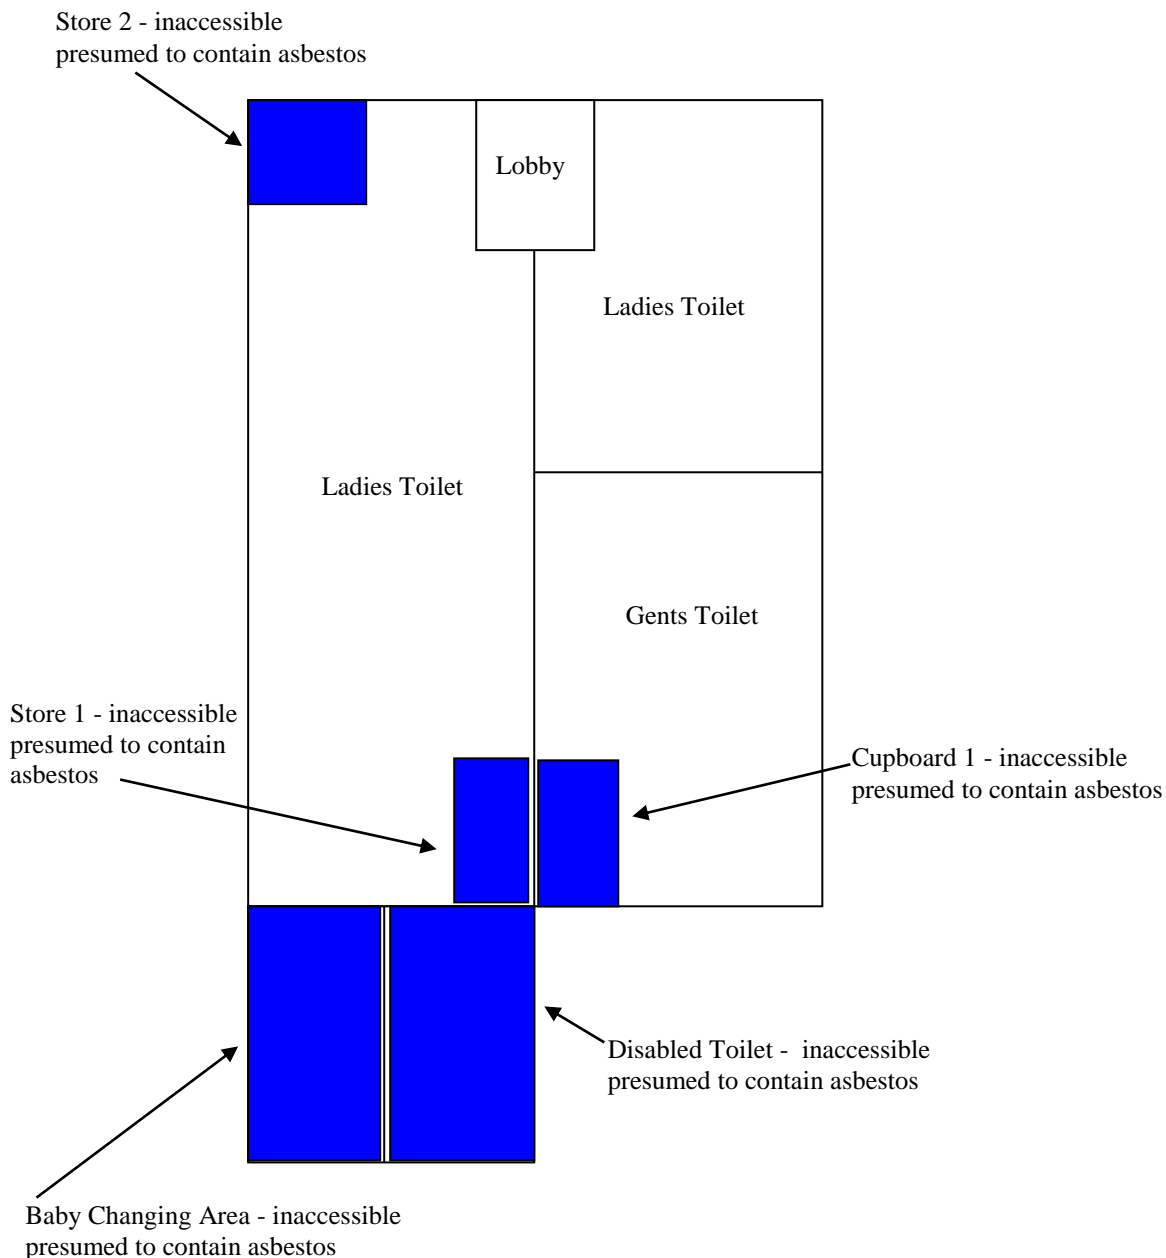
Seafield Toilets

Baby Changing Area, Stores 1 and 2, Cupboard 1 and Disabled Toilet were inaccessible (locked), therefore we must presume they contain asbestos. It is recommended an inspection takes place prior to any refurbishment work.

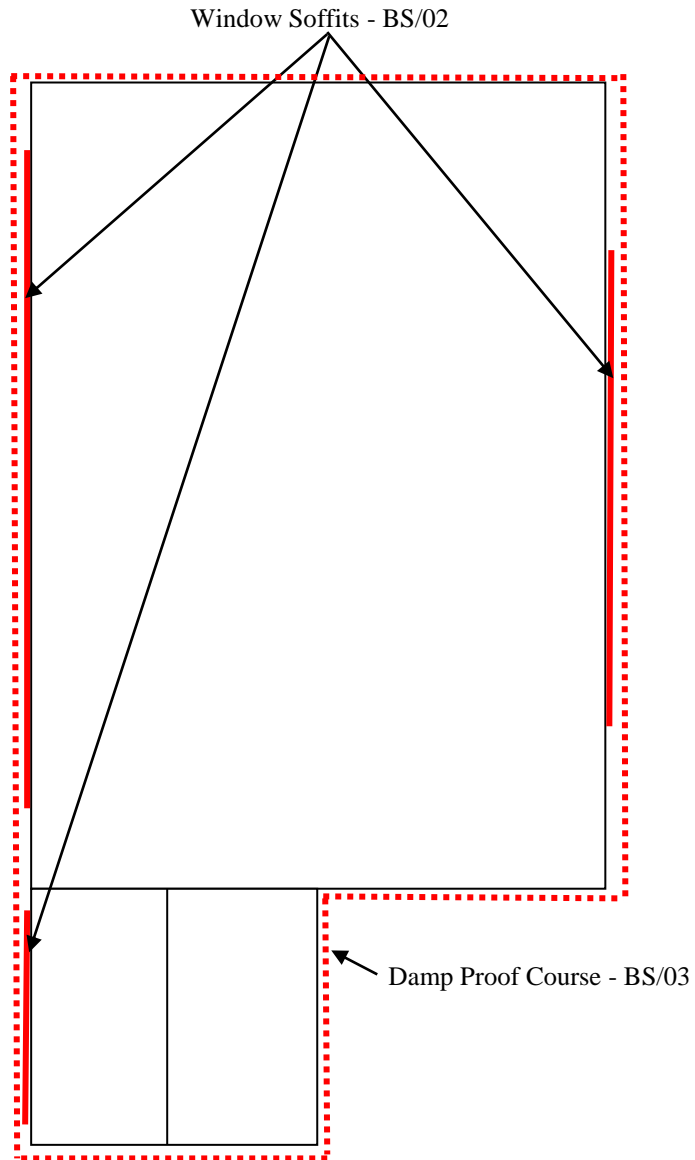
Exterior - insulation board (under UPVC) is an asbestos containing material (ACM BS/02). It is in good condition and recommended it be left undisturbed and monitored.

Exterior - damp proof course is an ACM (sample BS/03). It is in good condition and recommended it be left undisturbed and monitored.
