**Report No: AR/10/01568 (update 01)**

**BURNSIDE PRIMARY SCHOOL  
CRAMLINGTON  
MANAGEMENT ASBESTOS SURVEY**

Survey to identify asbestos based materials  
carried out on behalf of Northumberland County Council

Issue Date: 19 February 2020

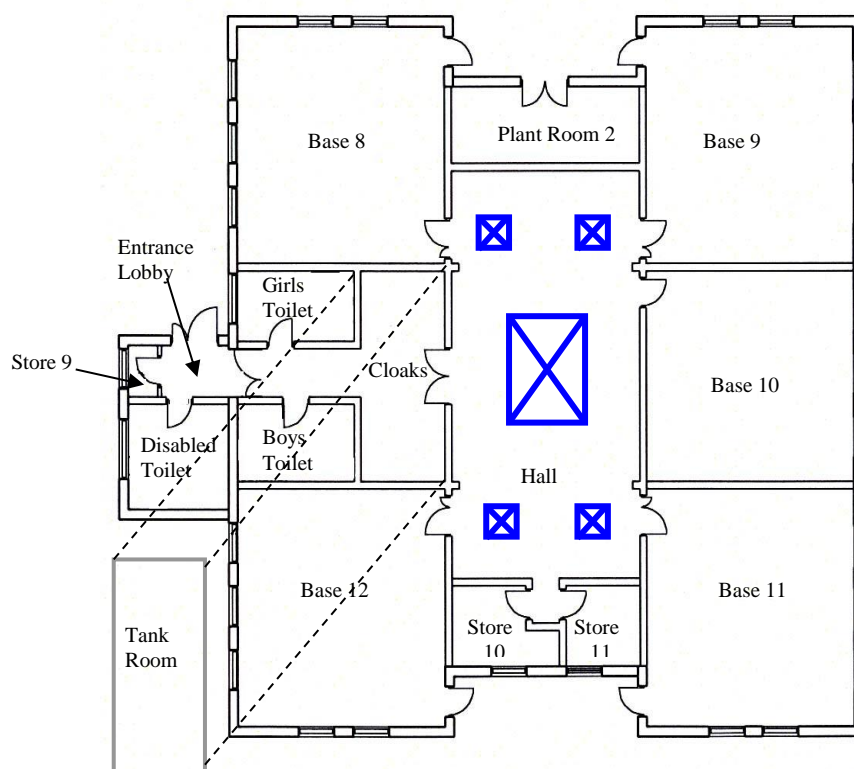
**Year 5 & 6 Building**

✓ Hall - Skylights were not accessed due to height, therefore we must presume they contain asbestos. It is recommended an inspection take place prior to any refurbishment work.
