Report No: AR/10/01469

**EAST LEA PRIMARY SCHOOL
CRAMLINGTON
MANAGEMENT ASBESTOS SURVEY**

**Survey to identify asbestos based materials
carried out on behalf of Northumberland County Council**

Issue Date: 20 July 2010

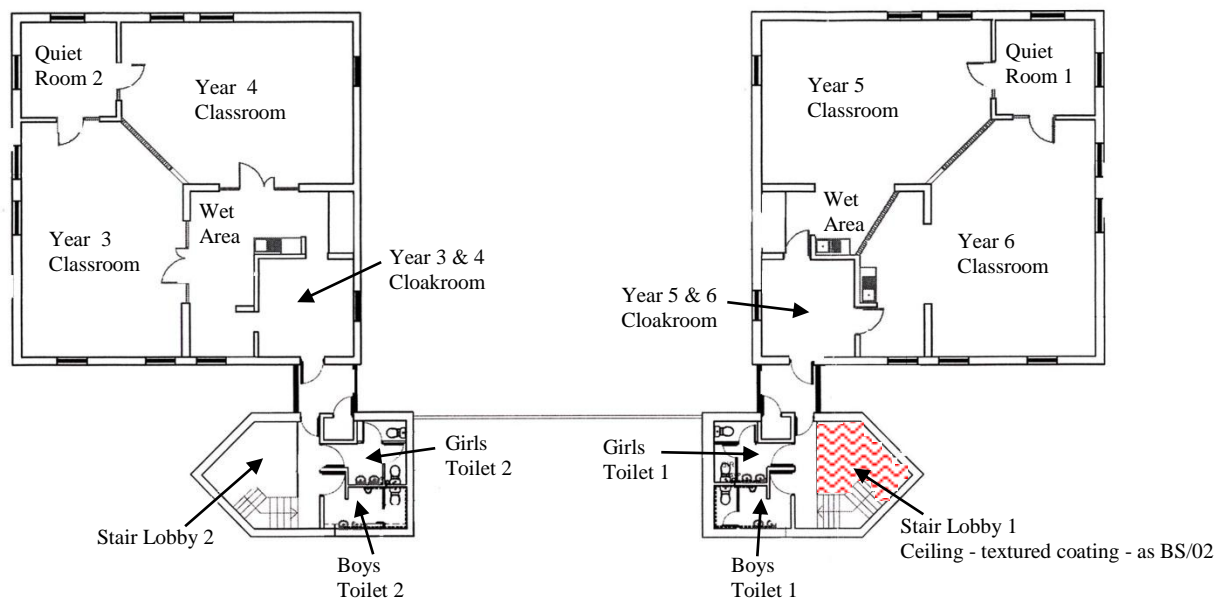
First Floor

Similar textured coating can be found on the ceiling of stair lobby 2 and stair lobby 1 on the first floor. Refer to Asbestos Register Page 4.

**DRAWING TO DEPICT ASBESTOS CONTAINING MATERIALS
AND ASBESTOS SAMPLE POINT LOCATIONS**
