Investigation into the accident on  
Cambridgeshire Guided Busway (near to  
Hills Road bridge) on 21<sup>st</sup> June 2017

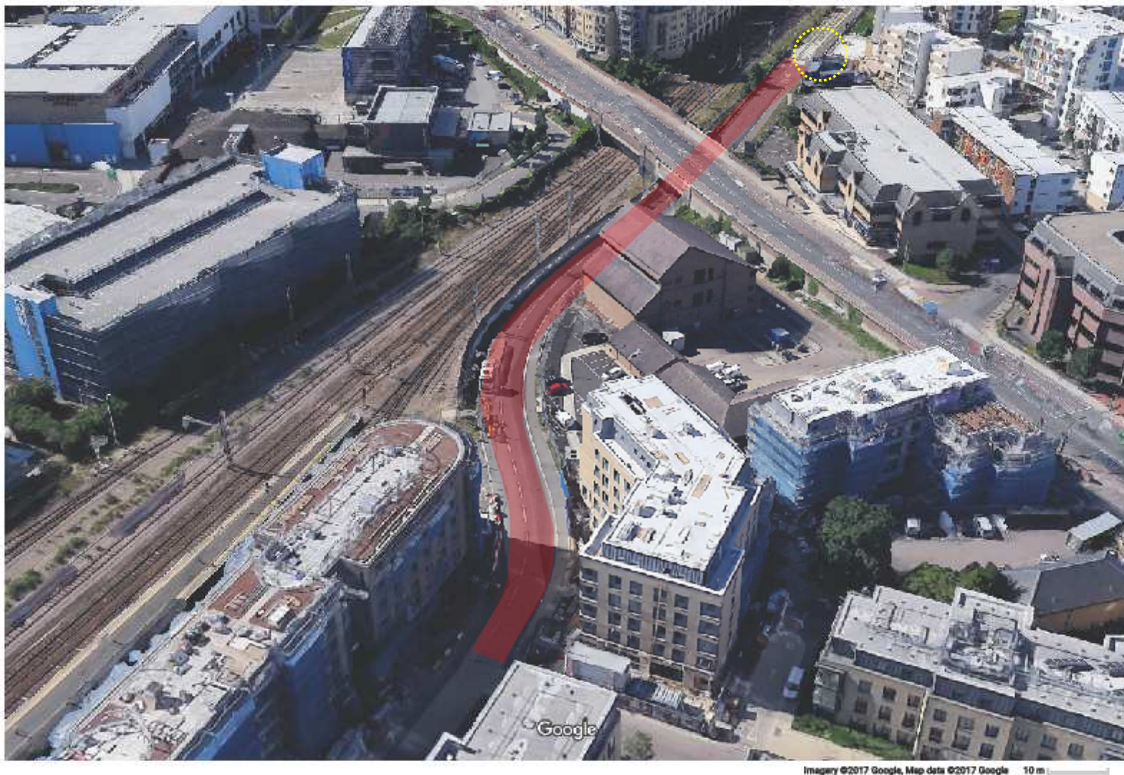
Figure 2: Google Earth image showing the single carriageway road between the Brookgate development and the mainline guideway where a 15 mph speed limit (shaded) is in force. The accident site is also marked.
