Scheduled Monument Quinquennial Condition Assessment Surveys

**RM Sandhurst Training Area,
Berkshire**

July 2021

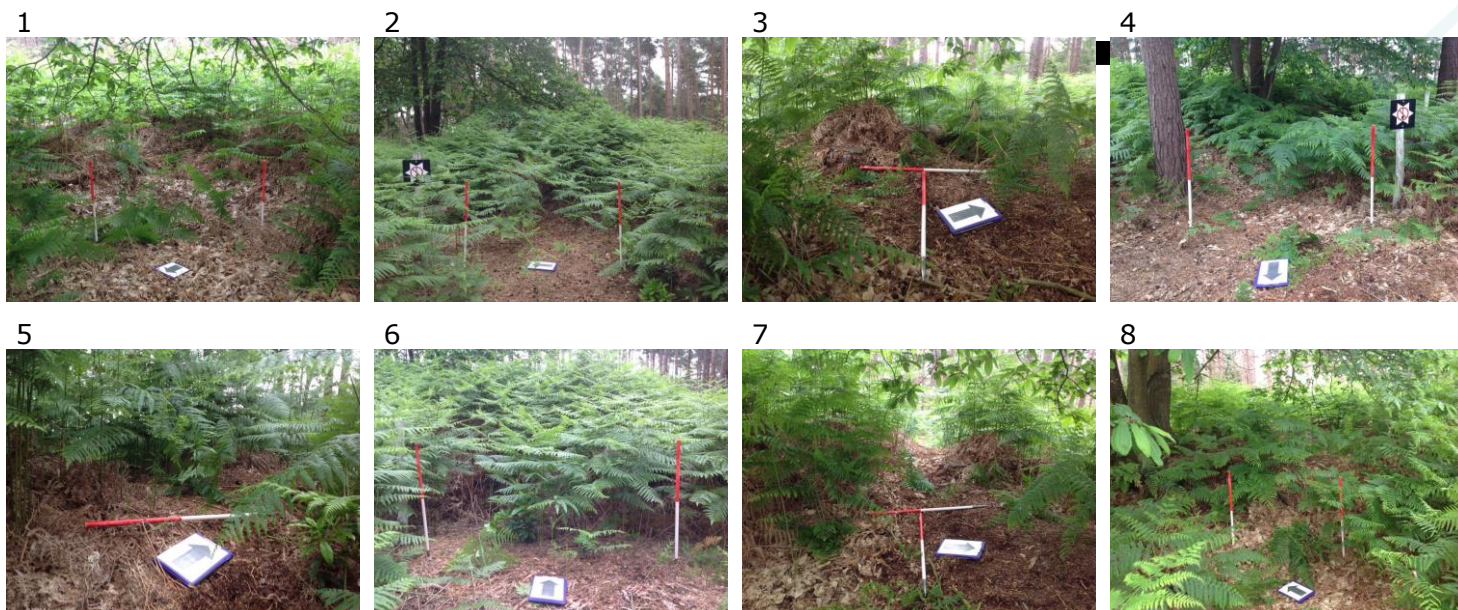
B.1 1016331 - Five Napoleonic practice redoubts in both Crowthorne Woods and Bramshill Forest

The Napoleonic Redoubt was found to be in fair condition and in gradual decline, primarily due to the large amount of bracken growing on the monument. Previously the monument

was also found to be in fair condition and in gradual decline, and was similarly heavily overgrown with bracken. Trees have also established themselves atop of the earthworks, with some having been felled. It is recommended that bracken is cleared from the monument.

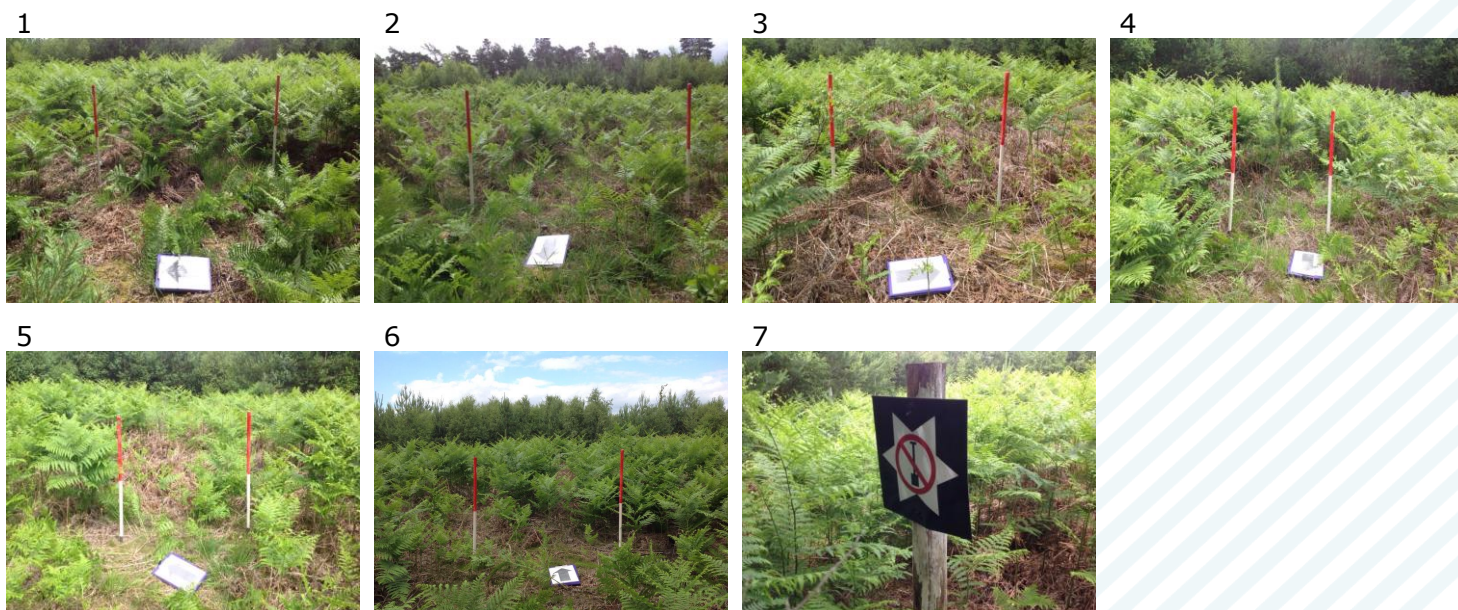
B.2 1017818 - Windmill Stem mound in Bramshill Forest

Windmill Stem mound (1017818) was found to be in fair condition and in gradual decline, due to being heavily overgrown by bracken. Tree sapling [REDACTED] noted growing atop of the mound. The monument was previously assessed as being in good condition and stable, due to having been cleared of bracken. It is recommended that bracken and trees are cleared from the monument.
