## Earth Structures Remediation

### Feasibility Report

Kingsbury to Wembley Park

Document No: TLL-B088-P954-EST-RPT-00001

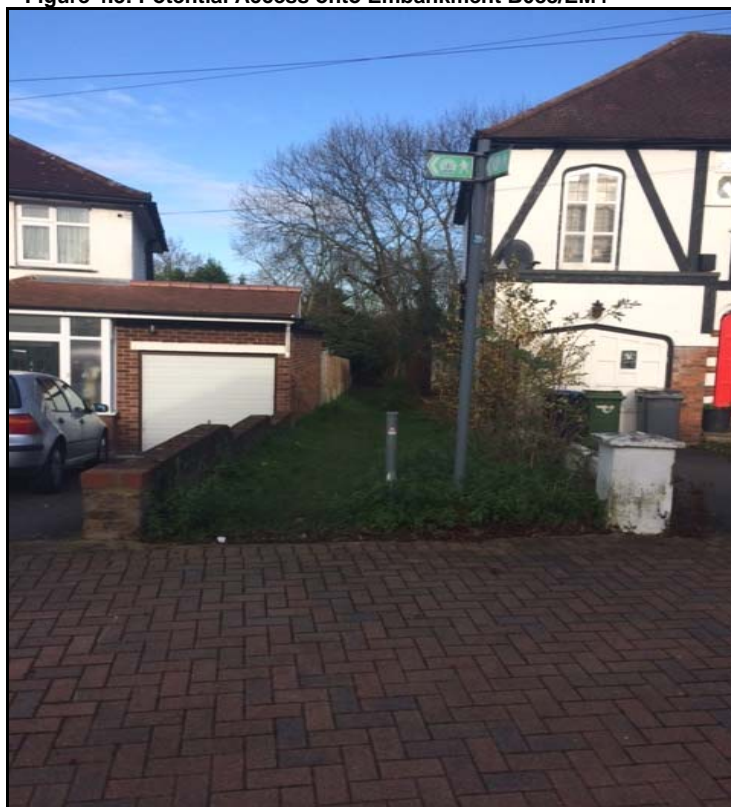
**Figure 4.3: Potential Access onto Embankment B088/EM4**

There is a potential to create a new access point onto the embankment at approximate chainage B088/JSB1200 (See Site Location Plan – Appendix B). Access is possible between residential properties 79 and 81 Uxendon Hill (Figure 4.3), where an access lane exists to service an electrical substation, located adjacent to the existing LU boundary fenceline (Plate 8 Appendix C). Considerations required to use this access point are as follows:

By utilising this additional access point, it will allow the separation of the embankment into two independent working sections, each supplied by separate access points. It will also negate the requirement to construct temporary works over the existing reinforced concrete bridged culvert (S3). This would inevitably reduce the programme length and cost and should be considered in the temporary works design for any permanent remedial works. Further discussion on the benefit of utilising this additional access point can be found in Section 7.4.2.

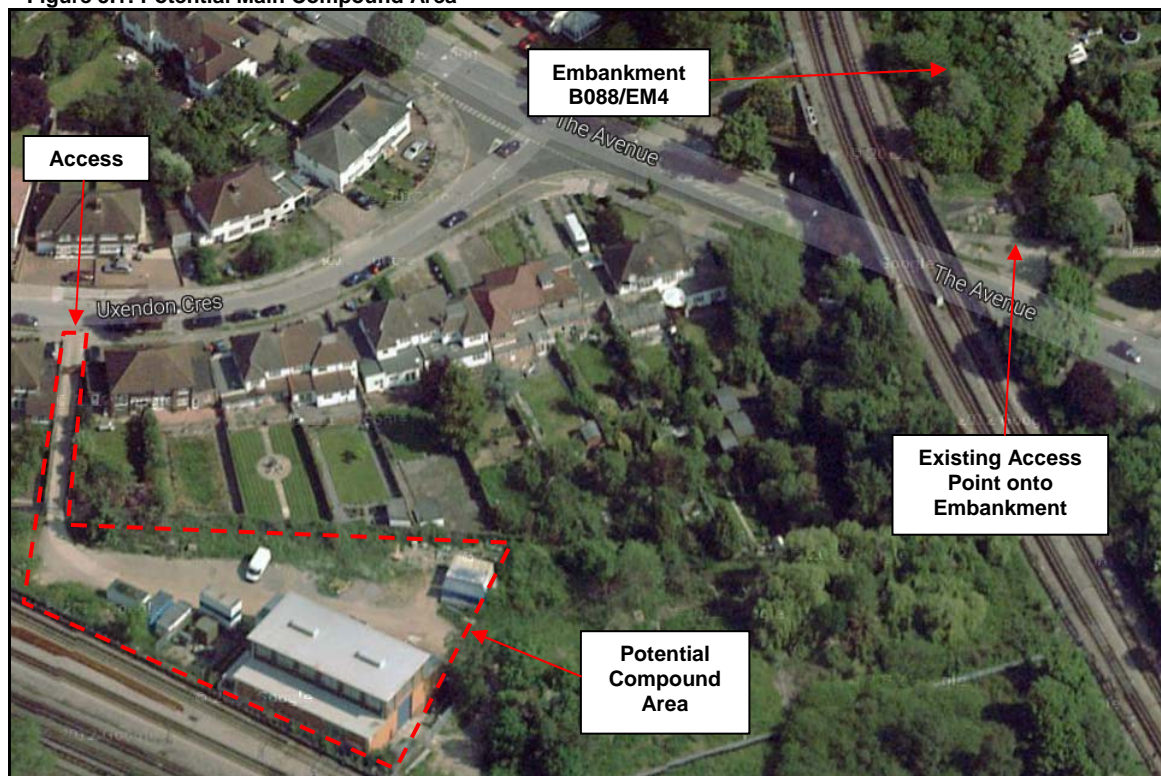
Figure 5.1: Potential Main Compound Area

There is the potential to install a main compound on land adjacent to the Metropolitan Line, in the area of Substation SGS4 (See Site Location Plan – Appendix B). The area is located to the rear of residential properties on Uxendon Crescent, with access possible between residential properties 24 and 26 (Figure 5). Historically, the area has been used as a compound by track maintenance teams, therefore, it already has a suitable working surface and secure gated access (Plates 1-4 Appendix C). The area is of a sufficient size, such that all potential remedial options can be considered, without the compound size posing any restrictions. Considerations required to use this compound area are as follows:

- Access and land use negotiations, along with third party asset protection and parking restrictions to ensure unimpeded access. Contact details are presented in Appendix D.
- Services connections, including Water, Sewerage, Electricity, Communications.
- Security when the compound is in use.
- A full time lorry marshal/banksman will be required at the access point from Uxendon Crescent, to ensure public and third parties are segregated from construction traffic attending the compound.

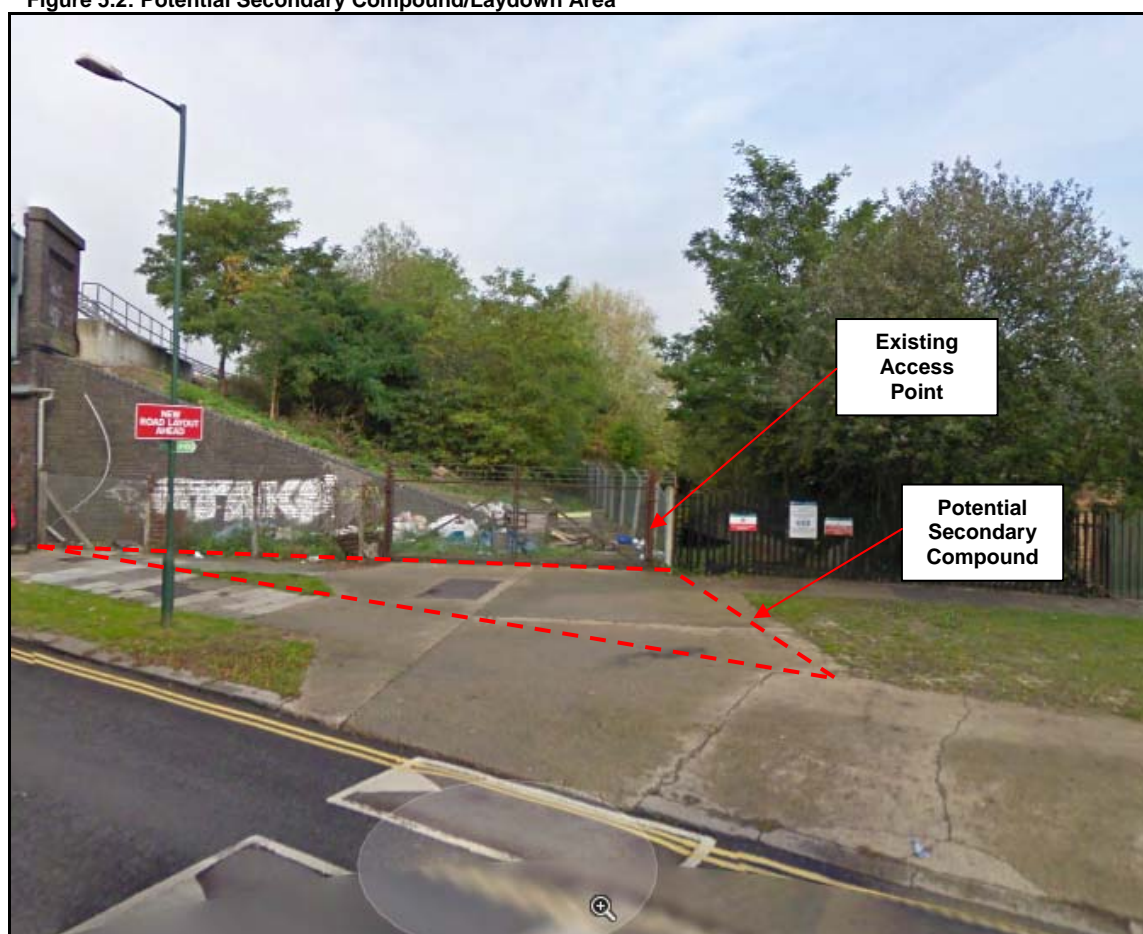
Figure 5.2: Potential Secondary Compound/Laydown Area

As discussed in Section 4.1, the area in front of the existing access point offers an opportunity to create a secondary compound/laydown area for deliveries of materials. This could prove more useful for delivering materials used on a daily basis, with longer-term storage of materials and site welfare located in the main compound detailed in Section 5.1. Considerations required to use this compound area are as follows:

- Access and land use negotiations, along with third party asset protection and parking restrictions to ensure unimpeded access. Contact details are presented in Appendix D.
- Security when the secondary compound is in use.
- A full time lorry marshal/banksman will be required to ensure public and third parties are segregated from construction traffic attending the embankment.

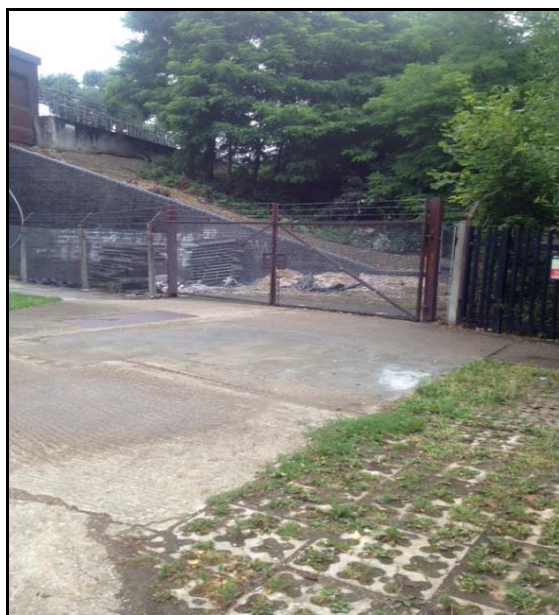
**Plate 5 – Existing Access Point**

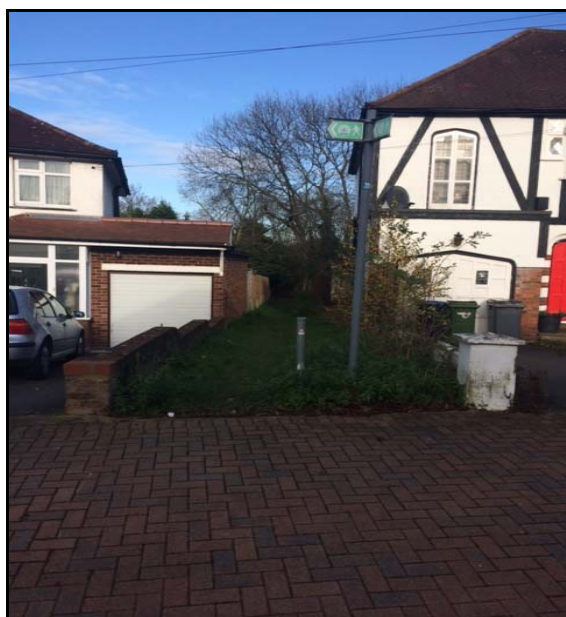
**Plate 7 – Potential New Access Point**

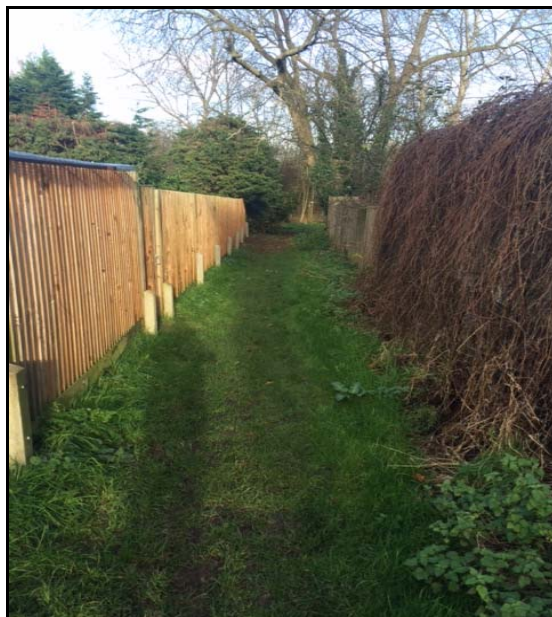
**Plate 8 – Access Lane to Electrical Substation and LU Boundary Fenceline**
