Land at Plas Offa Farm, Whitchurch Pentre, Chirk

# **CPAT Report No 1224**

# Offa's Dyke De138, Chirk, Wrexham Survey, Excavation and Recording

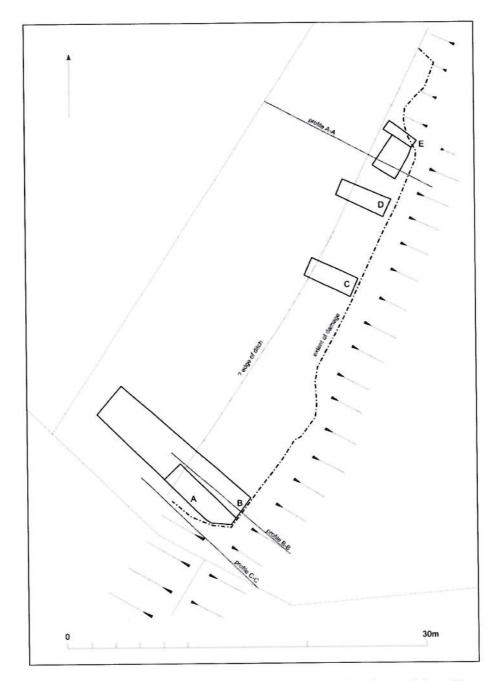
Fig. 8 The location of the sondages and sections (A-E) and recorded profiles.

- 3.2 All spoil and disturbed material resulting from the unauthorised machining was removed from five locations along the main axis of the dyke. These areas, subsequently cleaned and excavated by hand, are here termed sondages and are labelled A to E (as on Fig. 8); they were designed to establish the extent of re-deposited material and where possible record the stratigraphy of the original bank where this was exposed. Adjacent sondages were excavated where the bank had been removed in order to observe any surviving stratigraphy relating to the earthwork and in particular to pick up the inner edge of its ditch. As a by-product, modern disturbances that included a farm trackway and drainage channels were also recorded. Each of the sondages provided a vertical section which to avoid any confusion in the report are also labelled A-E (see Figs 11-16).

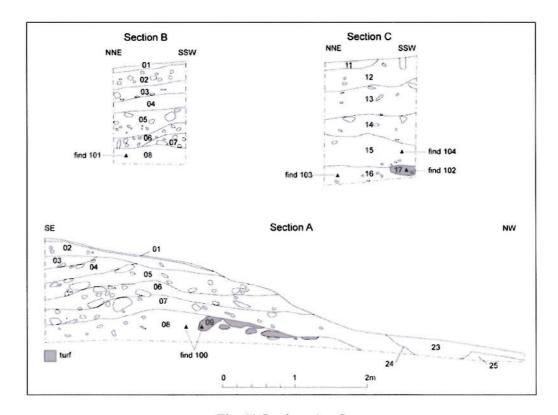
Fig. 11 Sections A – C

- 3.5 Two contiguous sondages were located at the south-western corner of damaged area (Fig. 8), which recorded both a partial cross-section through the earthwork on its western side (A; Figs 9 and 11), and a short longitudinal section through the deposits in the core of the bank (B; Figs 10 and 11). In both sections at least eight layers could be identified within the bank (01-08).

3.9 Sondages C and D together with their respective sections (Figs 11, 12 and 13), were located 6m apart in the central part of the damaged area where the remaining bank of the bank survived to a height of about 1.4m. Both sections revealed a succession of deposits (14–11) which was similar to the upper deposits (04–02) in Sections A and B. However, the initial dump of stony clay forming the low bank in sections A and B was not present; conceivably it could have been removed during the earlier machining, but it was not possible to confirm that this was the case. As in sections A and B the basal layer (16) contained patches of redeposited turf (17). Bulk soil samples were taken from both these contexts as well as from one of the construction layers (15) within the bank (Find nos 102, 103 and 104).

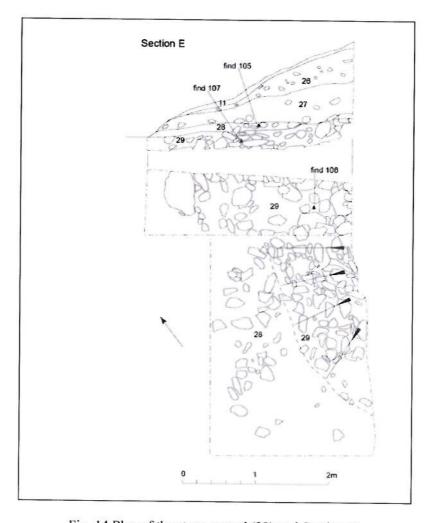
Fig. 14 Plan of the stone spread (29) and Section E.

- 3.11 Sondage E (Figs 15 and 16) was positioned at the north-eastern end of the damaged area. At this point the bank survived to a height of around 1m and consisted of three layers, a basal layer of charcoal-flecked reddish brown silty-clay (28) and two upper layers (26 and 27). All of these were comparable with similar layers encountered in Sections A D.

- 3.12 The ground surface in the vicinity of sondage E was strewn with rounded stones of varying sizes. Initially this was thought to be similar to the material encountered at the base of the bank in the south-western corner of the damaged area (see paragraph 3.6). However, further investigation exposed a spread of large stones (29) at least 0.3m thick lying beneath the base of the bank and spreading for approximately 2.5m within the excavated area, but obviously extending beyond it (see Figs 14 and 15). The stone clearly represented an earlier phase of activity, pre-dating the construction of the earthwork. Bulk soil samples were recovered from within the stone spread (Find nos 106-7), along with a sample from the base of the bank (28) (Find no. 105).
