APPENDIX B

Geomorphological Assessment

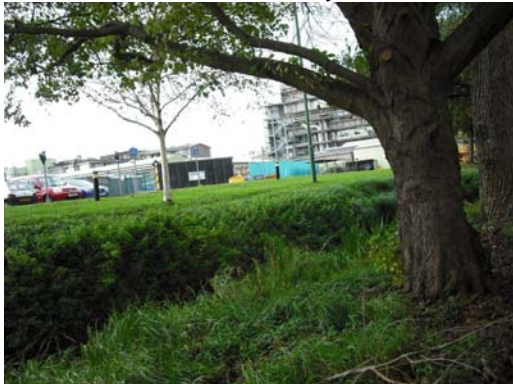
Reach reference	2 (GSK)

Conservation Status	1 – Culverted	
Channel type	Highly modified channel – realigned and extensively culverted	
Baseline Geomorphological Characteristics		
<ul style="list-style-type: none">• Reach 2 is a highly modified reach which runs through the GSK plant.• This section was not fully accessed during the site walkover.• The channel has been modified by digging a straight, overdeep course with steep banks.• Through the GSK site the channel is partially culverted and other modifications include sheet piling bank protection and sluice gates (Royal Haskoning report for Adur District Council, 2009).• Channel flows on clay geology rather than chalk, which appears to maintain a larger amount of flow in the channel by reducing any loss of flow from the bed and allowing ponding.• Gradient is very low and channel bed actually rises toward culvert entrance, which will also pond back flow.• Baseflow supplemented by runoff/drainage from GSK site increasing discharge.• Vegetation clearance at downstream extent (bank vegetation cut and reeds cleared from channel).

Does the geomorphology support good ecology (for WFD)?		
<ul style="list-style-type: none">• The extensive physical habitat modification and barriers to flow through this section mean that the channel is unlikely to support typical aquatic fauna and flora.• This creates a disconnect between the natural headwaters of the stream and the downstream reaches, disrupting water body continuity.		
Restoration Recommendations / Opportunities for long list		
<ul style="list-style-type: none">• Re-route entire channel out of GSK site and through land to east (noting that ground levels and GSK requirements may constrain this option).

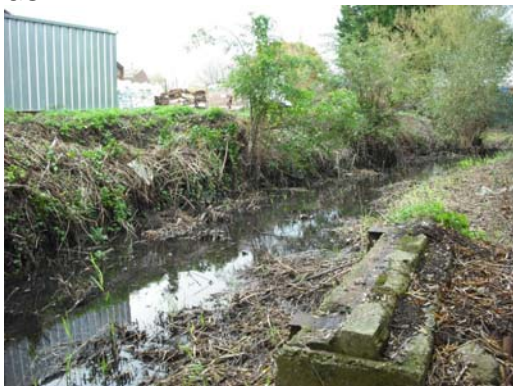
Reach reference	3 (GSK to Deacon Way culvert)	<div>A – Left to right bank downstream of GSK</div>

Conservation Status	3 – Low	
Channel type	Modified channel – realigned and widened	
Baseline Geomorphological Characteristics		
<ul style="list-style-type: none">• Reach 3 is a modified reach which runs between the GSK site and Deacon Way culvert, with the landfill site on the left bank.• This section was not fully accessed during the site walkover.• The channel is a mostly straight, overwide and overdeep course with steep banks.• There is a substantial depth of water in the channel but visible flow is negligible, being ponded by the very low bed gradient and control of Deacon Way culvert at the downstream end which represents a topographic high point in the bed• There is likely to be a considerable depth of fine sediment on the bed due to the low flow velocity, sourced from a combination of runoff from neighbouring agricultural and urban areas• Extensive reed growth in channel potentially slows flow and traps fine sediment.

Does the geomorphology support good ecology (for WFD)?		
<ul style="list-style-type: none">• The very limited flow velocities observed mean that this section of channel provides a standing water rather than flowing water habitat type.• Reed beds and other aquatic plants are present which would provide potential cover for fish.• Extensive fine sediments mean only silt-tolerant species are likely to be present.• Potential water quality issues would limit ecology due to lack of pollutant dispersal resulting from sluggish flow.		
Restoration Recommendations / Opportunities for long list		
<ul style="list-style-type: none">• Re-route channel to east of landfill (meandering channel with marginal and wetland habitats).• Create managed reedbed at upstream end.• Block Deacon Way culvert inlet.• Retain channel as a backwater linked to new channel.• Retain channel as an isolated standing water habitat (not connected to new channel).
