Earthwork Inspection 5 Chain Record

Earthwork Type	Soil Cutting - SCHI
Route	
Operational Route	LNE
Strategic Route	G - East Coast and North East
SRS	G.03 - Hertford Loop
Territory (Pre-Nov 2011)	LNER
Earthwork Management Area	3
Classification	London and SE Commuter

Line					
ELR	HDB				
Route Description	Hertford Nth Loop				
Reverse Mileage	False				
Start Mileage (Miles.Yards)	7.1320	End Mileage	7.1430	Side	Down
Start Easting	531,513	Northing	194,503		
End Easting	531,545	Northing	194,597		
Length (Mile.Yards)	0.0109				
Track Name	NT - Not 6ft or 10ft Earthwork	Track ID	2200 Down Slow/Local/Relief		
Reverse Mileage	False				
Disused Line	Open

Earthwork Type	Soil Cutting - SCHI
Earthwork Name	-
Inspection Season	Winter 2012/2013
Inspection Type	Cyclical Examination
Weather Conditions	Overcast; Calm
Competence Certificate No.	66020703
EE Recommendations	None
EE Inspection By	[REDACTED], Amey (LNE and Midlands)
EE Inspection Date	19 March 2013
EE Inspection Time	16:04
Last Modified By	[REDACTED], Amey (LNE and Midlands)
Last Modified Date	19 March 2013
Last Modified Time	16:04

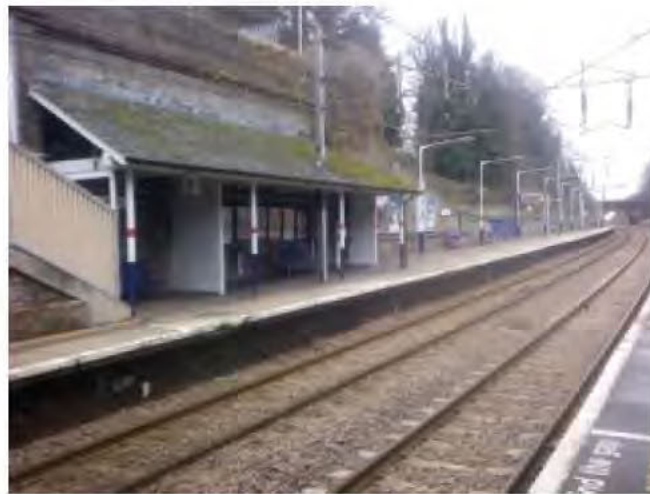
HDB_7.1326_D_531522_194505_19_03_2013_14_01_03

Subject	Cess Level from start, increasing mileage
Taken Date	19 March 2013
Taken Time	14:01
Filename	FO:LNE:jpg:1441329833
Orientation	Down line
Description	taken from UP. [REDACTED], Amey (LNE and Midlands): 19/03/13:

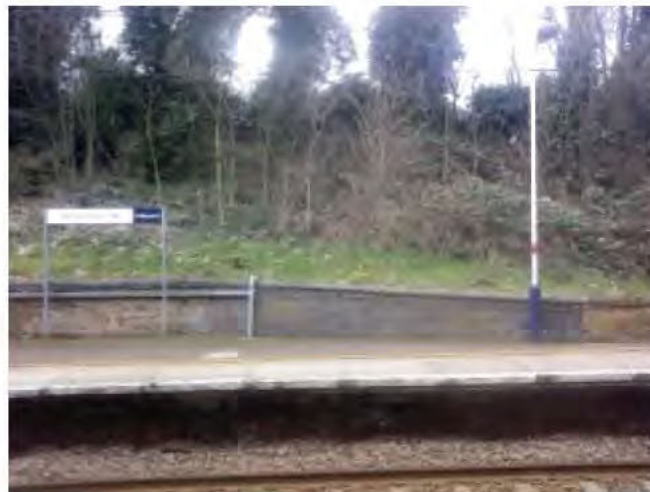
HDB_7.1429_D_531560_194592_19_03_2013_14_03_45

Subject	Cess Level from end, decreasing mileage
Taken Date	19 March 2013
Taken Time	14:03
Filename	FO:LNE:jpg:1441135753
Orientation	Away from line
Description	-

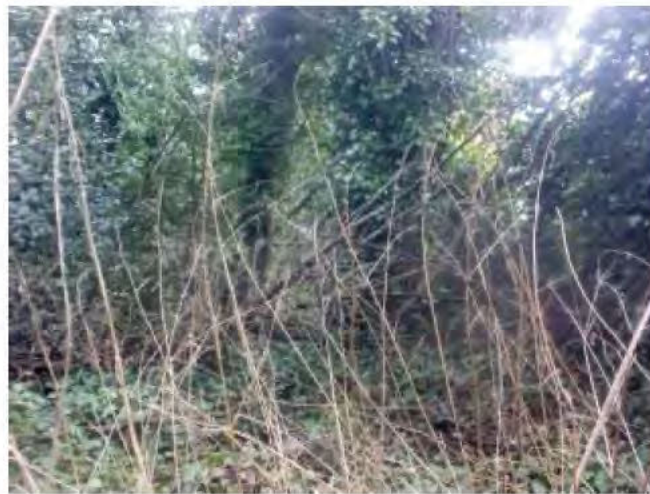
HDB_7.1424_D_531534_194595_19_03_2013_15_41_28

EE: layers of dead vegetation cause difficulty in assessing what is superficial veg cover and what is earth. monitor brick retaining wall at cutting toe which is cracked and bulges out slightly due to burden of slope. [REDACTED], Amey (LNE and Midlands): 19/03/13:

Subject	Structure Defect
Taken Date	19 March 2013
Taken Time	16:03
Filename	FO:LNE:jpg:1441202994
Orientation	Away from line
Description	mortar cracks within retaining wall. bulging here. [REDACTED], Amey (LNE and Midlands): 19/03/13:
