Hilbre Island Defence Inspection and Report **July 2016**

Draft Report

September 2016

Hilbre Island Inspection and Report – July 2016 September 2016

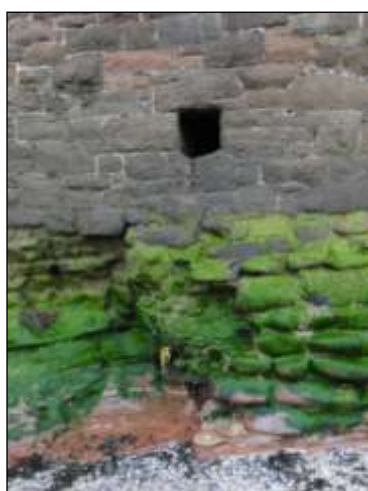
Frame HI_190728_071

This section of wall also has deliberately missing blocks as observed on sections on the east side of the island (which can be seen in plates 68, 71 and 74). As identified previously they are presumably to relieve ground water pressure build up behind the wall sections, although this was not clear from inspection.
