Ref: **Subsidence Damage due to Tree Root Nuisance**  
Loss at: [REDACTED] Cambridge, [REDACTED]  
Insured: [REDACTED]

# Arboricultural Consultancy for Royal & Sun Alliance

# Update Following Completion of Site Investigations

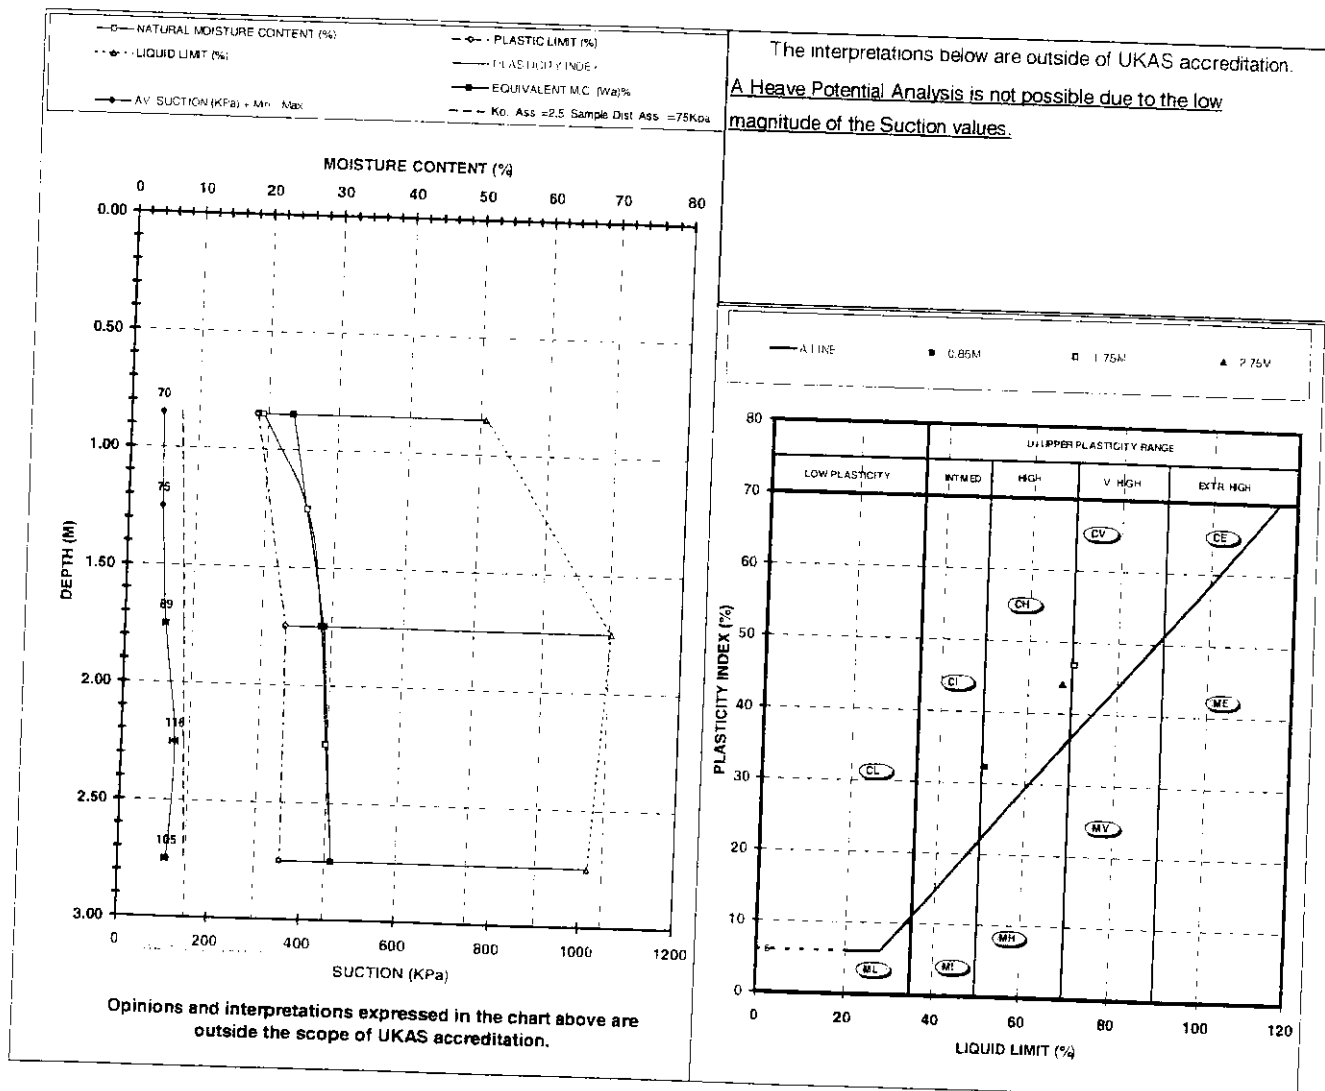
# SOILS LABORATORY RESULTS.

Firm/stiff banded grey/brown CLAY with rare silt veinings, sand veinings & rootlets.

Firm/stiff banded grey/brown CLAY with rare silt veinings, sand veinings, rootlets & root fibres.

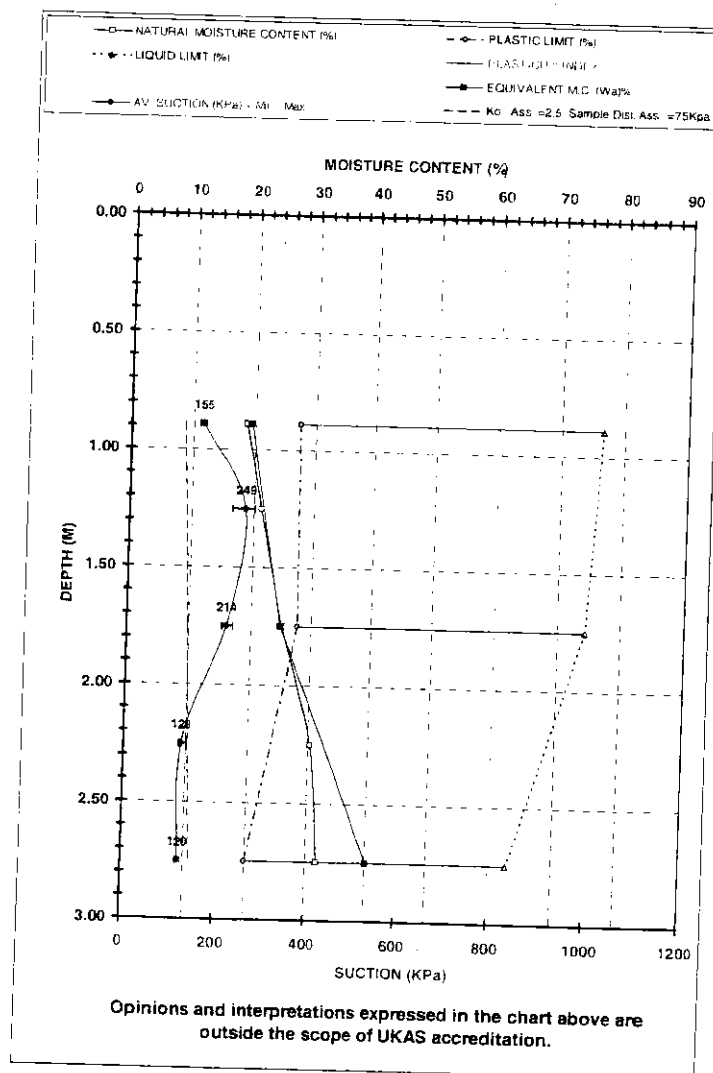
1.75	25	74	28	46	100	40.3467 (3)	3.5	Firm/stiff banded brown/grey CLAY with rare silt veinings, sand veinings & fine/medium gravel (inc. chalk).
2.25	30	-	-	-	-	44.2385 (3)	1.1	Firm/stiff grey CLAY with rare silt veinings, sand veinings & fine gravel.

2.75	32	63	20	43	80	44.4048 (3)	0.0	Firm/stiff grey CLAY

The Above Heave Analysis is based upon :-

BRE Digest 412 Feb 1996 'Using Suction Profiles'

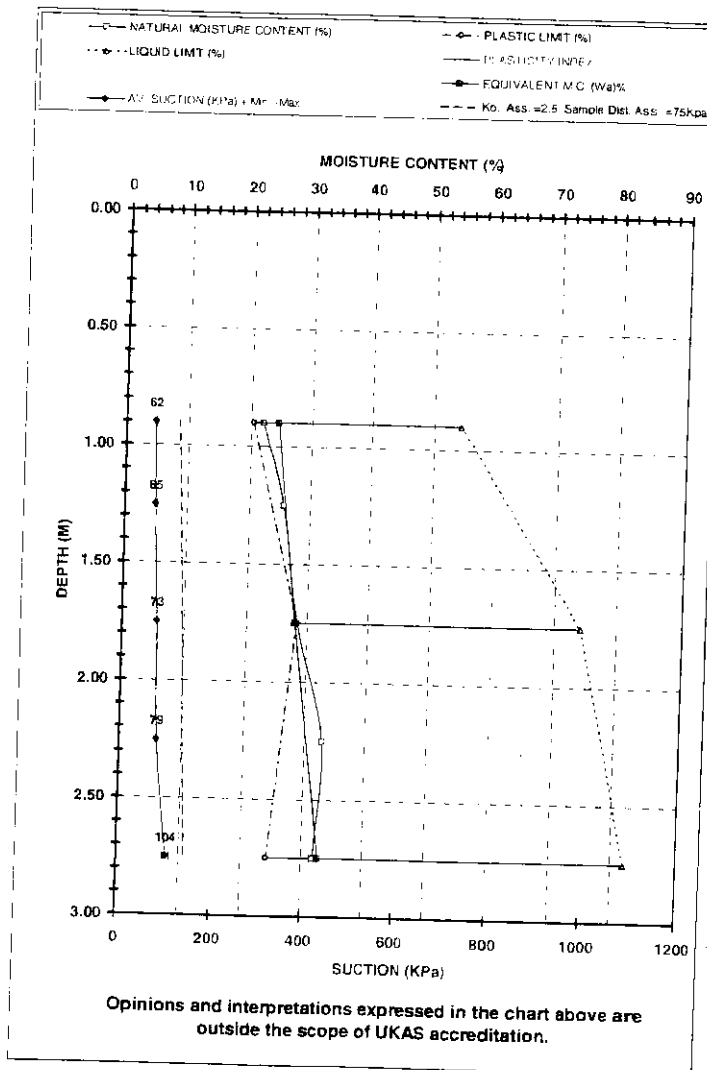
## BRIEF SOIL DESCRIPTION

Soft/firm banded brown/grey slightly sandy CLAY with occasional silt veinings, rare fine/medium gravel (inc. chalk), roots, rootlets & root fibres.  
Firm banded brown/grey slightly sandy CLAY with occasional silt veinings, rare fine/medium gravel (inc. chalk), roots, rootlets & root fibres.  
Firm/stiff banded grey/brown CLAY with occasional silt veinings, rare sand veinings, fine/medium gravel (inc. chalk), roots, rootlets & root fibres.  
Firm/stiff grey CLAY with rare silt veinings, rootlets & root fibres.  
Firm/stiff grey CLAY with rare dustings of sand, rootlets & root fibres.

The interpretations below are outside of UKAS accreditation.  
A Heave Potential Analysis is not possible due to the low magnitude of the Suction values.

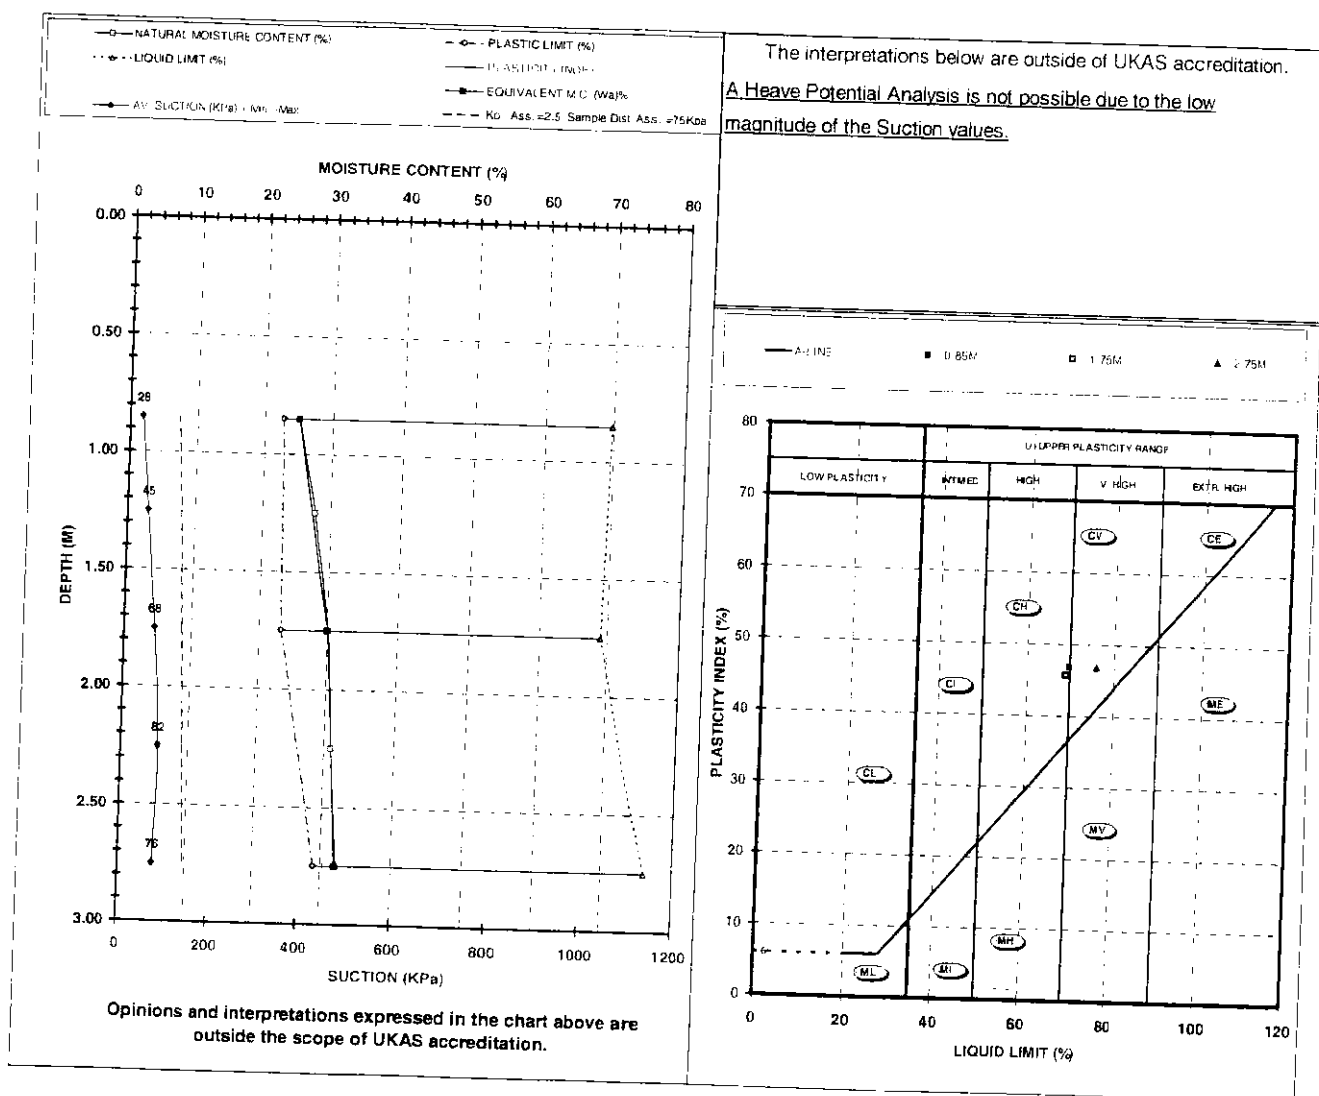
1.75	30	69	23	46	100	50.2547 (3)	0.0	Firm/stiff grey CLAY with rare silt veinings, fine gravel (inc. chalk), rootlets & root fibres.
2.25	31	-	-	-	-	46.9238 (3)	0.0	Firm/stiff grey CLAY with rare rootlets & root fibres.

2.75	32	76	29	47	100	47.991 (3)	0.0	Firm/stiff grey CLAY with rare rootlets & root fibres.
