**Principal Inspection
Report
Bridge No 1093**

**North Bridge, Station Road
Oundle**

**NORTHAMPTONSHIRE
COUNTY COUNCIL**

May 2018

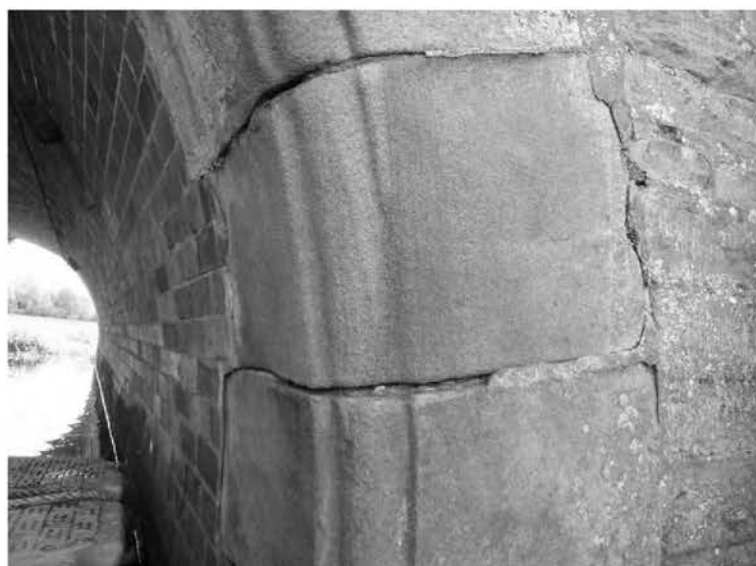
The stonework to the south voussoirs shows signs of erosion damage with some loss of mortar.

Eroded stonework and missing mortar to the Southern Voussoirs

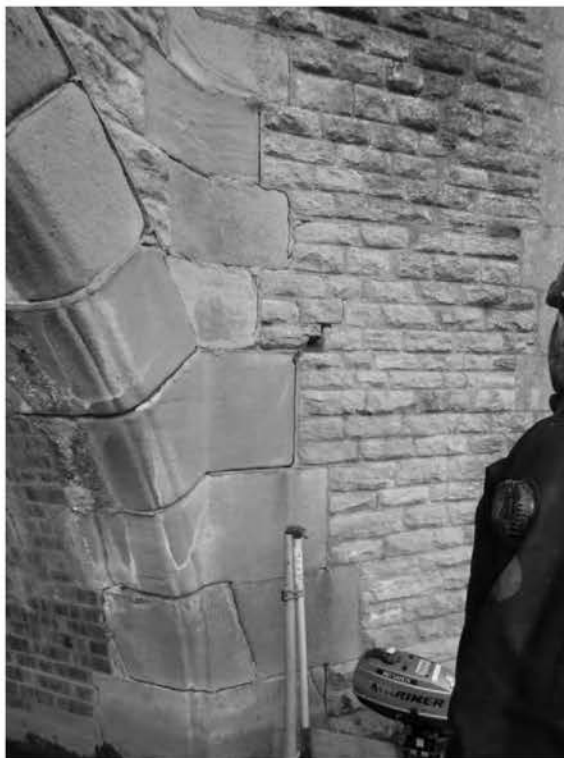
Cracking between the voussoirs and spandrel wall
at the south east corner

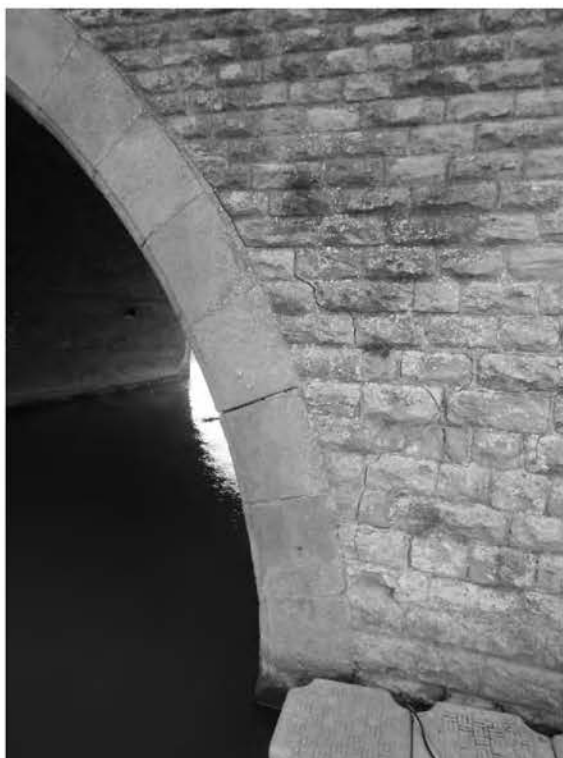
Crack between the southern voussoirs and the spandrel wall

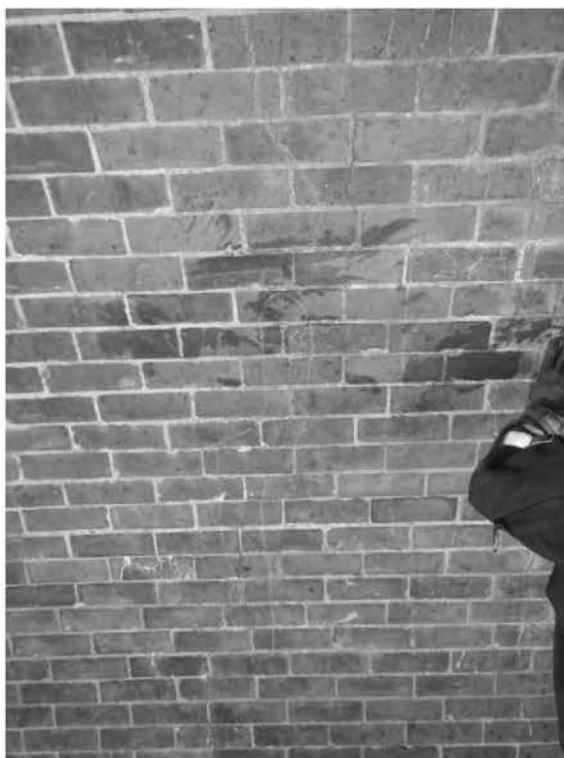
Typical longitudinal hairline crack in arch

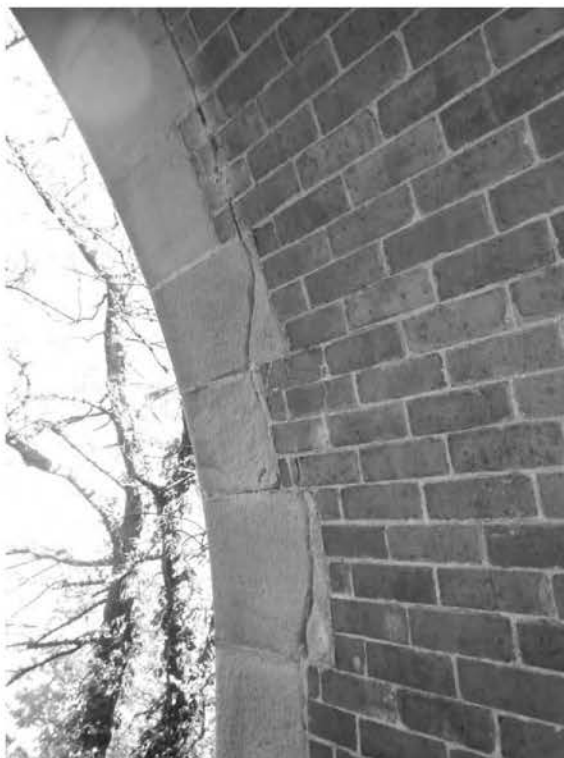
There is also a crack between the stone voussoirs and the spandrel wall at the southern end of the arch.

The stonework to the south voussoirs shows sign of erosion damage with some loss of mortar.

Crack between the southern voussoirs and the masonry arch

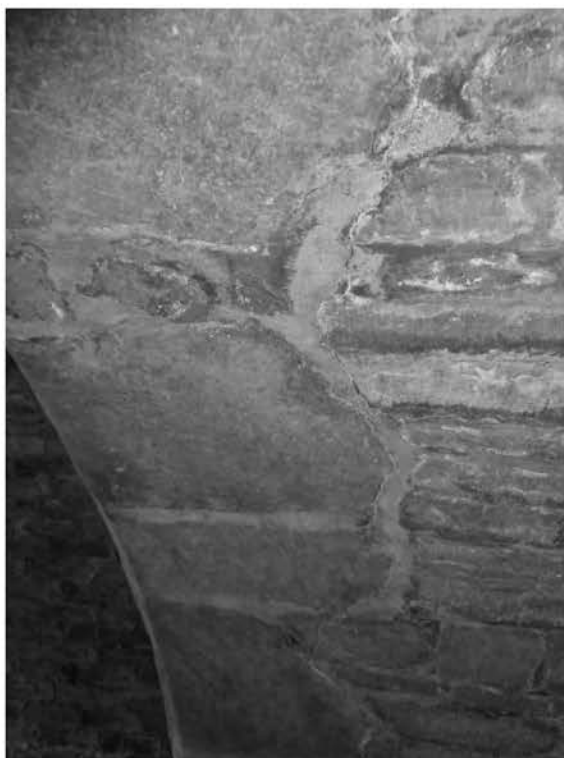
Previous repairs to arch showing the line of the original voussoirs

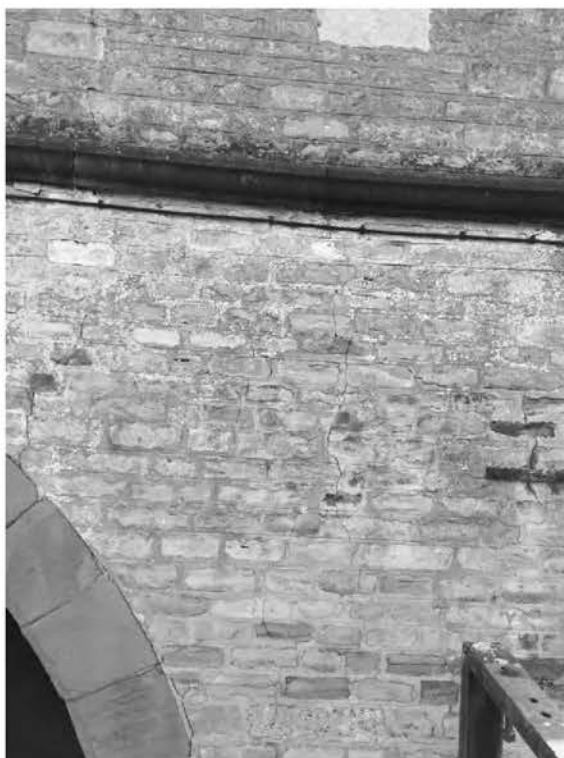
Cracking in spandrel wall between Arches 1 & 2.
Note crack between the Voussoirs and spandrel wall

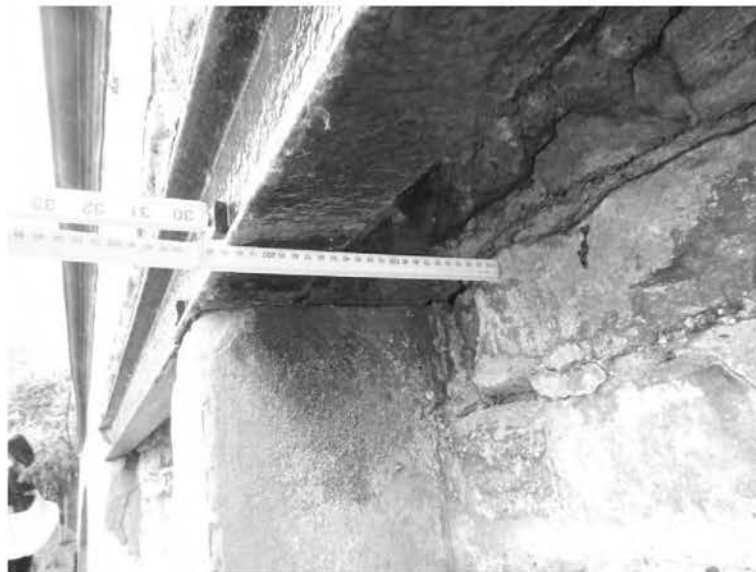
- 5.14.3 The string course over Arch 3 have been replaced with a steel joist supported on stone corbels. The spandrel wall and parapet are supported off the beam. There is a substantial void behind the beam/spandrel wall which is approximately 760mm deep in places. The date of the repair is not known but could have been carried out in 1946. Both the end corbels are cracked and eroded.

View of beam and stone corbel

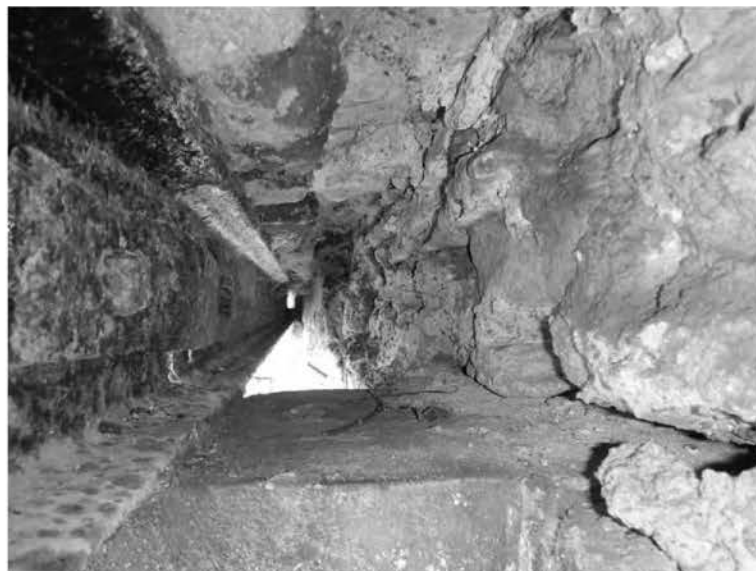
View of void behind beam

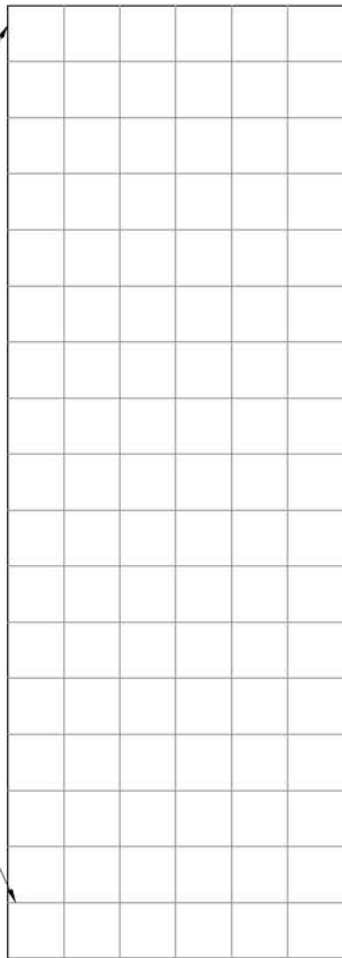
Project: A427 NORTH BRIDGE OUNDLE
Title: ARCH 3 INSPECTION SURVEY

CRACK STARTS A THIRD OF
THE WAY UP AND RUNS
TO BREAK WATER

CRACK THROUGH
KEY STONE

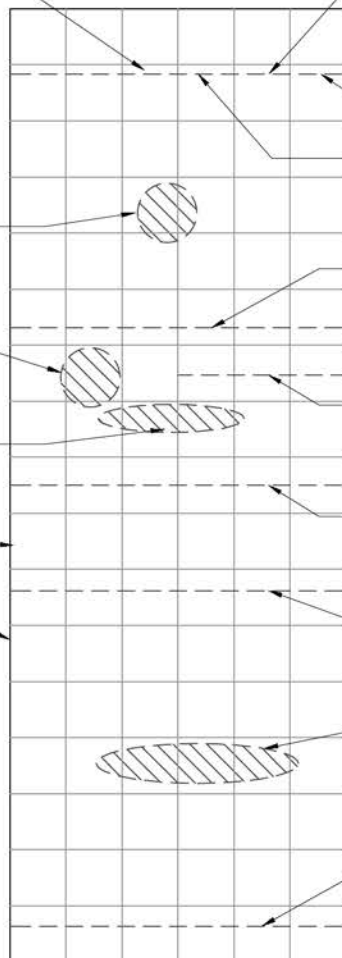
Project: A427 NORTH BRIDGE OUNDLE
Title: ARCH 4 INSPECTION SURVEY

CALCIFIED CRACKING

VOUSSOIR ERODING AND
CRACKING FROM ARCH
RING. 130mm MAX DEPTH

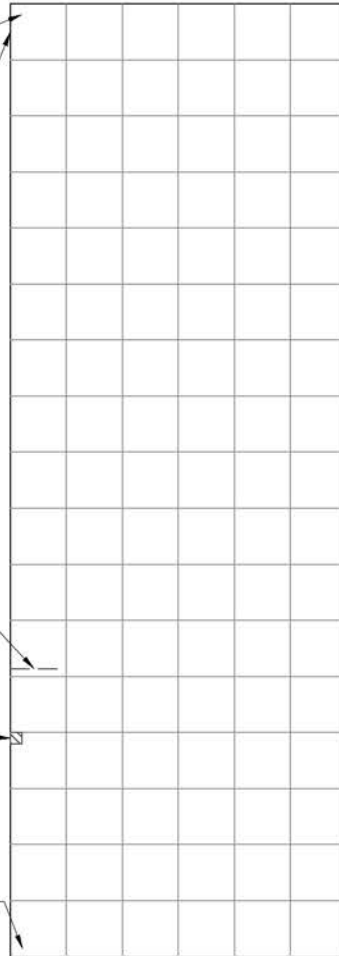
Project: A427 NORTH BRIDGE OUNDLE
Title: ARCH 10 INSPECTION SURVEY

LARGE CRACK IN BLOCKWORK
RUNNING DIAGONALLY TO
MEET BREAK WATER

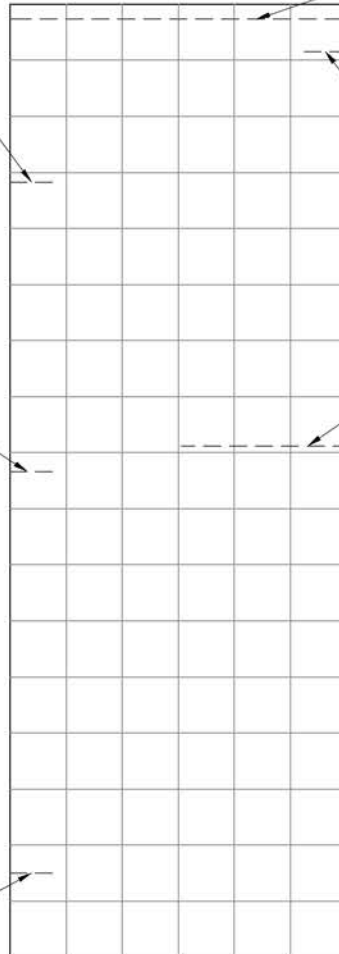
HAIRLINE CRACK FROM
WATERLINE TO APPROX.
1500mm HIGH

HAIRLINE CRACK FROM
WATERLINE TO 1000mm HIGH.
MOVEMENT TO BRICKWORK
ABOVE

LARGE CRACK AND MORTAR
MISSING RUNNING FULL SPAN
OF ARCH AND ENTIRE INSIDE
OF ARCH FACE

LARGE CRACK 5mm WIDTH
FROM WATERLINE TO 1300mm
HIGH

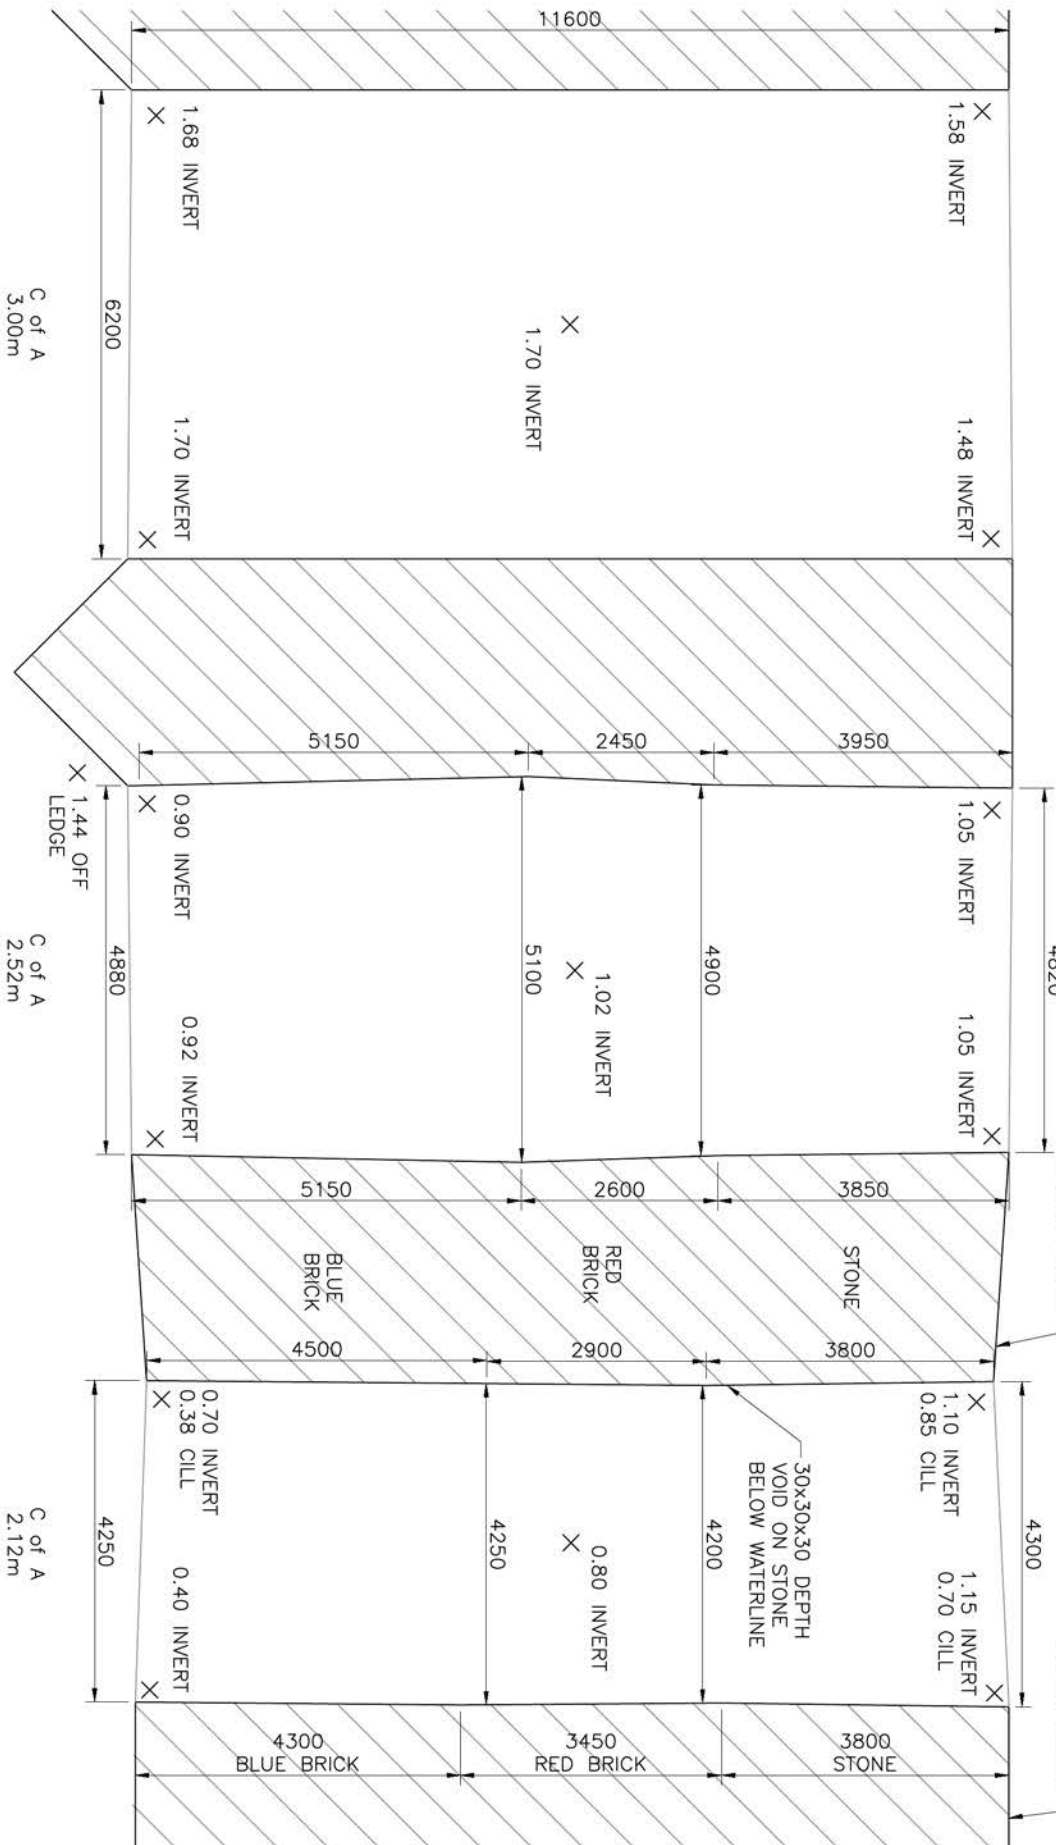
MORTAR LOSS
50mm DEPTH

MORTAR LOSS
70mm DEPTH

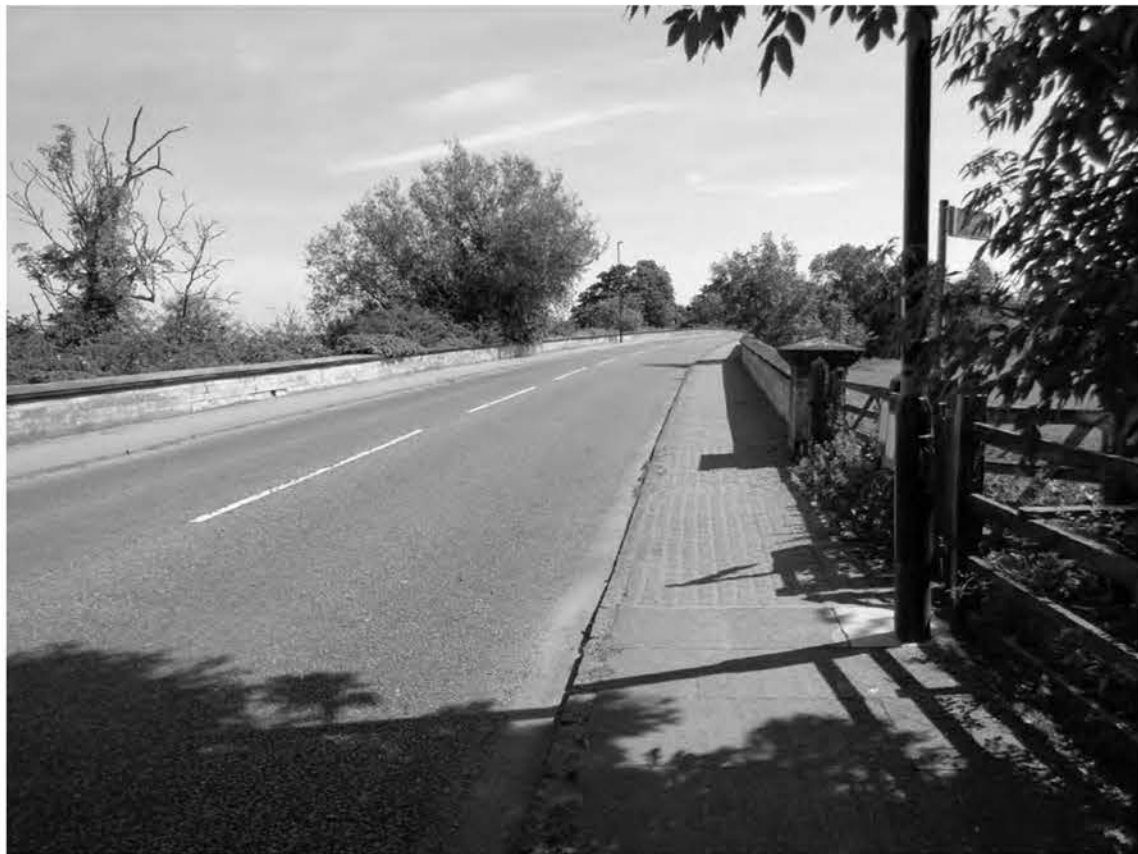
PHOTO 4 - GENERAL VIEW OF THE ROAD

The carriageway surfacing is in a poor condition with damage around the surface water gully inlets and areas of cracking and potholes. It is recommended that the drainage is jetted clear and the bridge is re-surfaced.
