Stanley Park Lake Revival Lake Engineering Study

Draft Report (V1.0)

APEM Ref: P00003679

Blackpool Council

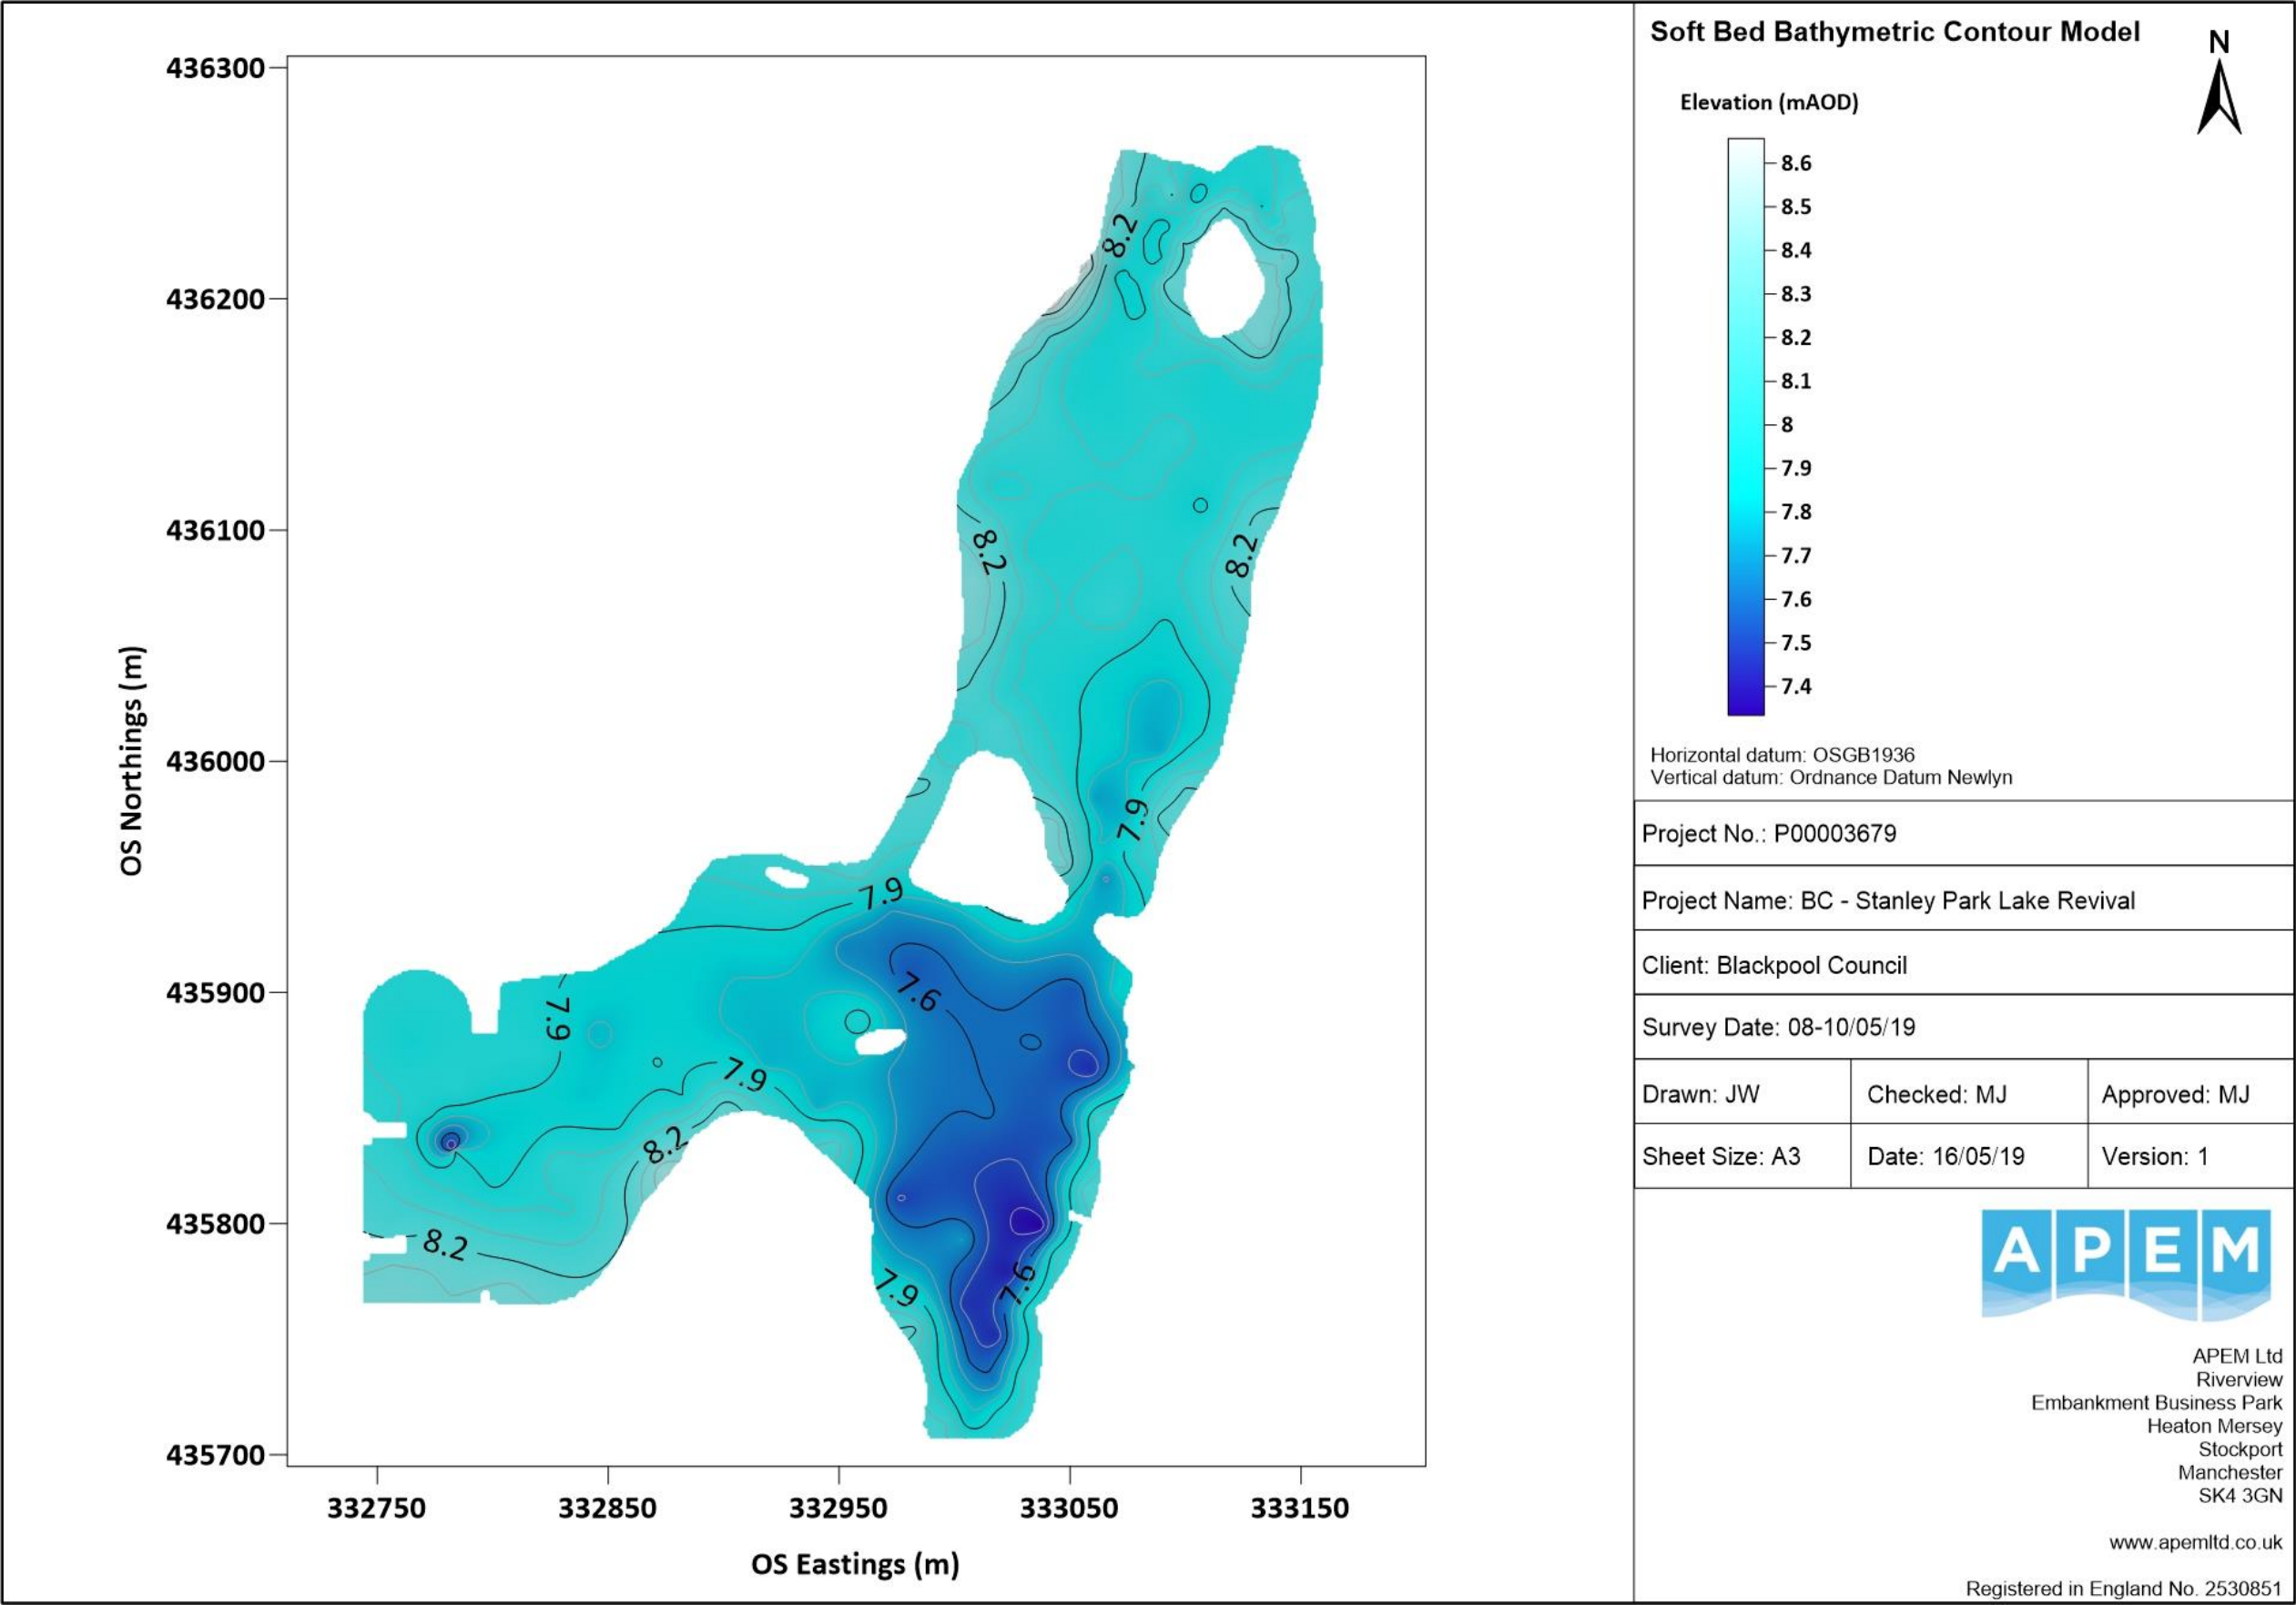
Figure 6 Stanley Park Lake bathymetric contour model

A 2D sediment depth contour map is presented in Figure 6. The sediment model generated an average sediment depth of 0.19 m across the lake. The sediment is distributed relatively evenly across the lake bed, with the exception of a few notable 'hot spots'. The maximum depth of sediment was 1.12 m which was observed in a small, deep 'pocket' toward the south west of the lake, in the vicinity of the small jetty. The volume of sediment detected above the hard bed layer was calculated as 15.29 ML which accounted for 11% of the hard bed volume in the reservoir.

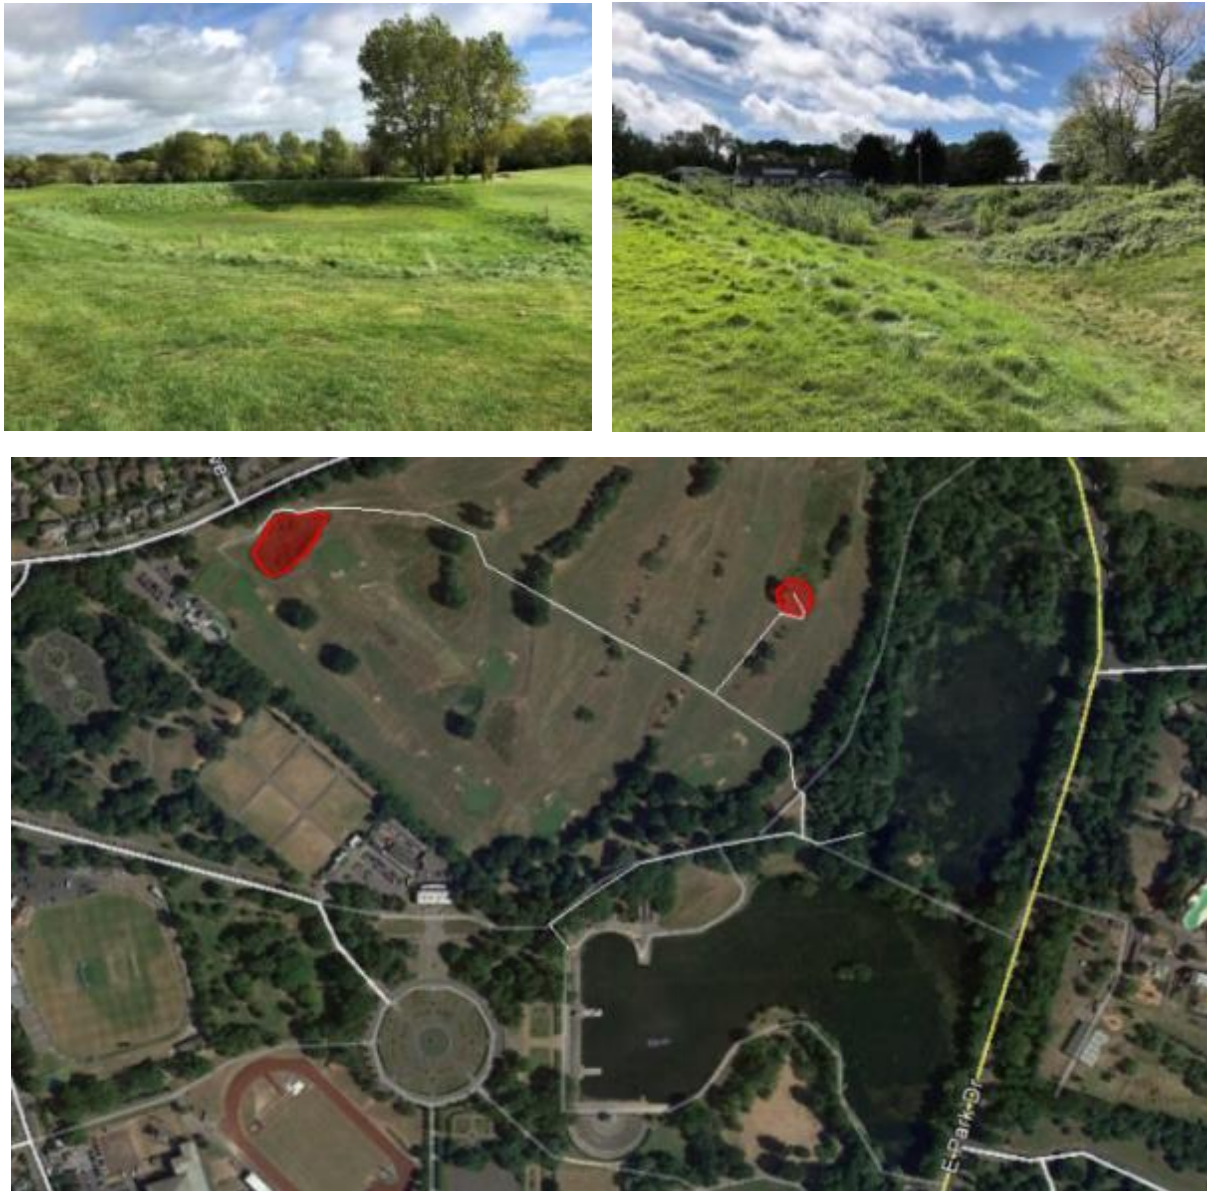
Figure 15 Photographs of the two golf course recesses/depressions (top) and their locations relative to the lake (bottom).

This option would require access agreements with the golf club and significant ground protection to ensure limited damage is done to fairways.

Should re-use/disposal under a waste exemption not be appropriate, then given the chemical characterisations and waste classifications that have been conducted, it is suggested that works could be completed under an agreed Materials Management Plan (MMP). Both options provide opportunity to deposit the asbestos containing silts at >0.6m depth.

Any requirement for further asbestos (or TPH) characterisation or other validation testing (in support of for example a MMP) would need to be confirmed via consultations with the Environment Agency and Local Authority planning and contaminated land officers. Given the volume of silts proposed to be removed, they are likely to require additional characterization/validation testing.

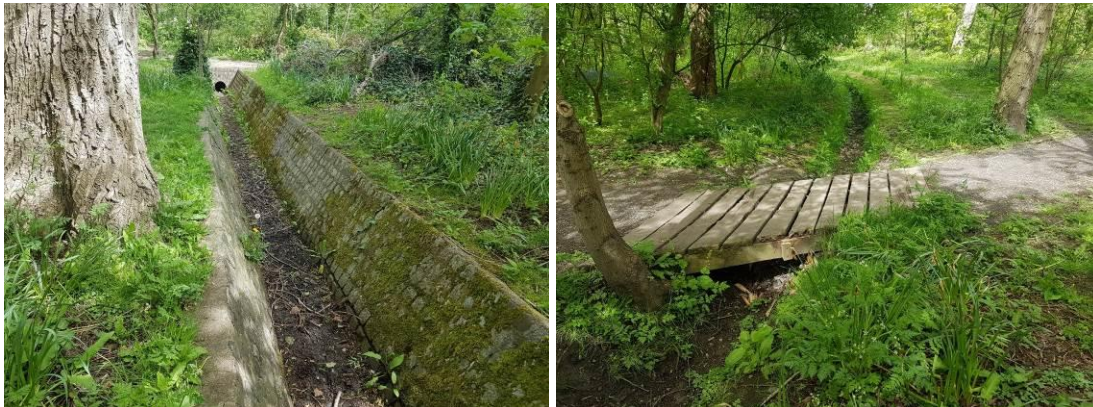
Figure 17 Principal inflow channels

The two principal inflow input to the lake at the same location (north end) and the existing structure of the channels i.e. discrete, fixed channels (Figure 17) provides opportunity for nutrient capture. These channels could be filled with a matrix (allowing percolation/throughput of water) of a phosphorus removal medium.

- 'Chemical filter medium' materials are generally derived from blast furnace slag (or other similar materials such as argon oxygen decarburization slags, electric arc slags etc.). The use of these materials, although known to be effective, often have waste disposal implications when it is time to remove and replace and the specific P removal rate would need to be monitored.
- A 'Biological filter medium' i.e. a reedbed, would likely be simpler and more appropriate given the locality. Two reedbeds could be installed within the inflow channels and reeds harvested annually (thus creating an annual net removal of nutrient). The rate of P removal may not be as great as a chemical filter but this option would be complementary to the conservation area and could be promoted with information boards etc.

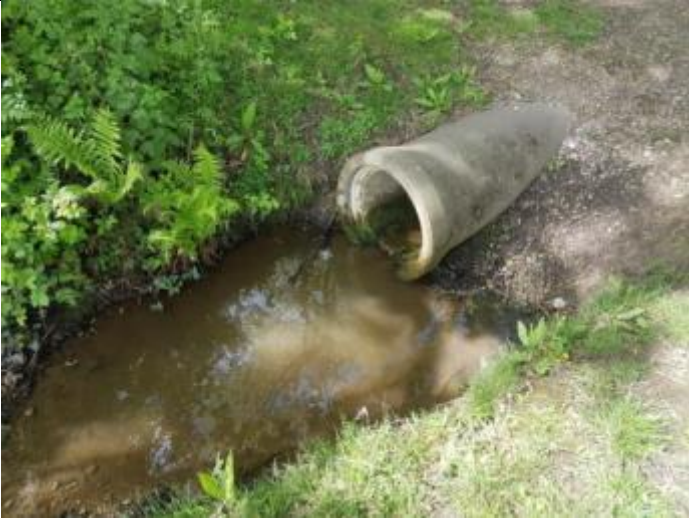
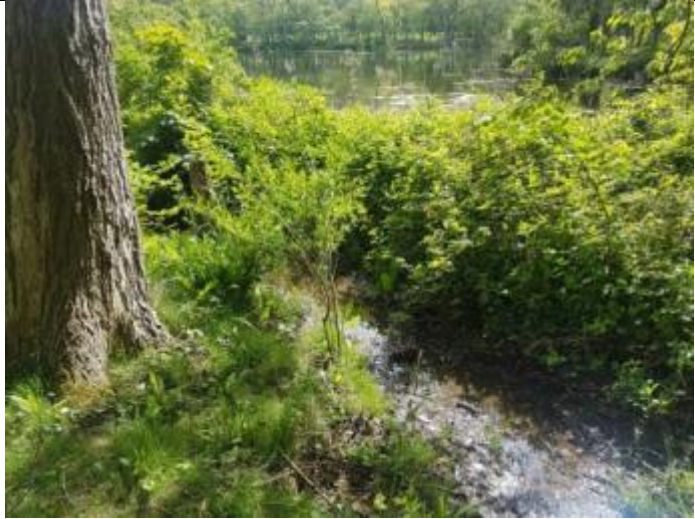
<p>Minor inflow on the west bank of the north basin</p>	<p>Same inflow channel looking towards north basin</p>

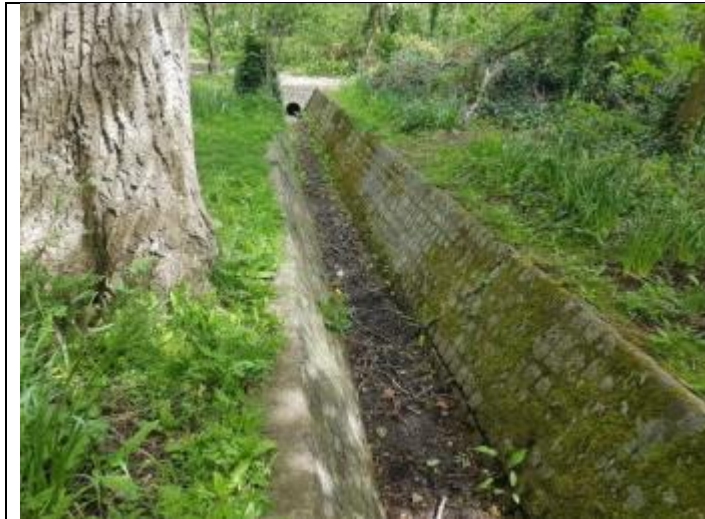
Brick/stone lined inflow channel (east channel of the two shown confluencing above); photo taken facing north. See recommendations for environmental (water quality driven) improvement suggestions.

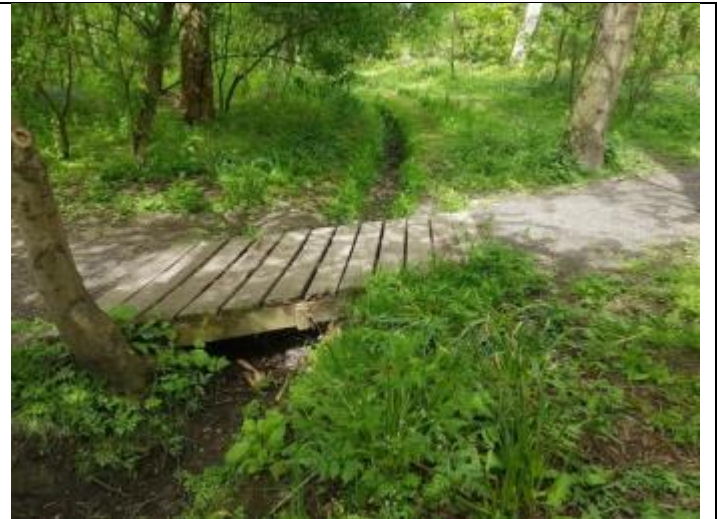
Inflow channel (west channel of the two shown confluencing above); photo taken facing ~west. See recommendations for environmental (water quality driven) improvement suggestions.

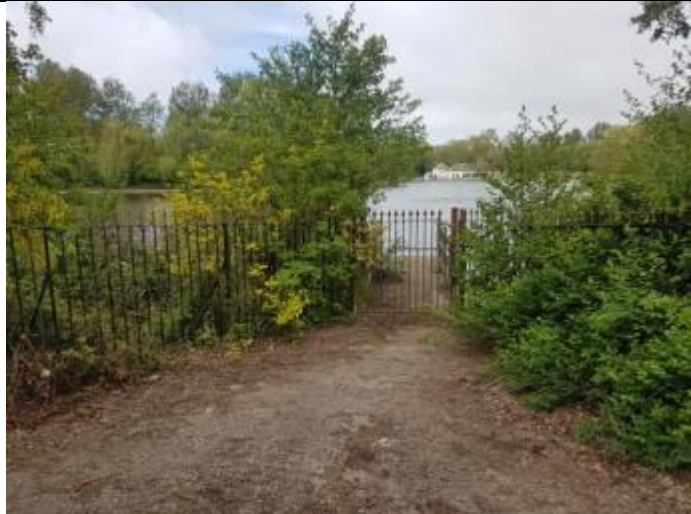
Access to fishing peg in southern basin (from east bank).

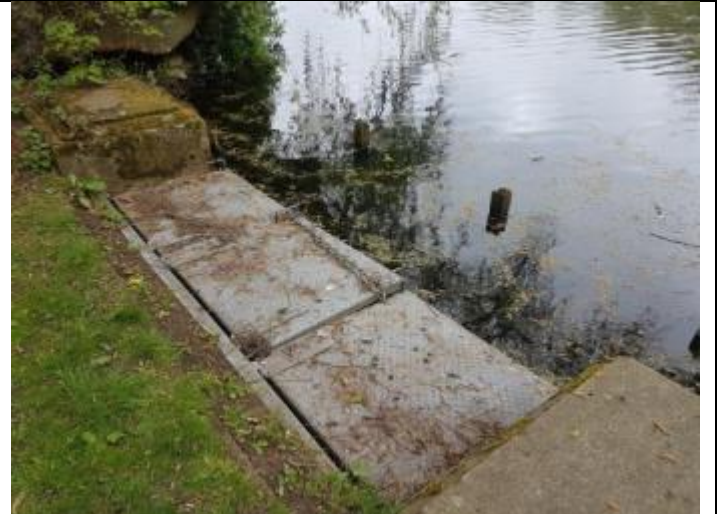
Covered and screened outfall.
