Emergency Preparedness Plan (EPP)

Embankment B088/EM4 Kingsbury to Queensbury

Jubilee Line

TLL-B087-P855-EST-PLN-00001

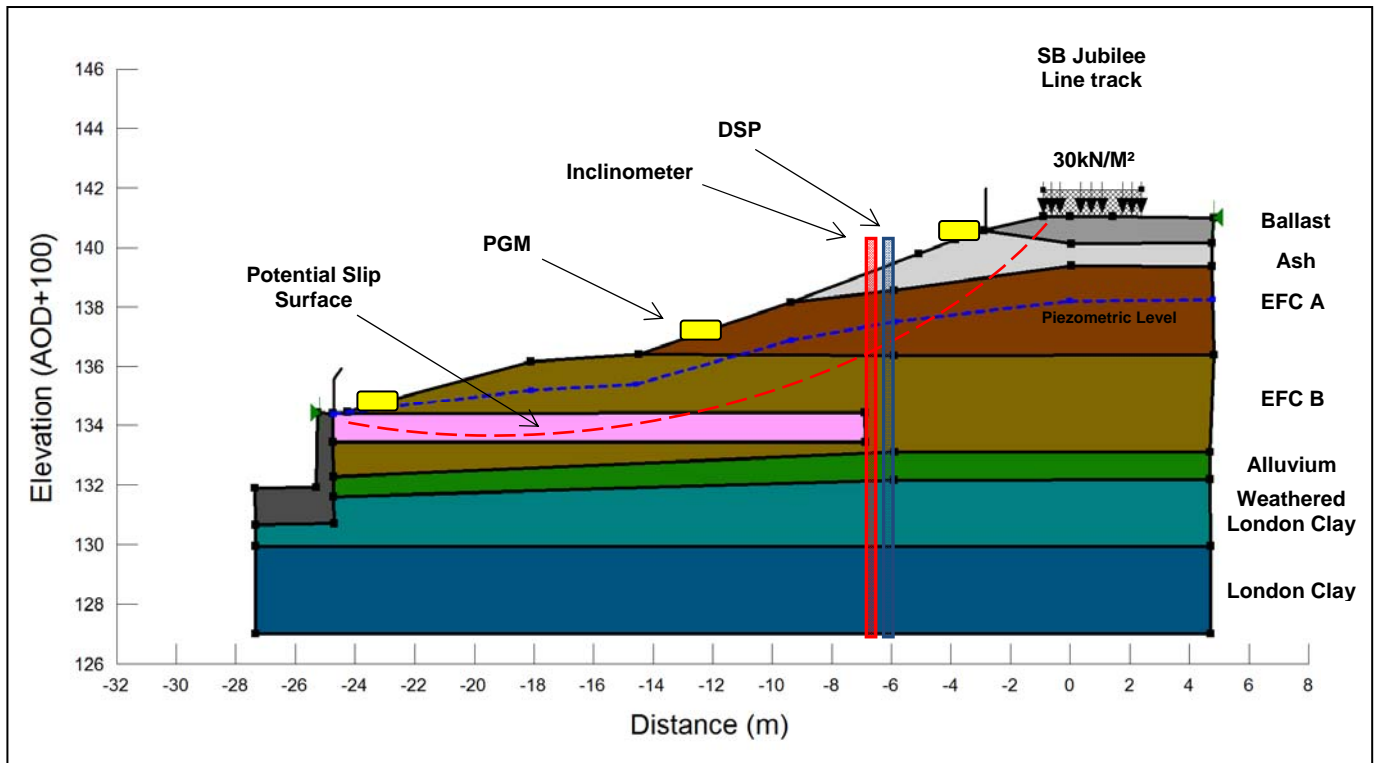
Figure 5.2: Ground Model and General layout of Embankment Geotechnical Monitoring Instrumentation

Permanent Ground Markers (PGM's): Basic instrumentation in the form of PGM's are used to monitor ground movements and are generally installed at the crest, upper mid-slope, mid-slope, lower mid-slope and toe of the embankment (Figure 1). Depending on the slope height and geometry, additional PGM's have been installed to allow complete monitoring of the slope profile. Retaining structures also have monitoring points installed at various locations on the structure. The PGM's are monitored by the LU COP PDP survey team and the results supplied to the LU COP PDP ES team on an excel spreadsheet. The results are plotted into graphical format for review.

Dual Standpipe Piezometers (DSP's): Intermediate instrumentation in the form of DSP's are used to monitor piezometric levels and pore water pressures within the embankment. They have been installed on the upper slope and comprise a deep piezometer tip, located approximately 1m beneath the embankment and a shallow piezometer tip, located approximately within the embankment core (Figure 1). The DSP's are monitored by the LU COP PDP ES team and the results stored on an excel spreadsheet and plotted into graphical format for review.

Inclinometers: Detailed instrumentation in the form of inclinometers are used to monitor slope movements and are installed on the upper slope (Figure 1). The inclinometers are monitored by the LU COP PDP ES team and the results stored on an access database and plotted into graphical format for review.

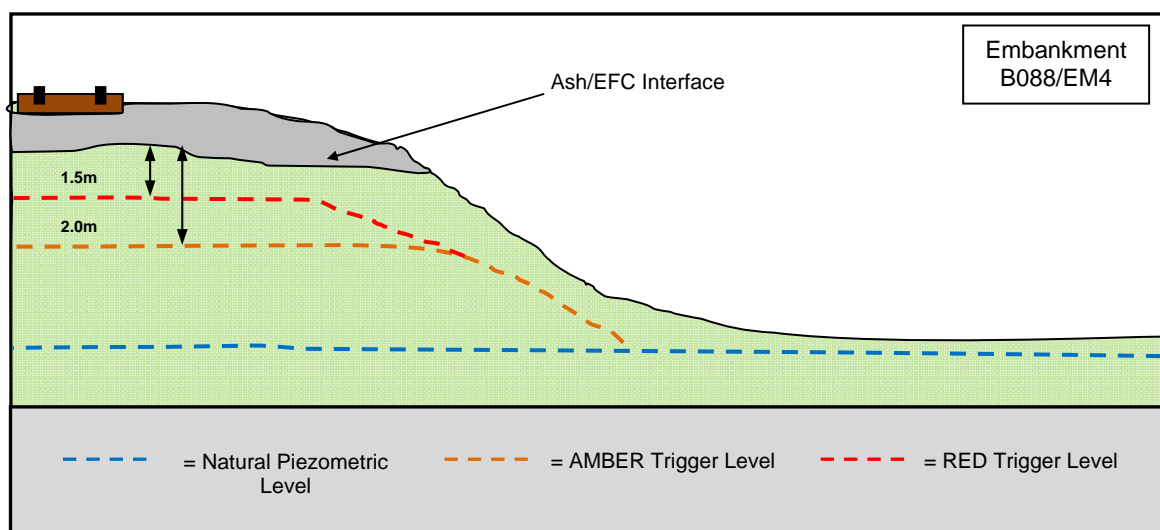
Figure 8.3: Generalised diagram showing DSP trigger levels for Embankment B088/EM4

No BLACK status will be adopted for DSP monitoring data.

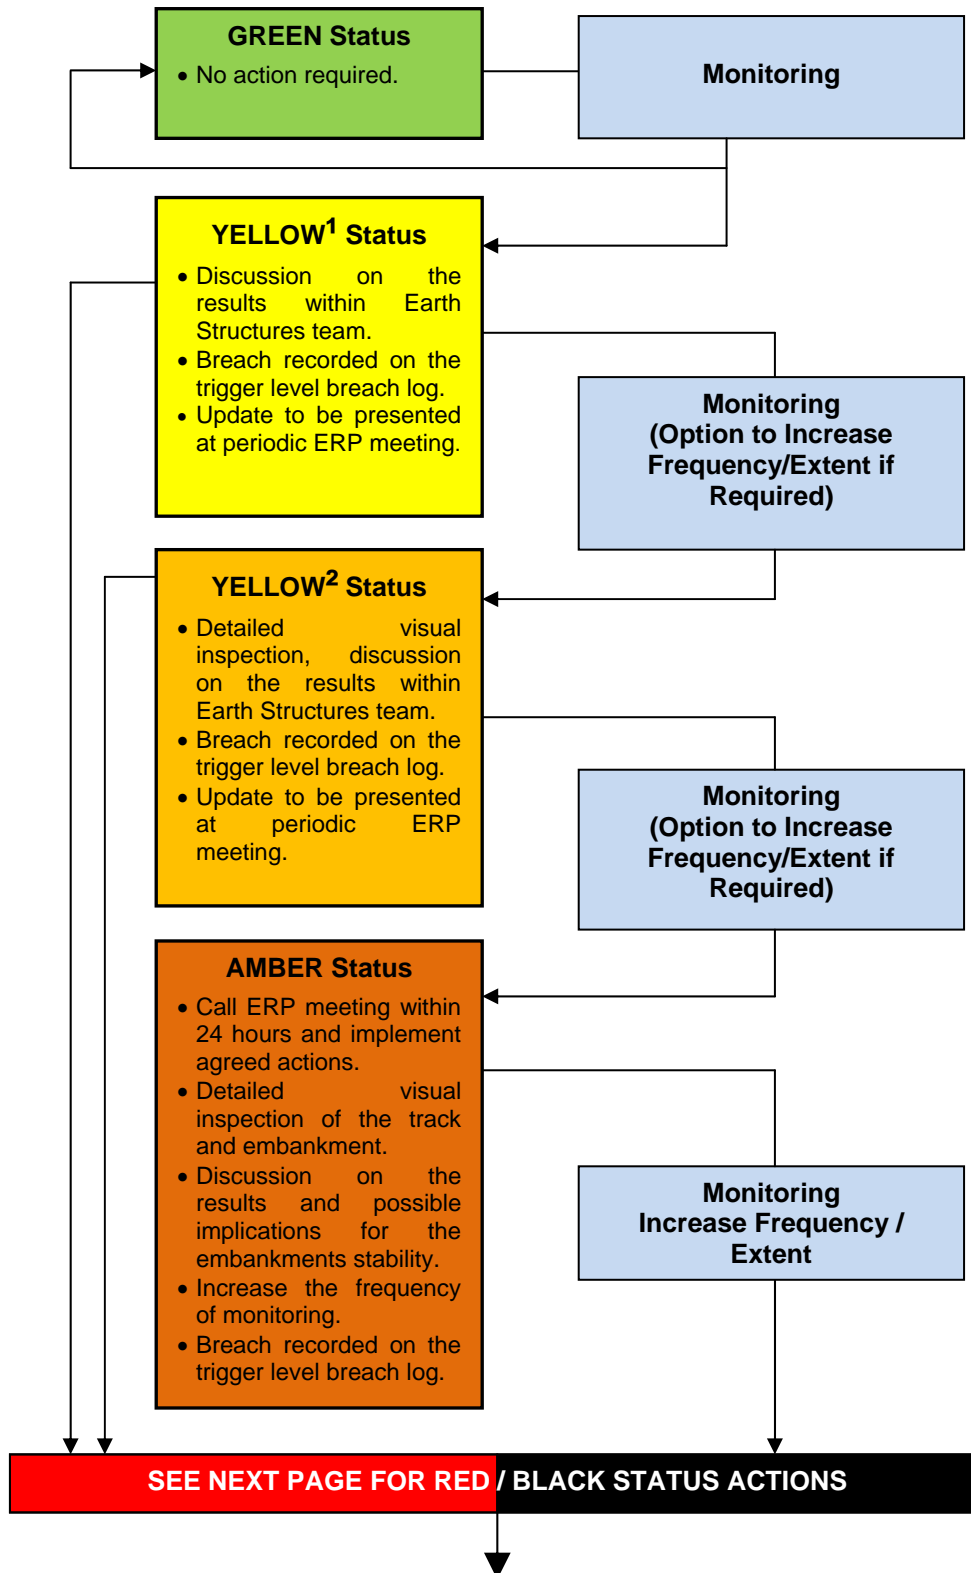
In the event of a change of status higher than GREEN shown in Tables 8.1-8.6, the following actions shall be carried out.

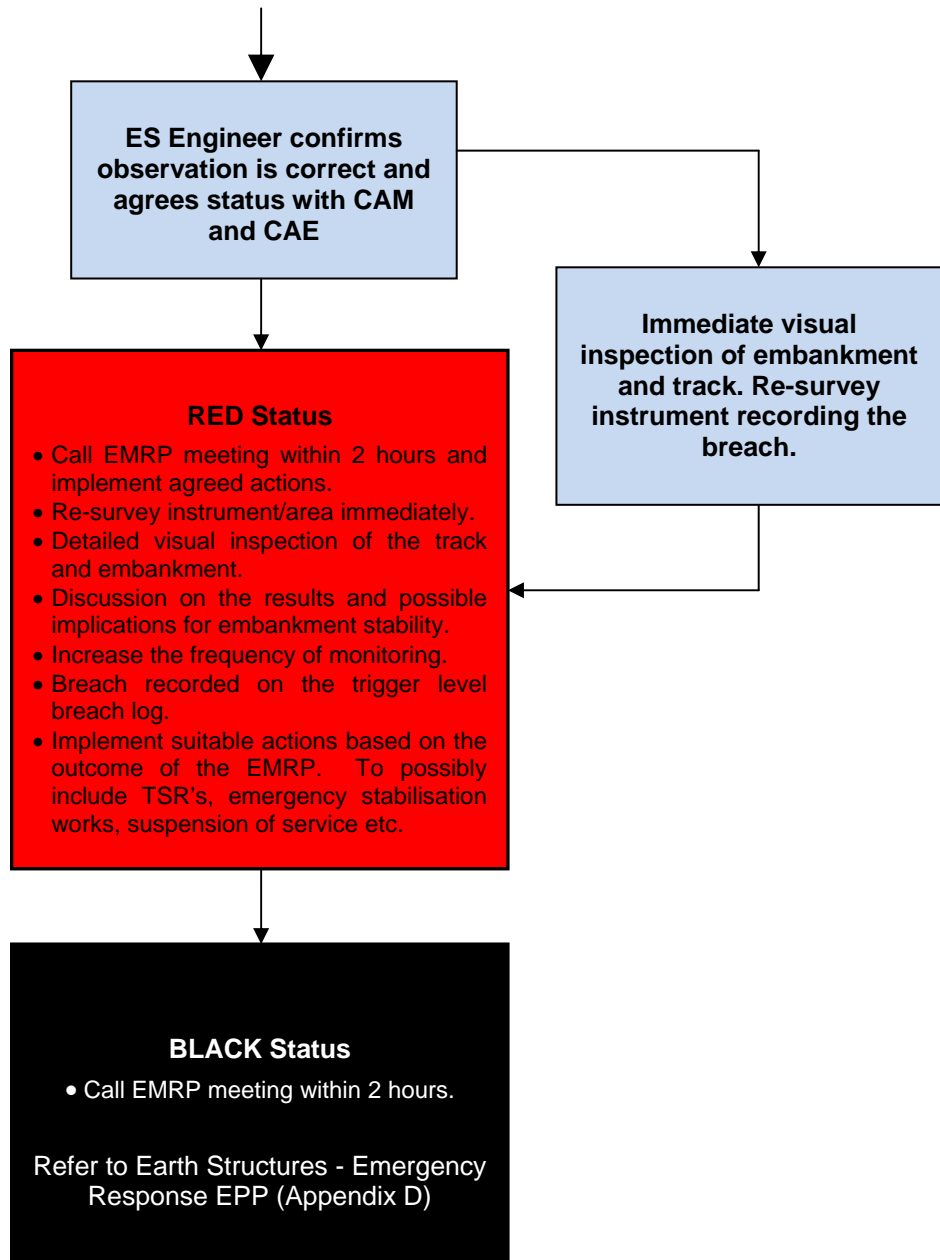
In the event of a change of status higher than AMBER shown in Tables 8.1-8.6, the following actions shall be carried out.

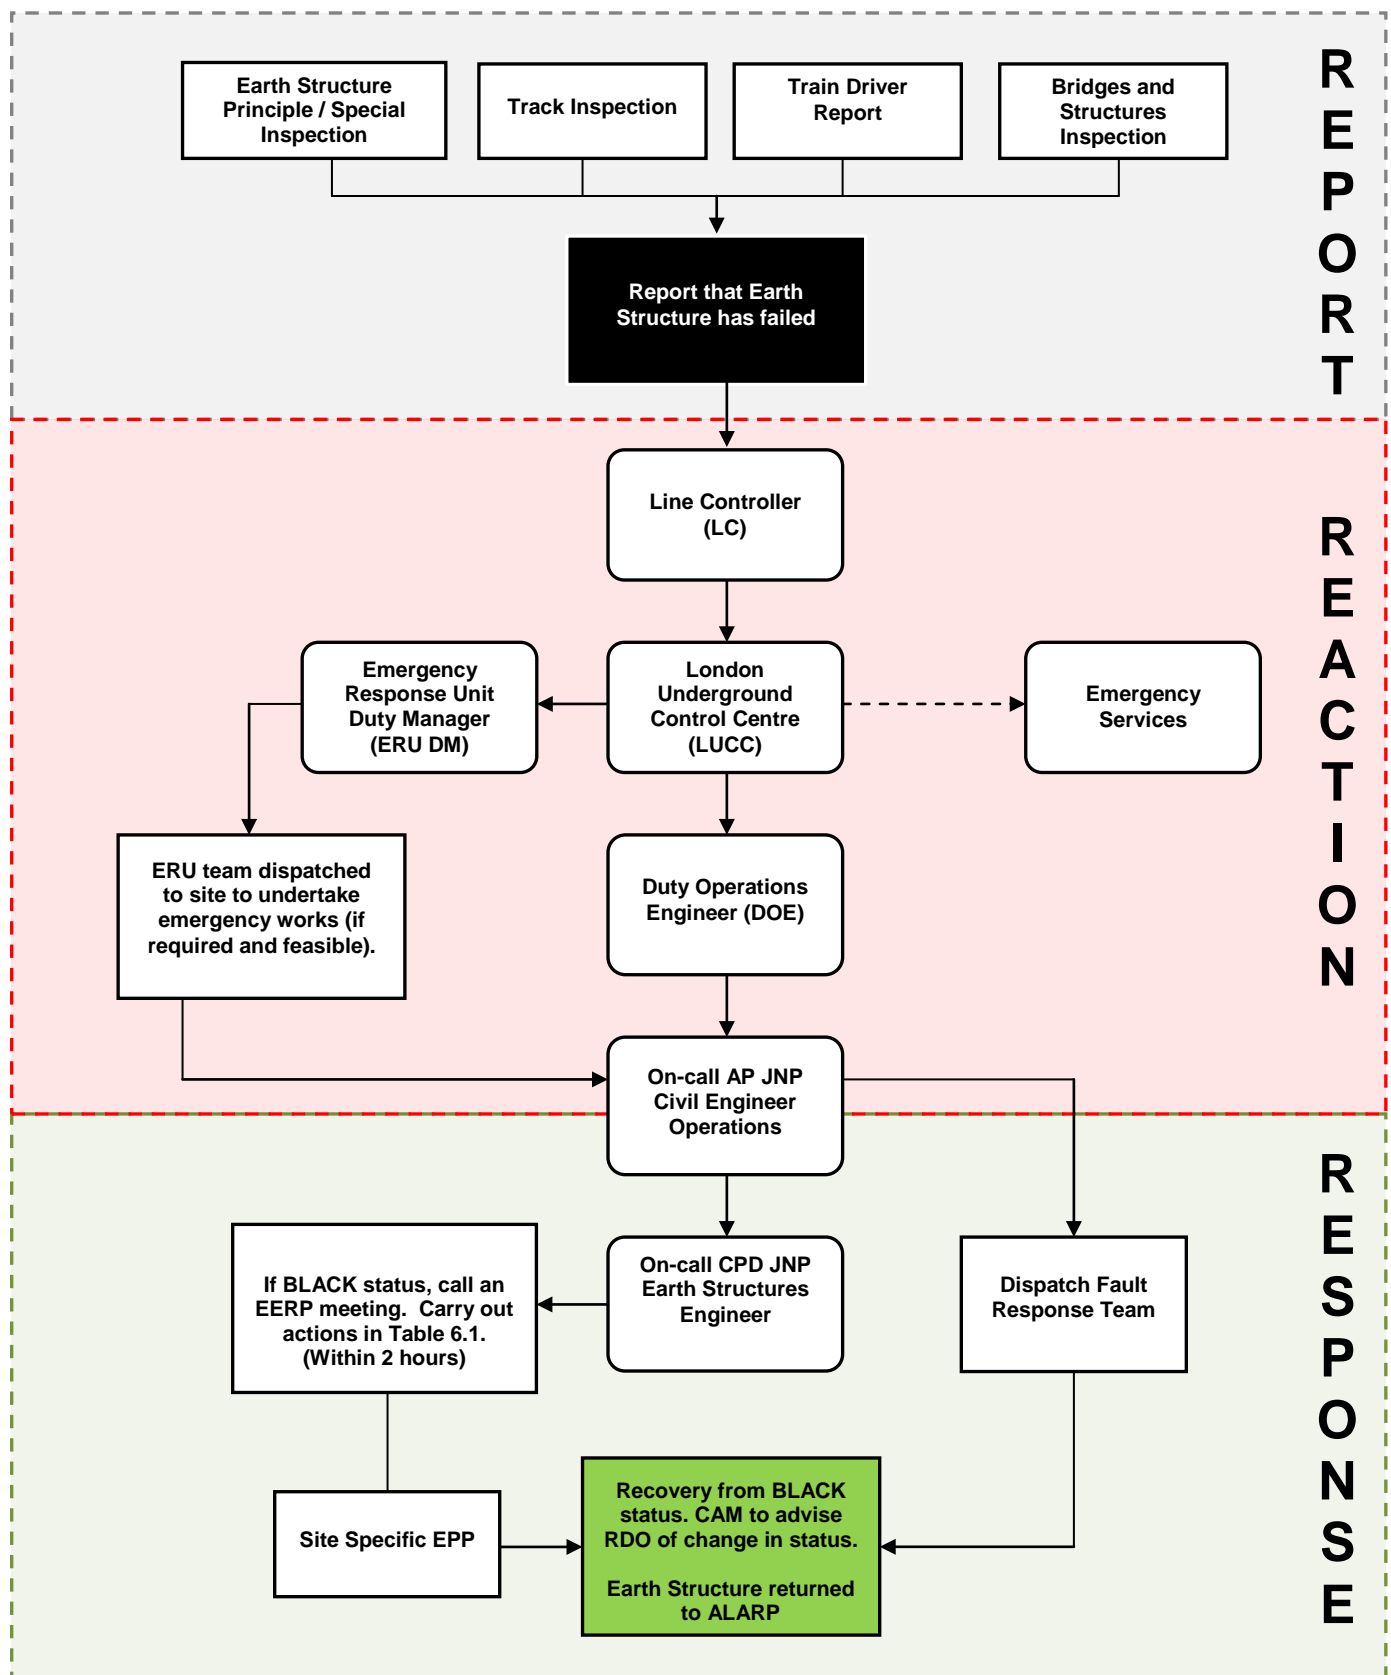
In the event of a **BLACK** status emergency, the following actions shall be carried out:
