Earthwork Inspection 5 Chain Record

Earthwork Type	Soil Cutting - SCHI
Route	
Operational Route	LNE
Strategic Route	G - East Coast and North East
SRS	G.03 - Hertford Loop
Territory (Pre-Nov 2011)	LNER
Earthwork Management Area	3
Classification	London and SE Commuter

Line					
ELR	HDB				
Route Description	Hertford Nth Loop				
Reverse Mileage	False				
Start Mileage (Miles.Yards)	7.1430	End Mileage	7.1540	Side	Down
Start Easting	531,545	Northing	194,597		
End Easting	531,571	Northing	194,694		
Length (Mile.Yards)	0.0109				
Track Name	NT - Not 6ft or 10ft Earthwork	Track ID	0		
Reverse Mileage	False				
Disused Line	Open

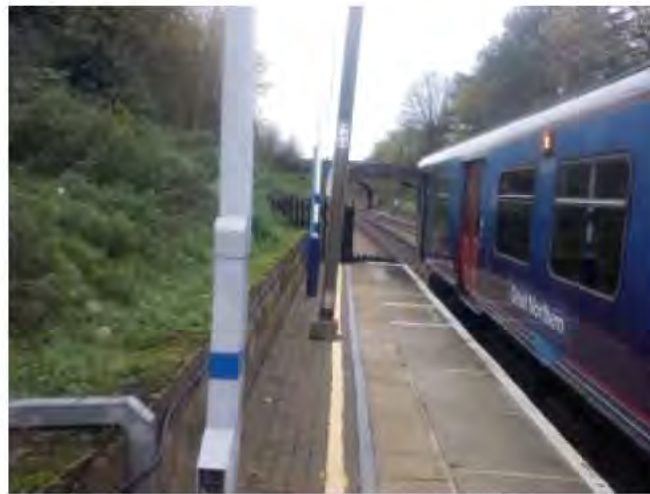
HDB_7.1432_D_531550_194597_20_11_2015_09_43_33

Subject	Cess Level from start, increasing mileage
Taken Date	20 November 2015
Taken Time	09:43
Filename	FO:LNE:jpg:1441084270
Orientation	Down line
Description	-

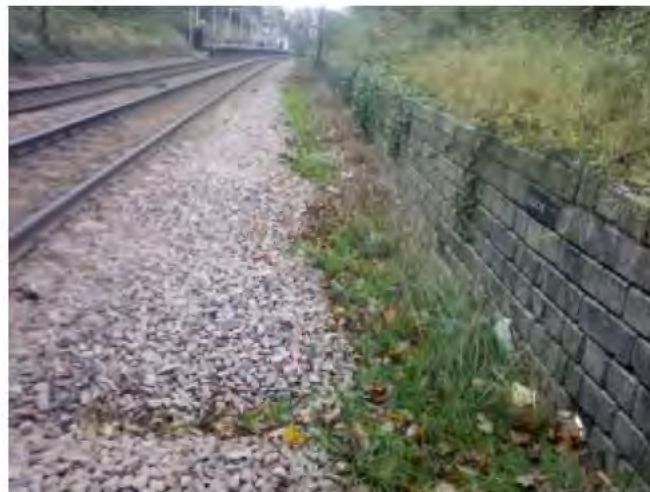
HDB_7.1534_D_531579_194687_20_11_2015_10_45_05

Subject	Cess Level from end, decreasing mileage
Taken Date	20 November 2015
Taken Time	10:45
Filename	FO:LNE:jpg:1440999633
Orientation	Up line
Description	-

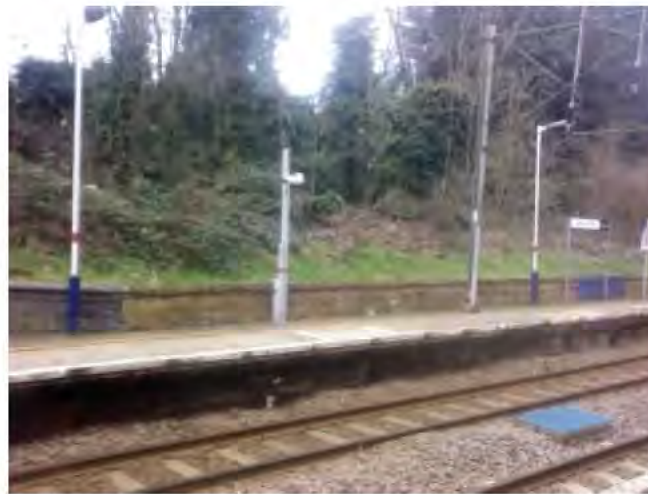
HDB_7.1429_D_531559_194592_19_03_2013_14_05_11

Subject	Cess Level from start, increasing mileage
Taken Date	19 March 2013
Taken Time	14:05
Filename	-
Orientation	Away from line
Description	-

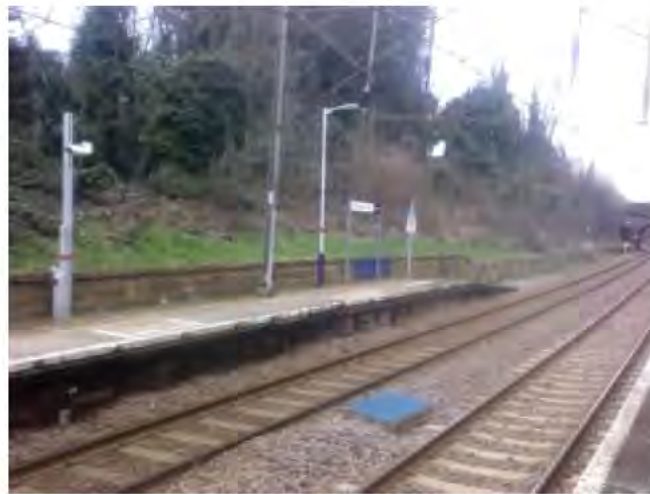
HDB_7.1429_D_531559_194592_19_03_2013_14_05_44

Subject	Cess Level from start, increasing mileage
Taken Date	19 March 2013
Taken Time	14:06
Filename	-
Orientation	Down line
Description	-
