**DEVON &
SOMERSET**
FIRE & RESCUE SERVICE

Rapid Intervention Vehicle

Pilot Closure Report

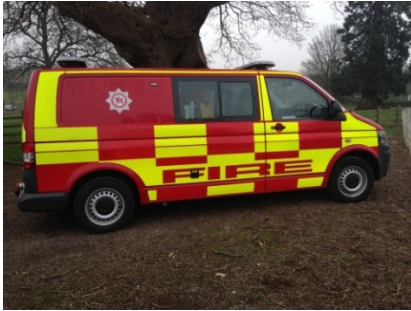
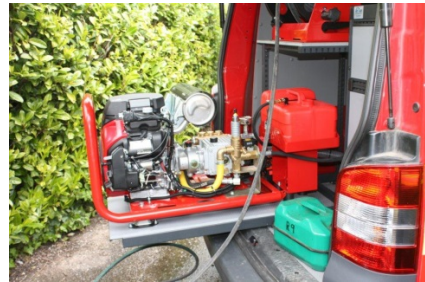
Option 1 VW T5 3.2T Van with a Brendon Pump powered by a 16HP Honda petrol driven engine

4.1 Option 1

4.1.1 Observations

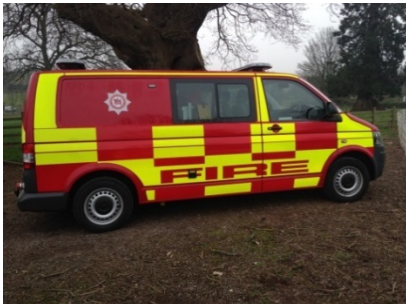
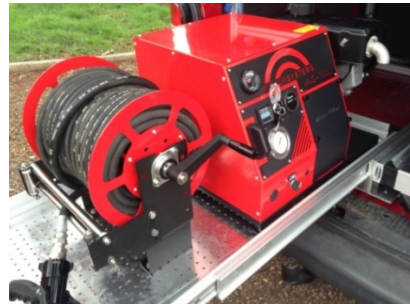
Option 2 VW T5 3.2T Van with a Vehicle Misting Systems Pump driven by a 6.5HP Briggs & Stratton Vanguard pump

4.2 Option 2

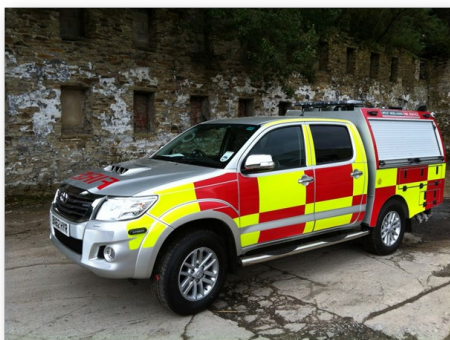
Option 3a Toyota Hilux 3.5T Pickup with a Briggs and Stratton petrol engine driving a Hale HPX 75 pump

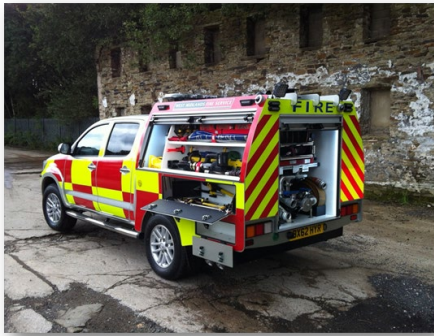
Option 3b Isuzu 3.5T Pickup with a Briggs and Stratton petrol engine driving a Hale HPX 75 pump

3b Isuzu PickUp – 3.0 Litre turbo charged diesel engine.

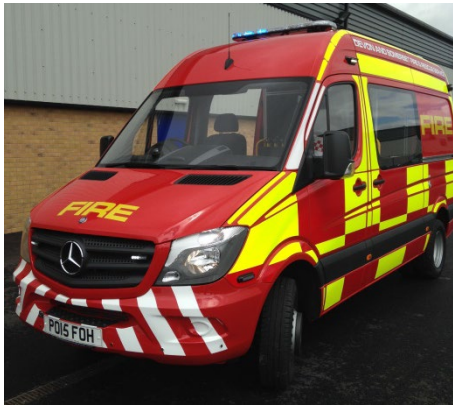
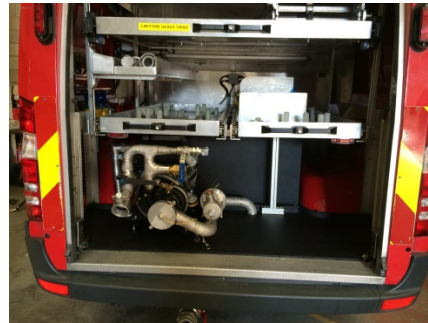
Option 4 Mercedes Sprinter (MWB) 5T van with a Briggs and Stratton petrol engine driving a Hale HPX 75 Pump

4.4 Option 4

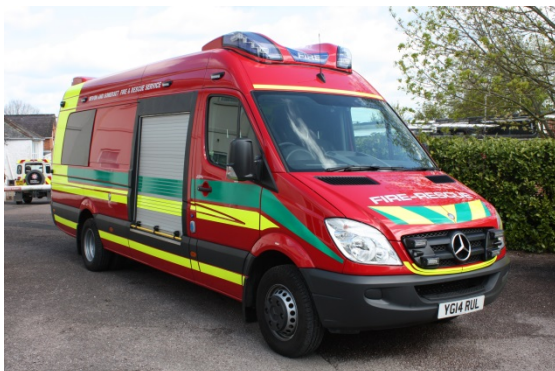
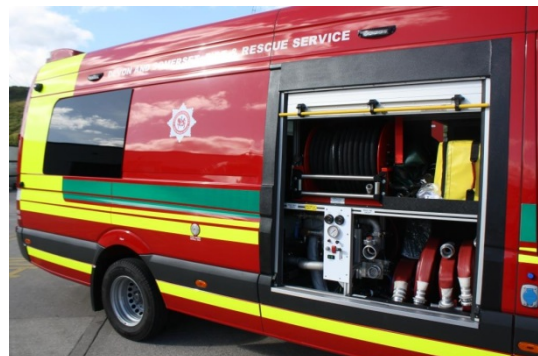
Option 5 Mercedes Sprinter (LWB) 5.3T van with a Briggs and Stratton petrol engine driving a Hale HPX 75 Pump

4.5 Option 5

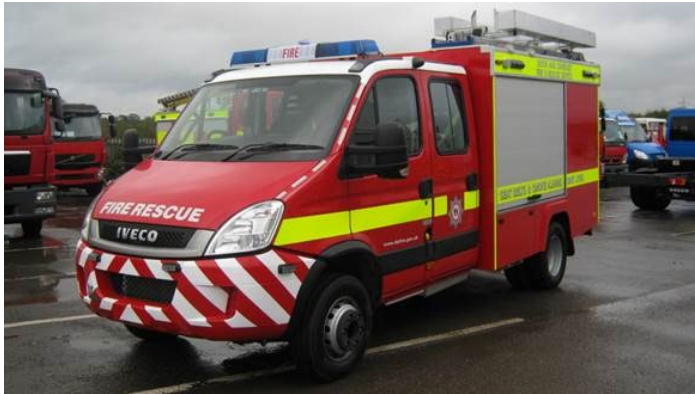
Option 6 Iveco Daily 6.7T crew cab with a PTO driven Godiva 20/10 pump

4.6 Option 6

Although originally considered part of the pilot this vehicle was deployed operationally at Porlock and was therefore not part of the survey.

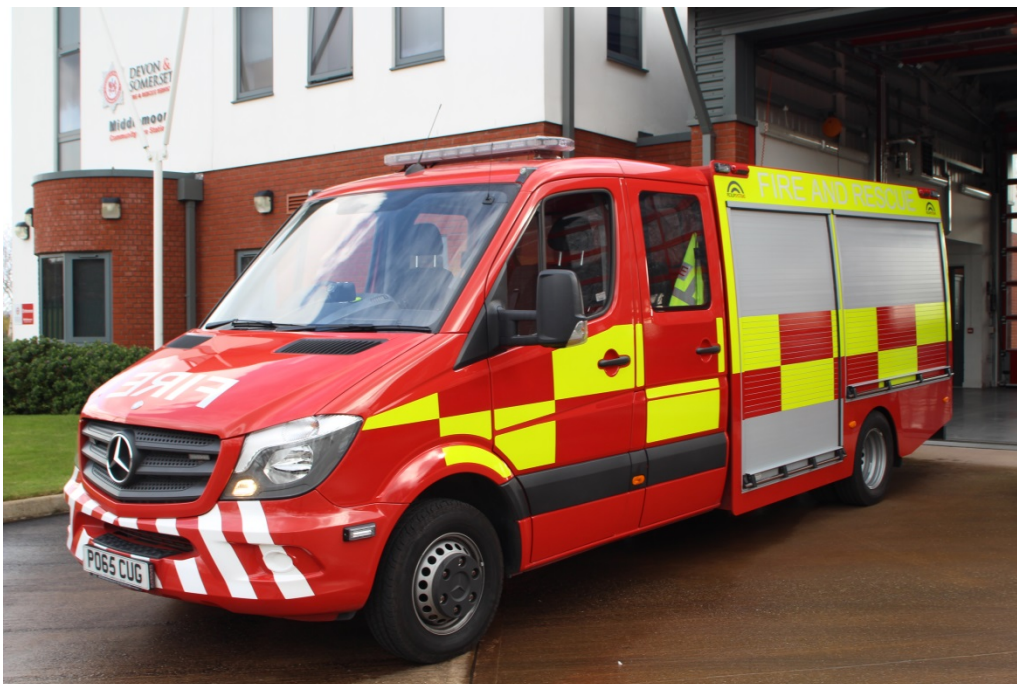
To aid these deliberations the SERVICE has been able to acquire the loan of a vehicle (at minimum cost = £600) for eight weeks. This vehicle has been developed by Pickup Systems. Whilst this vehicle should NOT be considered the complete solution to our requirements it has the benefit of encompasses a number of the lessons learned from the pilot.

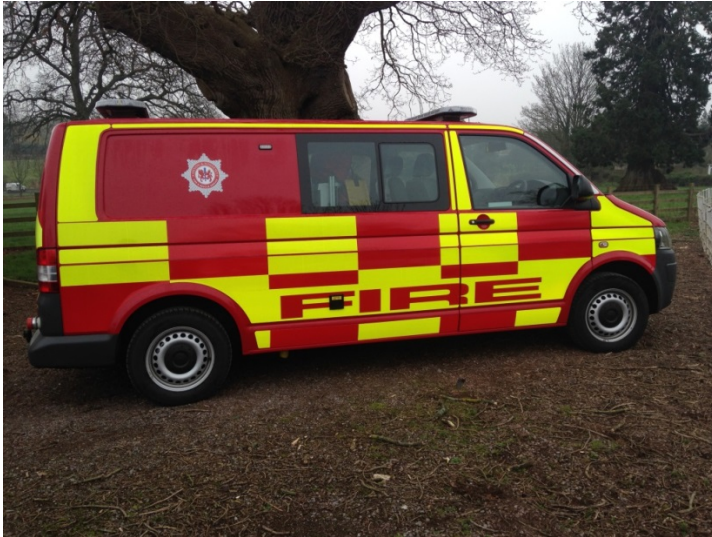
VW T5 Van 4x4

Maximum crew of 3 firefighters (300 kgs)

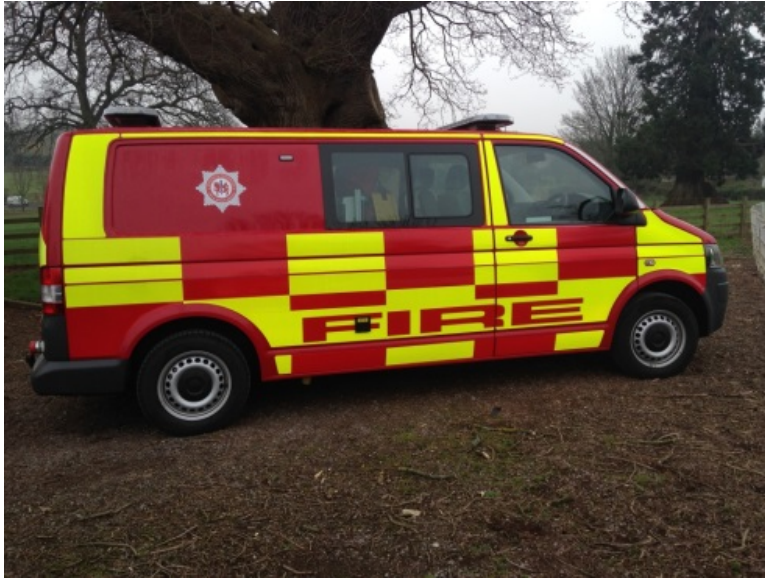
VW T5 Van 4x4

Maximum crew of 3 firefighters (300 kgs)

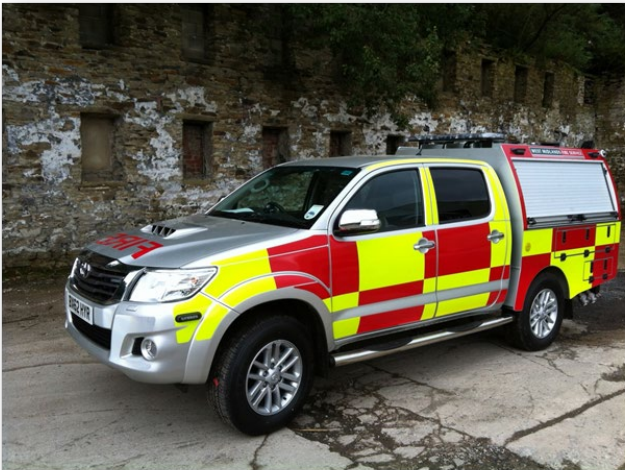
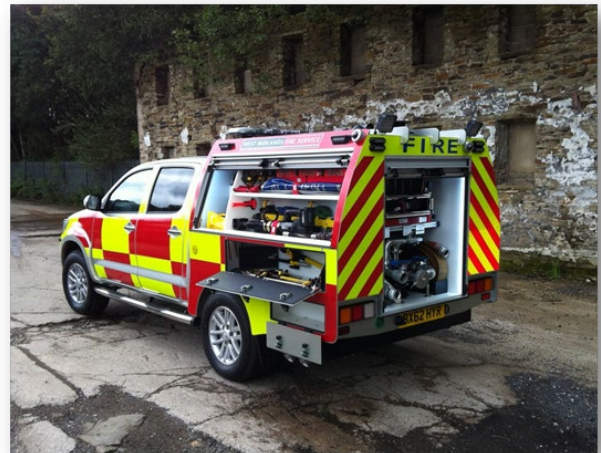
Maximum crew of 3 firefighters (300 kgs)

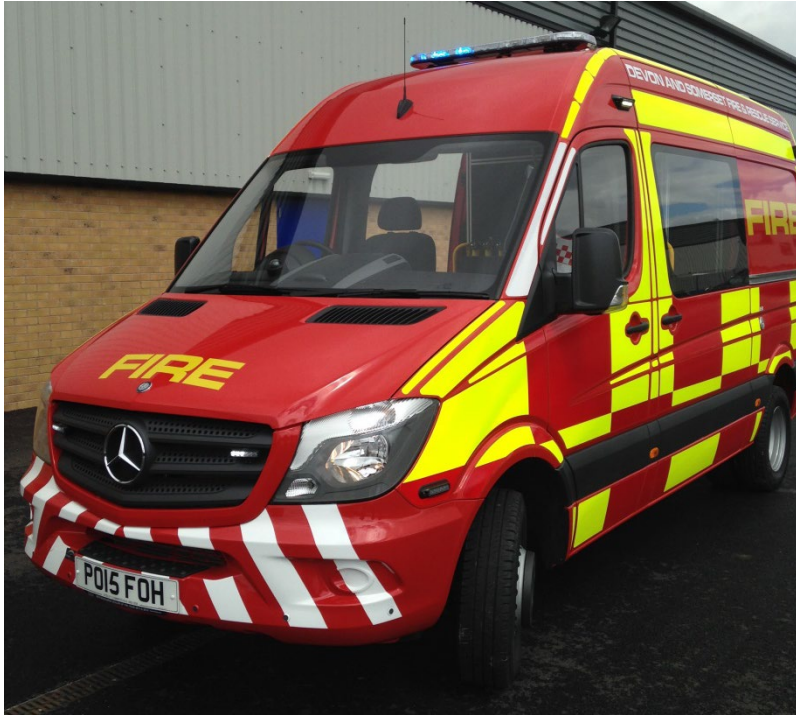
Gross vehicle weight = 5T

Maximum crew of 4 firefighters (400 kgs)

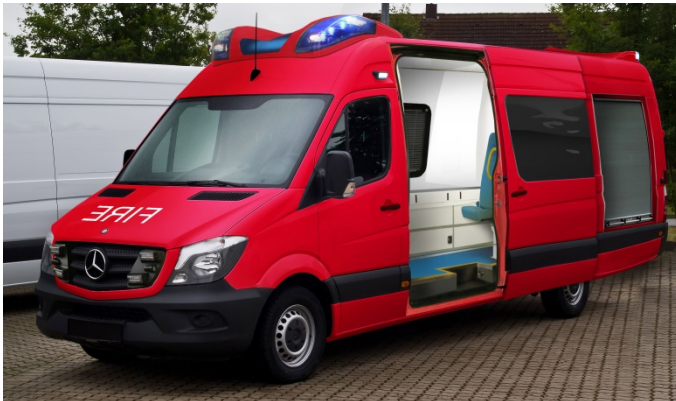
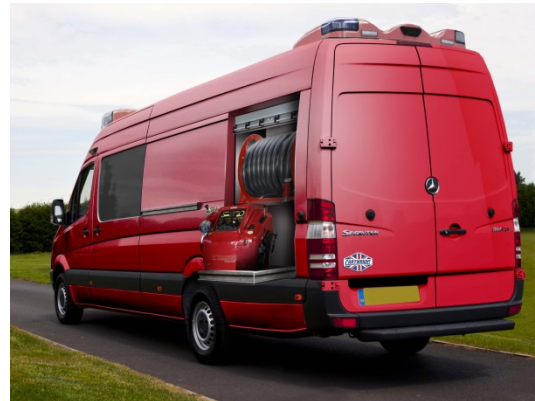
Gross vehicle weight = 5T

Maximum crew of 4 firefighters (400 kgs)

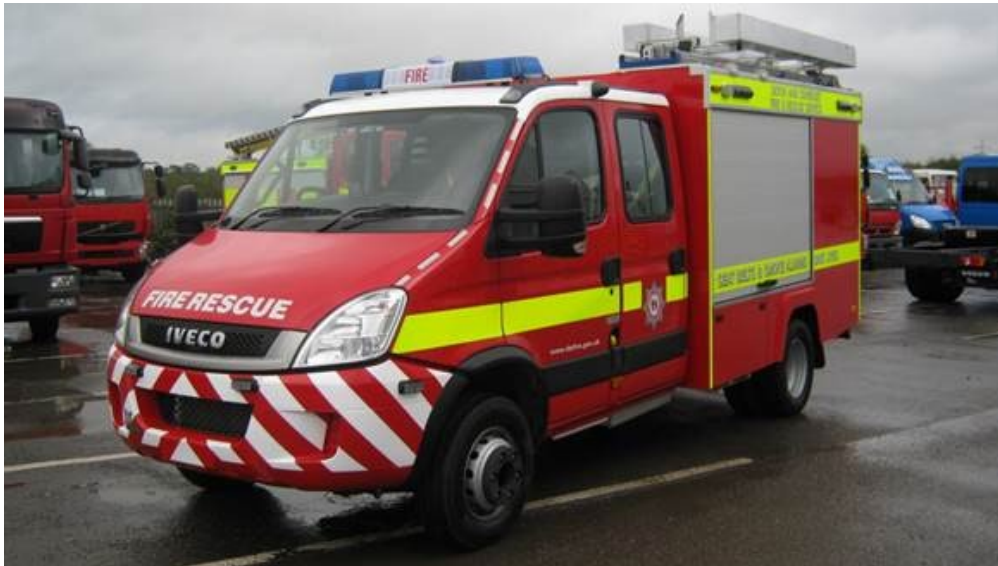
Gross vehicle weight = 6.5T

Maximum crew of 4 firefighters (400 kgs)
