Location:

Dyce Primary School
Gordon Terrace
Dyce, Aberdeen AB21 7BD

Survey Date

14/09/2015

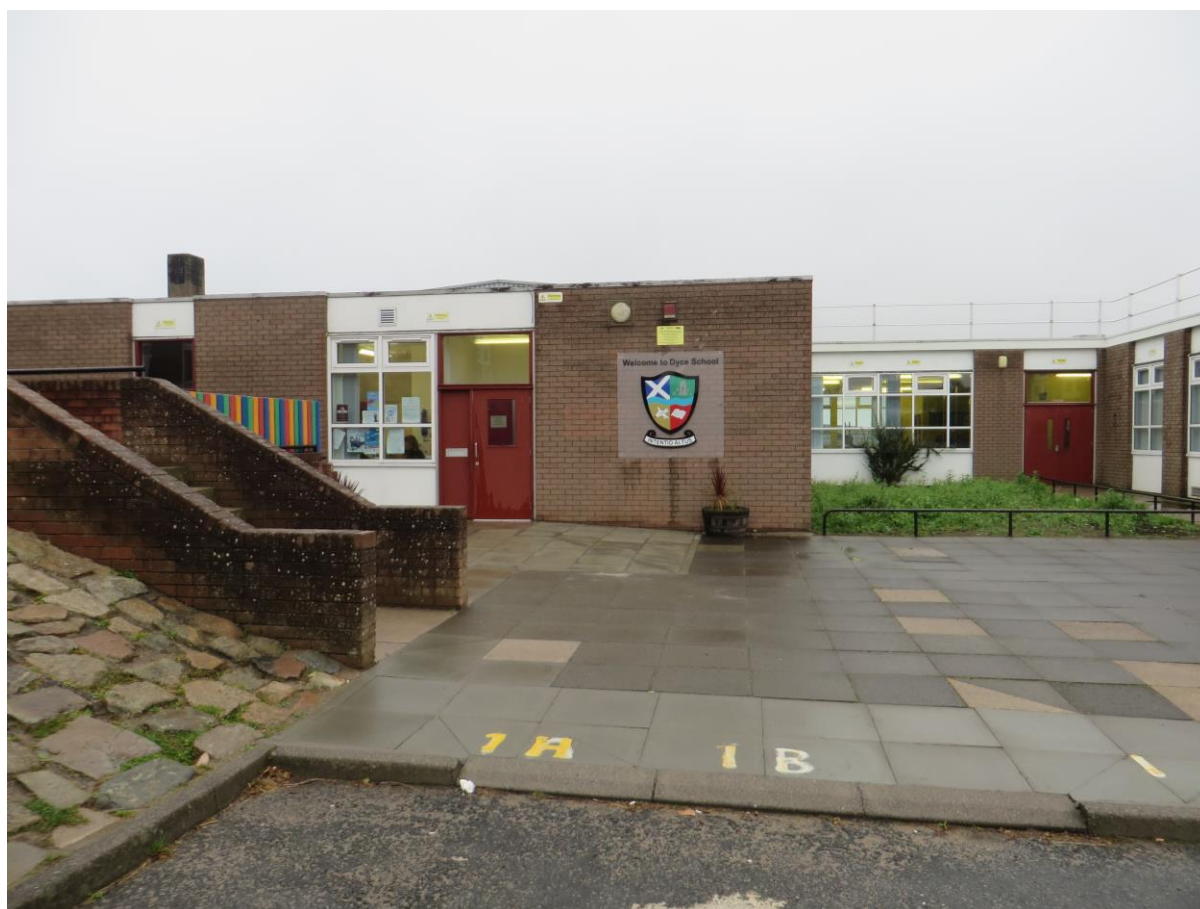
Single storey building constructed around 1970 comprising central core block with 3 linked teaching blocks. The Community wing is also linked to the core block.
