**Communities, Housing & Infrastructure
Land and Property Assets
Condition Survey Report File No. 240
Overall Grade: - B**

Northfield Swimming Pool
Kettlehills Crescent, Northfield
Aberdeen. AB16 5PL

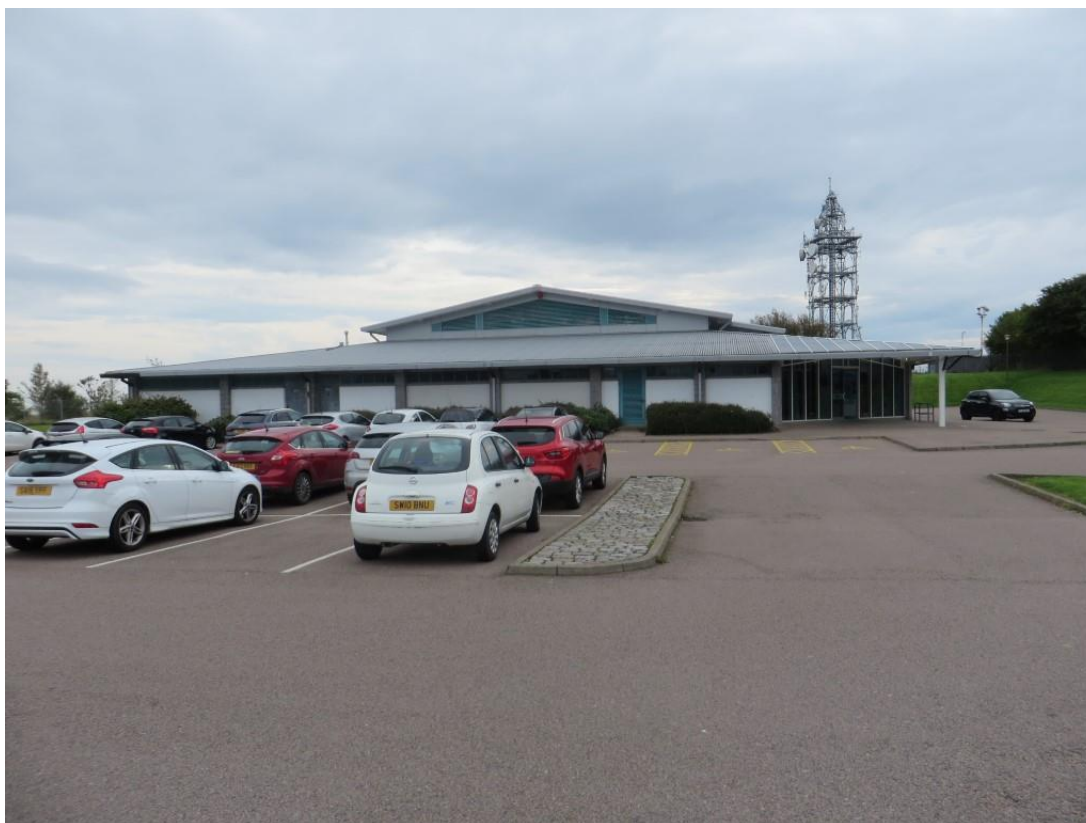
Northfield Swimming Pool was constructed in 1997. Steel framed with rendered infill panels and facing block features with composite profiled roof. There is a large car park in front of the building with a level access. Entry to the building takes you directly to the reception desk and seating area. The communal changing rooms and public toilets are accessed from this area.

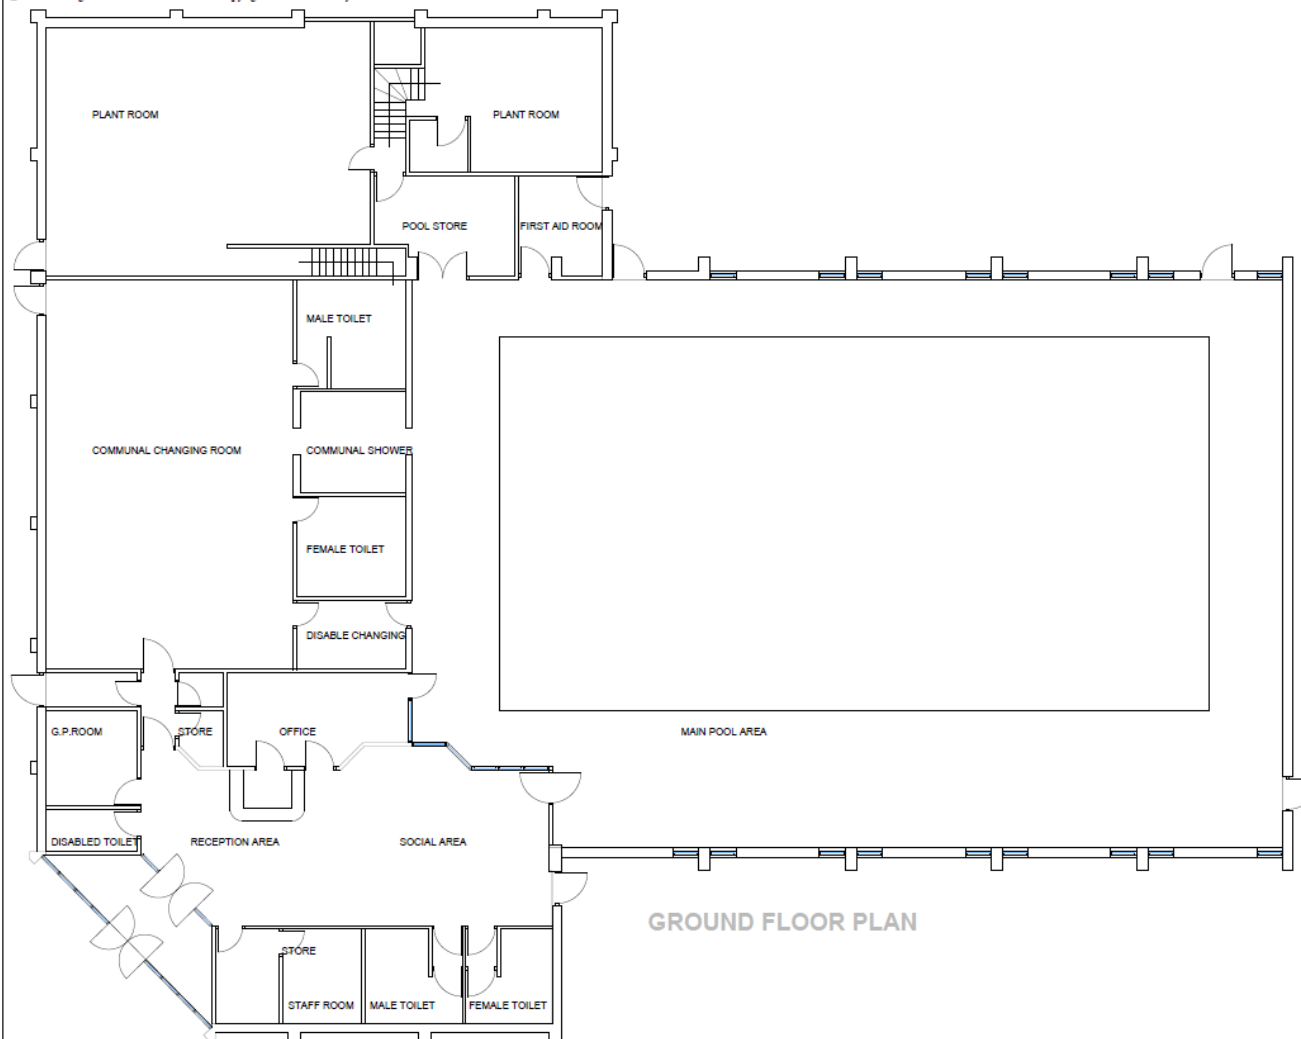
GROUND FLOOR PLAN

NB. DRAWN FROM SCANNED PLAN. ALL SIZES ARE APPROXIMATE.
