**Corporate Landlord  
Resources  
Condition Survey Report    File No. 2972  
Overall Grade: - A**

TULLOS SWIMMING POOL  
Girdleness Road, Torry  
Aberdeen. AB11 8FJ

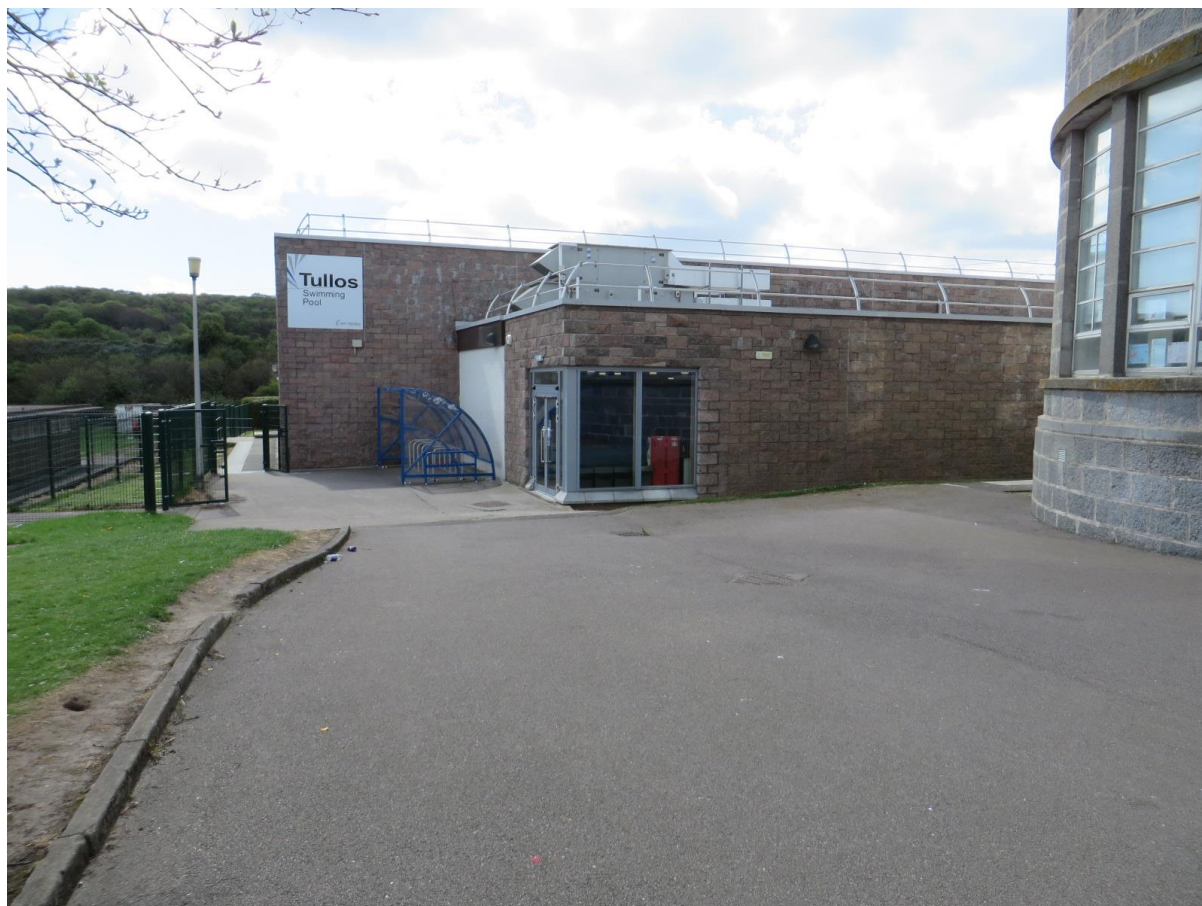
The building was constructed in 1978 and has granite walls. Main access to the building is from the rear car park. Staff and public enter the building through the main entrance doors into a reception space with counter leading to the changing area. The pool sits behind and is connected to Tullos Primary School. The car park is to the rear.
