**Project Information:**  
Project Name: Fife

**Plot Information:**  
Date of Plot:  
Monday, August 09, 2010  
09:03:01

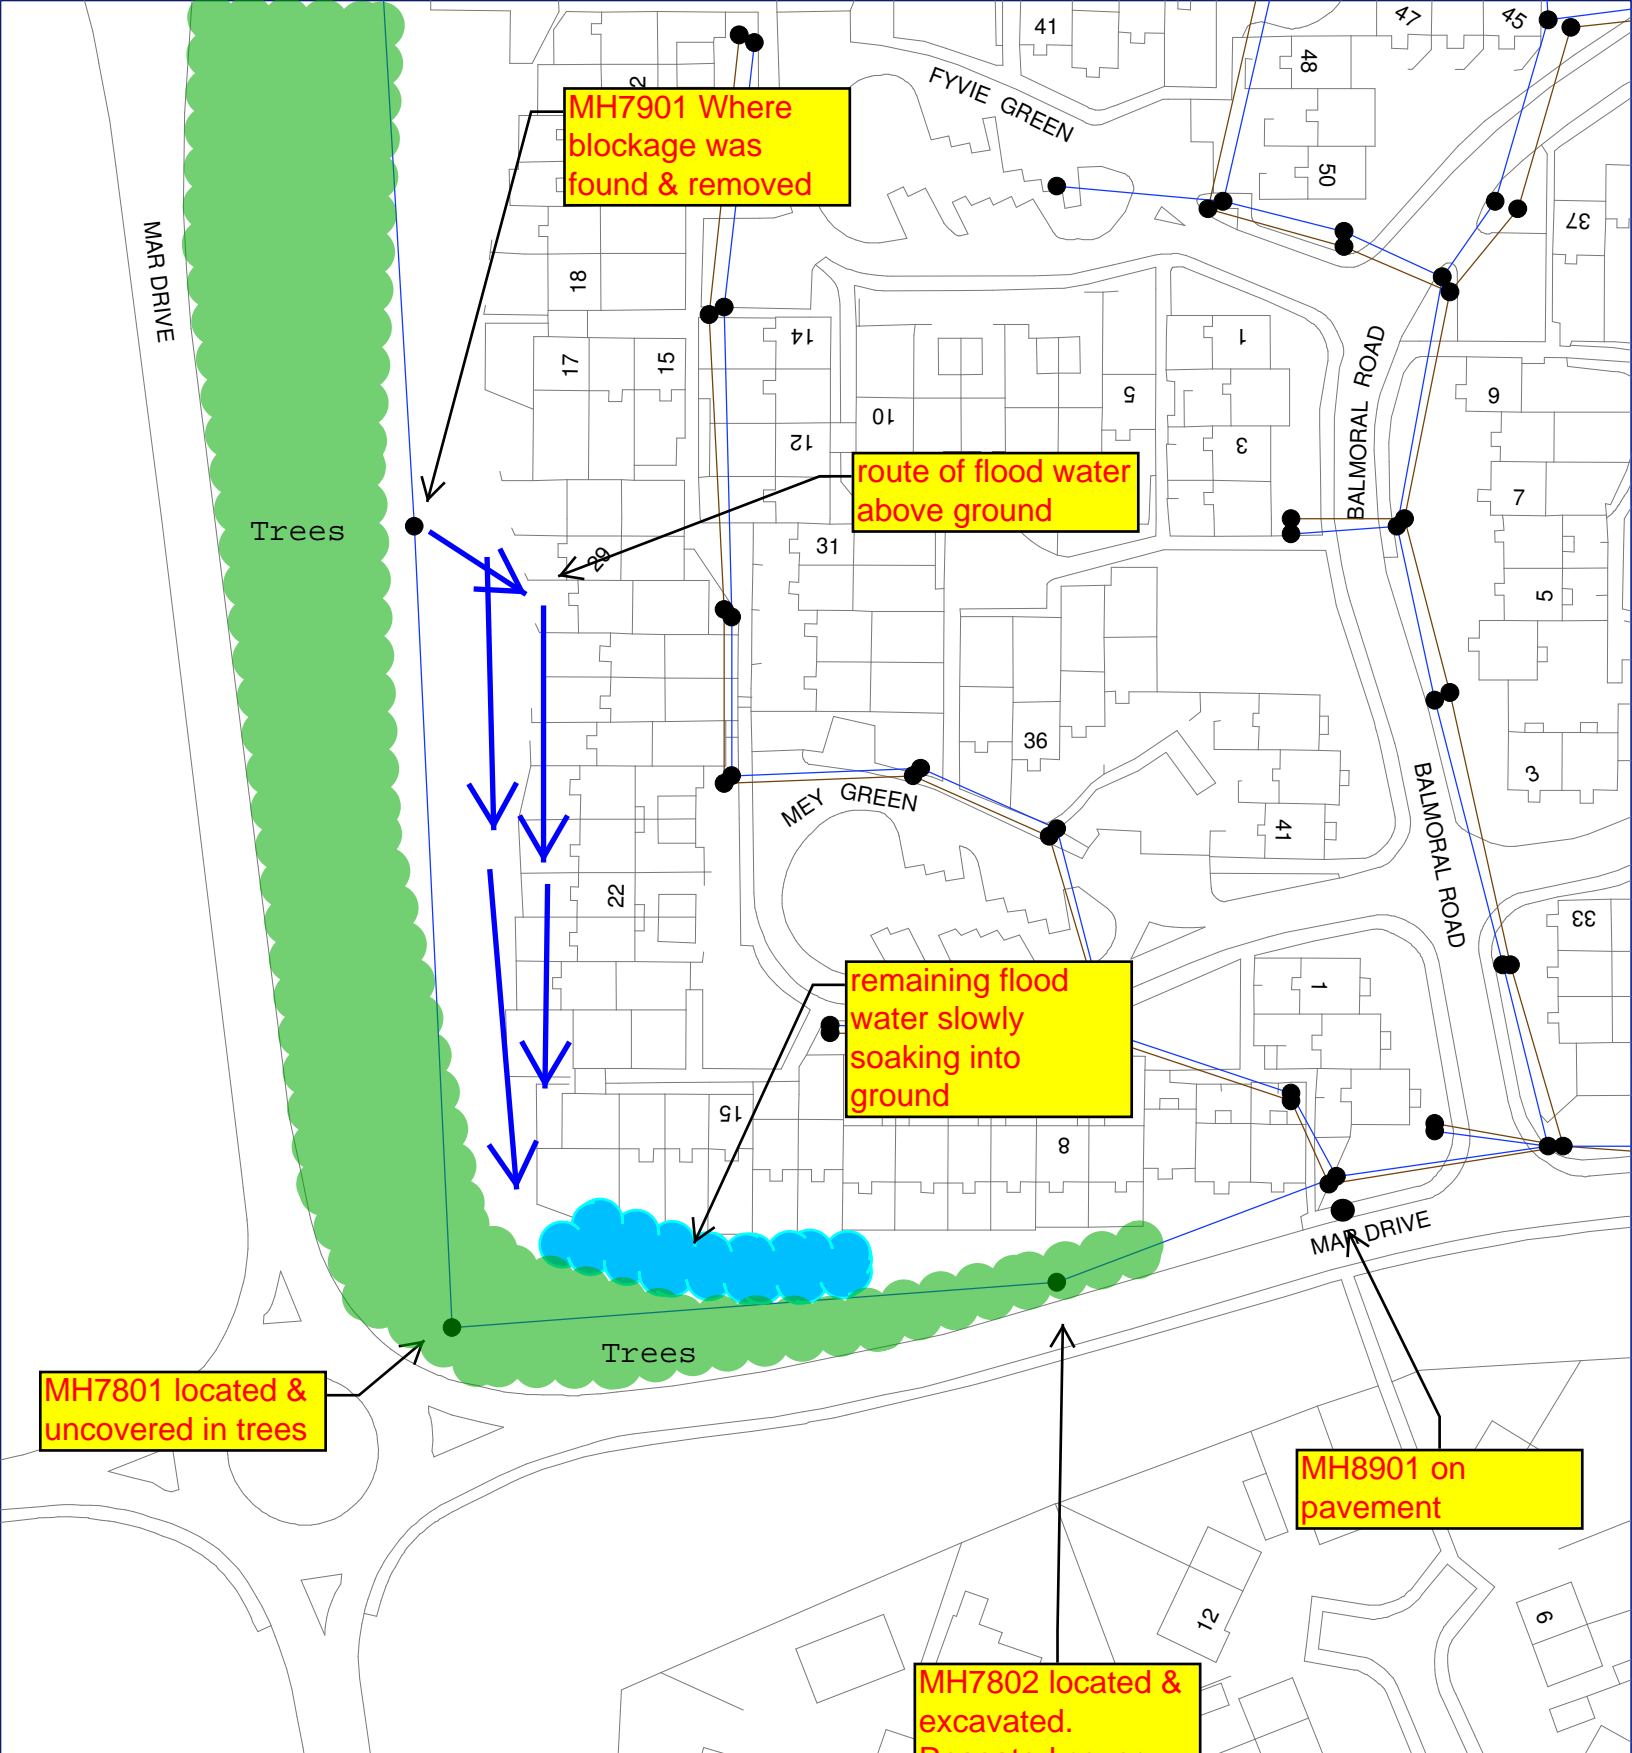
**MH7901 Where blockage was found & removed**

**route of flood water above ground**

**remaining flood water slowly soaking into ground**

**MH7801 located & uncovered in trees**

**MH8901 on pavement**

**MH7802 located & excavated. Resealed cover and replaced soil around frame.**
