Freedom of Information Request – Queensbury Tunnel Shaft Infilling

From: Wilson, James - York [REDACTED]
Sent: 03 October 2019 14:15
To: Smith, Fiona
Cc: Dave Thomas
Subject: RE: Queensbury Tunnel

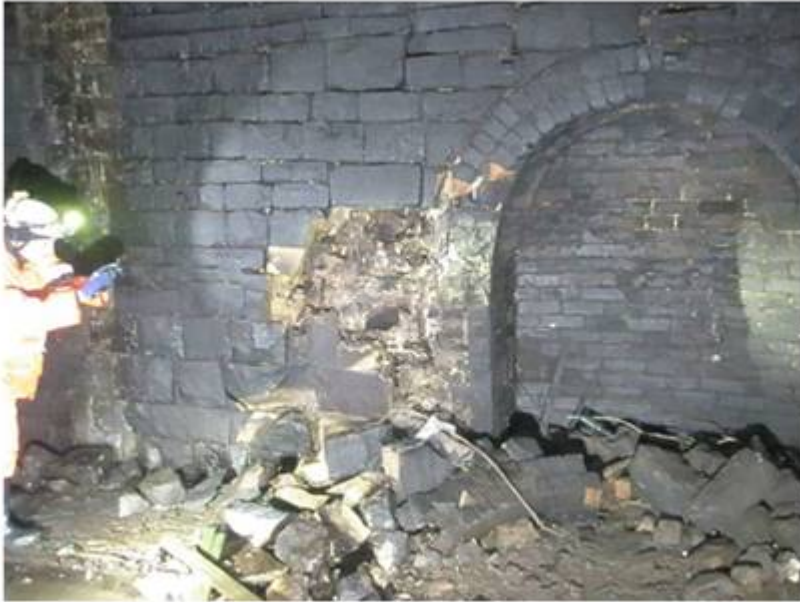
127+05 Refuge Up	Brickwork, collapsed, Sidewall on the upside bulged, approx. 1ft., area 20m.sq.
------------------	---

Photo No. 20: 127+05 Refuge Up, Brickwork, collapsed, Sidewall on the upside bulged, approx. 1ft., area 20m.sq.

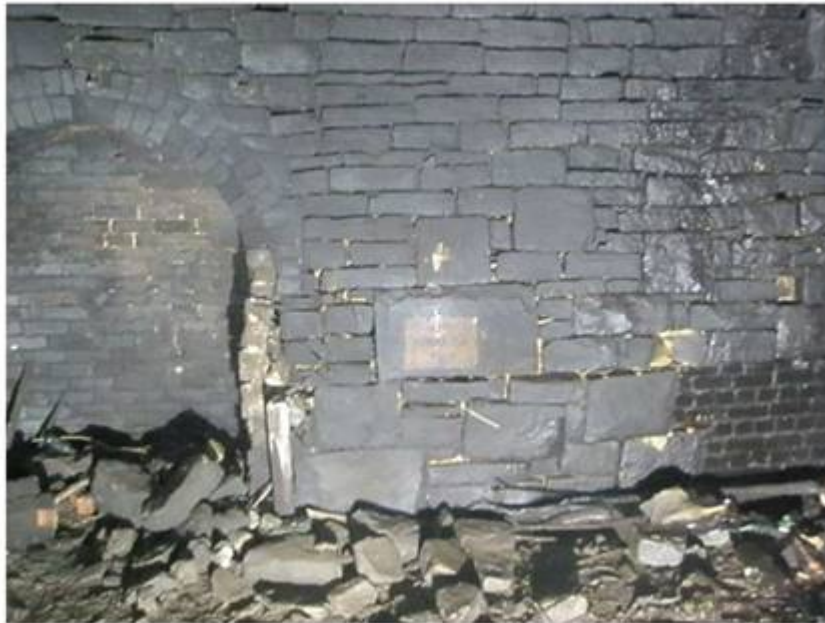
Photo No. 21: 127+05 Refuge Up, Brickwork, collapsed, Sidewall on the upside bulged, approx. 1ft., area 20m.sq.

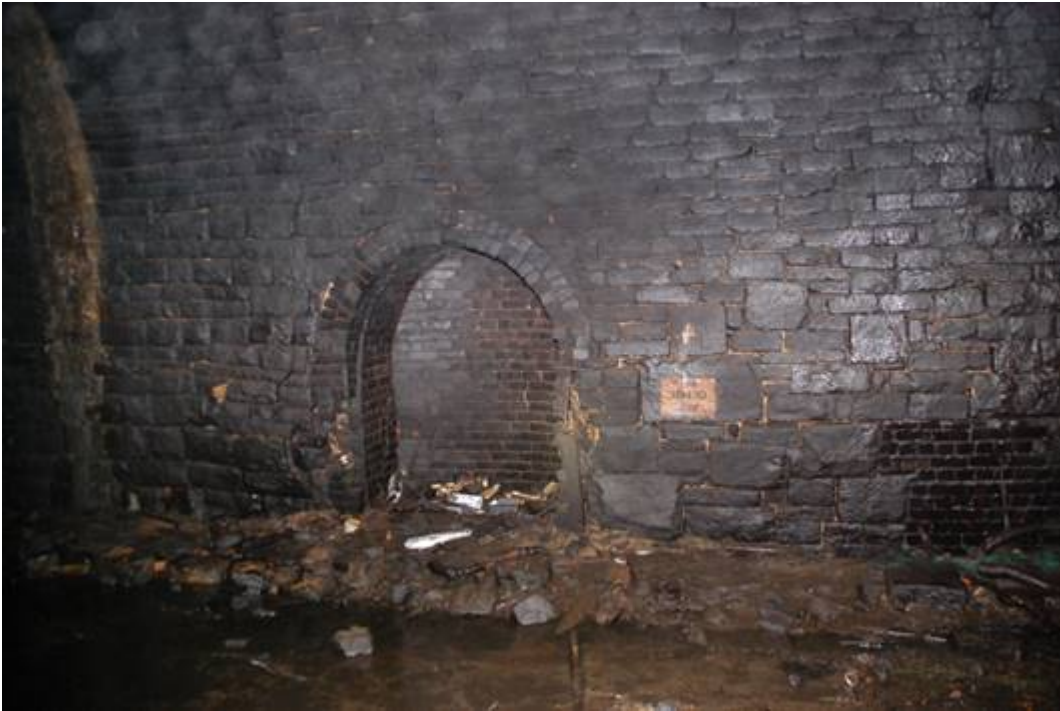
It is also worth noting that the above was already a significant deterioration since our inspection in July 2012, as shown in the photograph below.

Clearly the flood water is causing a relatively rapid deterioration of the tunnel lining. It is of particular concern at this location however, due to the proximity of the eye of Shaft No. 2.
