Our Ref: J105900 FI: 3
Your Ref: .
Date: 17/08/2016

MAJOR REFURBISHMENT ASBESTOS SURVEY
OF
BUILDING 375,
HMS DAEDALUS,
BROOM WAY,
LEE-ON-SOLENT,
HAMPSHIRE
ON BEHALF OF
HOMES & COMMUNITIES AGENCY

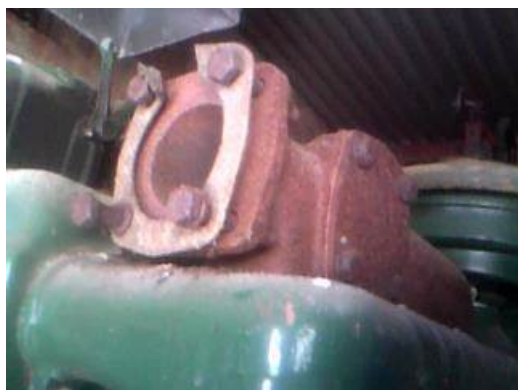
Sample 1: Building 375. Ground Floor. Internal.
Gasket to machinery

Sample No.	Sample Ref.	Location	Asbestos Detected	Asbestos Type
Sample 1	AB009360	Building 375, Ground Floor. G.01 Internal, Gasket to machinery	Yes	Chrysotile
Sample 2	AB009361	Building 375, Ground Floor. G.01 Internal, Textile wrap to pipes	No	
Sample 3	AB009362	Building 375, Ground Floor. G.01 Internal, Dust to floor	No

Sample No.	Location	Level of Identification	Product Type	Asbestos Type	Extent
Sample 1	Building 375, Ground Floor. G.01 Internal, Gasket to machinery	Identified	Gasket	Chrysotile	Small amounts

SAMPLE NUMBER	SAMPLE DESCRIPTION	PRODUCT TYPE	ACTION REQUIRED
Sample 1	Building 375. Ground Floor. G.01 Internal, Gasket to machinery	Gasket	Removal of licensed ACMs (Remove (licensed))

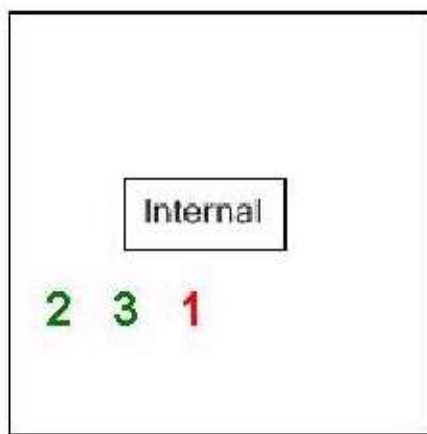
APPENDIX 5 - Marked Plans

Key: 1 Asbestos identified
1 No asbestos identified
