Elephant and Castle Northern Roundabout Improvement Scheme

Stage 2 Road Safety Audit

Ref: 2209/008/A3/TLRN/2015

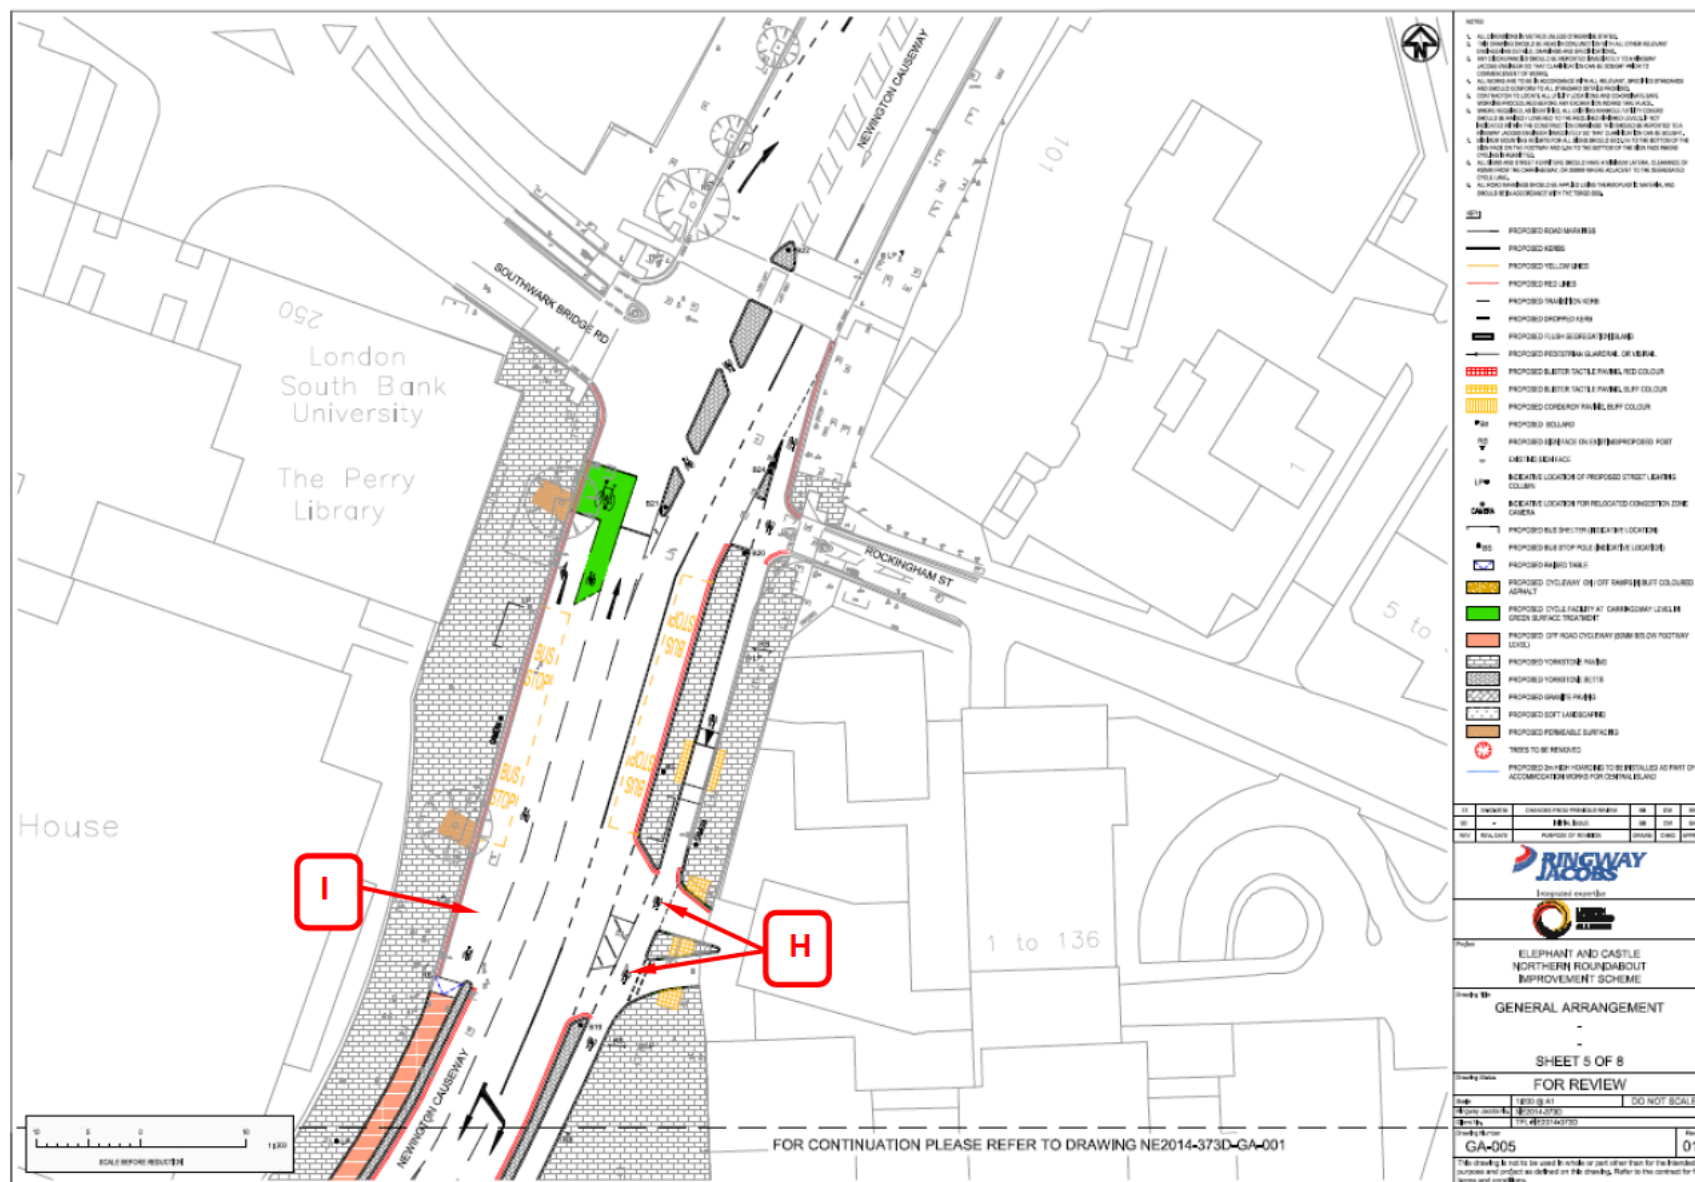
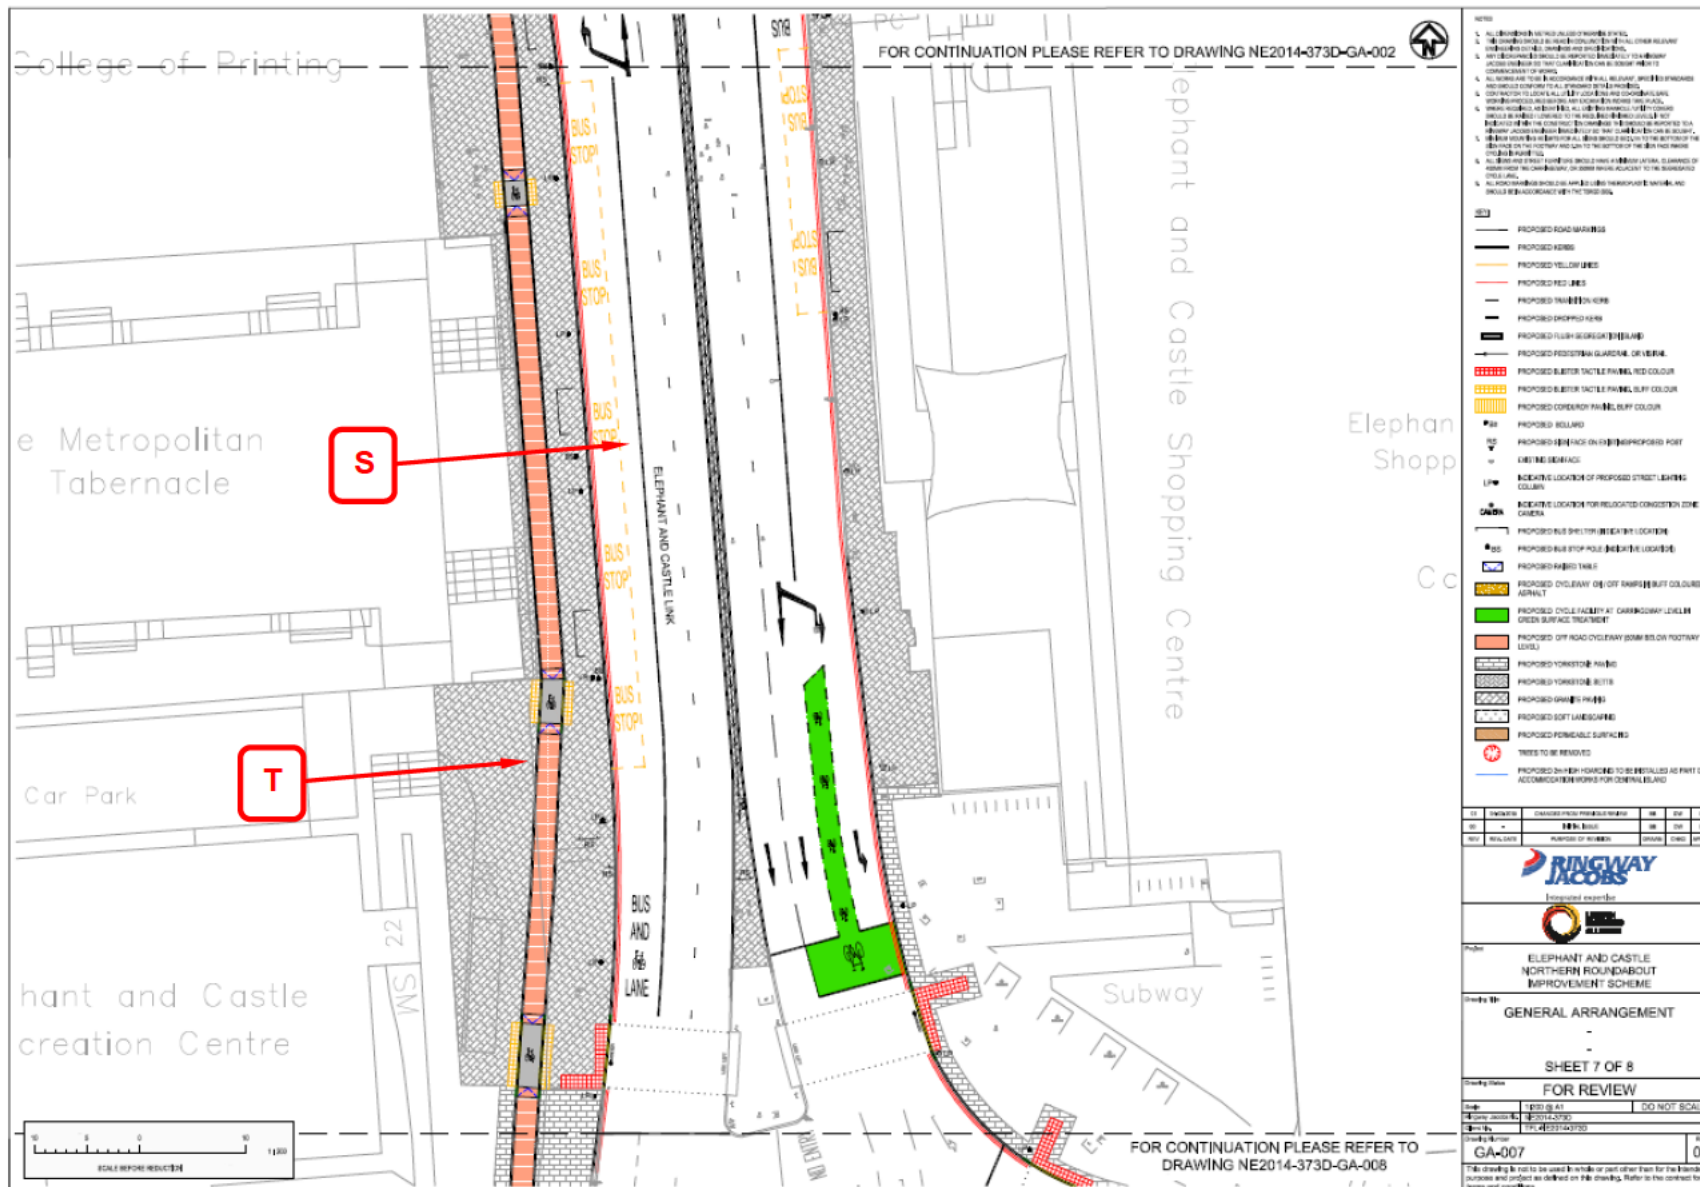
Problem Locations

Location: A – London Road junction with proposed Peninsular

Location: B – London Road junction with proposed Peninsular

Location: C – London Road junction with proposed Peninsular

Location: D – Exit from proposed Peninsular into Newington Causeway.

Location: E – Newington Causeway northeast bound approach to segregated cycle lane.

Location: F – Pedestrian crossing facility across Newington Causeway

Location: G – Newington Causeway approach to proposed Peninsular.

Location: H – Newington Causeway access south of Rockingham Street.

Location: I – Newington Causeway, northern extent of northbound segregated cycle lane.

Location: J – Newington Causeway j/w with Elephant and Castle Peninsular

Location: K – Anti-clockwise peninsular lanes between Newington Causeway and London Road.
