Toddbrook Reservoir

Inspection Report under Section 10 of the
Reservoirs Act 1975 (Amended)

April 2019
Confidential

Document reference: 381715 | CR02 | 01

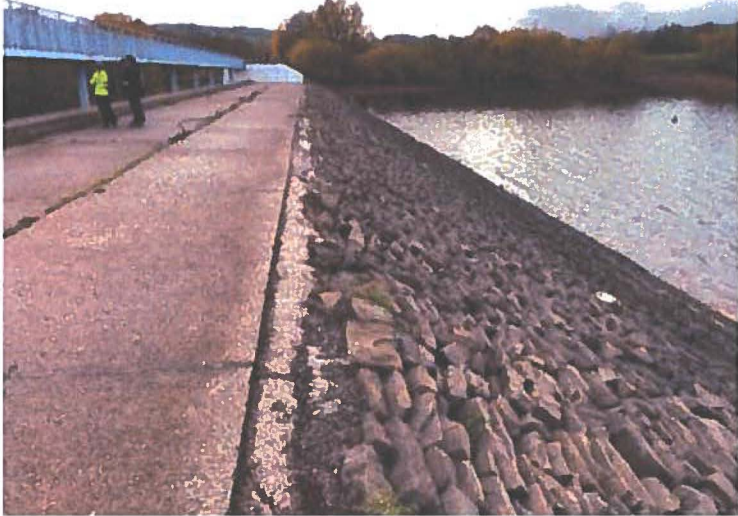
<p>5 – Upstream pitching</p> <p>[REDACTED]</p> <p>[REDACTED]</p>

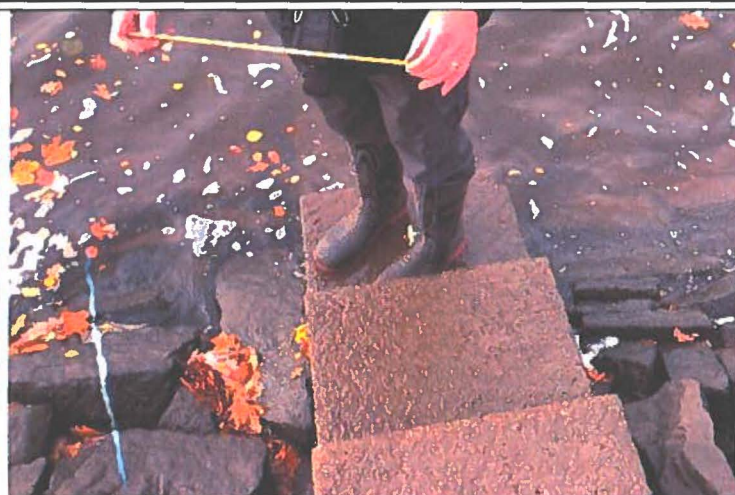
8 – Depth marker steps

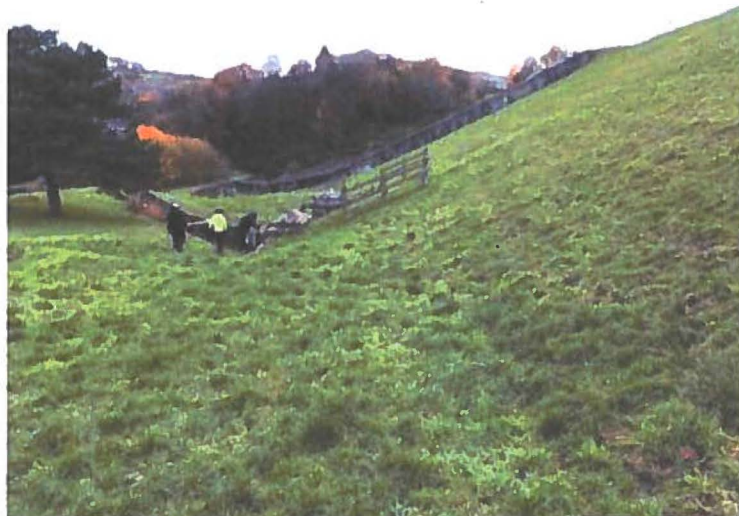
61 – Embankment toe
