Freedom of Information Request – Detailed Examination Reports for HRE Tunnels

Detailed Examination Report for

Balfour Beatty Rail, Manchester**Monks Ferry Tunnel****ELR:CCS3/01****Examined:03/10/2019**

Balfour Beatty Rail, Manchester**Law Tunnel****ELR:DDN/12A****Examined:07/10/2019**

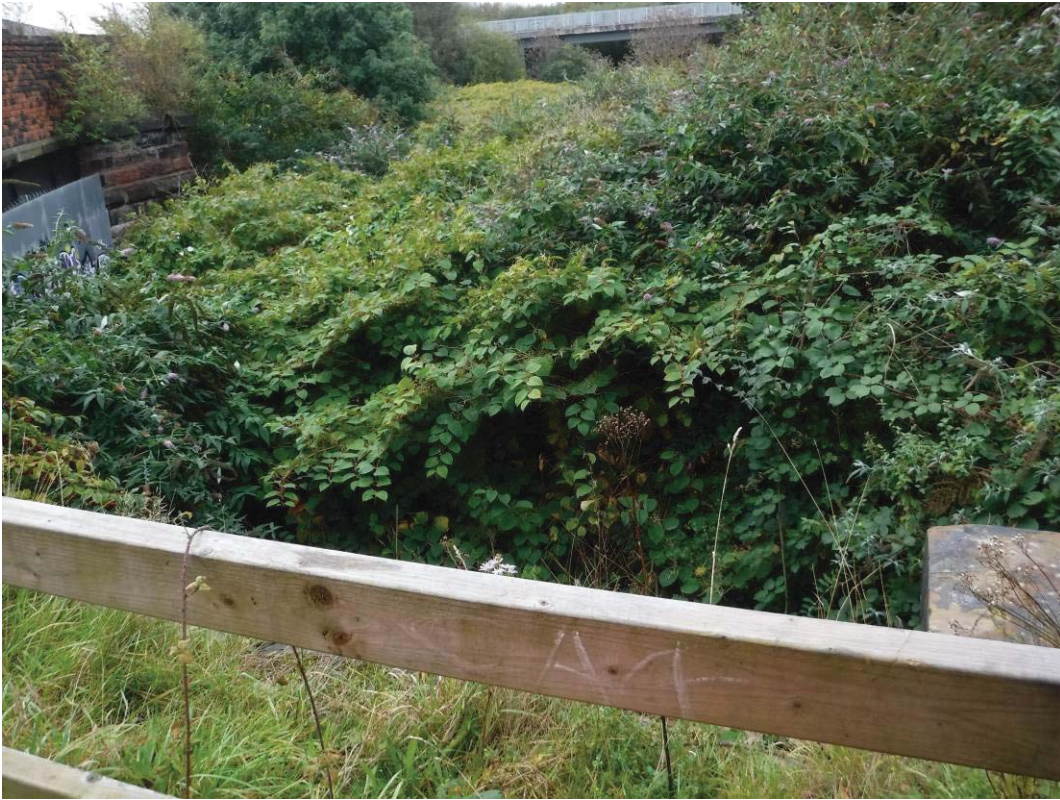
| Location | Defect | | Action |
|---|---|---|--|
| 000+00 Portal Up & Down | Rock Ferry Portal, view of solum approach overgrown with a forest of Japanese Knotweed. Access to tunnel difficult. | 1 | Recommend clear solum approach adjacent to portal, Priority 1, work to be completed 03/10/2020. |

**Photo No.1: Rock Ferry Portal, view of solum approach overgrown with a forest of Japanese Knotweed.
Access to tunnel difficult.**

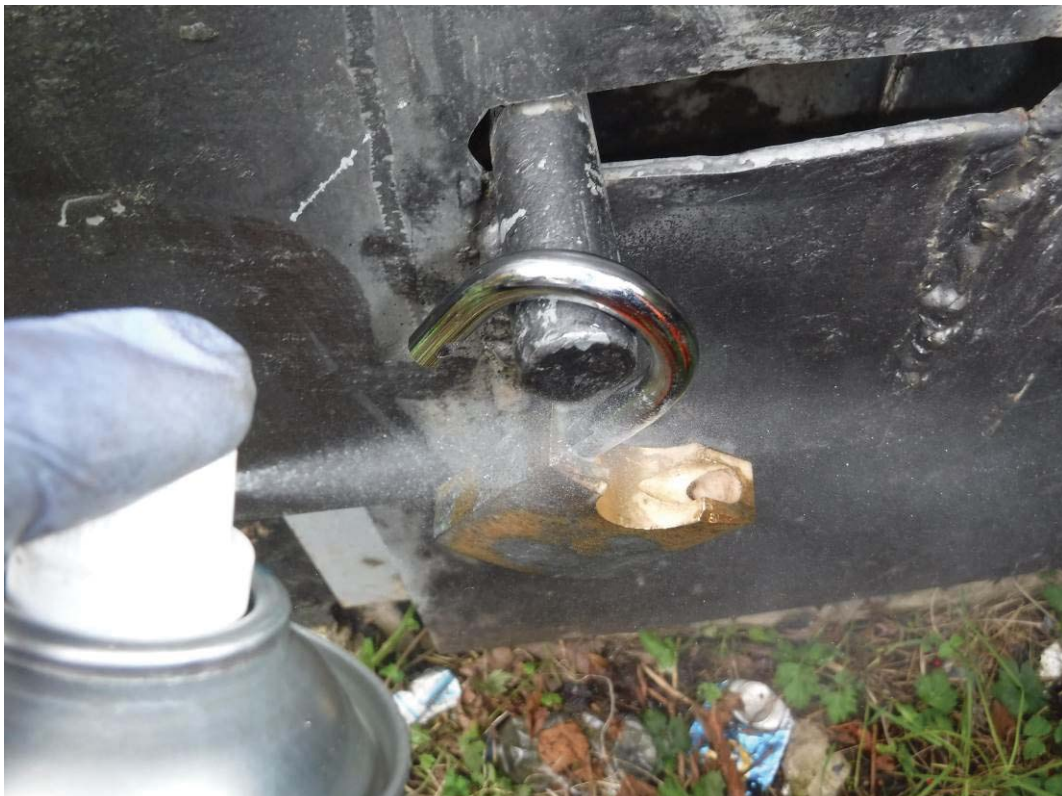
Photo No.6: 000+00 Portal Up & Down, Rock Ferry Portal, new padlock fitted to gate at this examination, oiling new padlock.

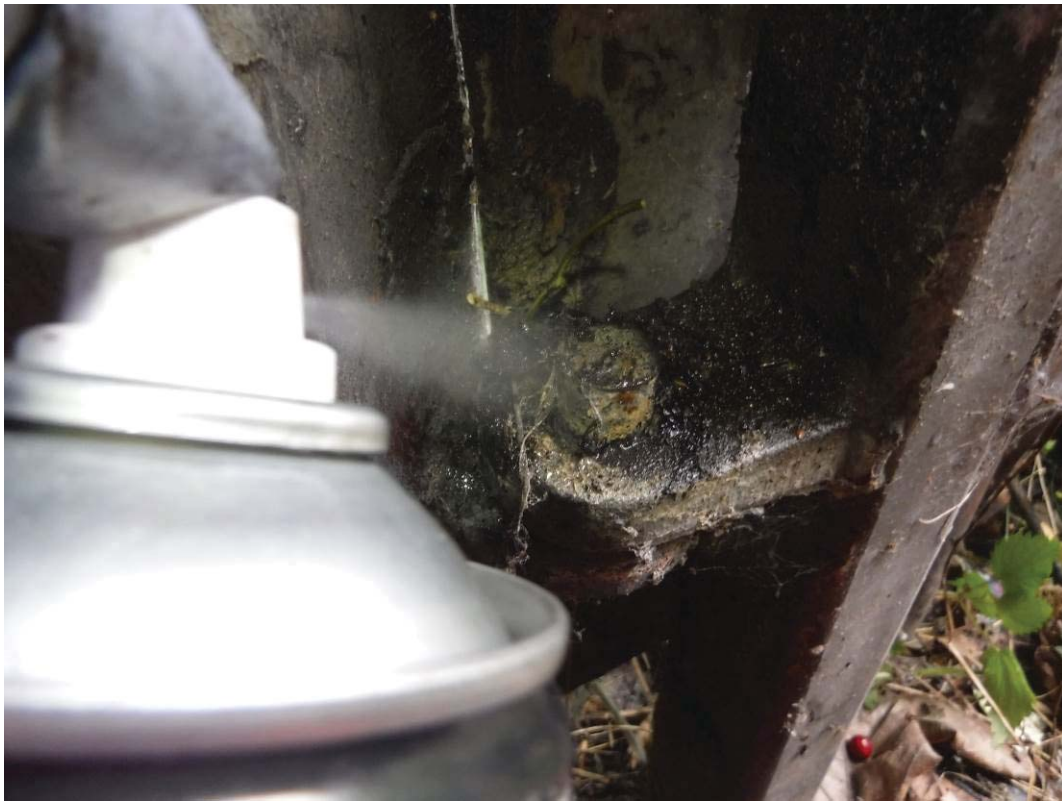
Photo No.7: 000+00 Portal Up & Down, Rock Ferry Portal, oiling gate hinges.

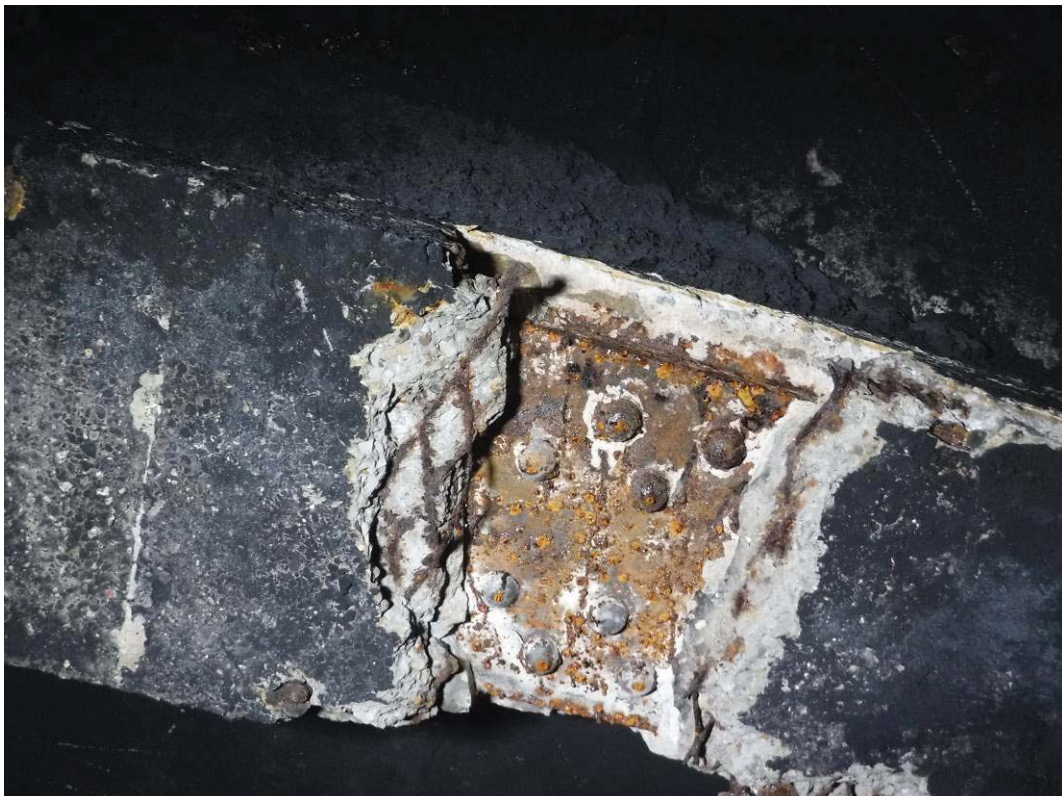
| Location | Defect | | Action |
|---|---|---|--|
| 000+00 to 003+10 Deck Up & Down | Brickwork, bridge extension to tunnel, concrete encased iron beams and brick jack arches at c.7ft. centres (view of scabbled-off window / investigation). | 8 | Recommend check and/or assess capacity of bridge on the basis of current condition and vehicle loadings above, Priority 1, work to be completed by 03/10/2020. |

Photo No.8: 000+00 to 003+10 Deck Up & Down, Brickwork, bridge extension to tunnel, concrete encased iron beams and brick jack arches at c.7ft. centres (view of scabbled-off window / investigation).

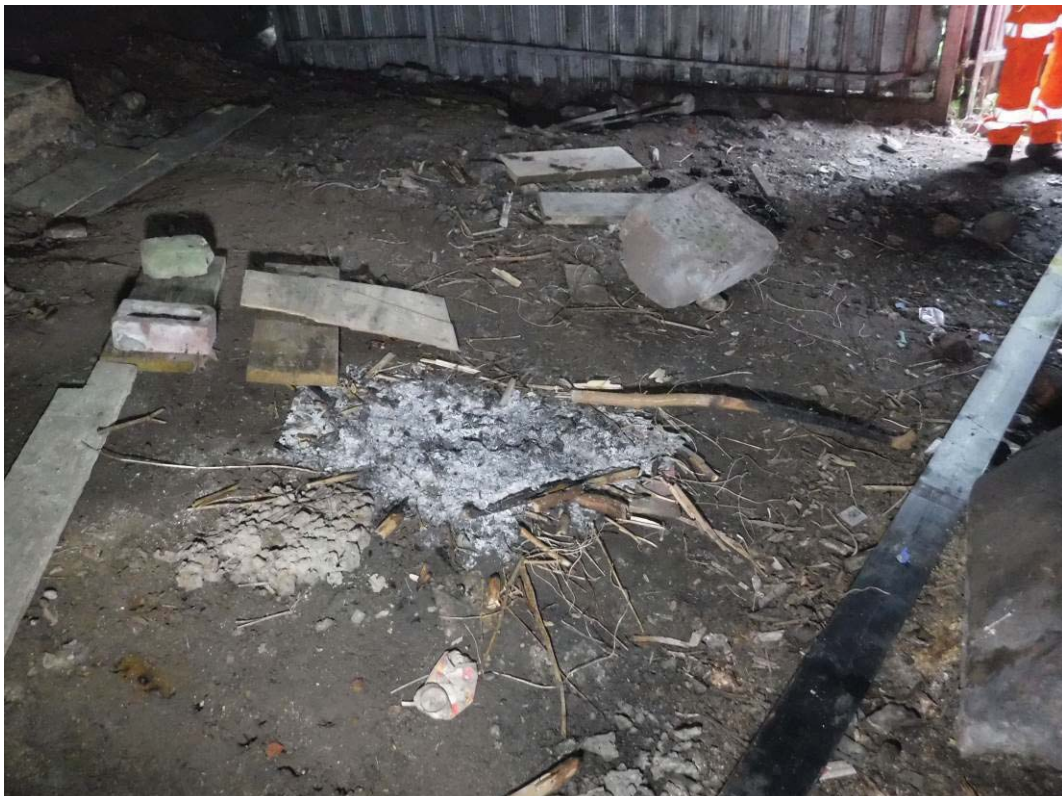
| Location | Defect | | Action |
|---|---|---|--|
| 000+00 to 012+15 Solum Up & Down | Debris, fly-tipping & fires throughout. | 9, 10 & 11 | Recommend remove all debris, Priority 1, work to be completed by 03/10/2020. |

Photo No.10: 000+00 to 012+15 Solum Up & Down, Debris, fly-tipping & fires throughout.

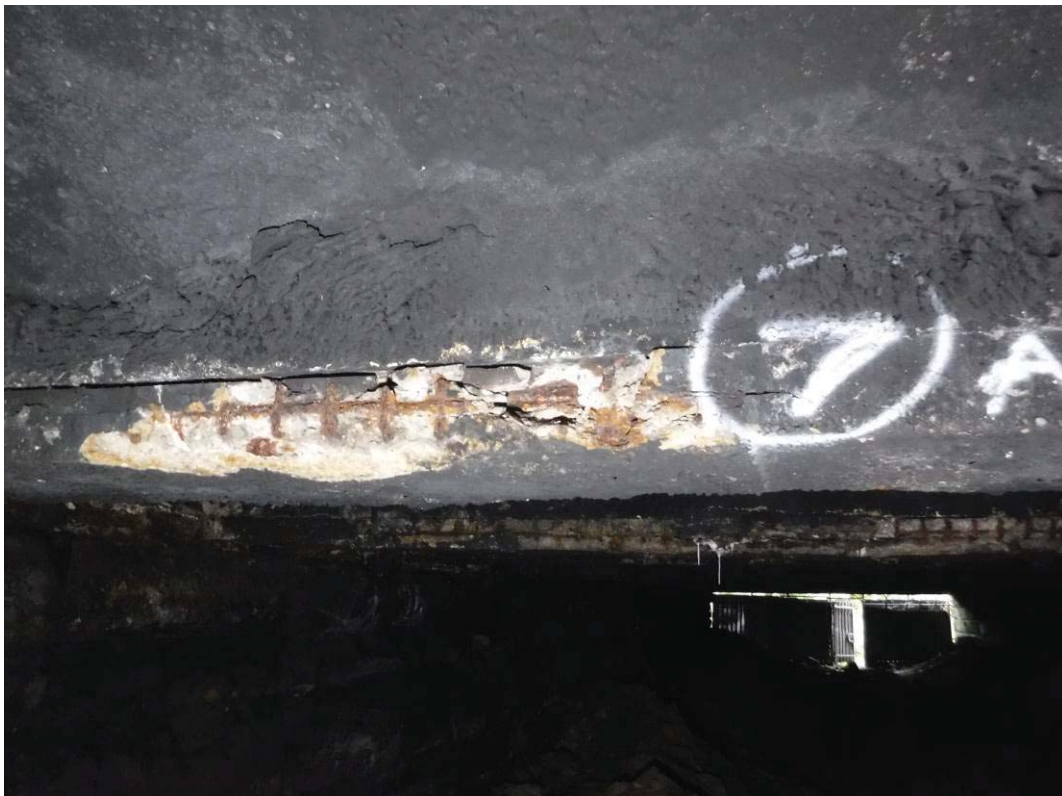
| Location | Defect | | Action |
|---|---|---|--|
| 001+14 Deck Up & Down | Concrete beam burst to the Rock Ferry side, re-bar showing, hollow, depth 50mm, area 6sq.m., medium. | 14 | Recommend repair concrete beam, Priority 1, work to be completed 03/10/2020. |

Photo No.14: 001+14 Deck Up & Down, Concrete beam burst to the Rock Ferry side, re-bar showing, hollow, depth 50mm, area 6sq.m., medium.

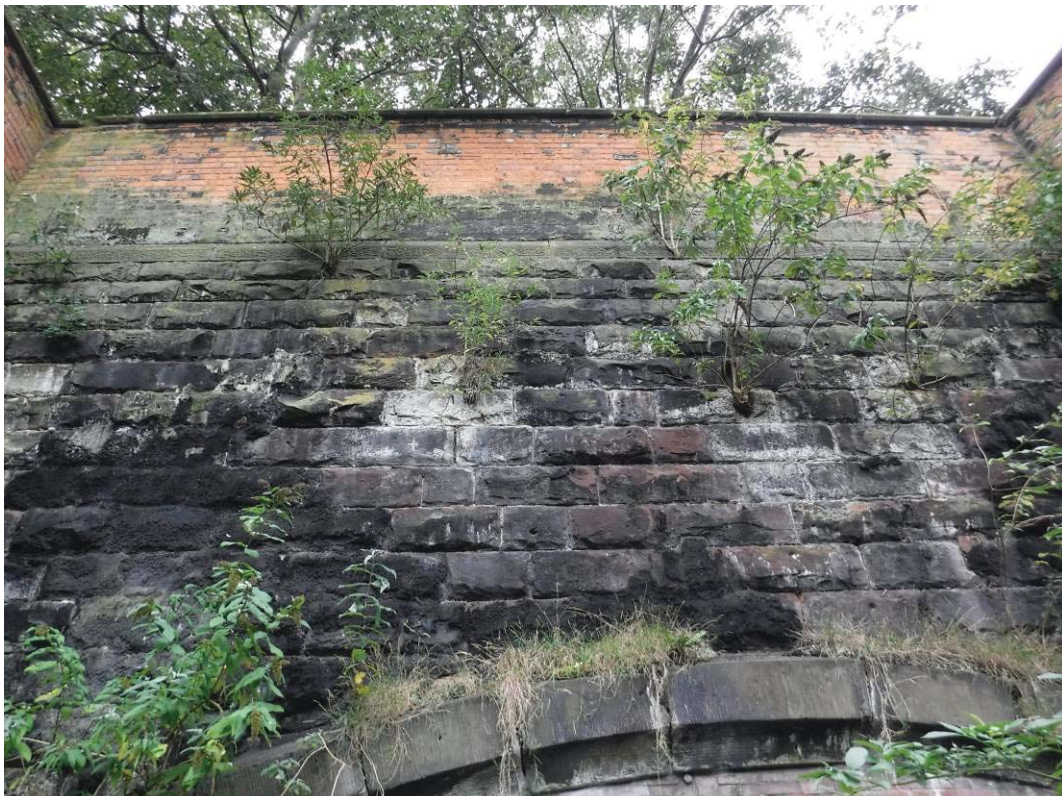
Photo No.20: 025+06 Portal Up & Down, Woodside Portal, vegetation growth to spandrel, area 20sq.m., light.

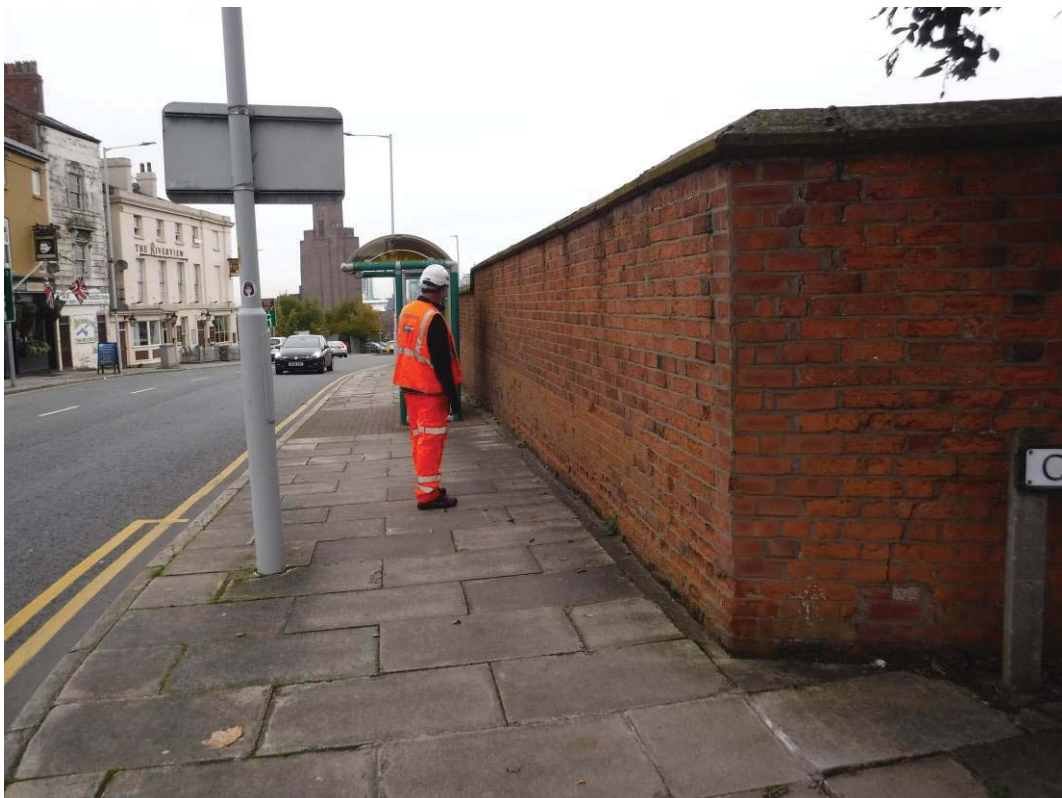
Photo No.22: 025+06 Portal Down, Woodside Portal, side bridge supporting 8m length of footpath above.

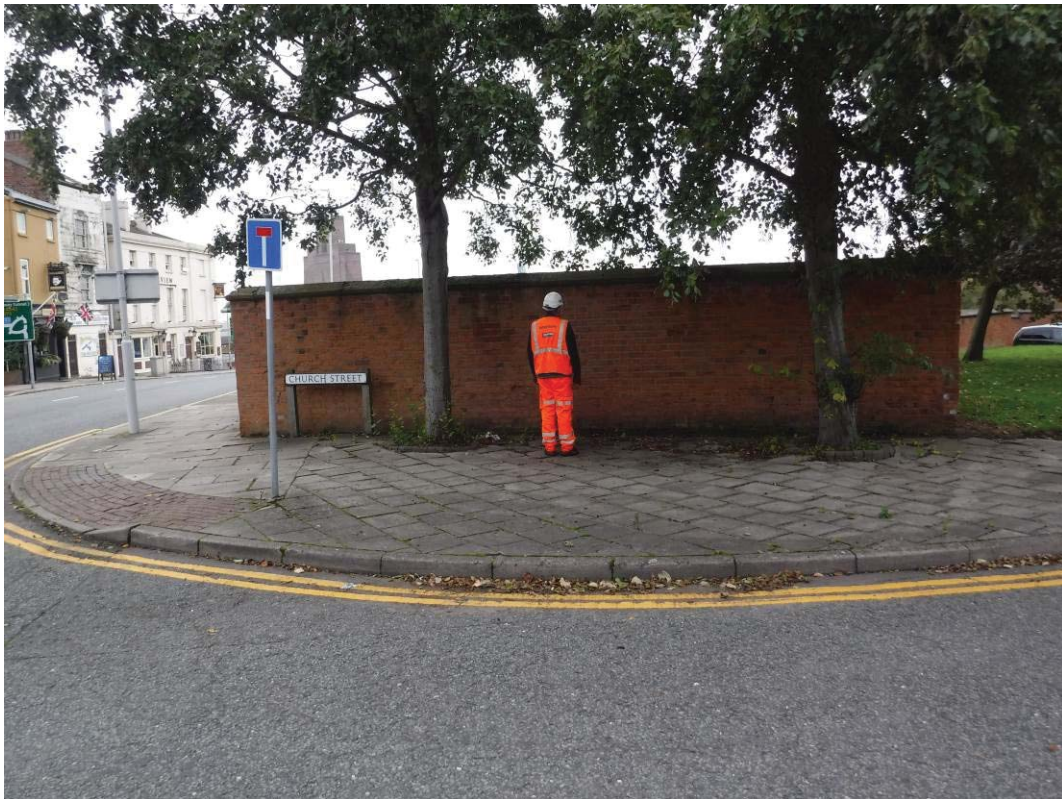
Photo No.23: 025+06 Portal Up & Down, Woodside Portal, Brickwork, roadside parapet.

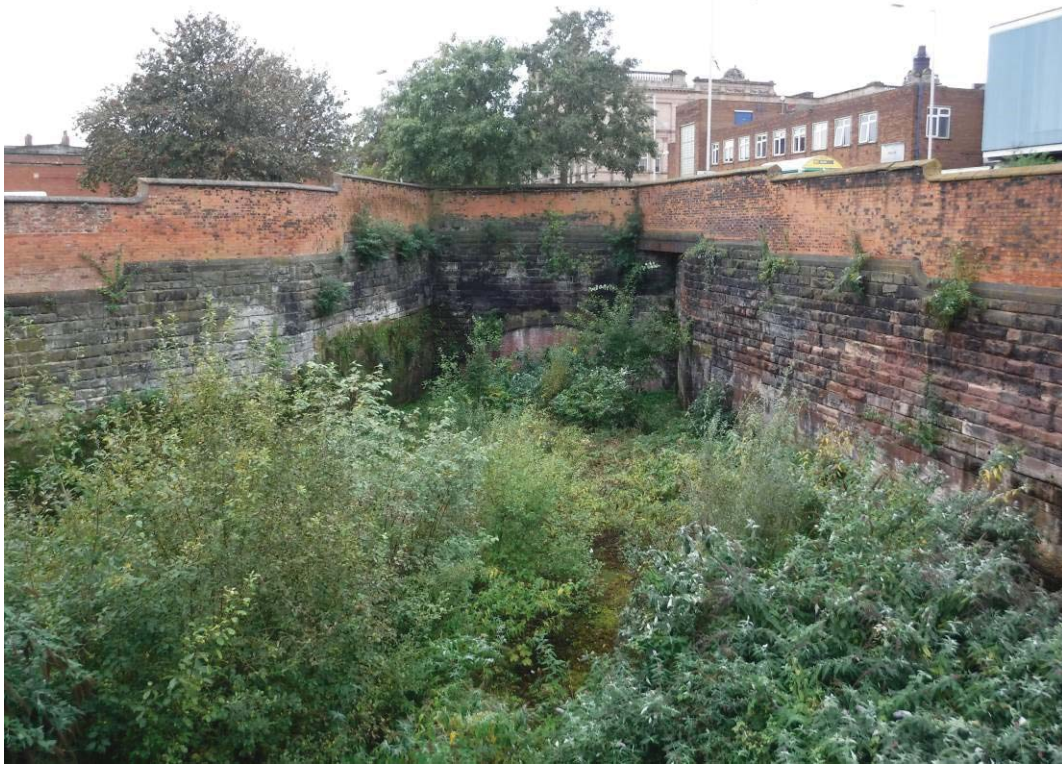
Photo No.27: 025+06 Portal Up & Down, Woodside Portal, view of approach overgrown with vegetation, shrubs & saplings.

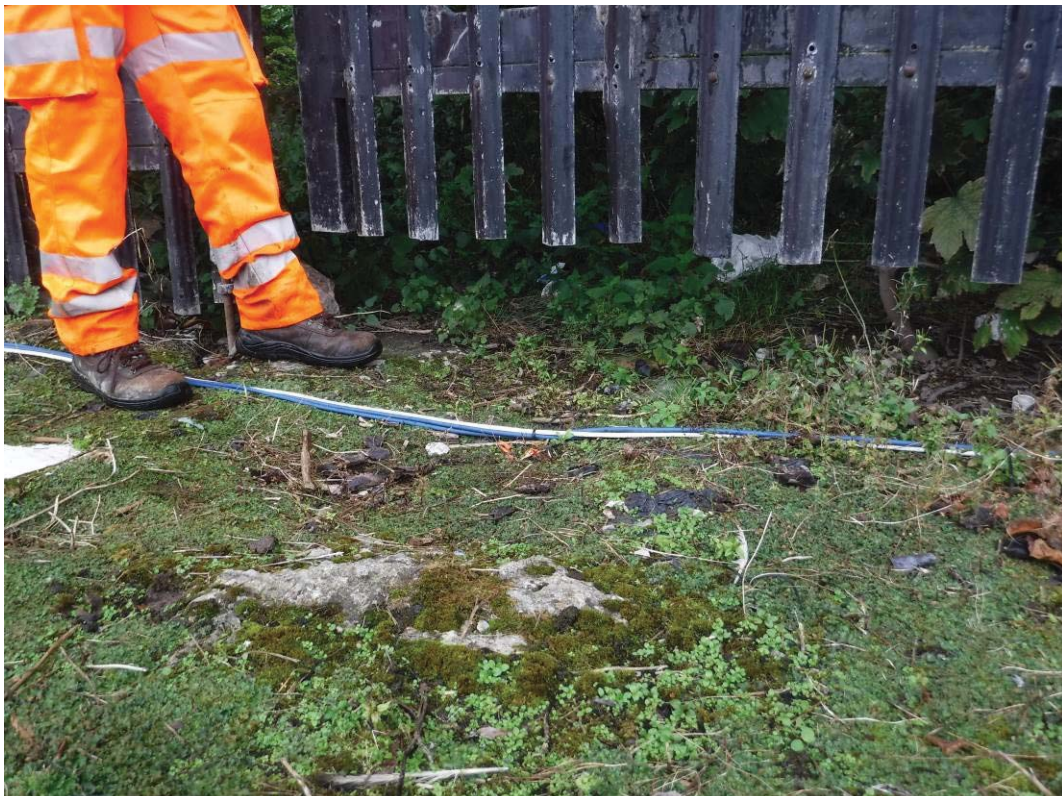
Photo No.28: 025+06 Portal Up & Down, Woodside Portal, evidence of trespass under gates at Bridge No.62.

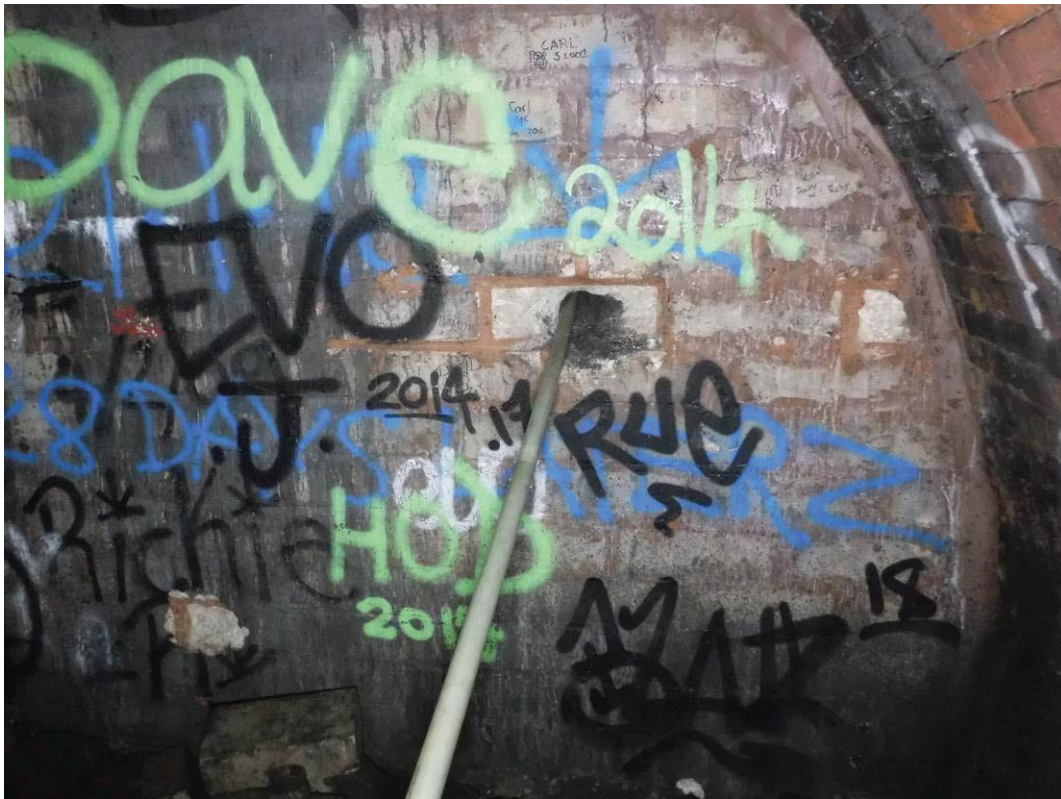
Photo No.1: 000+00 Infill wall, Infill wall, hole dug into blockwork by 3rd party, further enlarged, now 200mm² x 700mm deep.

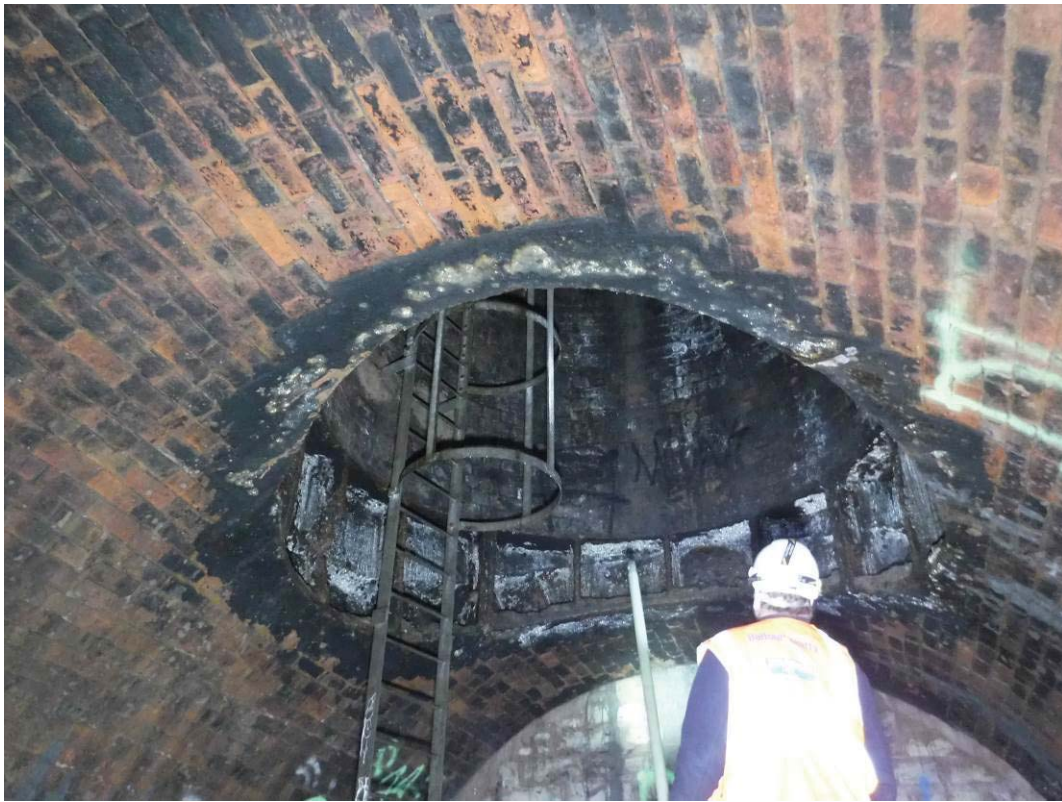
Photo No.3: 000+02 Crown & Haunch Up & Down, Shaft eye.

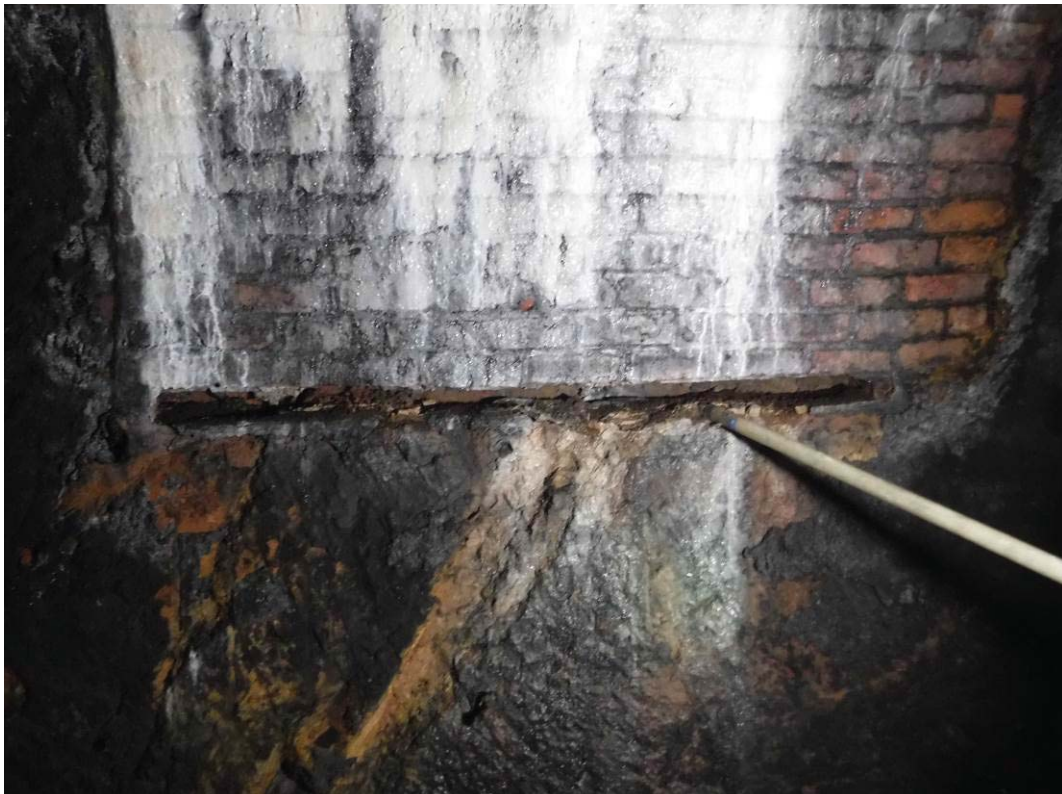
Photo No.4: 000+17 Haunch Down, Rotten timber lintel, brickwork above lintel is hollow, area 2sq.m., medium.

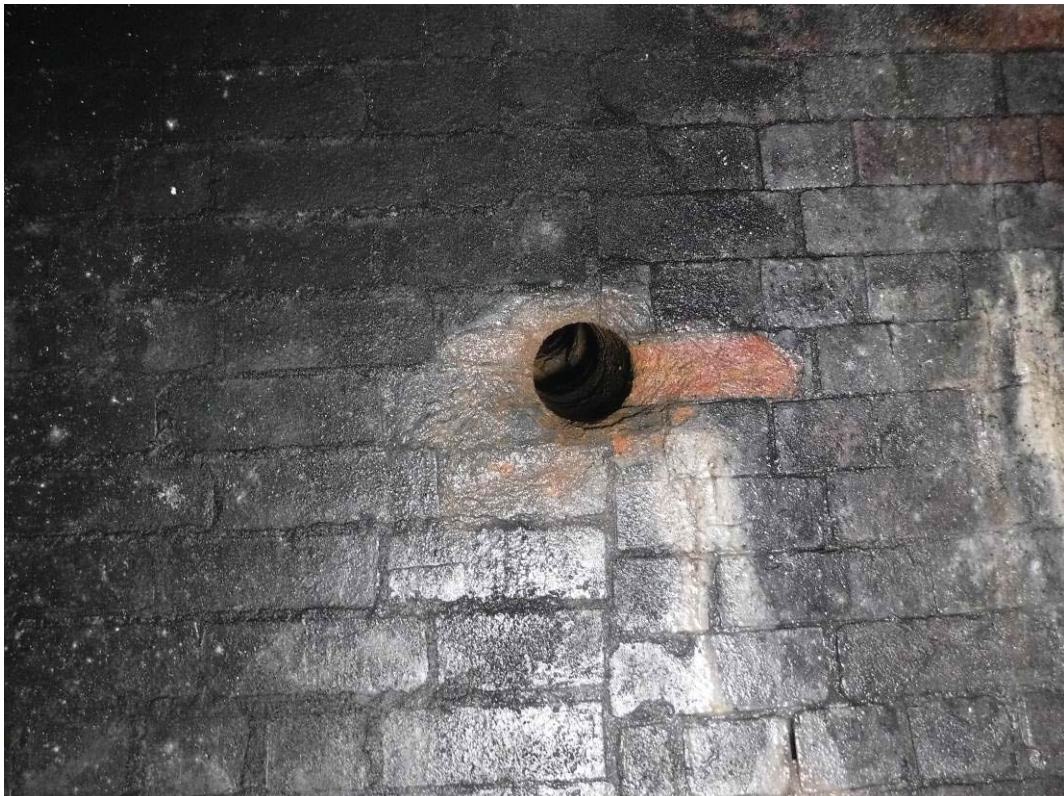
Photo No.6: 004+14 Crown Down, Brickwork, new 3rd party borehole, 5" dia.

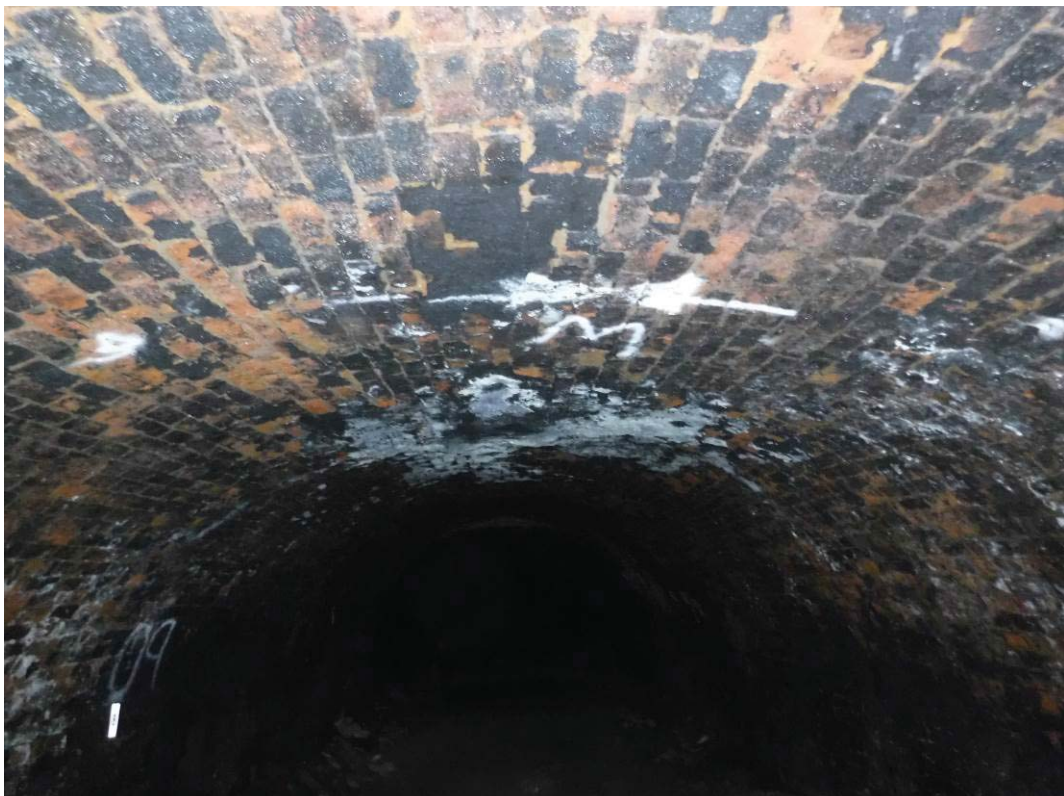
Photo No.10: 007+19 Crown Up & Down, Brickwork, flat/bulge, damp, hollow, area 4sq.m.

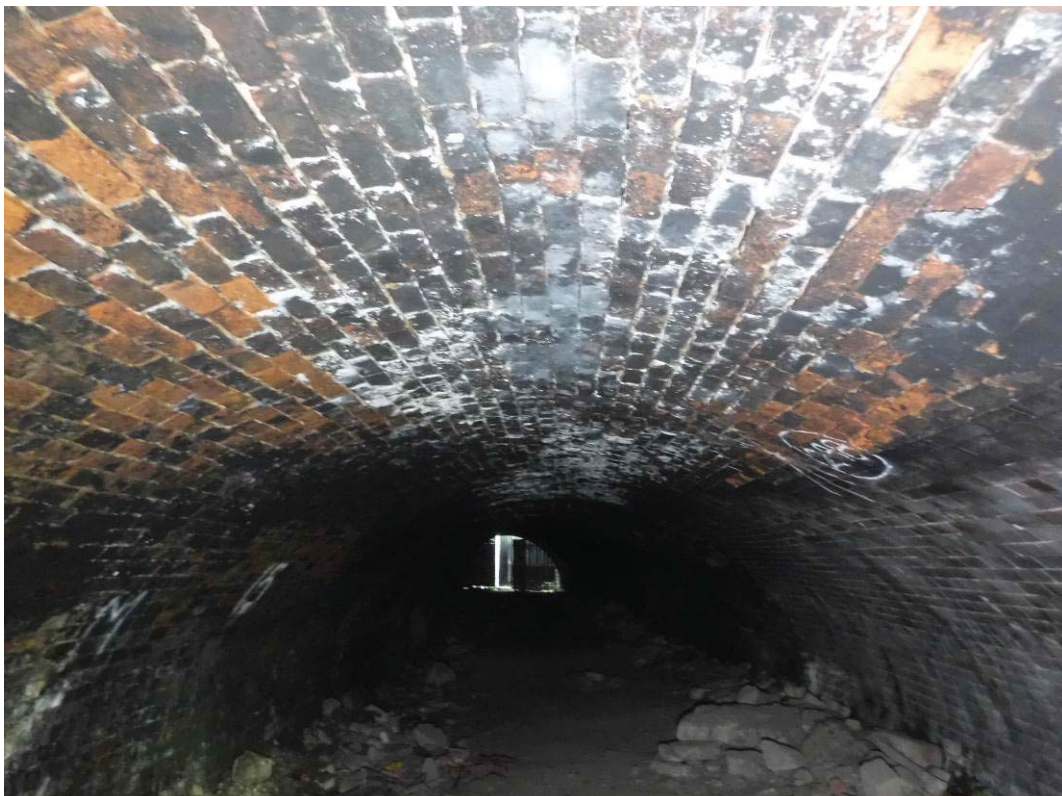
Photo No.12: 014+00 High Haunch Down, Brickwork, flat, length 4m.

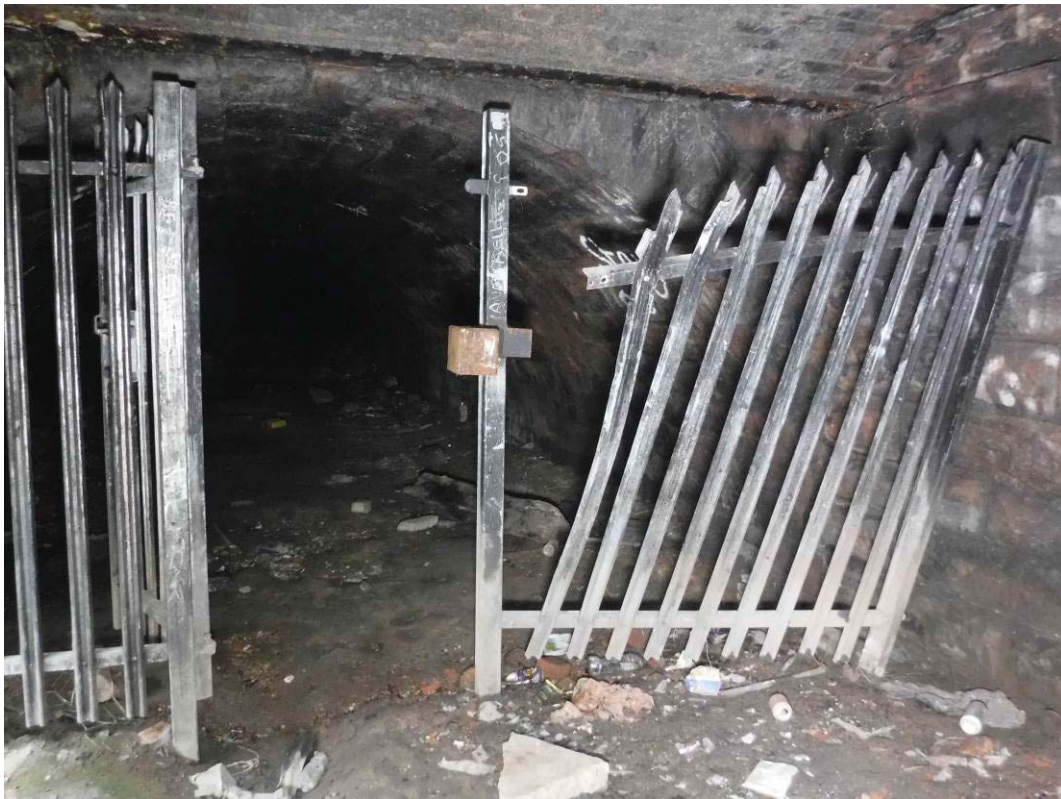
Photo No.13: 015+15 Portal Up & Down, Green Lane Portal, Internal former security fencing (redundant) vandalised / part collapsed. Sharp edges to ends.

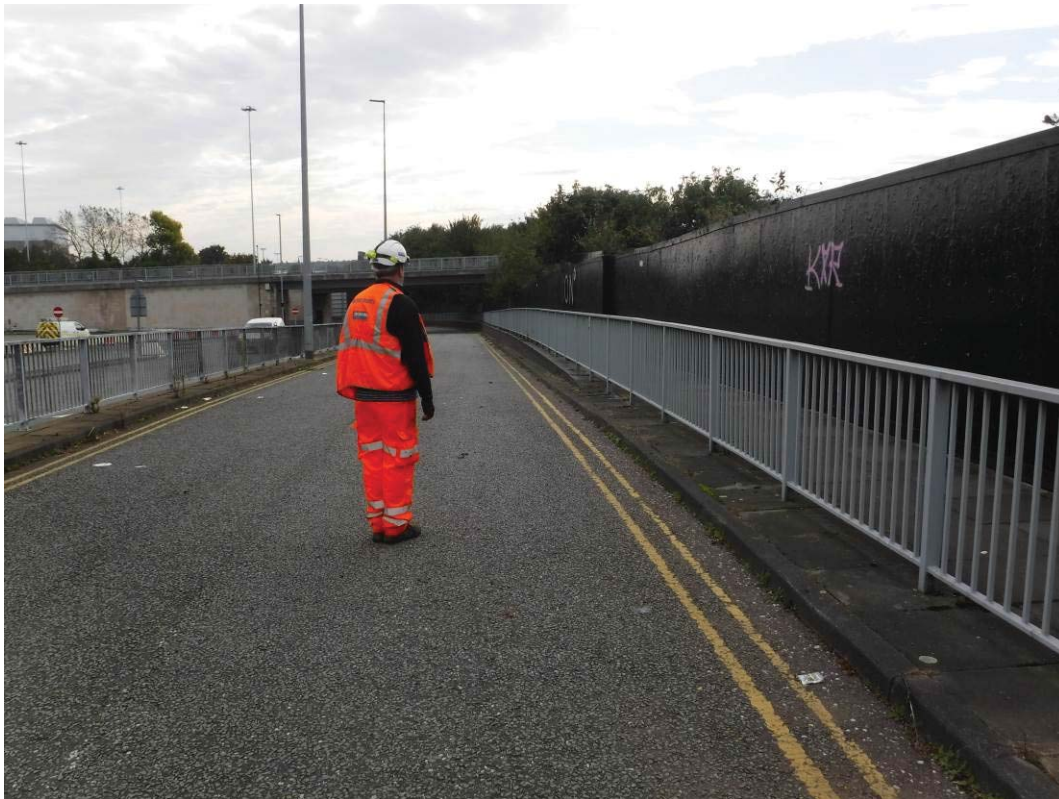
Photo No.15: 015+15 to 016+03 Crown Up & Down, Bridge deck in front of portal, triangular in plan, c.10yds long x c.5yds wide, carries road & footpath above.

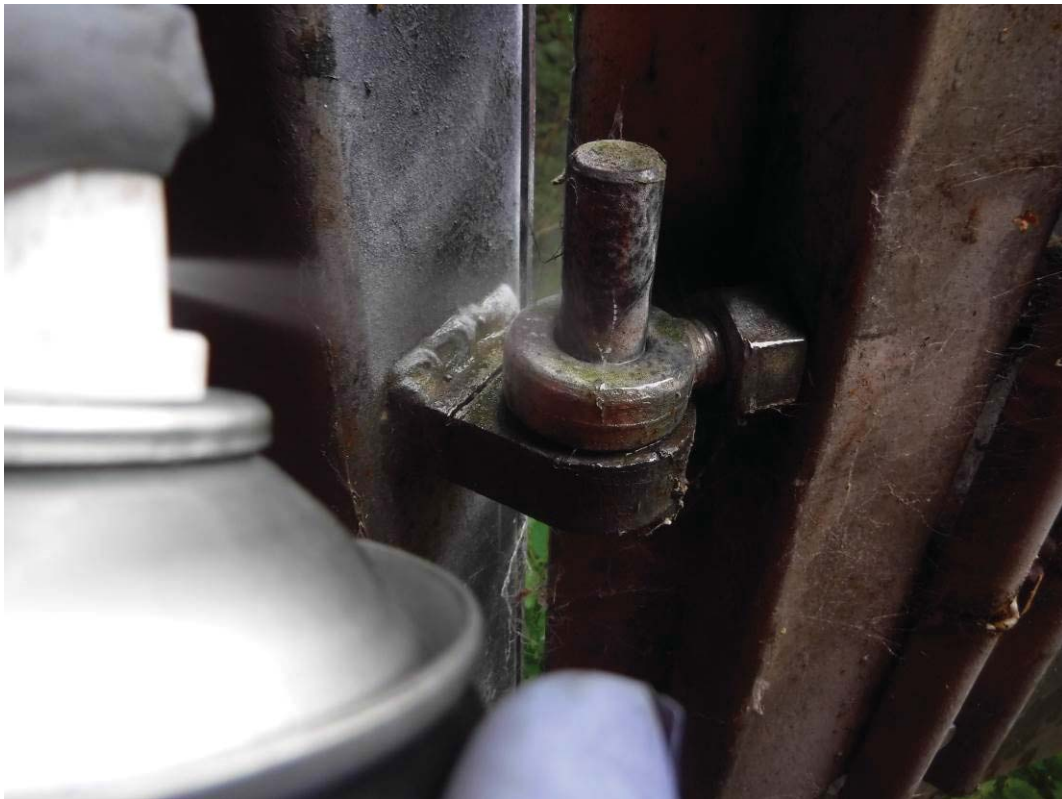
Photo No.19: Bridge deck in front of portal, oiling gate hinges.

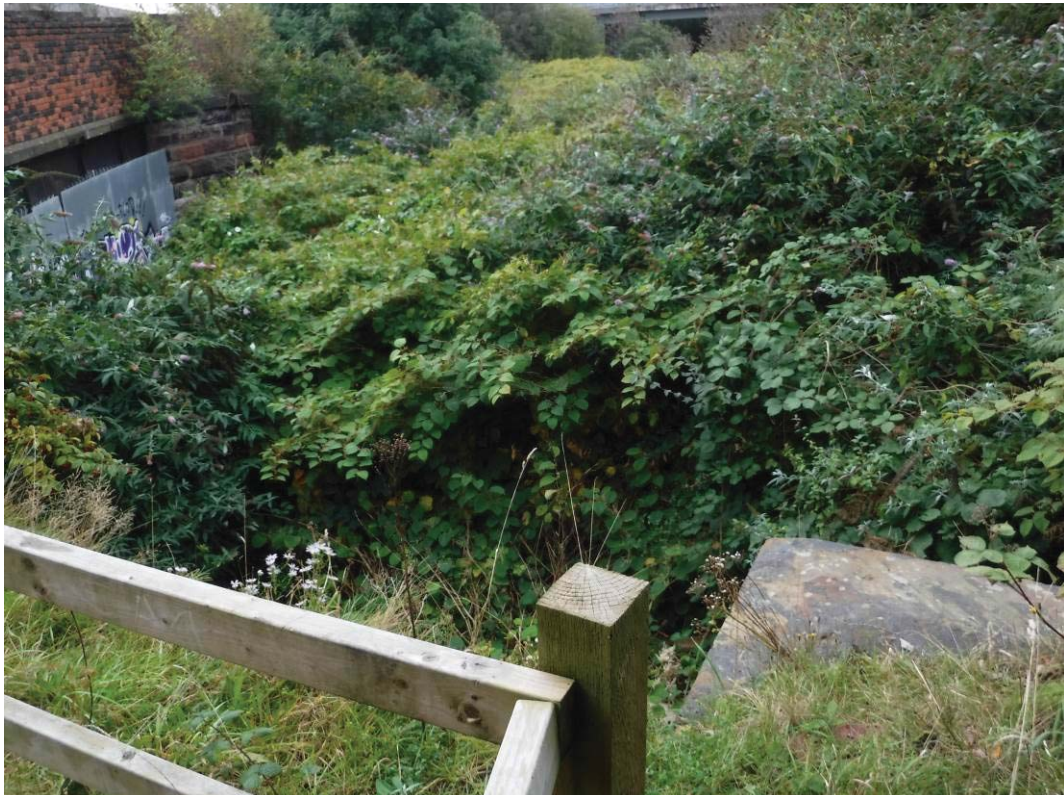
Photo No.22: Green Lane Portal, view of solum approach overgrown with a forest of Japanese Knotweed. Access to tunnel difficult.

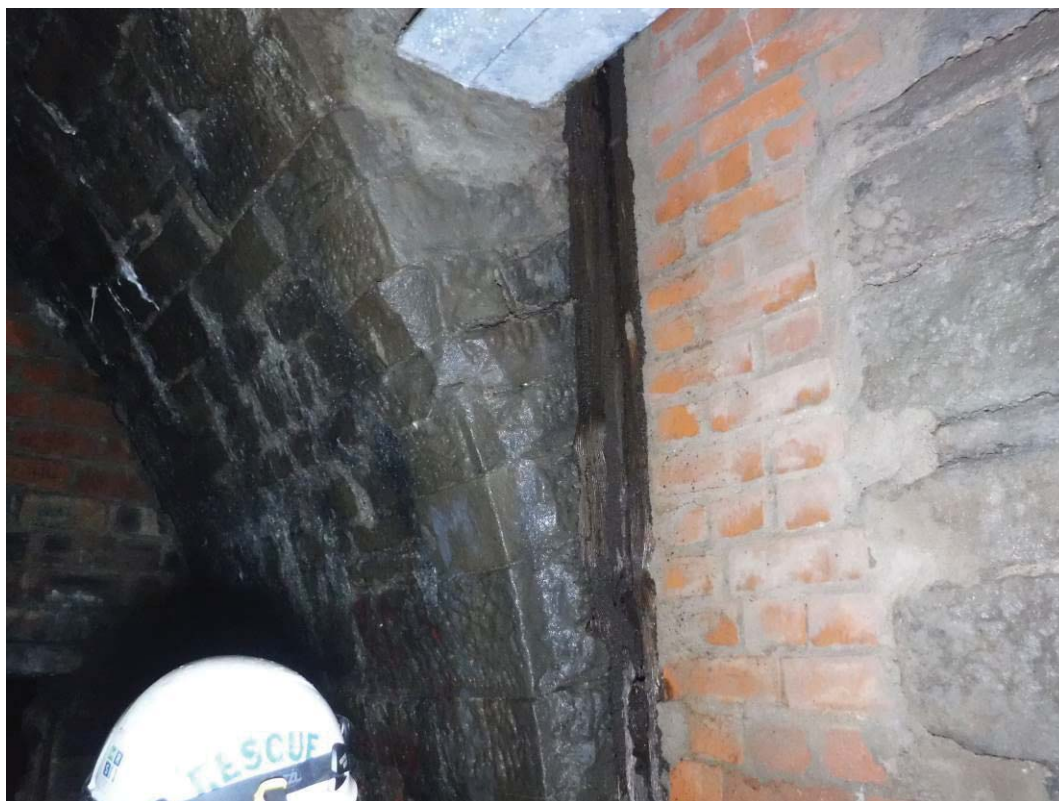
Photo No.7: Dundee Portal, Stonework, a small section of the portal can still be seen adjacent to the manhole shaft bottom.

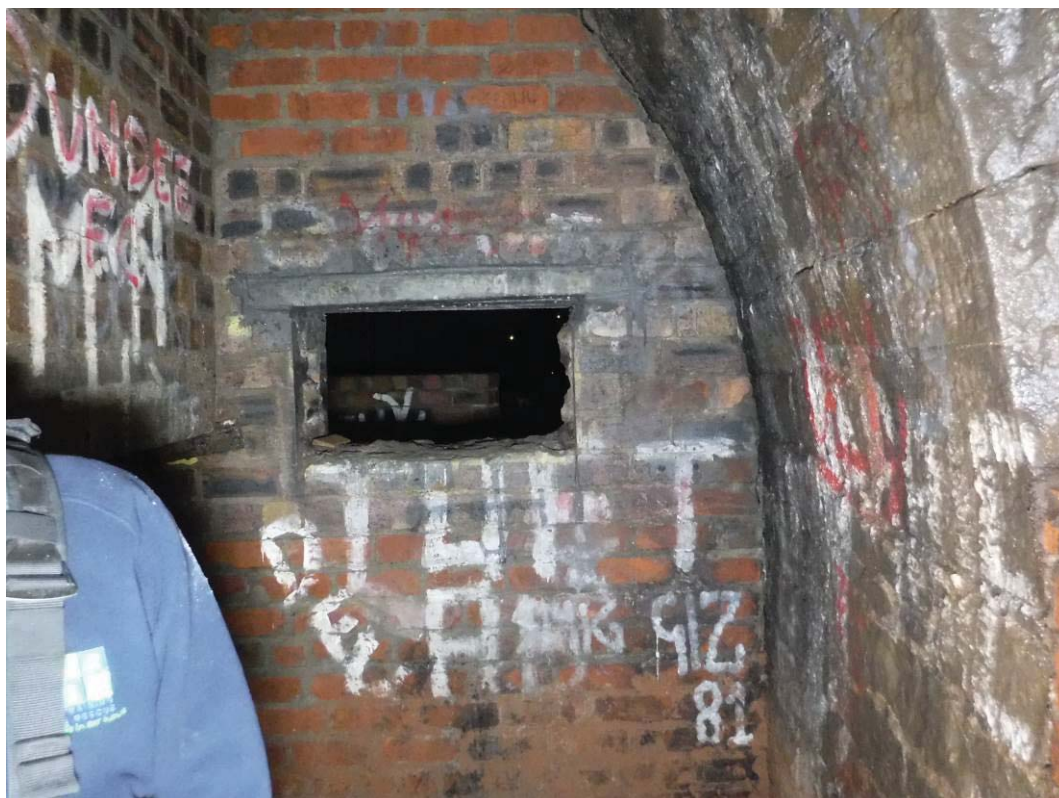
Photo No.8: New brickwork wall to base of manhole on entry to tunnel.

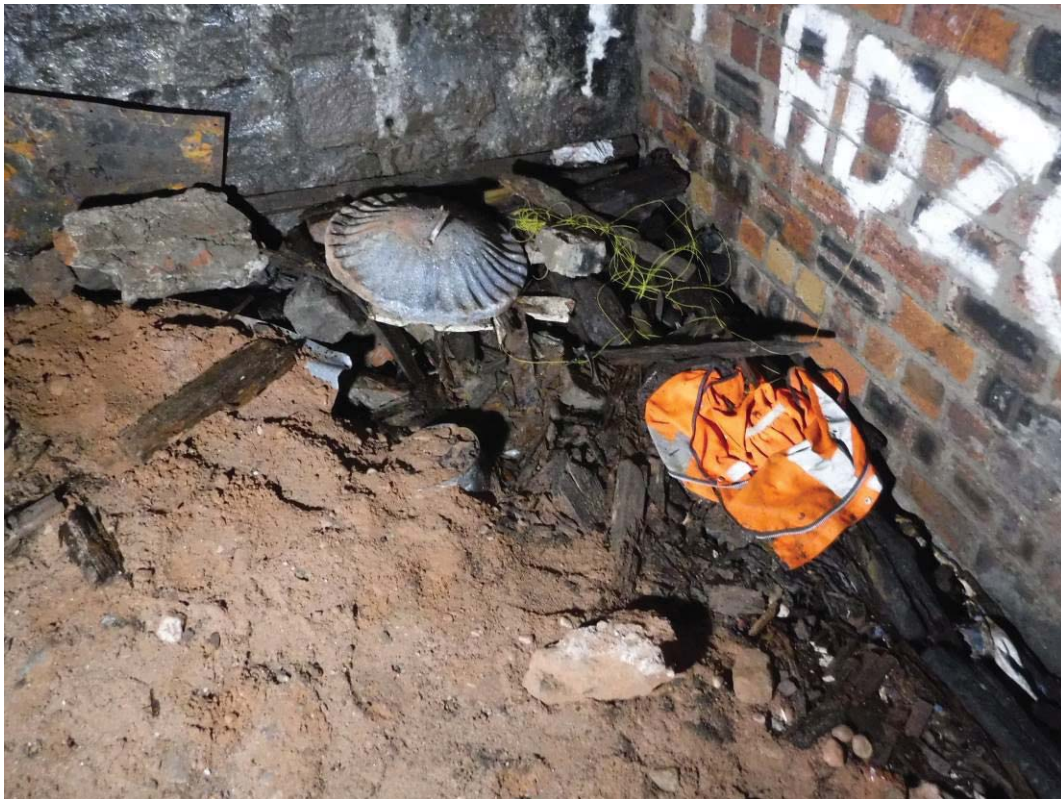
Photo No.13: Rubbish and fly-tipping laid to solum.

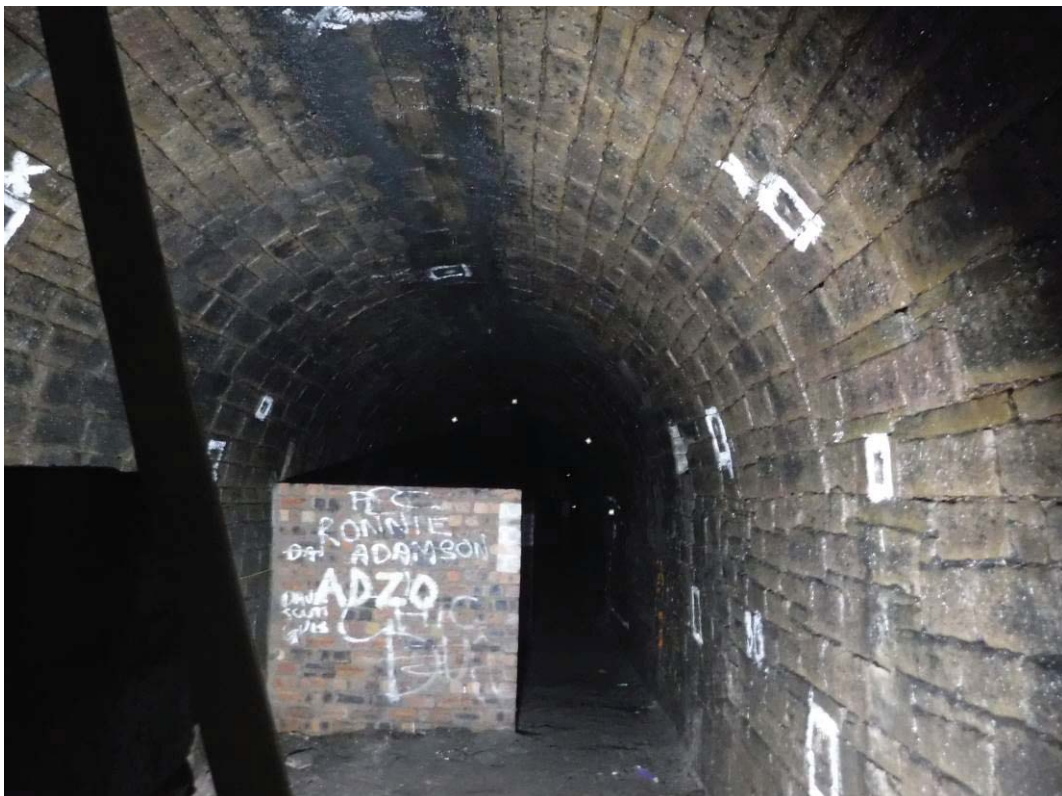
Photo No.18: View along tunnel looking northwards, prism array to lining throughout.

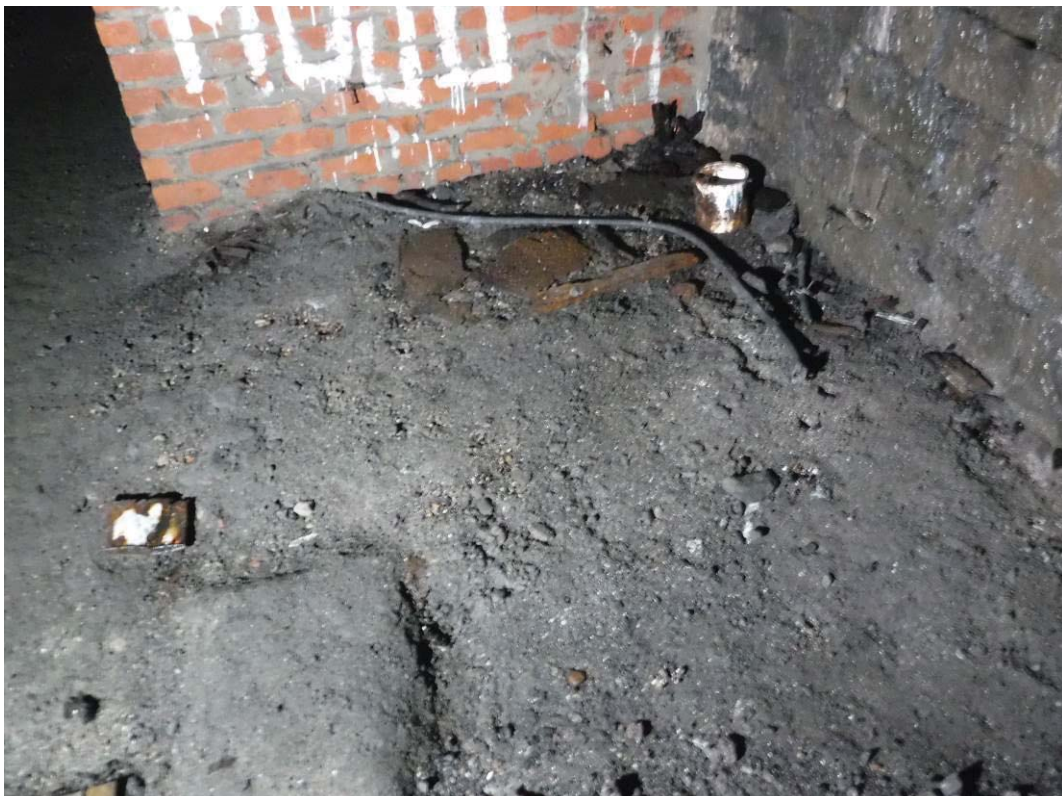
Photo No.20: Rubbish and debris laid to Solum.
