Freedom of Information Request – Detailed Examination Reports for HRE Tunnels

Detailed Examination Report for

Balfour Beatty Rail, Manchester**Monks Ferry Tunnel****ELR:CCS3/01****Examined:03/10/2019**

Balfour Beatty Rail, Manchester**Law Tunnel****ELR:DDN/12A****Examined:07/10/2019**

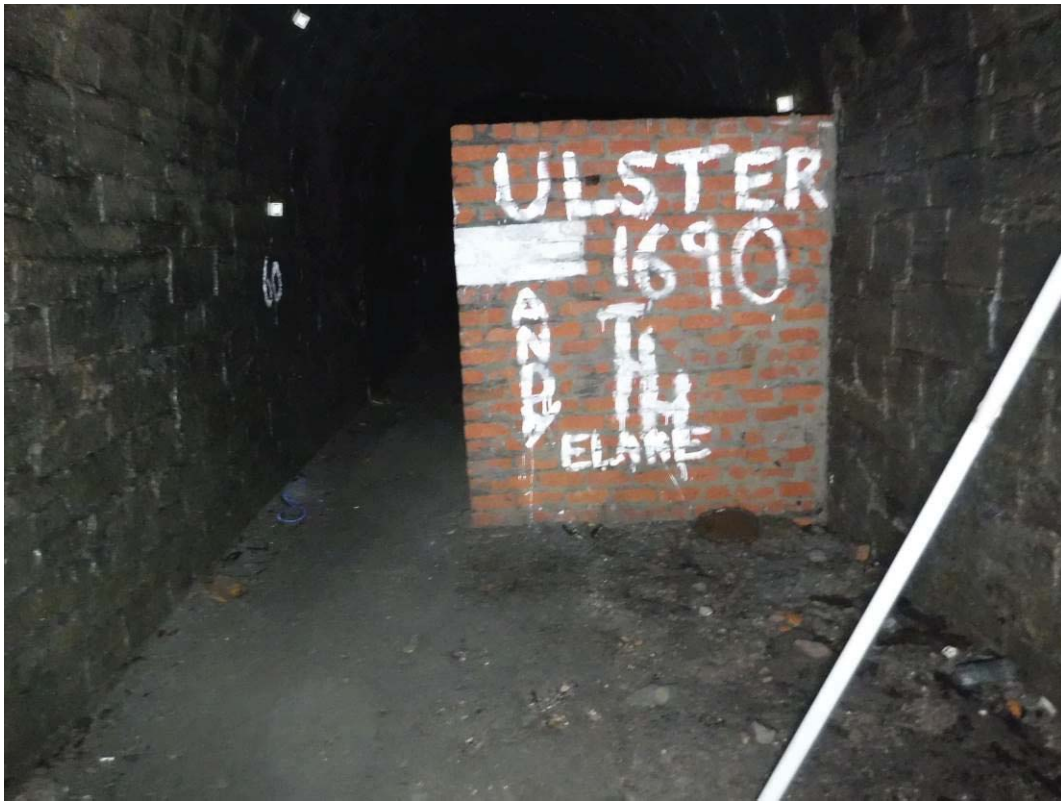
Photo No.21: Brickwork, Old Baffle Wall, 1.8m high x 1.8m wide (typical example at 006+01).

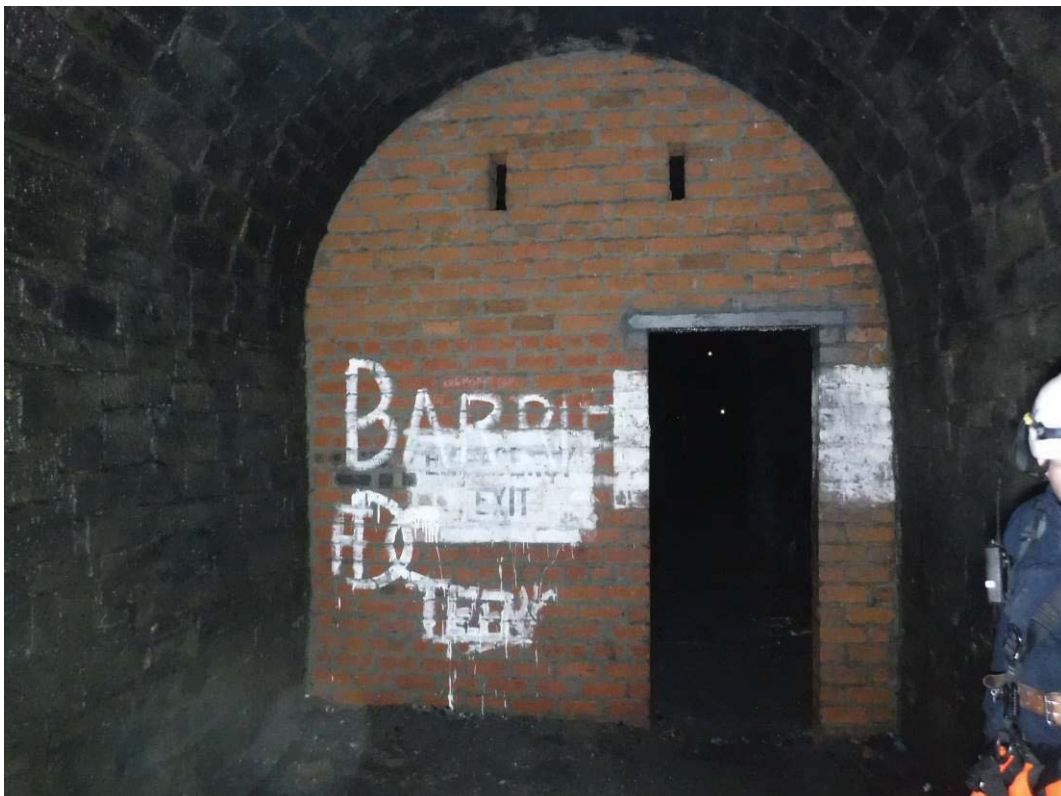
Photo No.22: Brickwork, Diaphragm Wall constructed full width of the tunnel with a doorway to the upside.

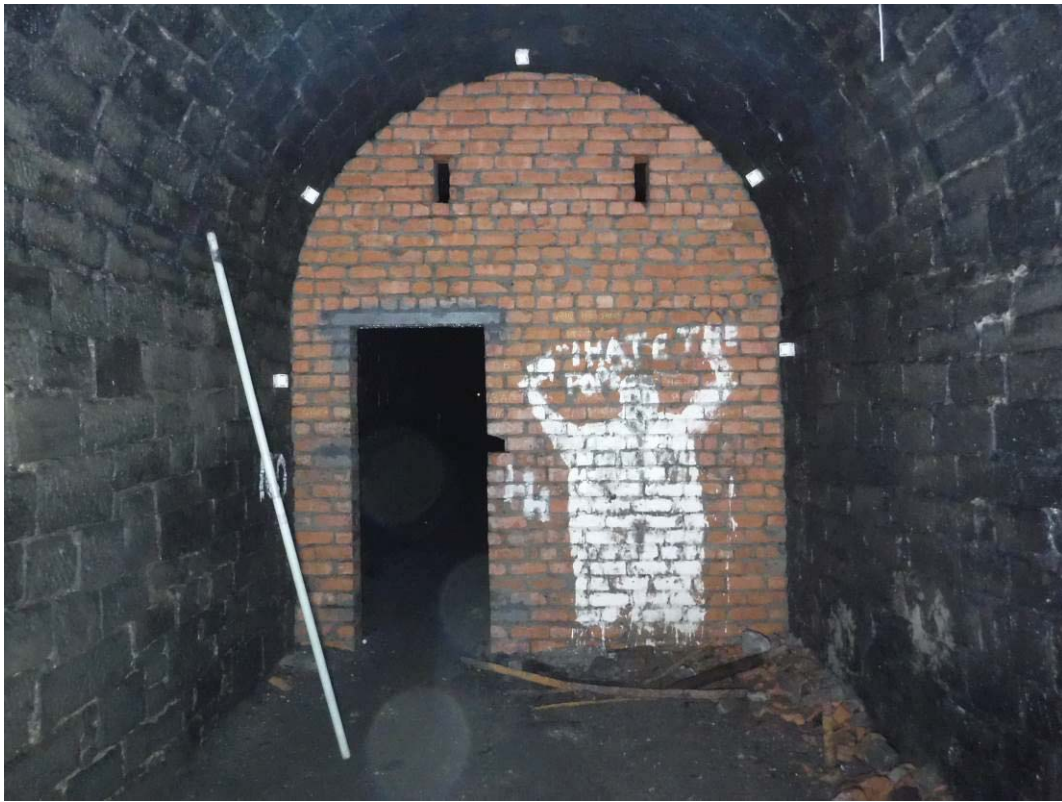
Photo No.23: Brickwork, Diaphragm Wall constructed full width of the tunnel with a doorway to the upside.

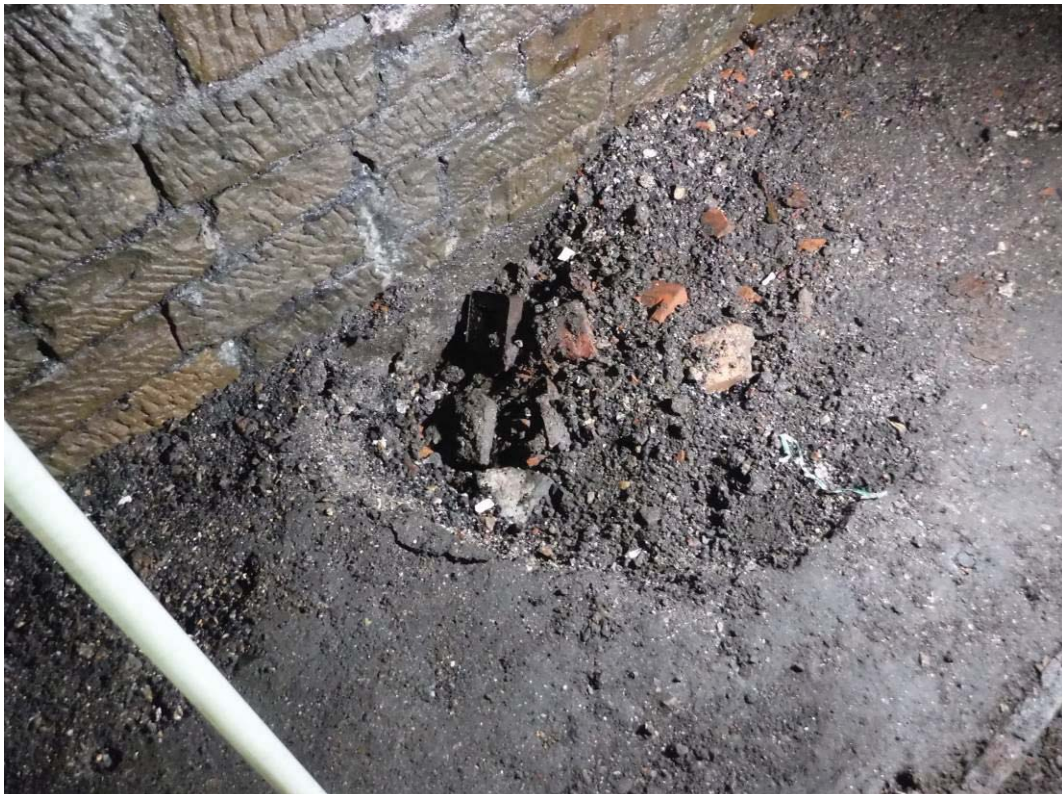
Photo No.24: Hole to solum.

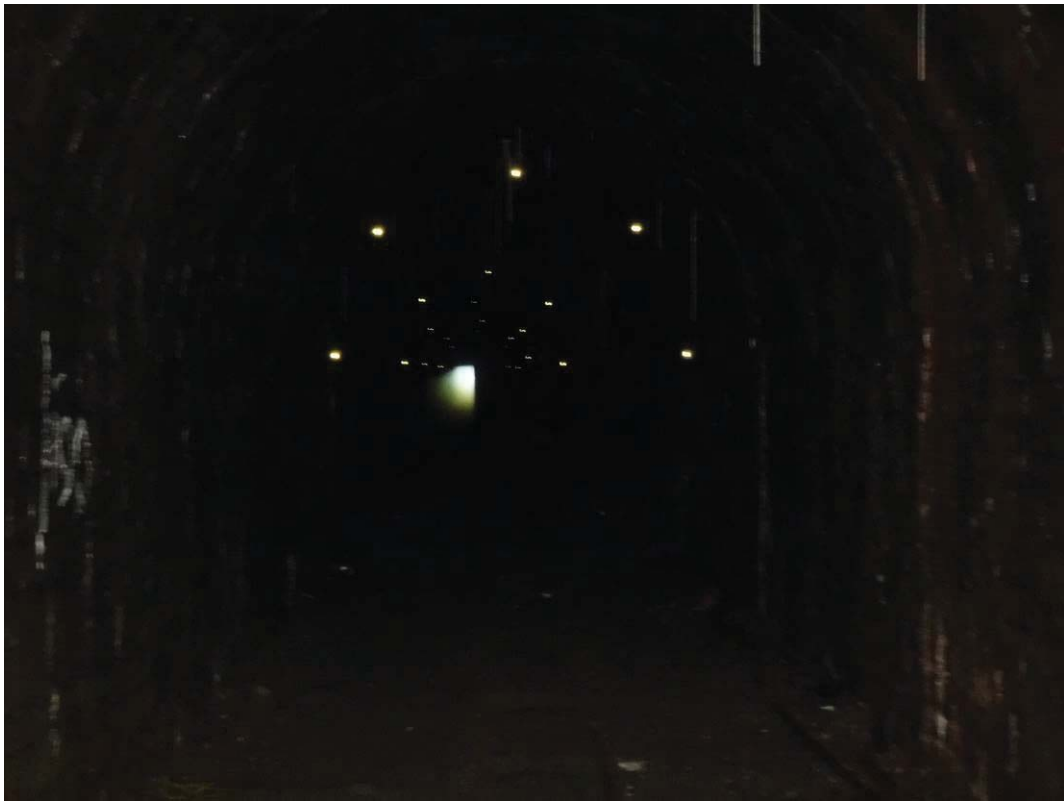
Photo No.25: View along tunnel looking southwards, prism array to lining throughout.

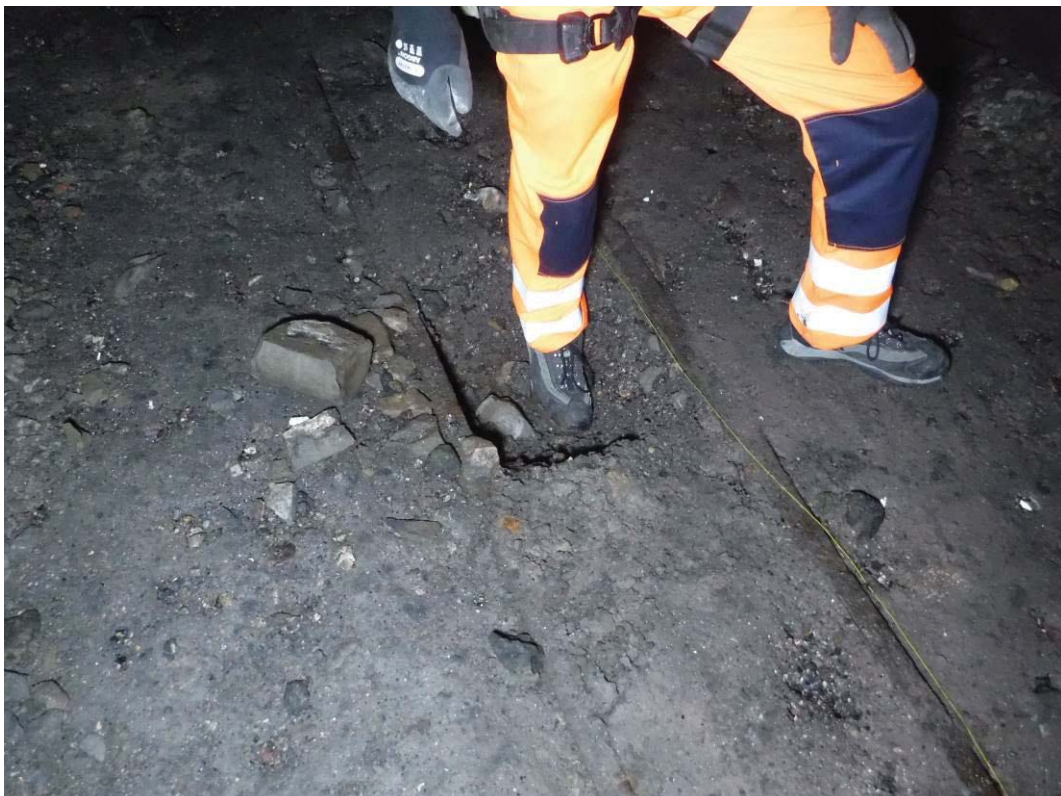
Photo No.28: 300mm deep hole to solum reportedly made by the boring bit being dropped down the vent shaft during the recent boring works.

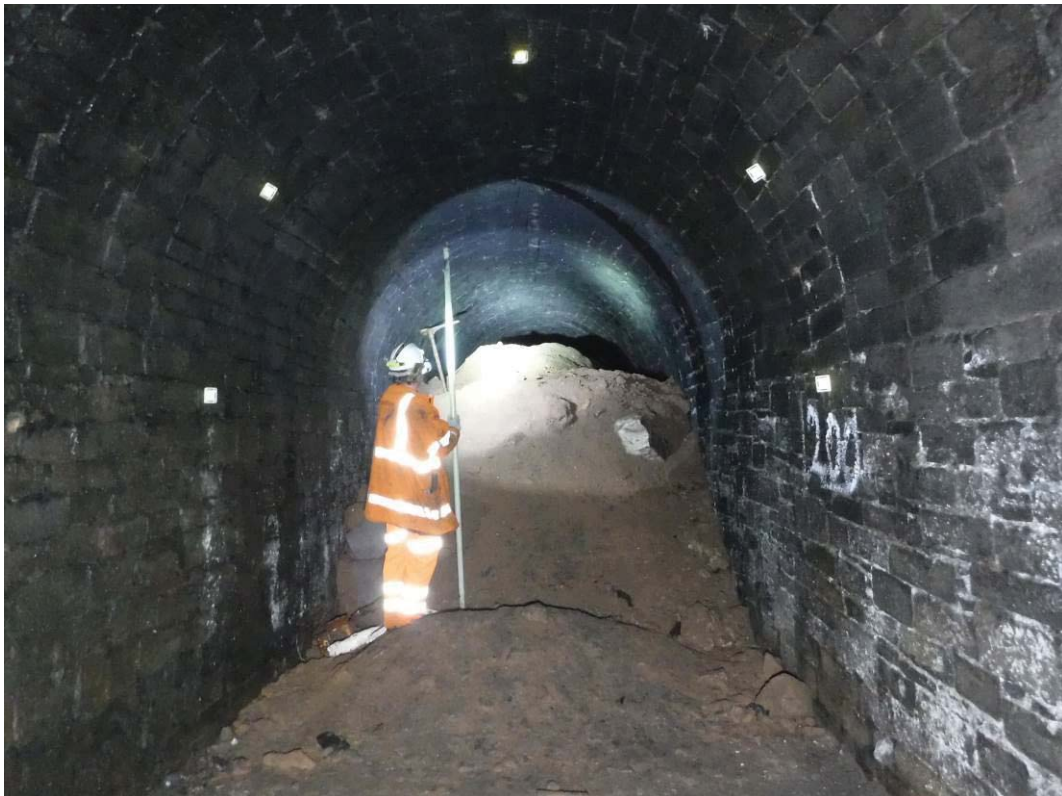
Photo No.30: 020+00 Full Profile Up & Down, Earth was ostensibly pushed southwards into the tunnel up to this point.

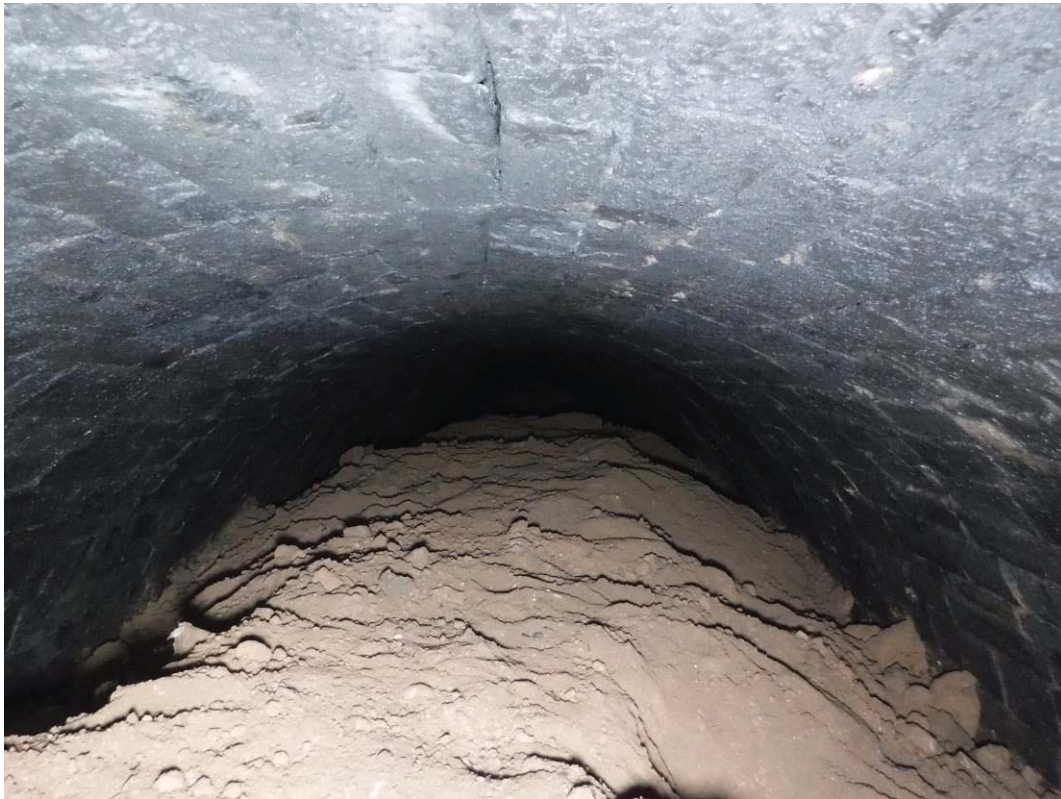
Photo No.31: 021+00 to Newtyle Portal, Full Profile Up & Down, View looking above partial infilling, bore filled to within 1m of the lining for as far as the eye can see, no access to the northern end of the tunnel - approx. a third of the length of the tunnel.

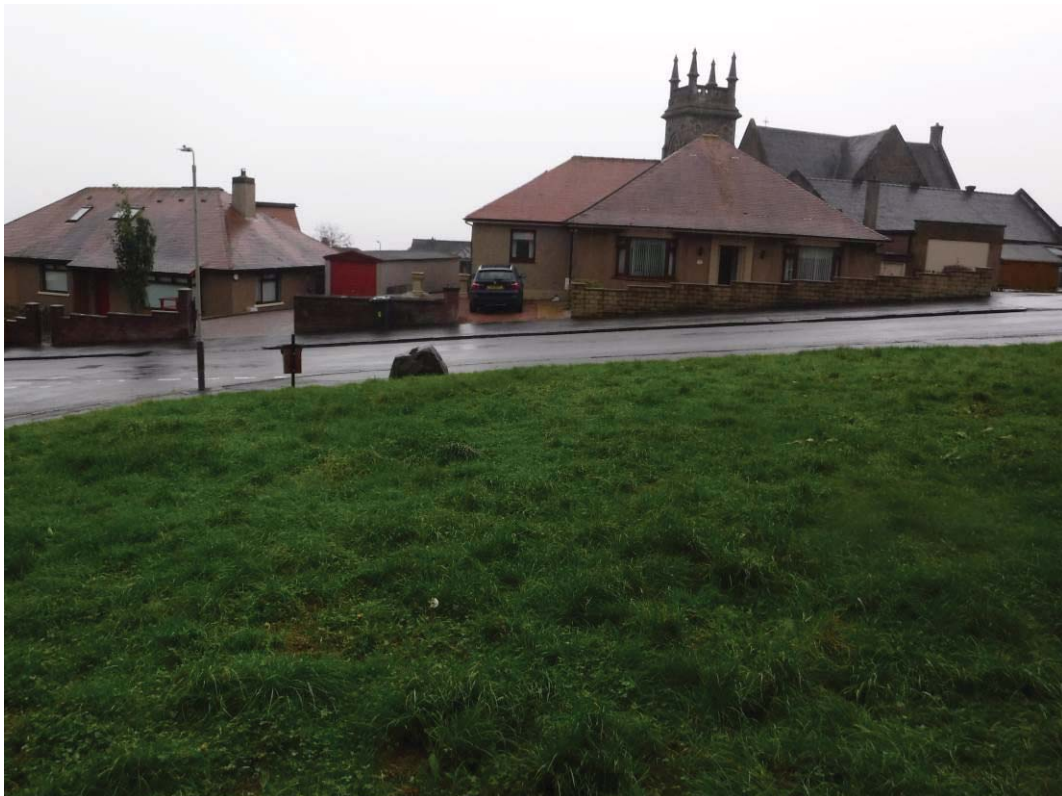
Photo No.32: Housing built over the tunnel.

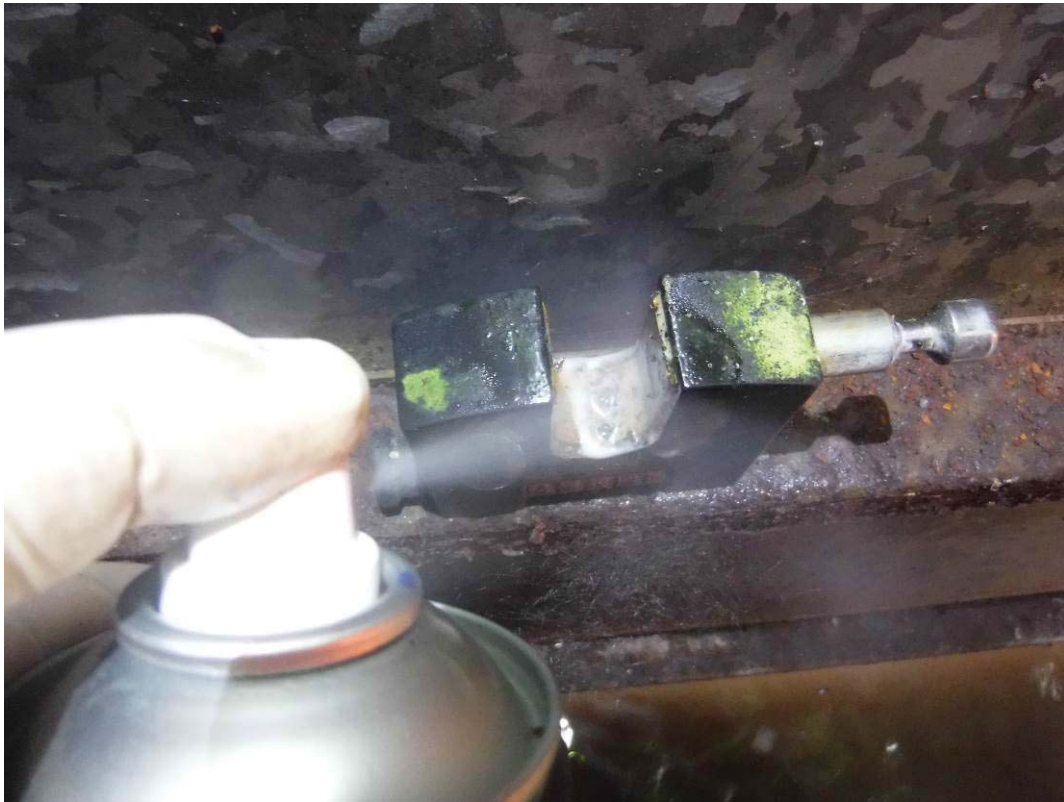
Photo No.5: 000+00 Portal Up & Down, Security Gates, oiling padlock.

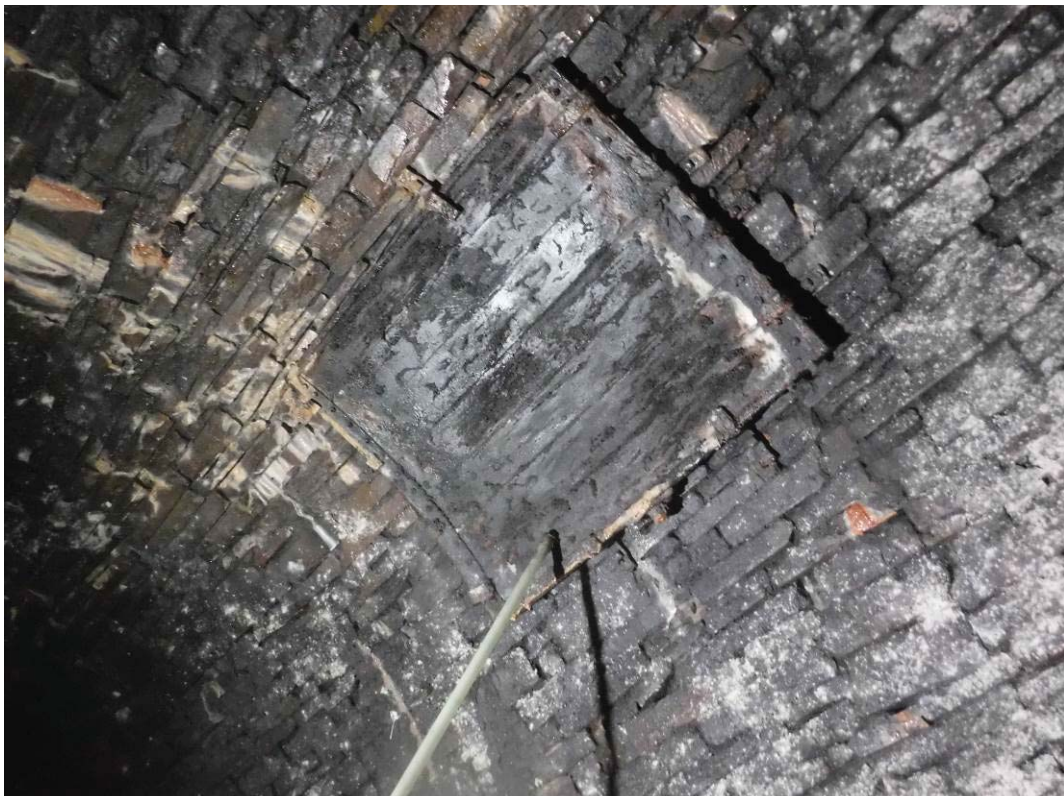
Photo No.8: 021+08 High Haunch Down, Pan fitted, downpipe has become detached and is laid in down cess.

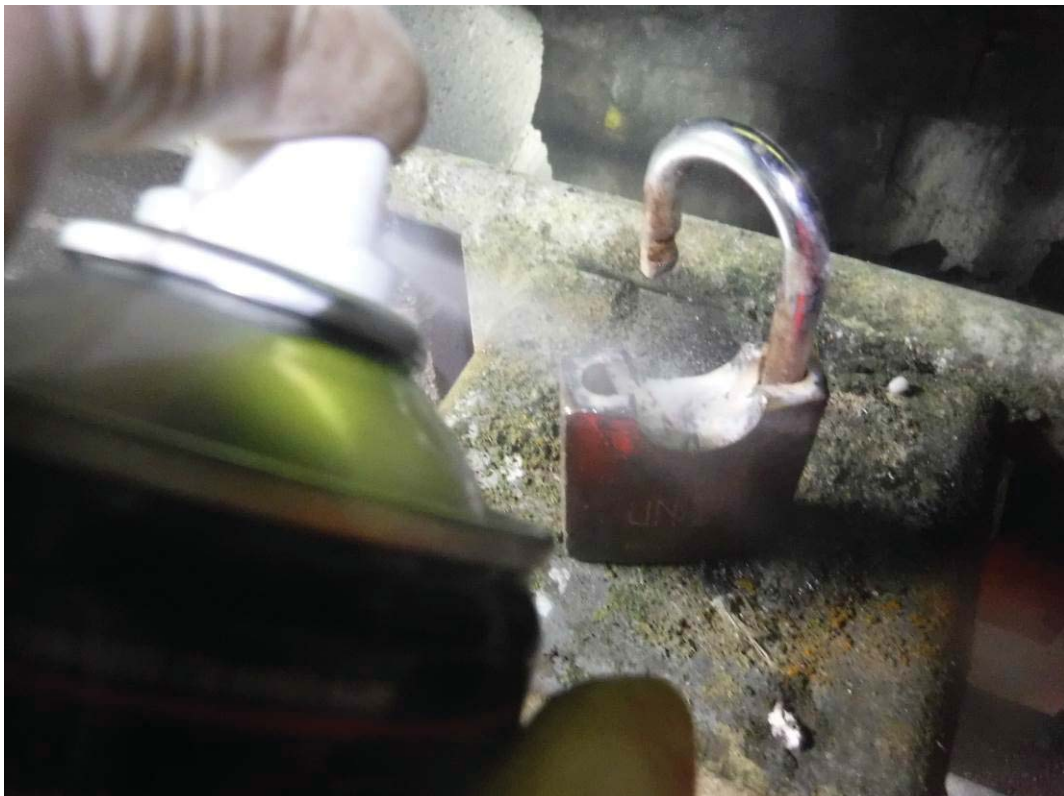
Photo No.10: 030+20 Portal Up & Down, Security Gate, oiling padlock.

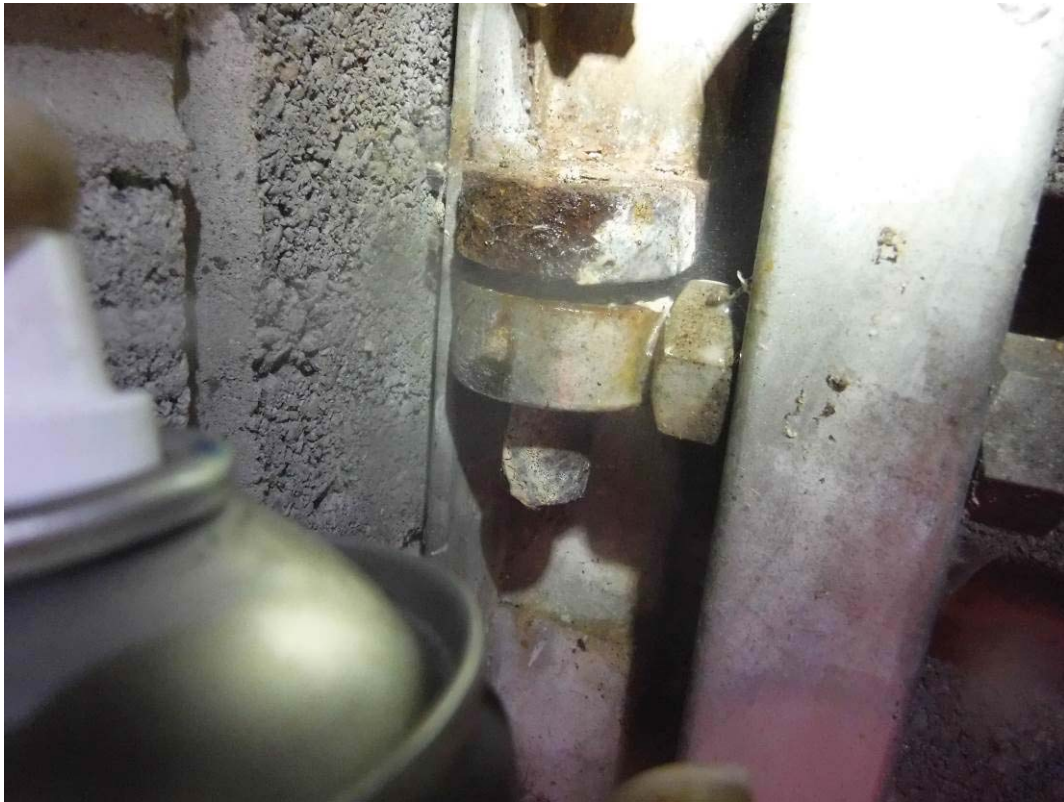
Photo No.11: 030+20 Portal Up & Down, Security Gate, oiling hinges.

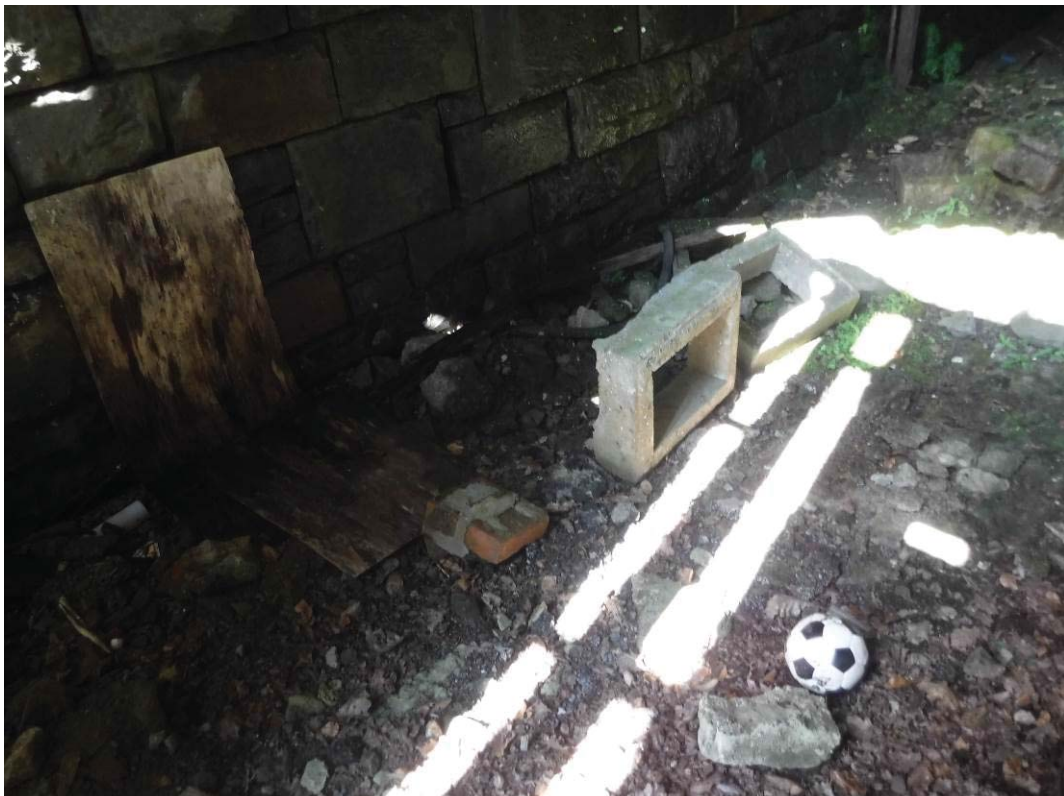
Photo No.2: 000+00 to 005+33 Solum Up & Down, Dumped debris.

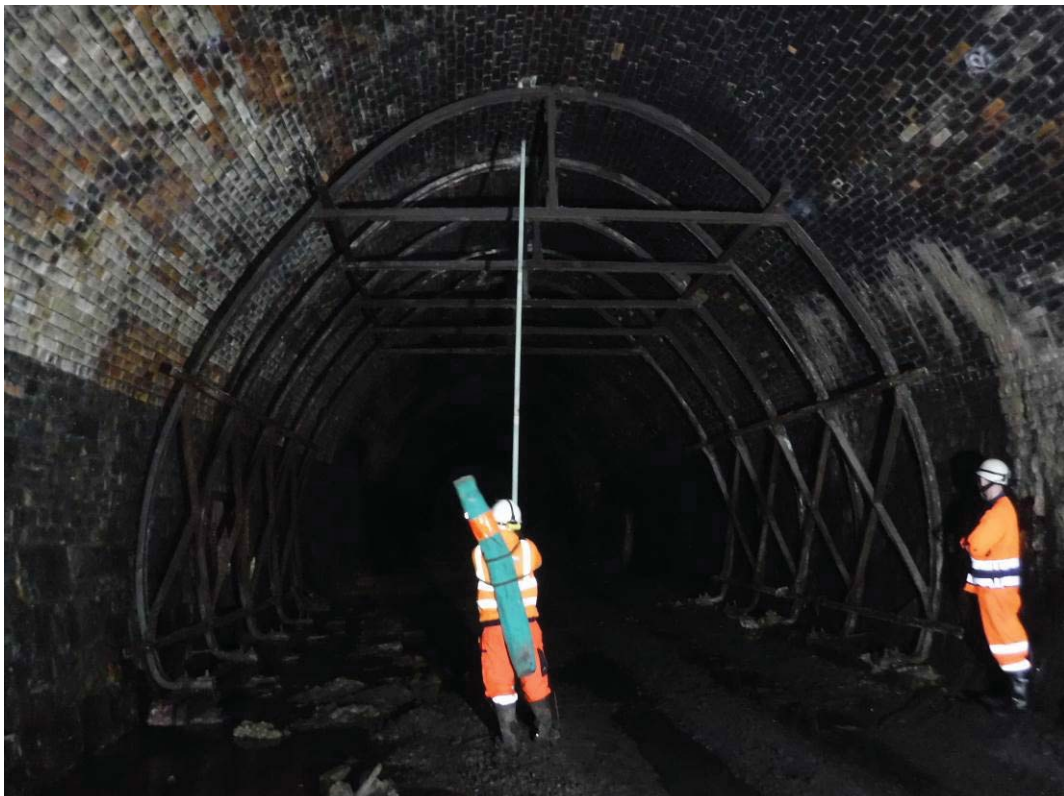
Photo No.4: 002+00 to 002+24 Full Profile Up & Down, Steel ribs fitted with substantial loss of section and appears to support nothing as timbers have rotted away.
