**TUNNEL EXAMINATION REPORT  
PHOTOGRAPHS OF STRUCTURE**

ELR : PTP Br. No. : 00

Mileage : 05 M 08 Ch Sheet 1 of 15

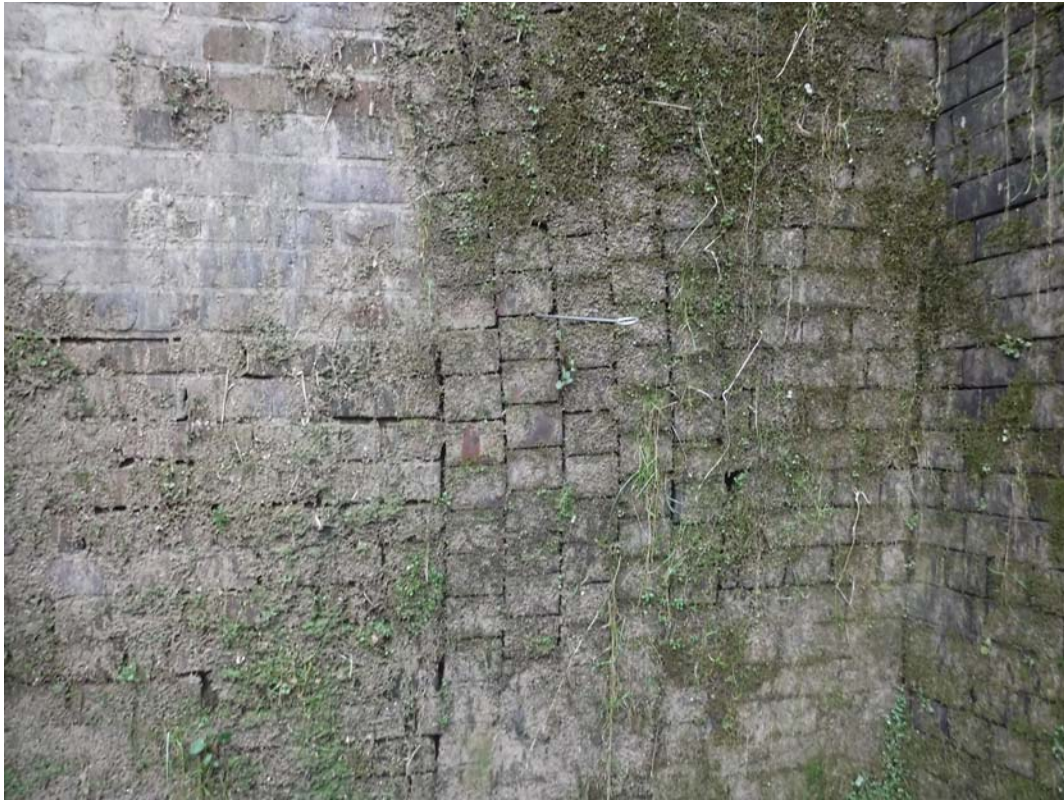
**Photo No. 1:** Southeast Portal, brickwork, 5 brick arch ring to voussoirs area has open joints and running water, depth 200mm, area 4sq.m.

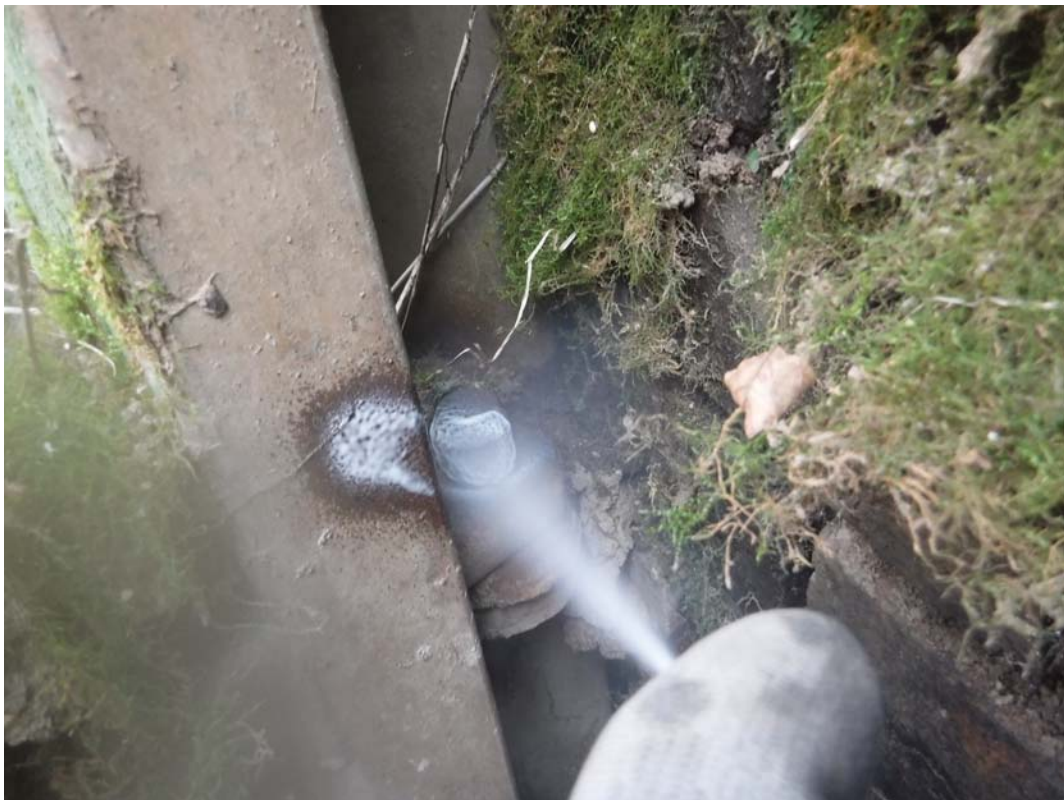
**Photo No. 6:** Southeast Portal, Oiling hinges.

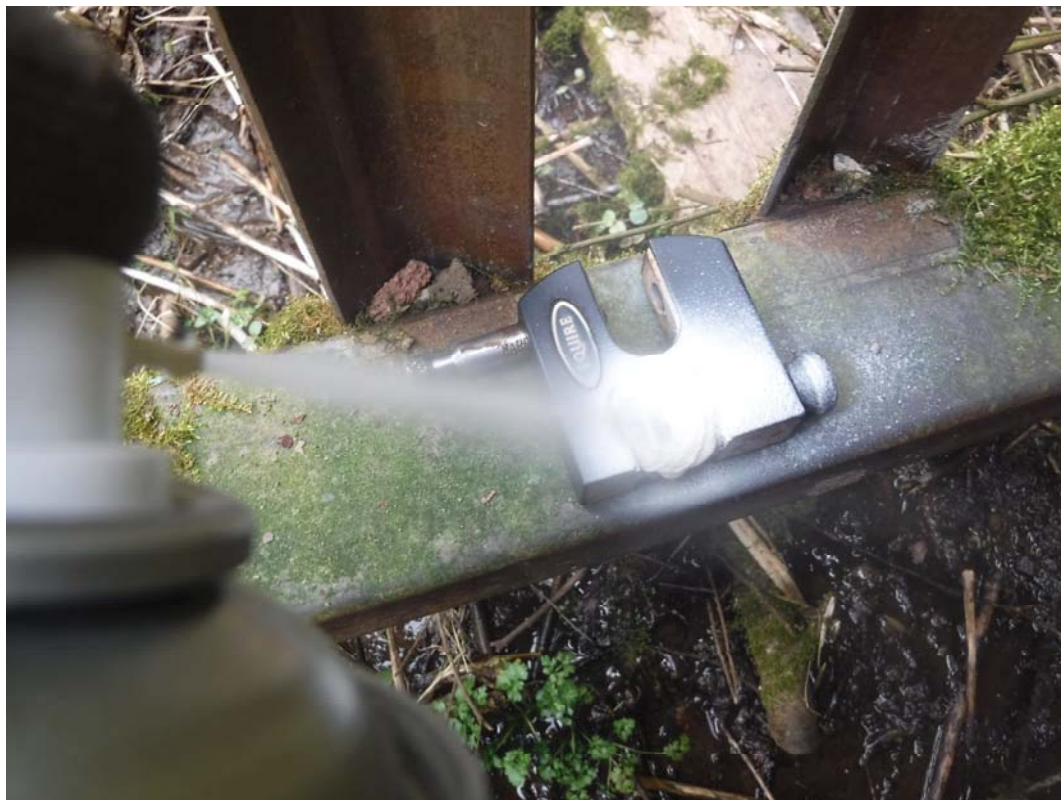
**Photo No. 7:** Southeast Portal, Oiling padlock.

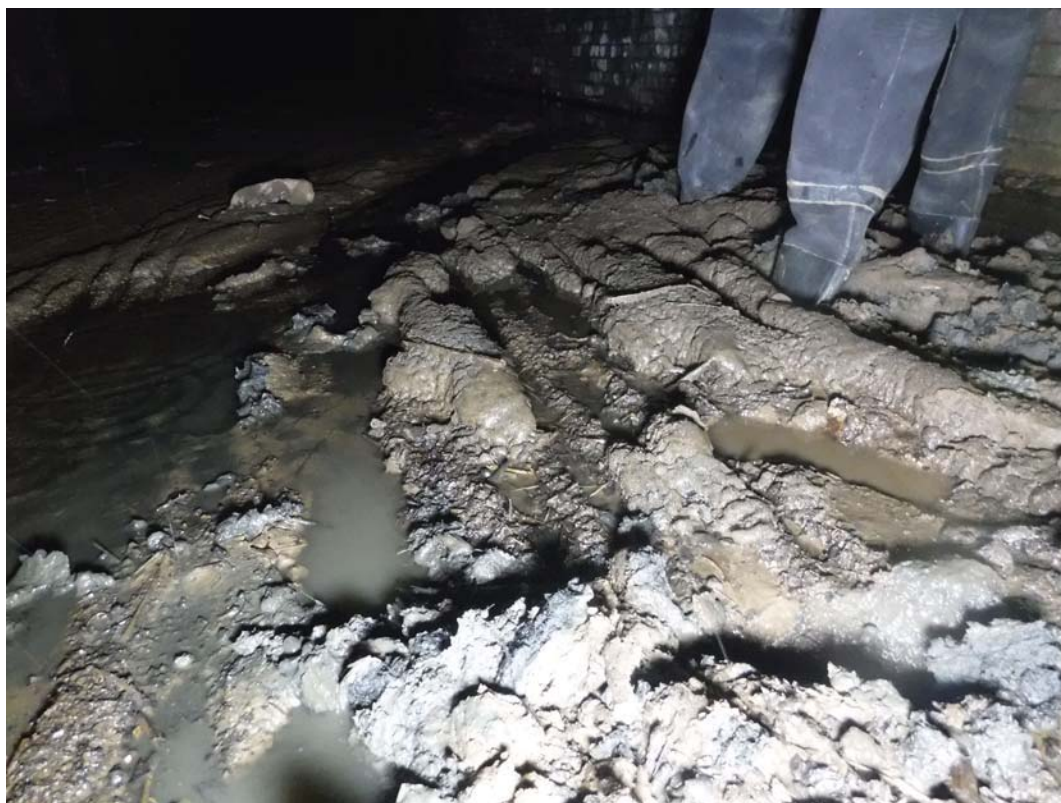
**Photo No. 8:** 000+00 to 028+00 Solum Up & Down, Standing water and mud to solum, max. depth 600mm.

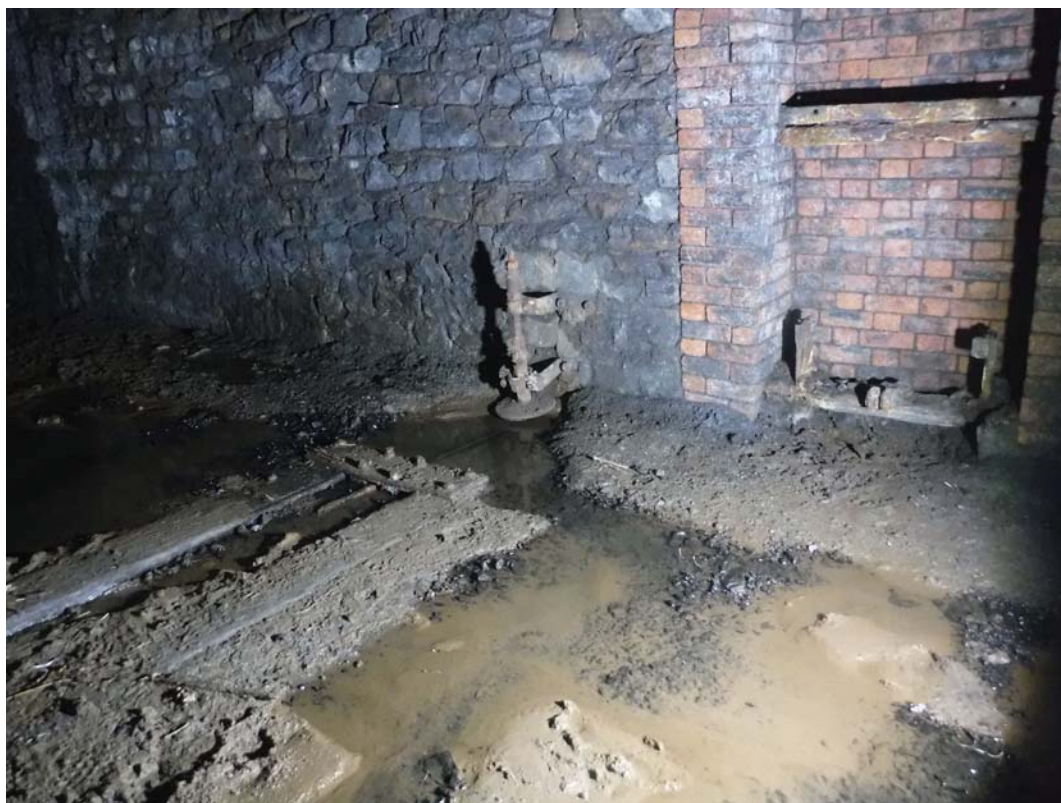
**Photo No. 10:** 028+40 Solum, Old signalling equipment.

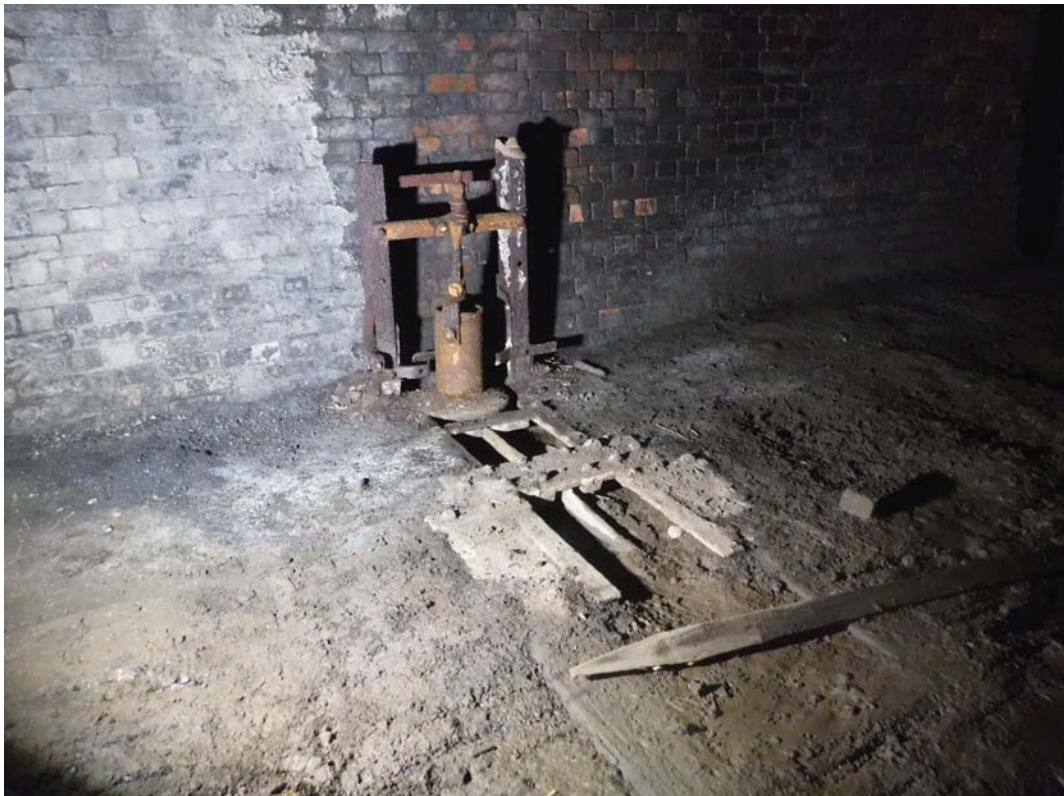
**Photo No. 18:** 057+03 Solum Down, Old signalling equipment.

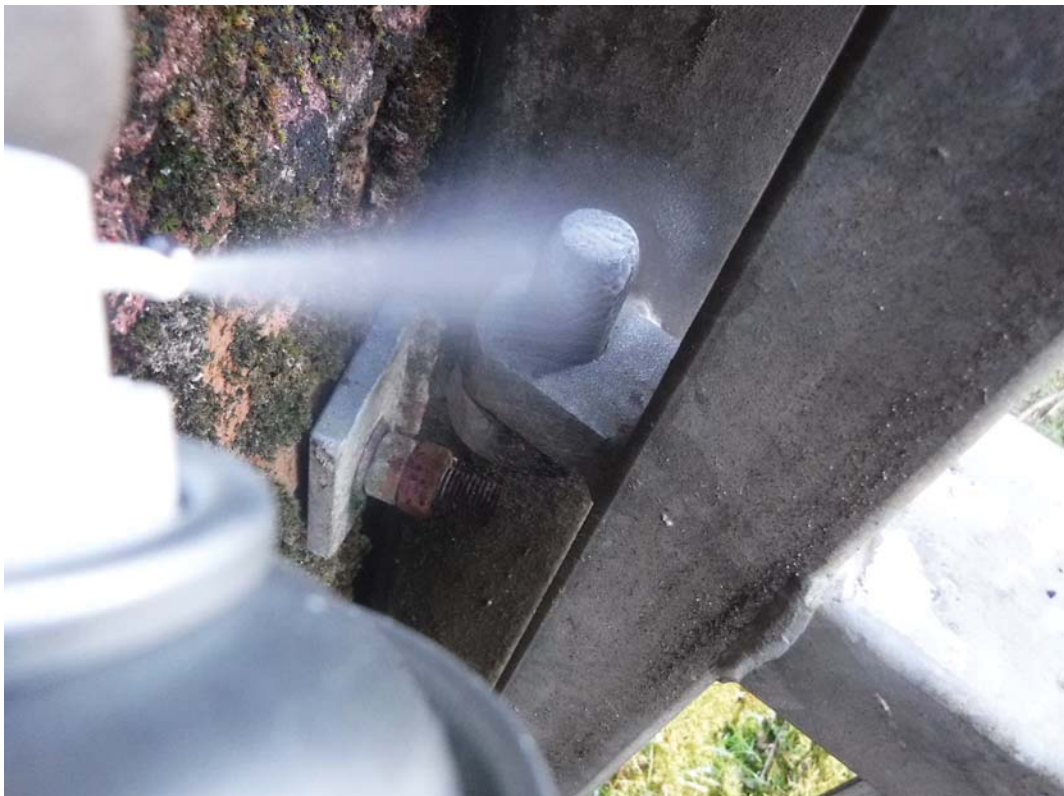
**Photo No. 20:** Northwest Portal, Oiling hinges

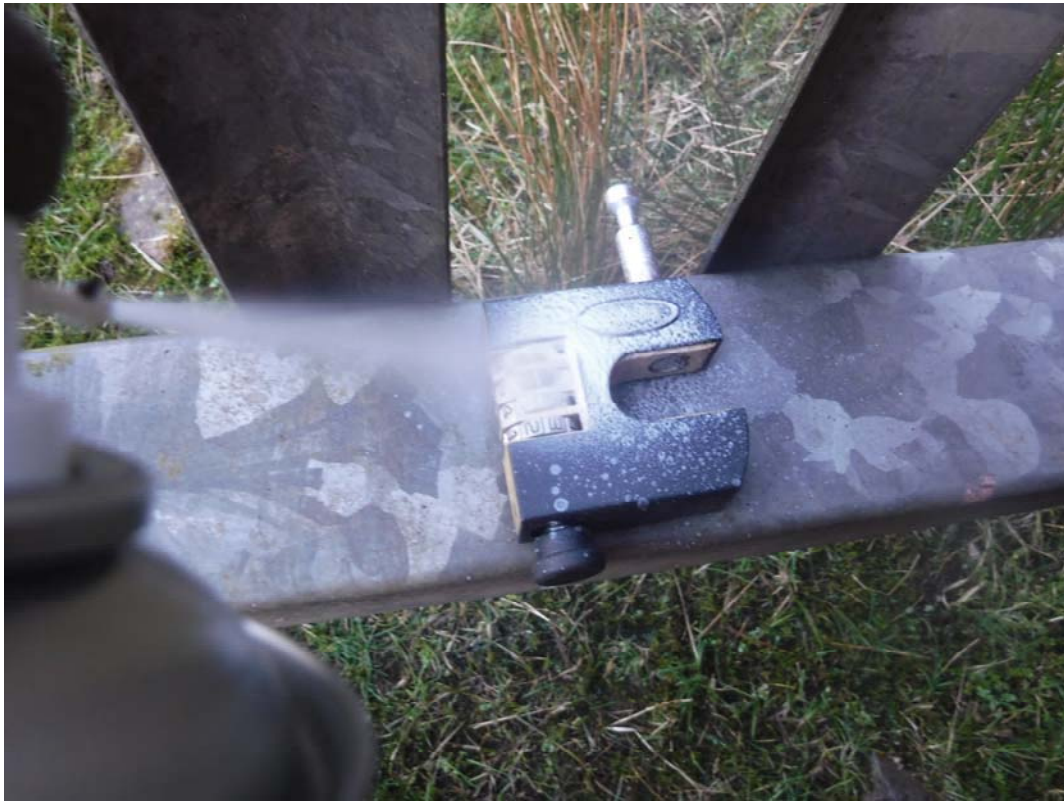
**Photo No. 21:** Northwest Portal, Oiling padlock.

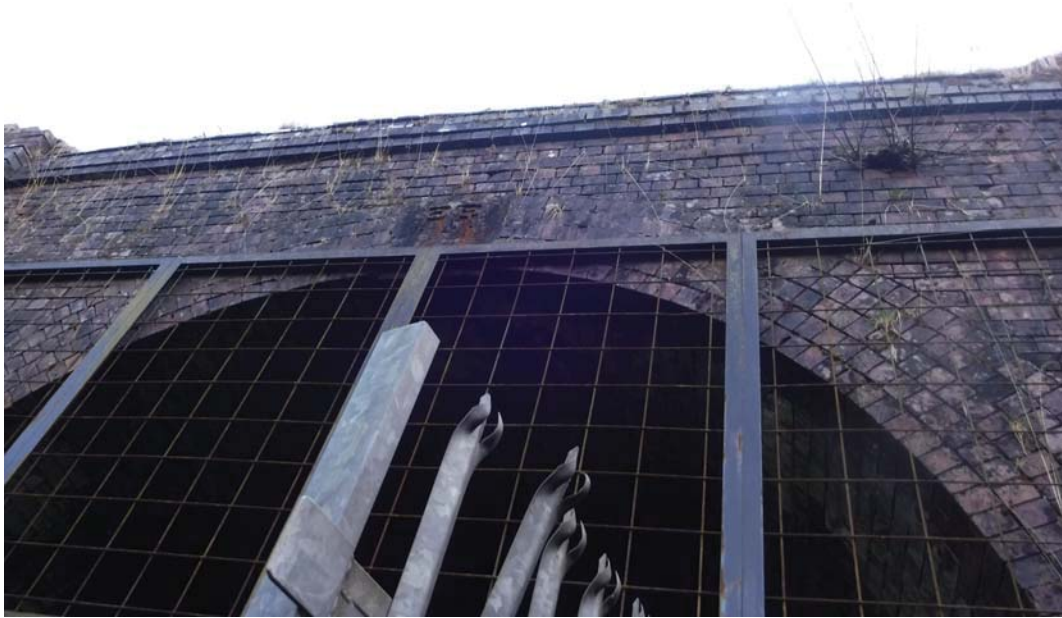
**Photo No. 25:** 060+36 Portal Up & Down, Northwest Portal, Brickwork, String course oversailing by a max. of 25mm over 8m in length.

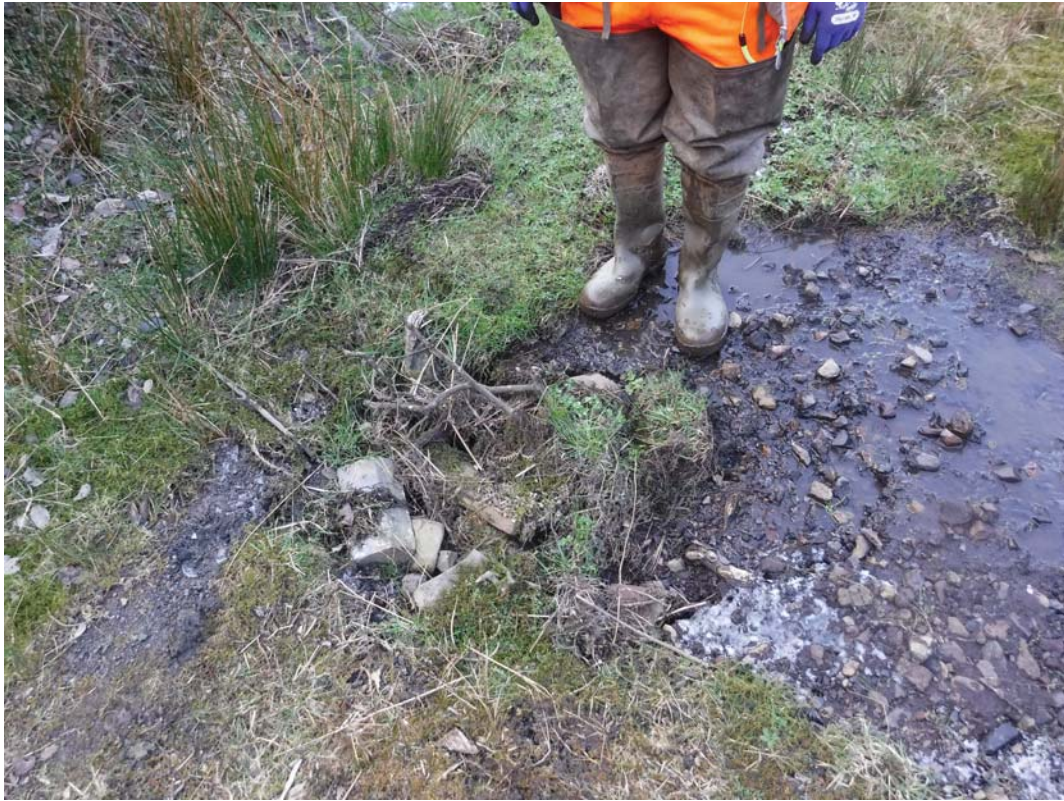
**Photo No. 27:** 060+36 Portal Up & Down, Northwest Portal, Level with the newel posts, Hole to solum just outside portal with running water, probably track drainage.

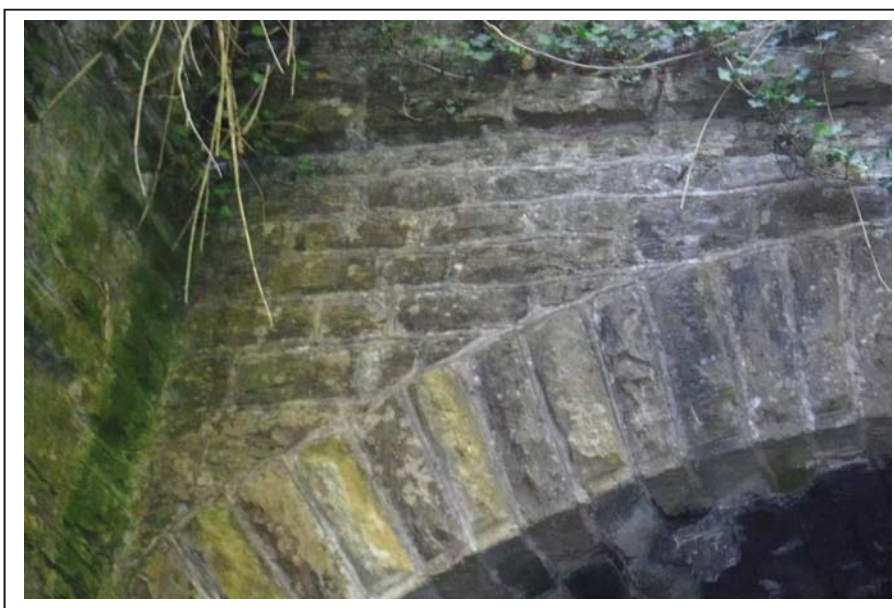
Photograph no 10: DL spandrel in good condition

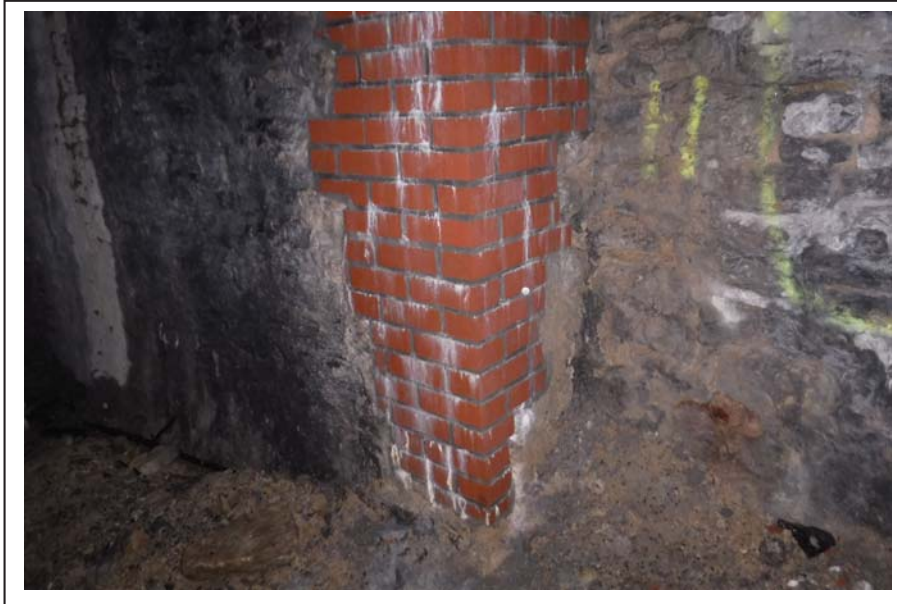
Photograph no 14: DL quoin refuge now repaired in brickwork to good standard

Photograph no 15: As photo 14

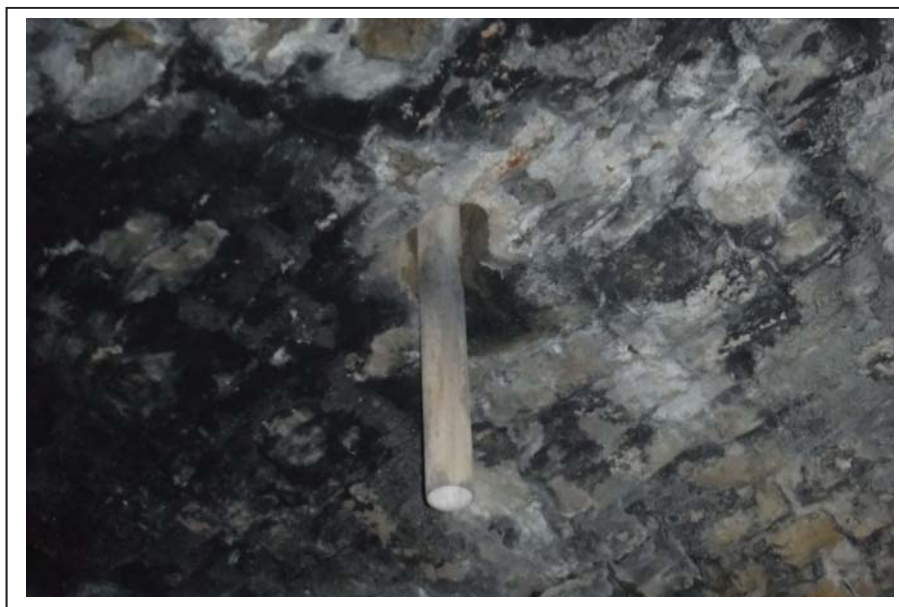
Photograph no 17: 100mm Ø down pipe at CE crown

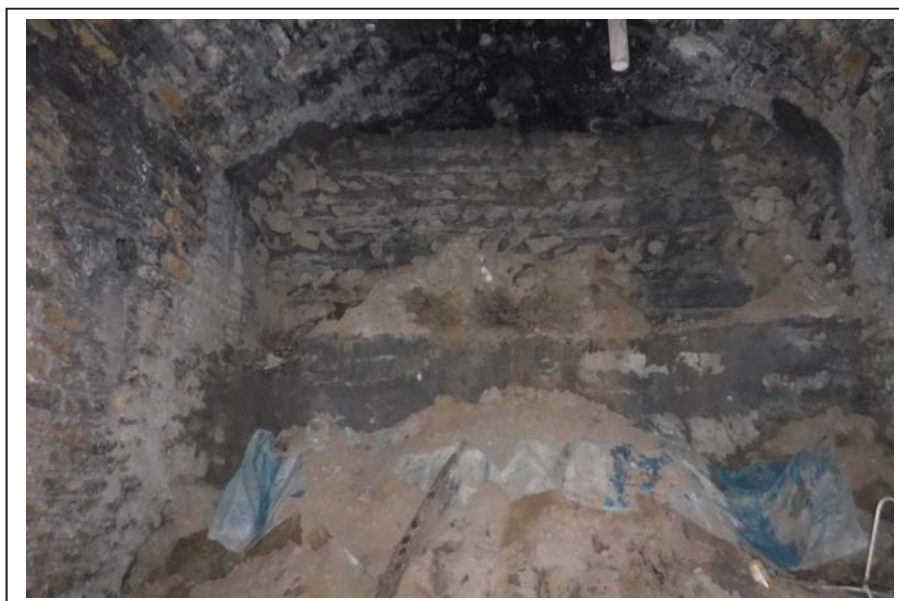
Photograph no 18: Diaphragm wall at 2.75c from LE: wall marks limit of examination

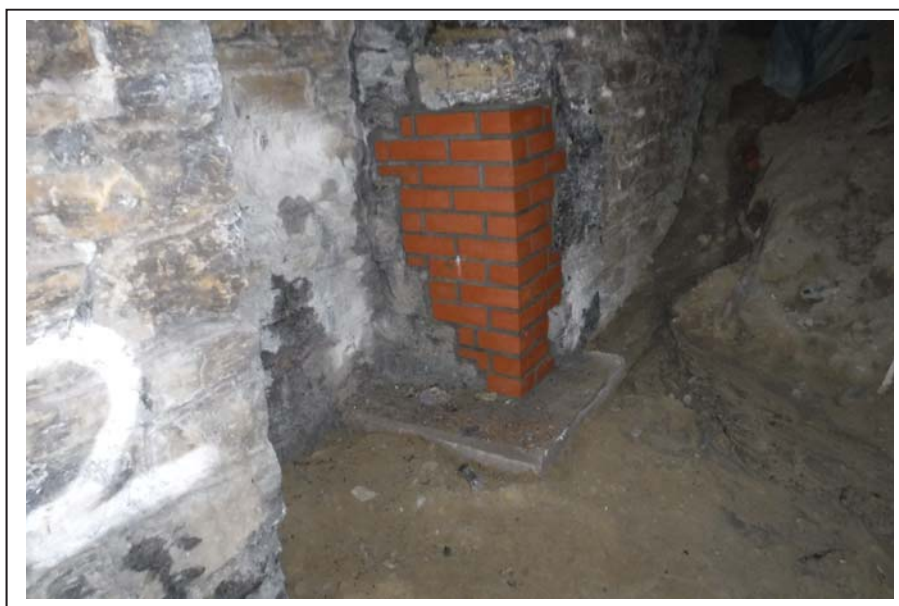
Photograph no 20: DC quoin now repaired to good standard

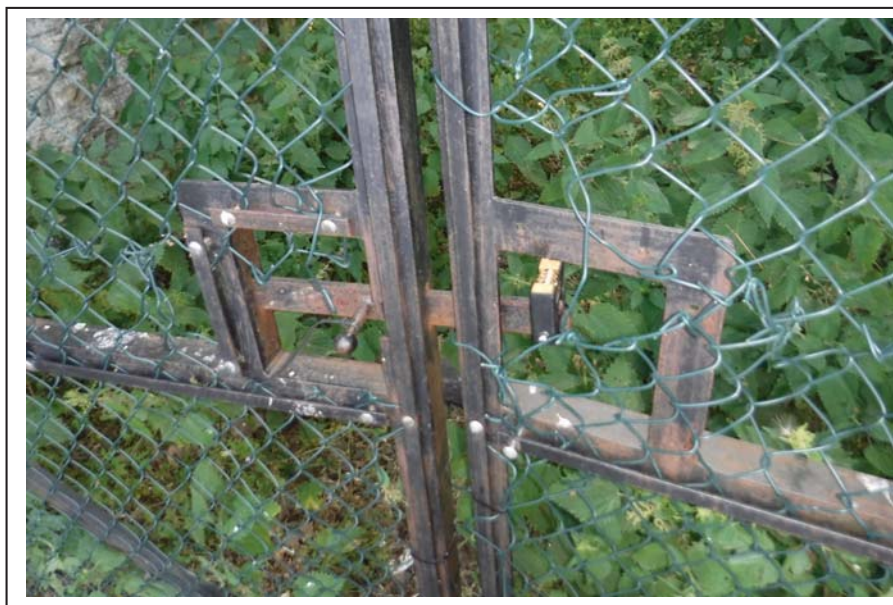
Photograph no 21: Gates fitted with a standard lock are installed to LE approach

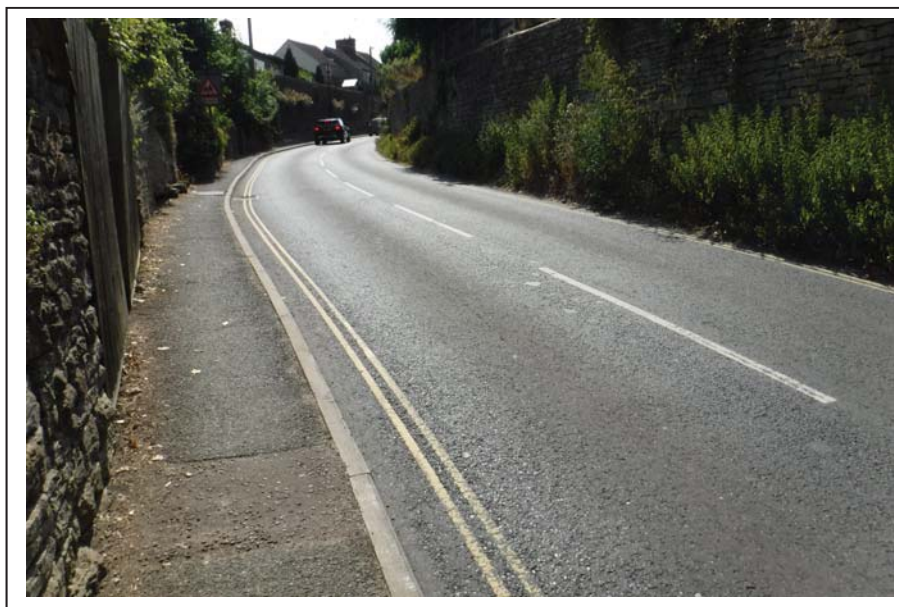
Photograph no 23: The road over the tunnel (B4040) is found in good condition over the tunnel line

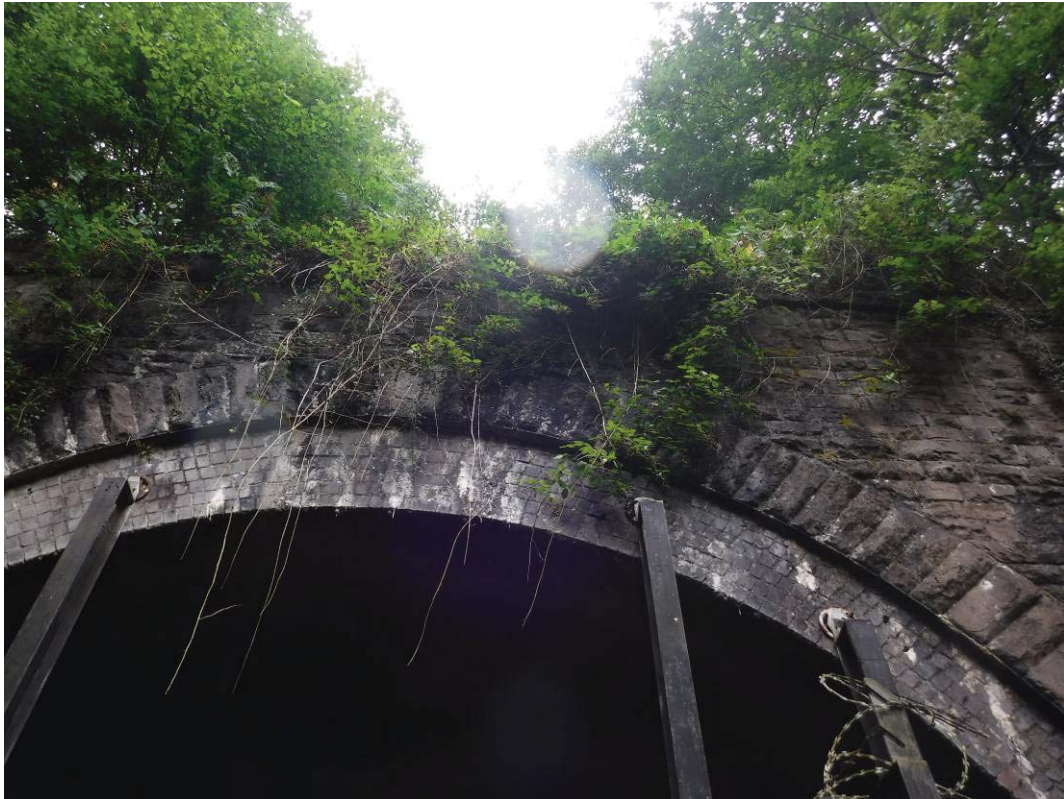
**Photo No.3:** Southwest Portal, Stonework, Vegetation. BEFORE WORKS.

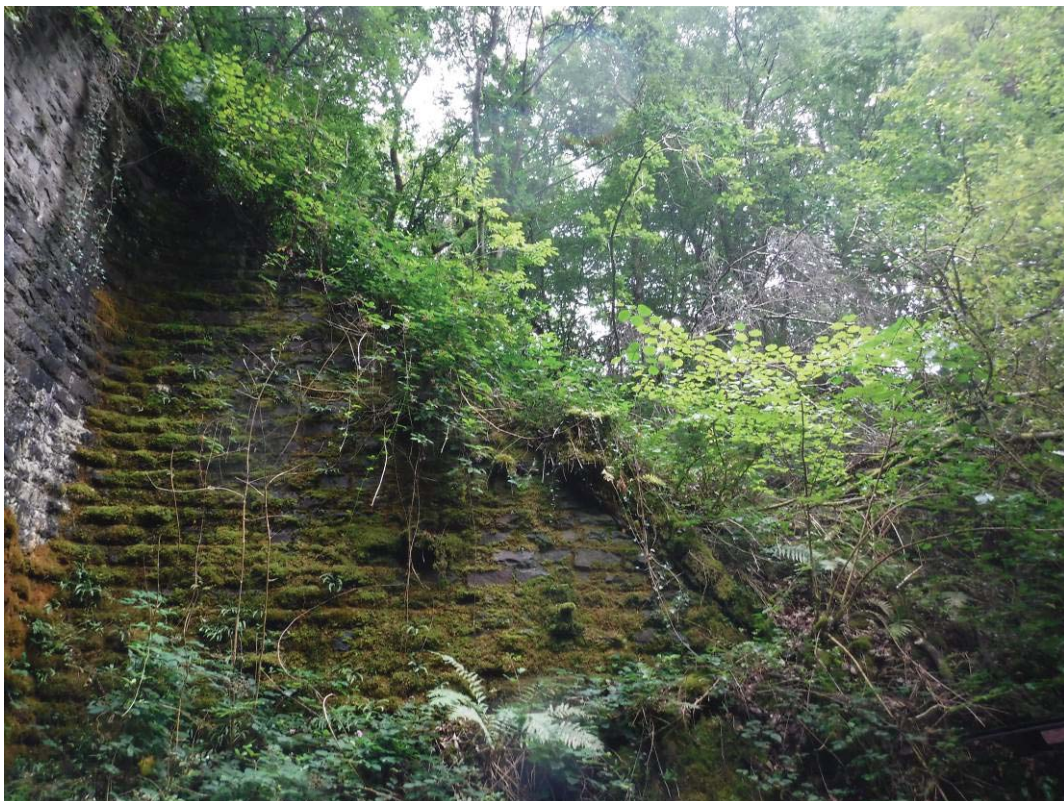
**Photo No.4:** Southwest Portal, Stonework, Vegetation. BEFORE WORKS.

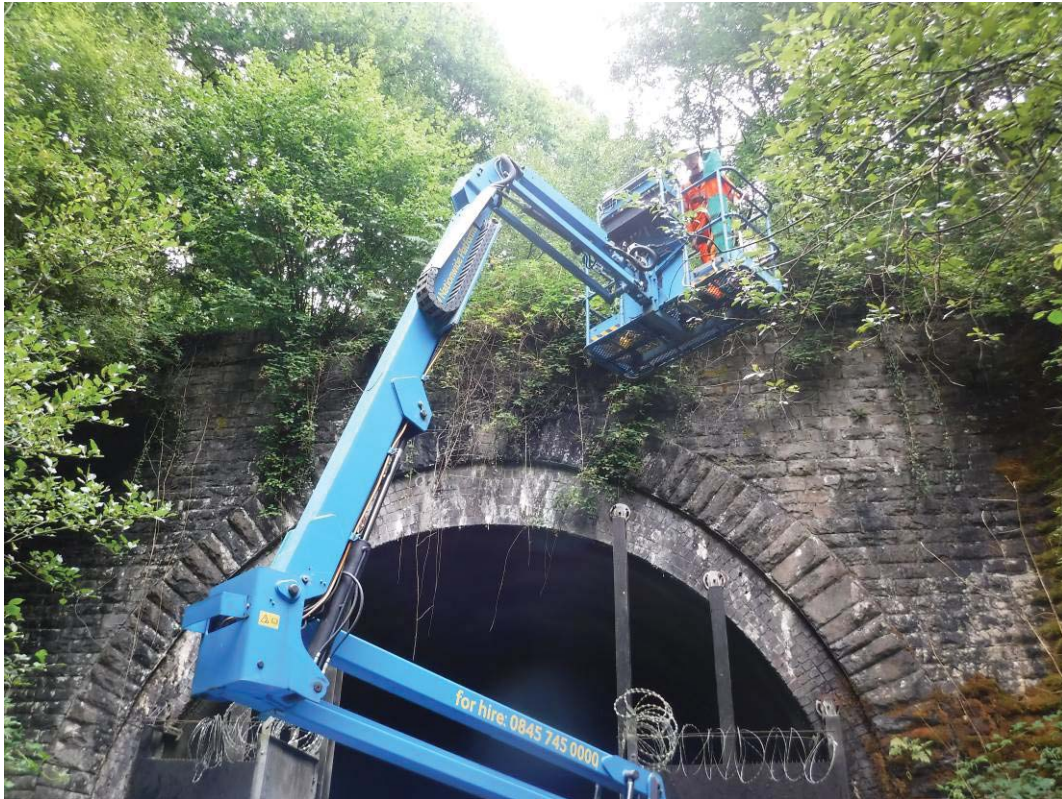
**Photo No.5:** Southwest Portal, Stonework, Vegetation. BEFORE WORKS - Ecological examination.

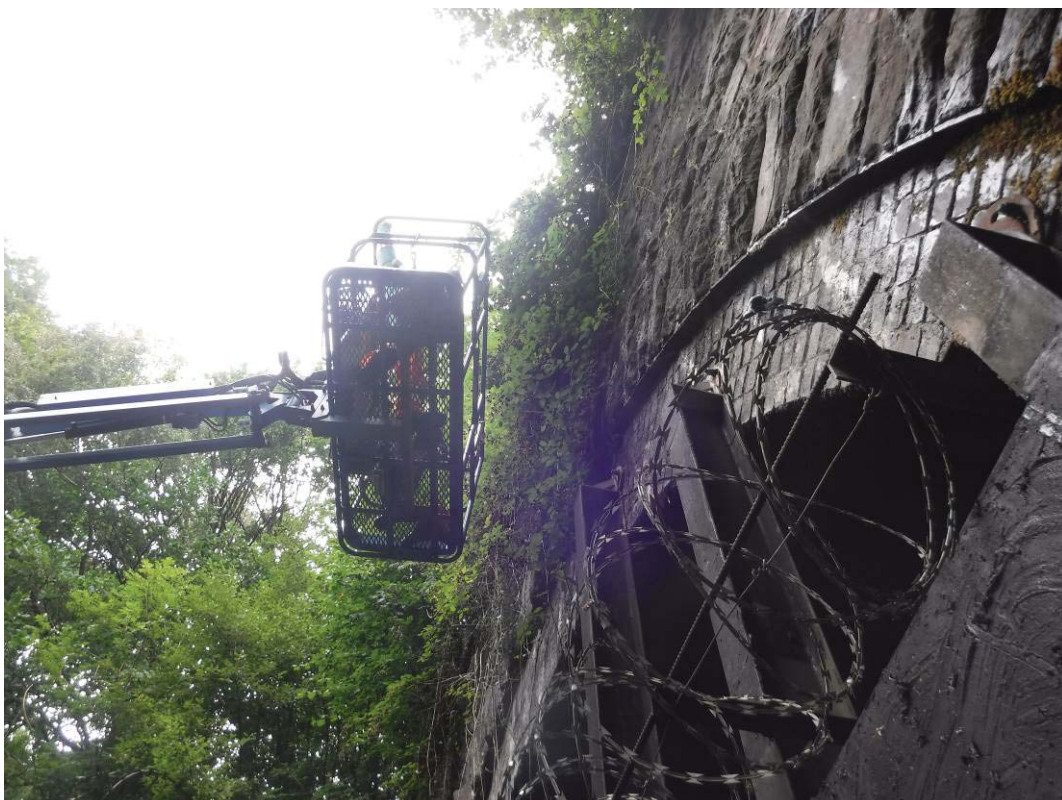
**Photo No.6:** Southwest Portal, Stonework, Vegetation. BEFORE WORKS - Ecological examination.

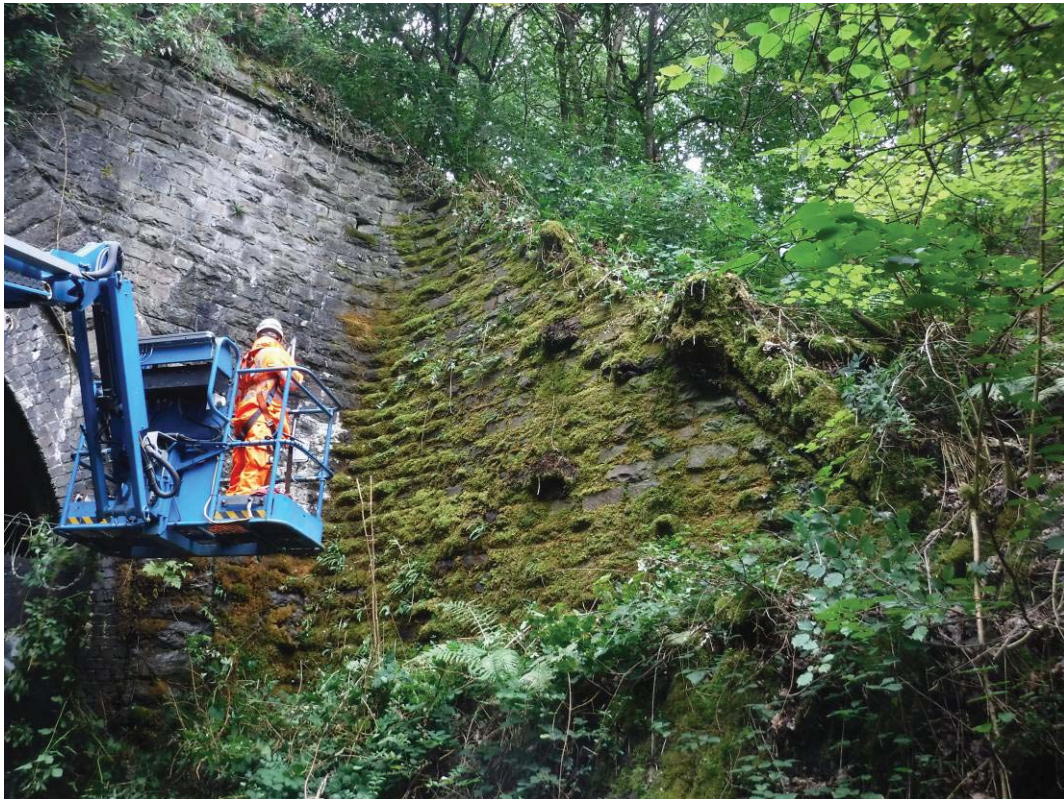
**Photo No.9:** Southwest Portal, Stonework, Vegetation. DURING WORKS - Removing vegetation.

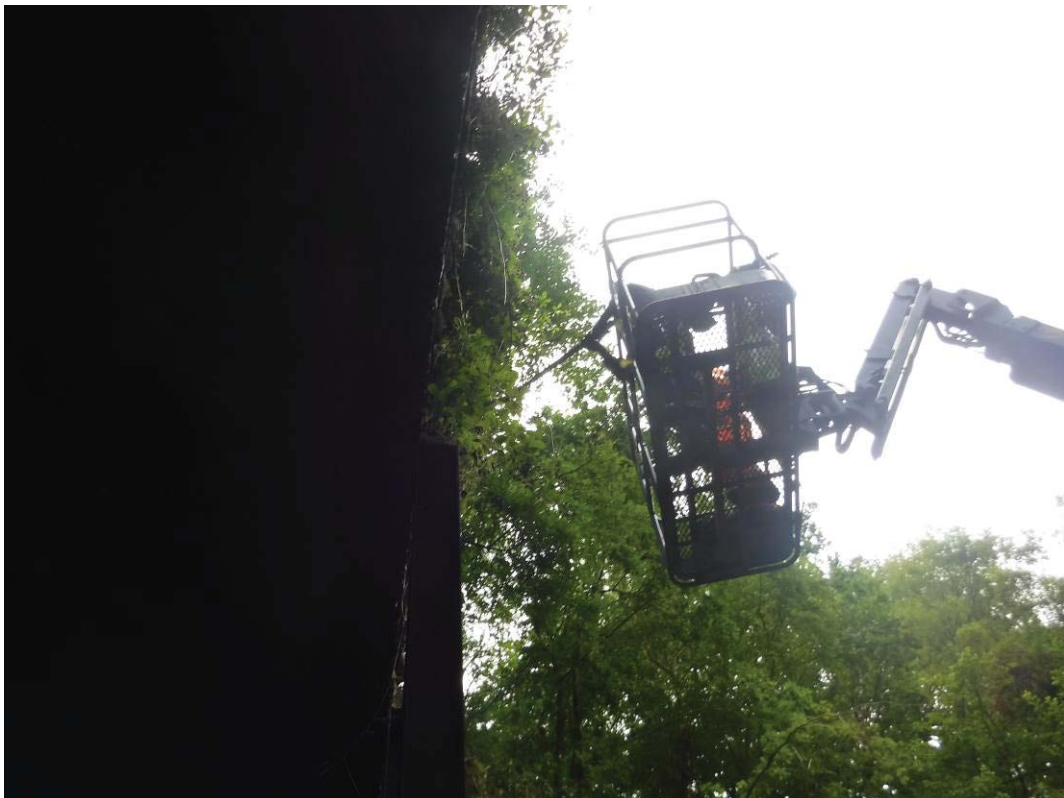
**Photo No.10:** Southwest Portal, Stonework, Vegetation. DURING WORKS - Removing vegetation.

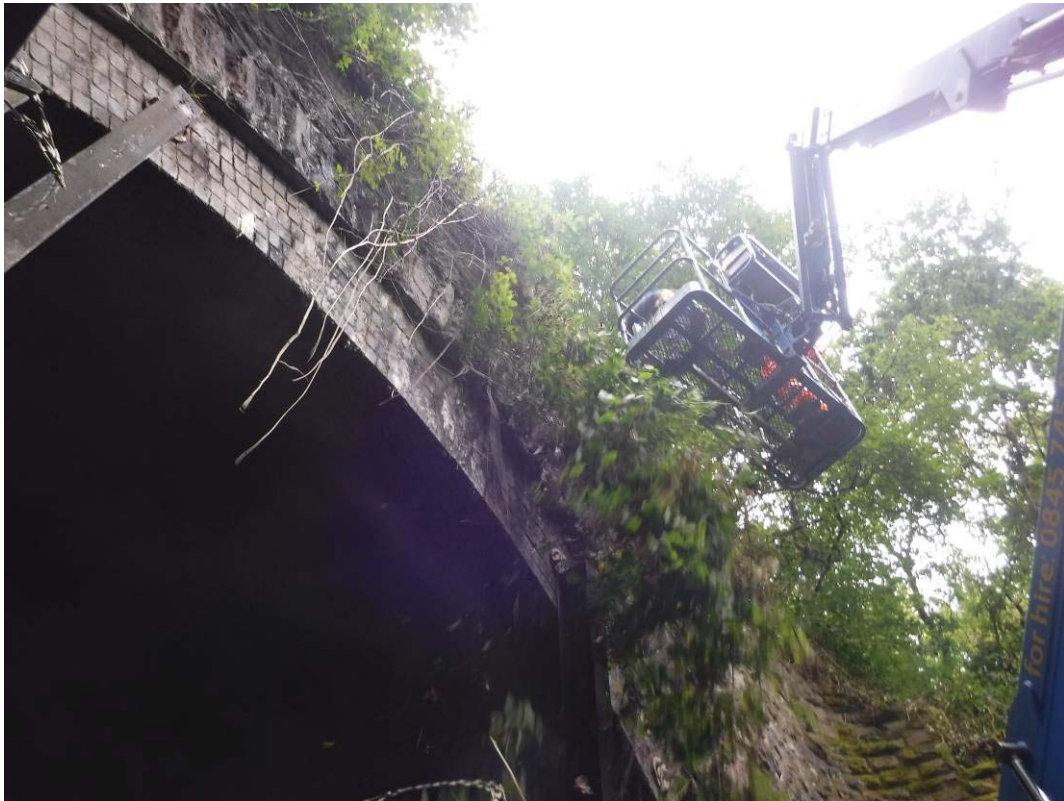
**Photo No.11:** Southwest Portal, Stonework, Vegetation. DURING WORKS - Removing vegetation.

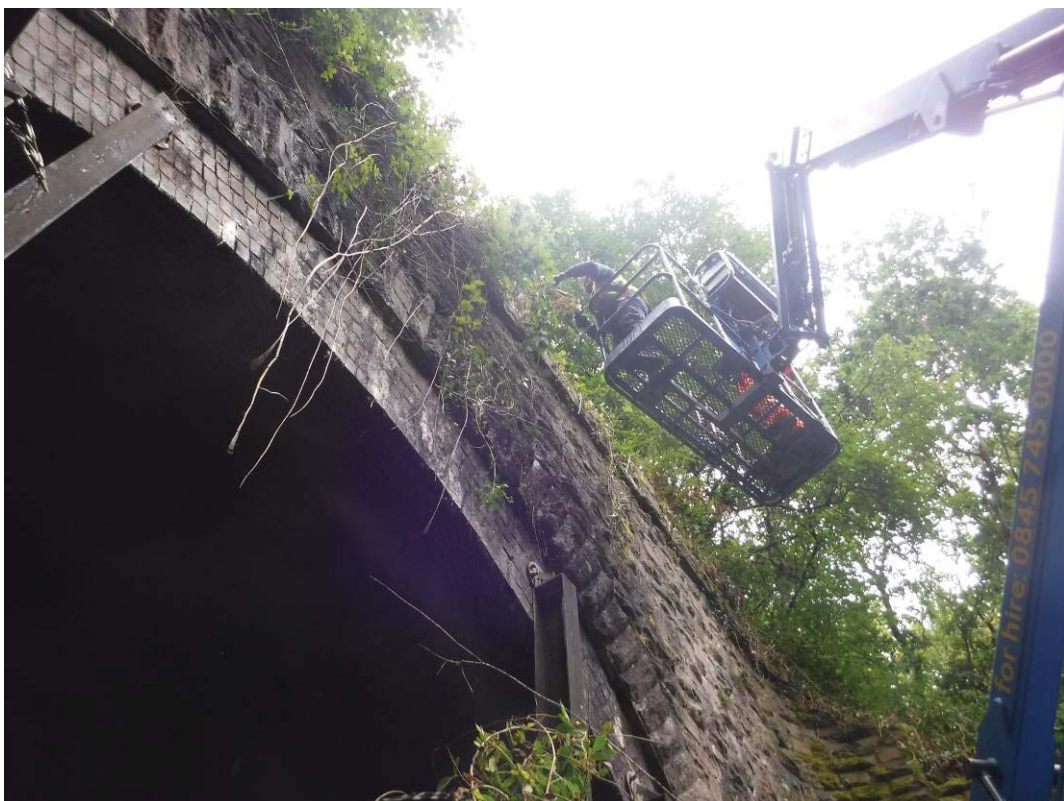
**Photo No.12:** Southwest Portal, Stonework, Vegetation. DURING WORKS - Removing vegetation.

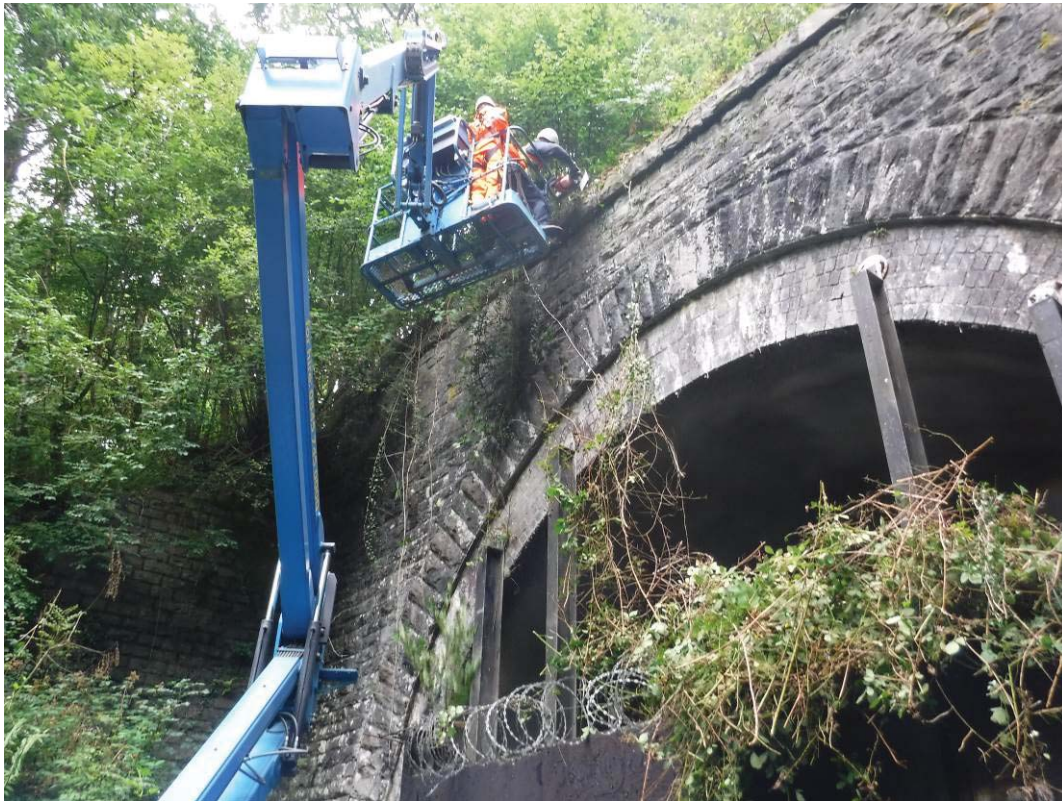
**Photo No.13:** Southwest Portal, Stonework, Vegetation. DURING WORKS - Removing vegetation.

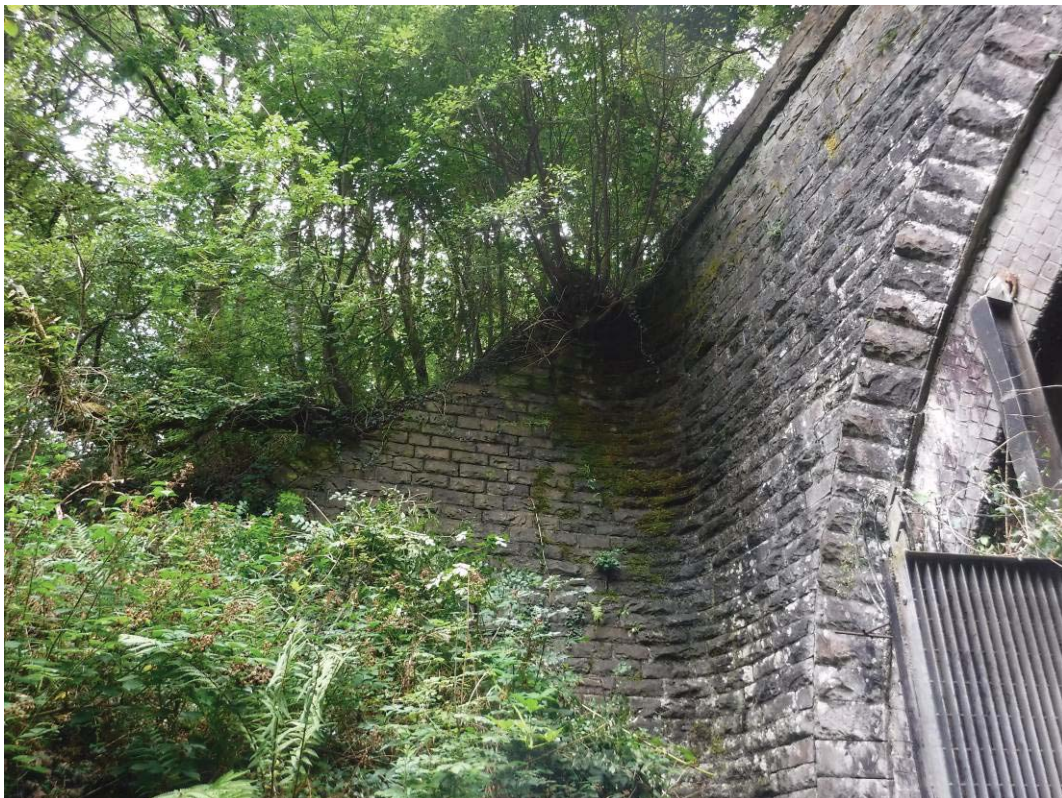
**Photo No.14:** Southwest Portal, Stonework, Vegetation. AFTER WORKS - only moss & lichens remain on stonework.

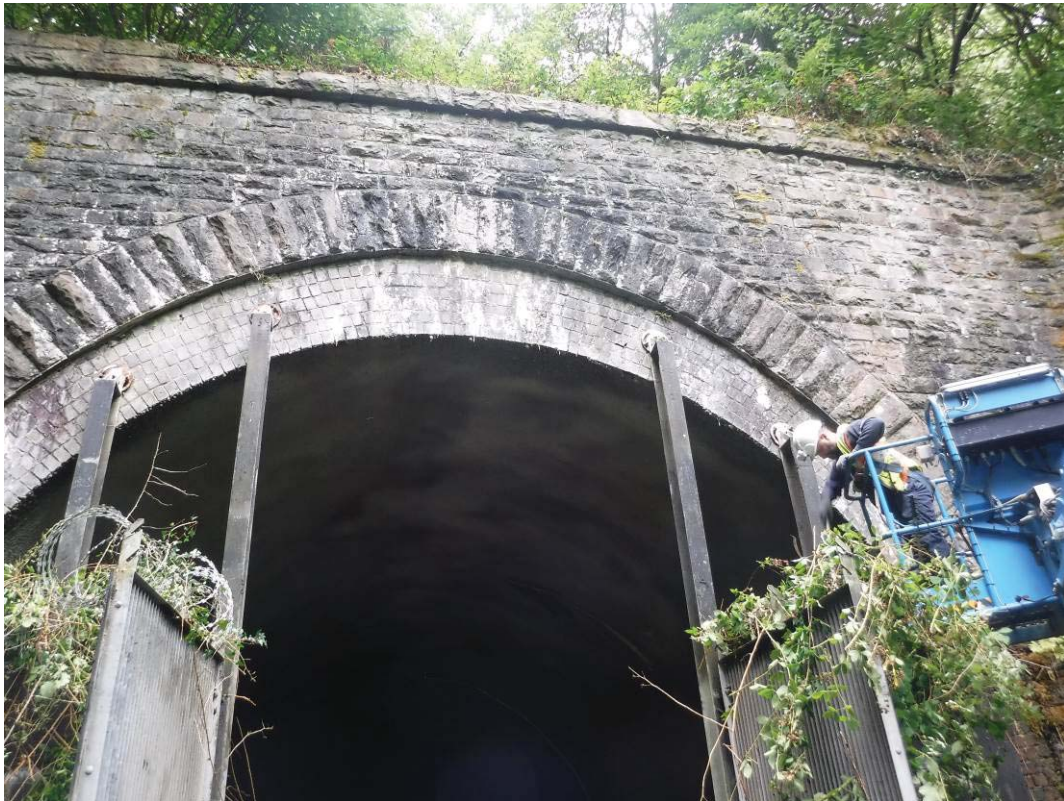
**Photo No.15:** Southwest Portal, Stonework, Vegetation. AFTER WORKS - only moss & lichens remain on stonework.

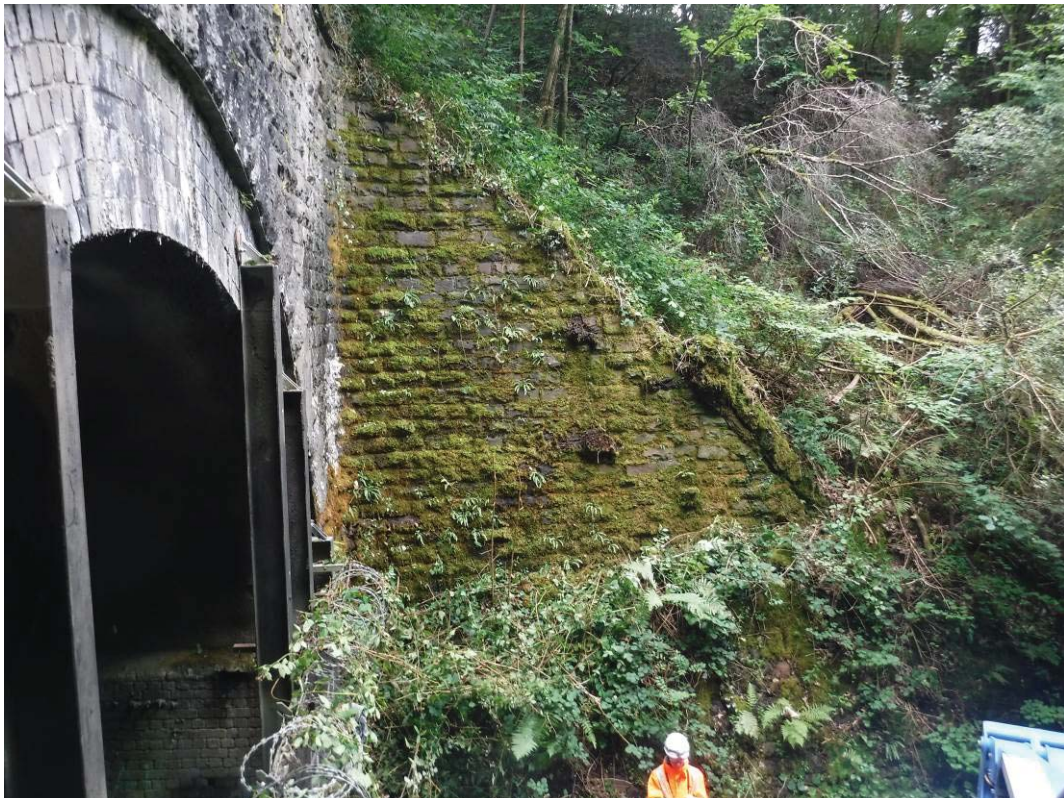
**Photo No.16:** Southwest Portal, Stonework, Vegetation. AFTER WORKS - only moss & lichens remain on stonework.
