**TUNNEL EXAMINATION REPORT  
PHOTOGRAPHS OF STRUCTURE**

ELR : PTP Br. No. : 00

Mileage : 05 M 08 Ch Sheet 1 of 15

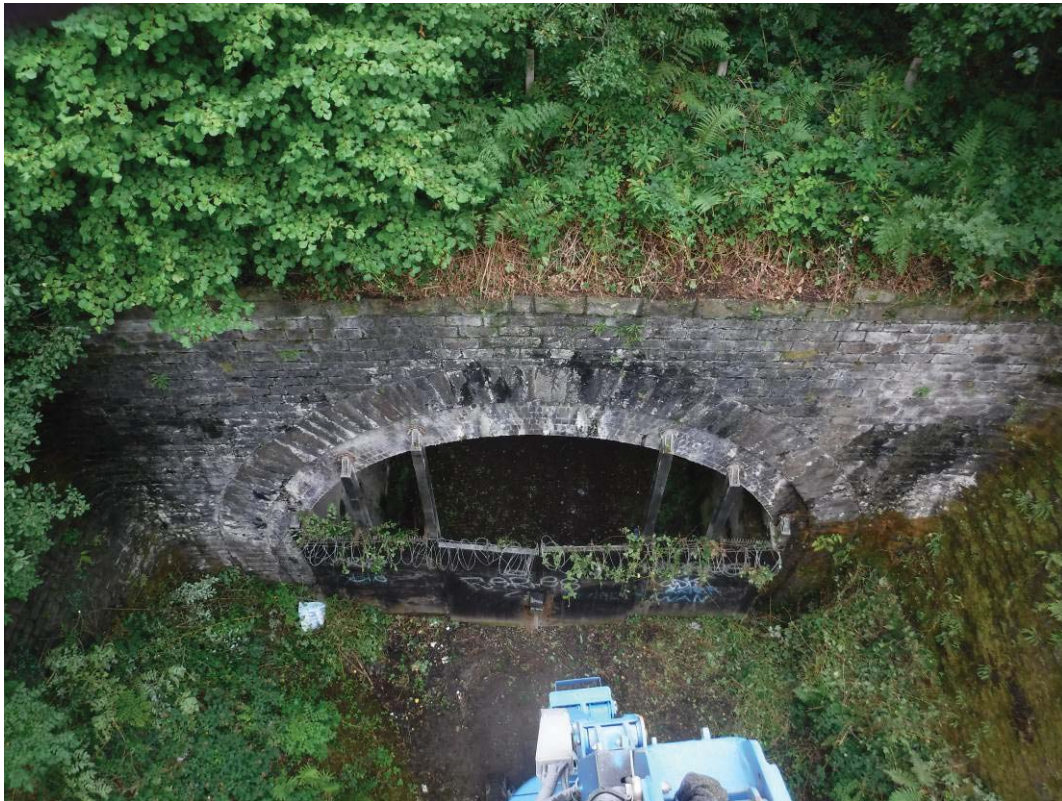
**Photo No.29:** Southwest Portal, Stonework, build up of rotting vegetation detritus adding load to the rear of the spandrel and hiding the buried drainage channel. (if built).

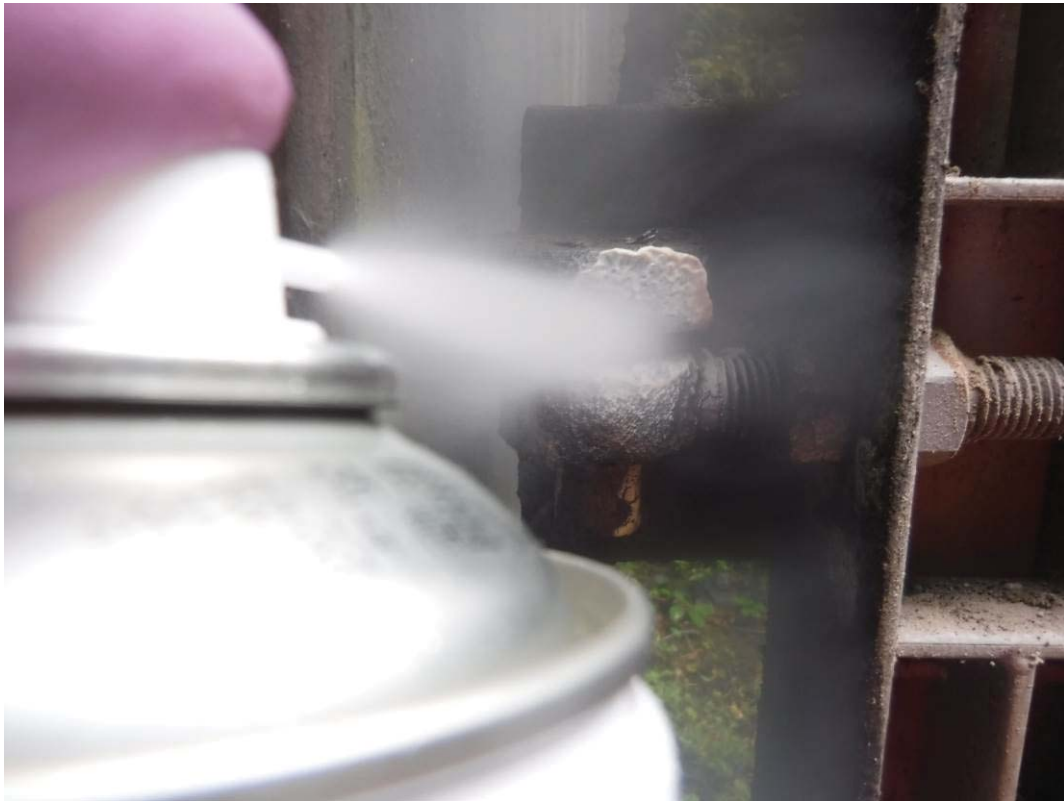
**Photo No.33:** Southwest Portal, oiling hinges.

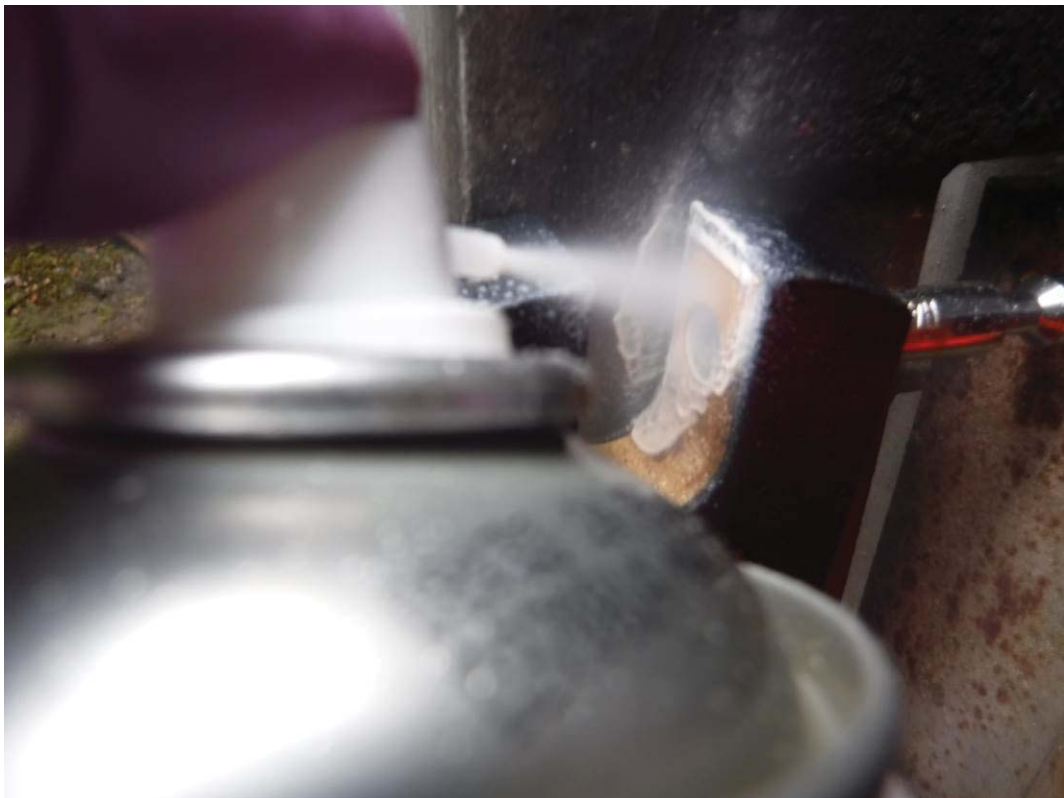
**Photo No.34:** Southwest Portal, oiling padlock.

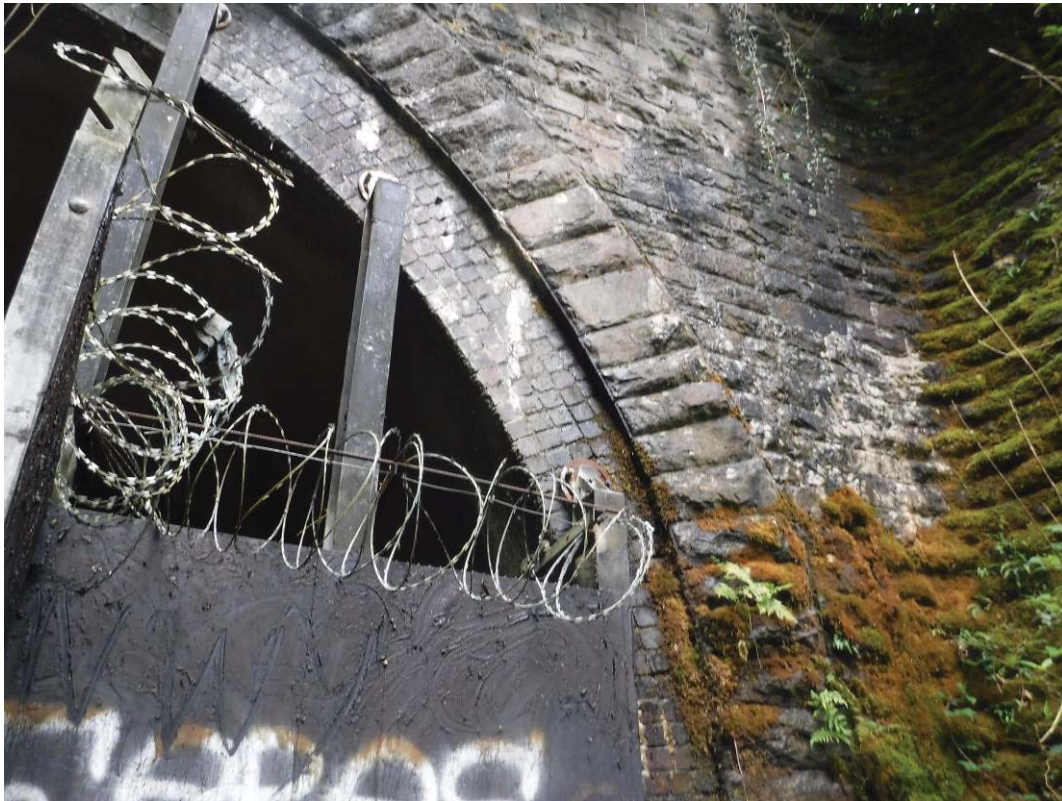
**Photo No.39:** 000+00 to 001+12 Crown & Haunch Up & Down, Arch relined in brickwork (archaic) and then recently strengthened with sprayed concrete.

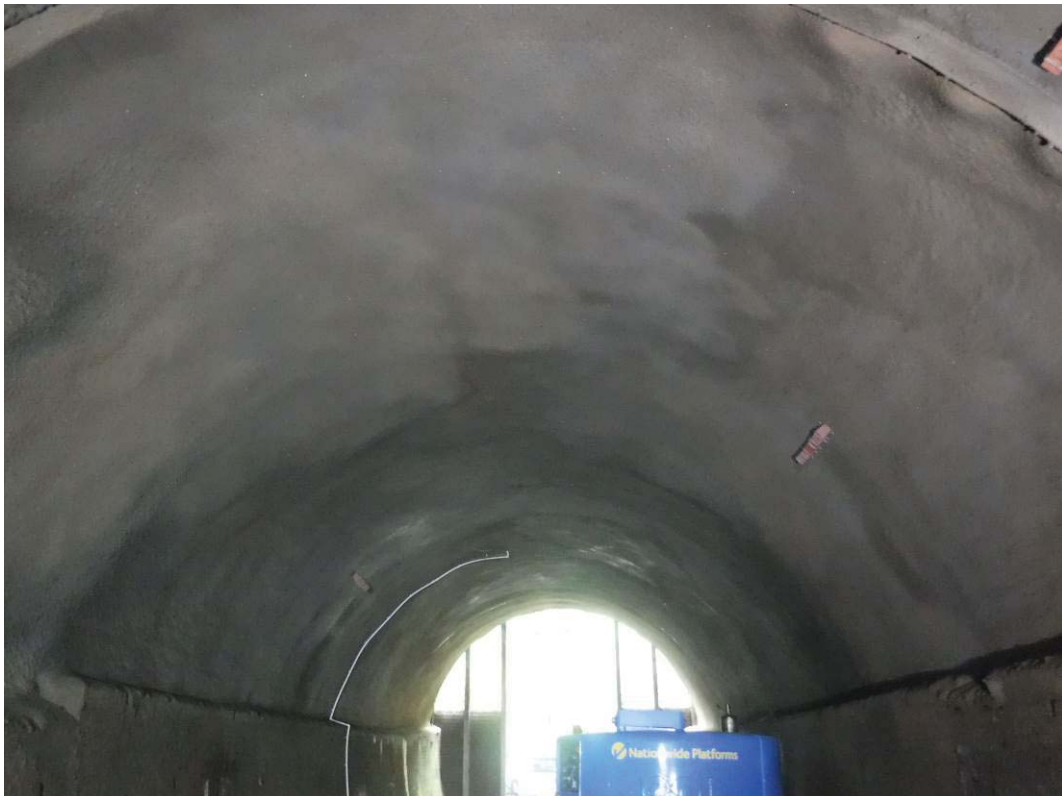
**Photo No.40:** 000+00 to 001+12 Crown & Haunch Up & Down, Arch relined in brickwork (archaic) and then recently strengthened with sprayed concrete.

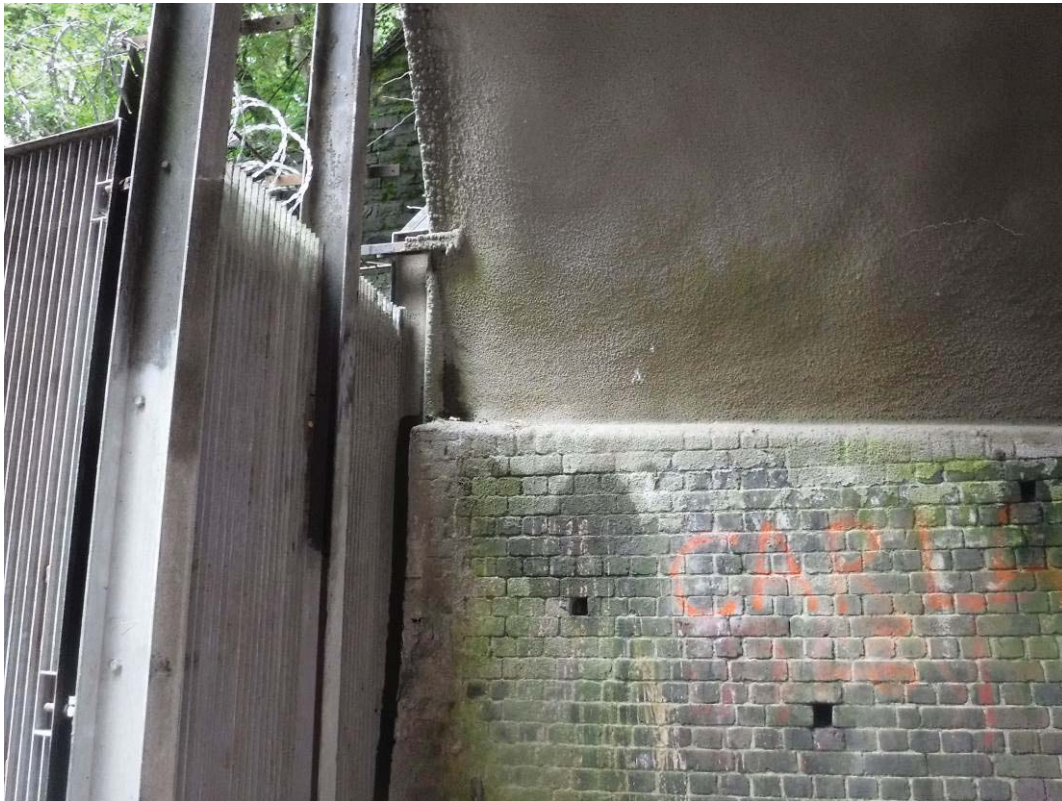
**Photo No.41:** 000+00 to 001+12 Sidewalls Up & Down, Relined in brickwork (archaic) and then strengthened with 3 or 4 course brickwork buttresses, height c.8ft (archaic).

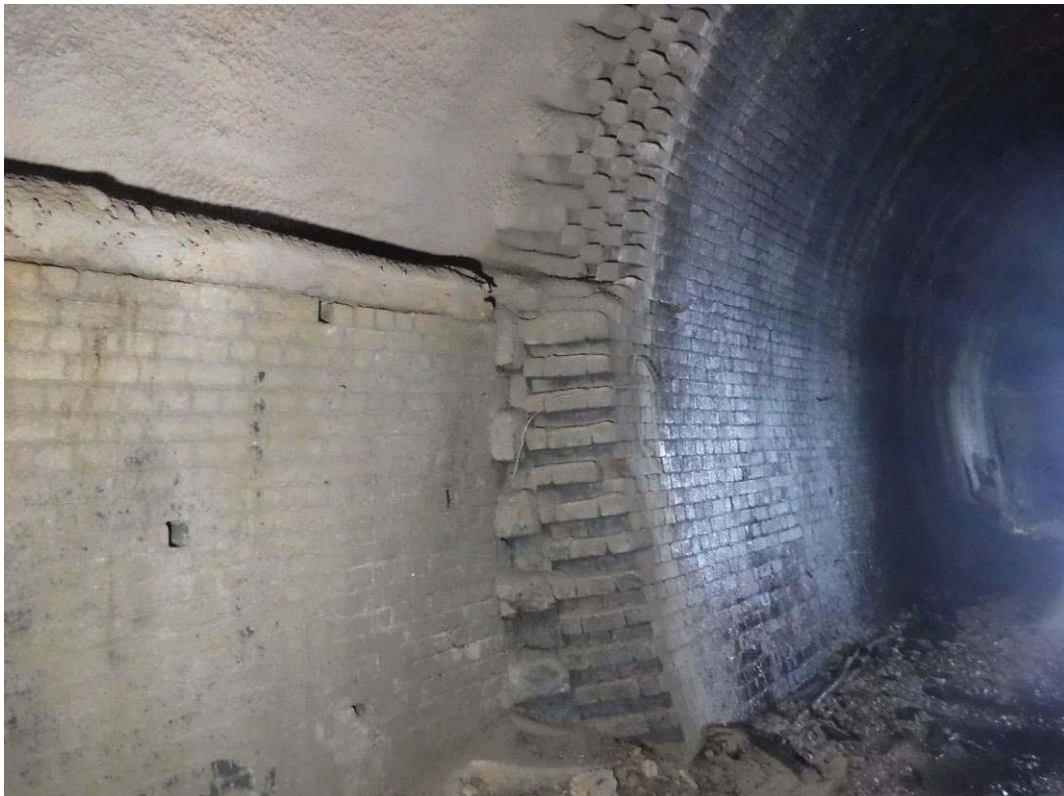
**Photo No.44:** 001+12 to 007+09 Full Profile Up & Down, Change in profile. Arch relined by a further 5course brickwork.

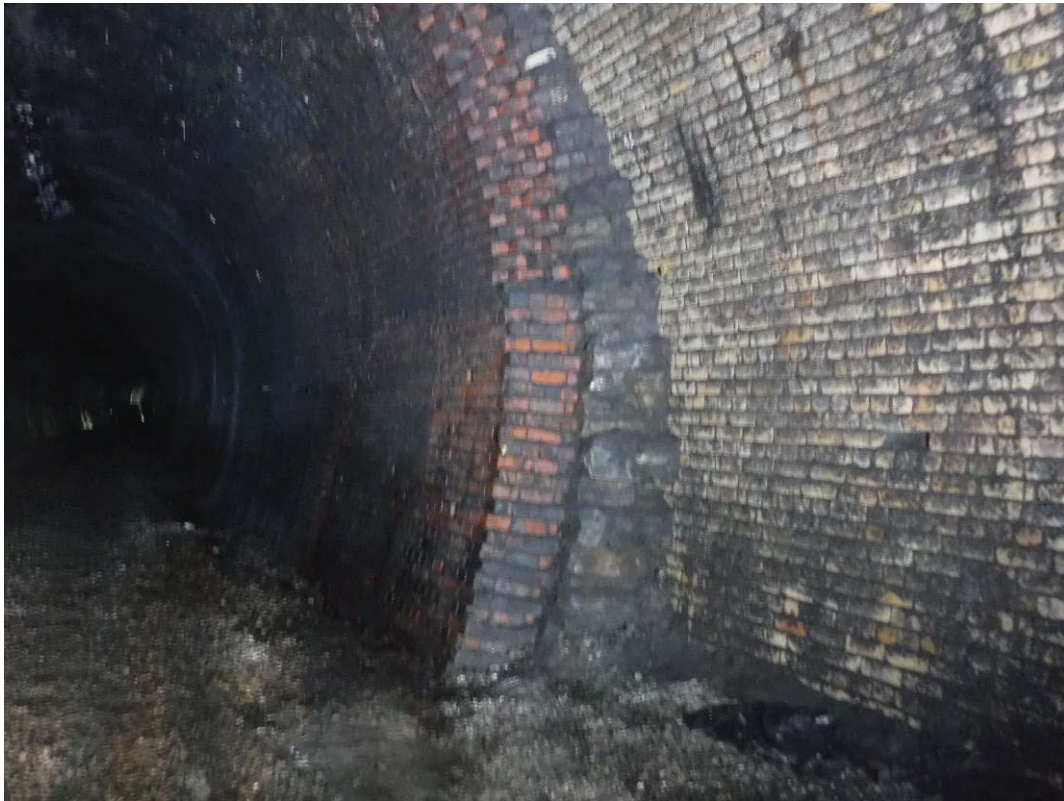
**Photo No.49:** 007+09 to 010+04 Full Profile Up & Down, Change in profile. Possibly original lining at opening of line or 1st relining in yellow brickwork (archaic).

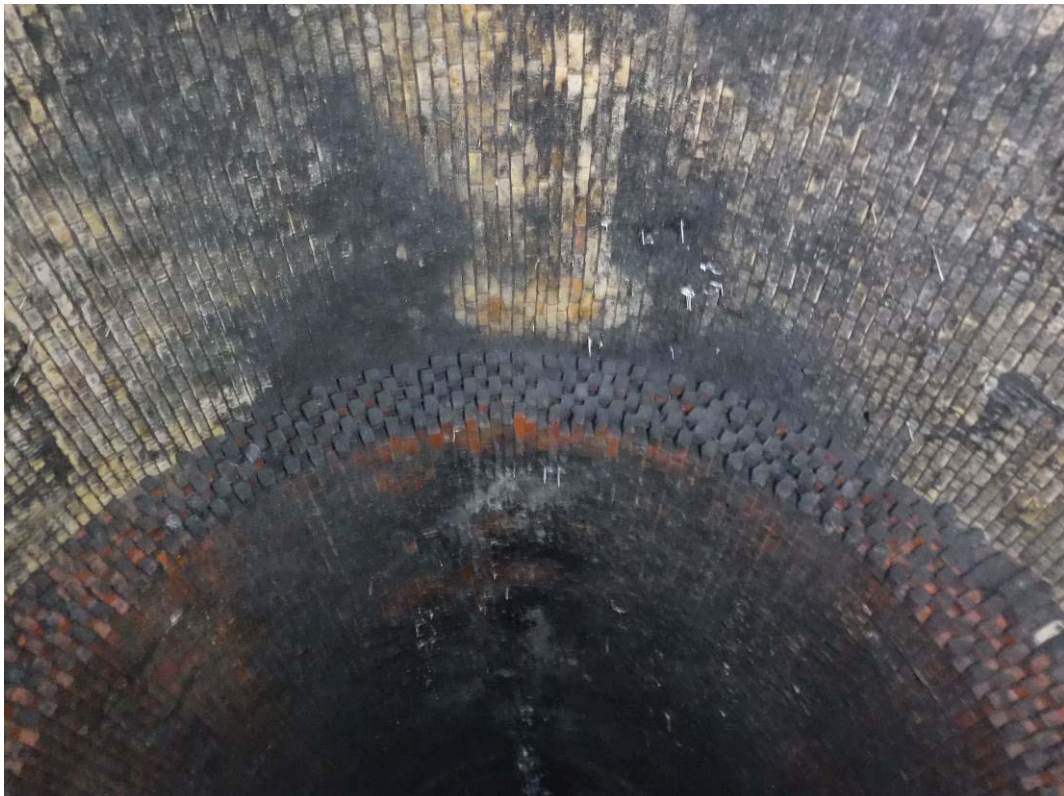
**Photo No.50:** 007+09 to 010+04 Full Profile Up & Down, Change in profile. Possibly original lining at opening of line or 1st relining in yellow brickwork (archaic).

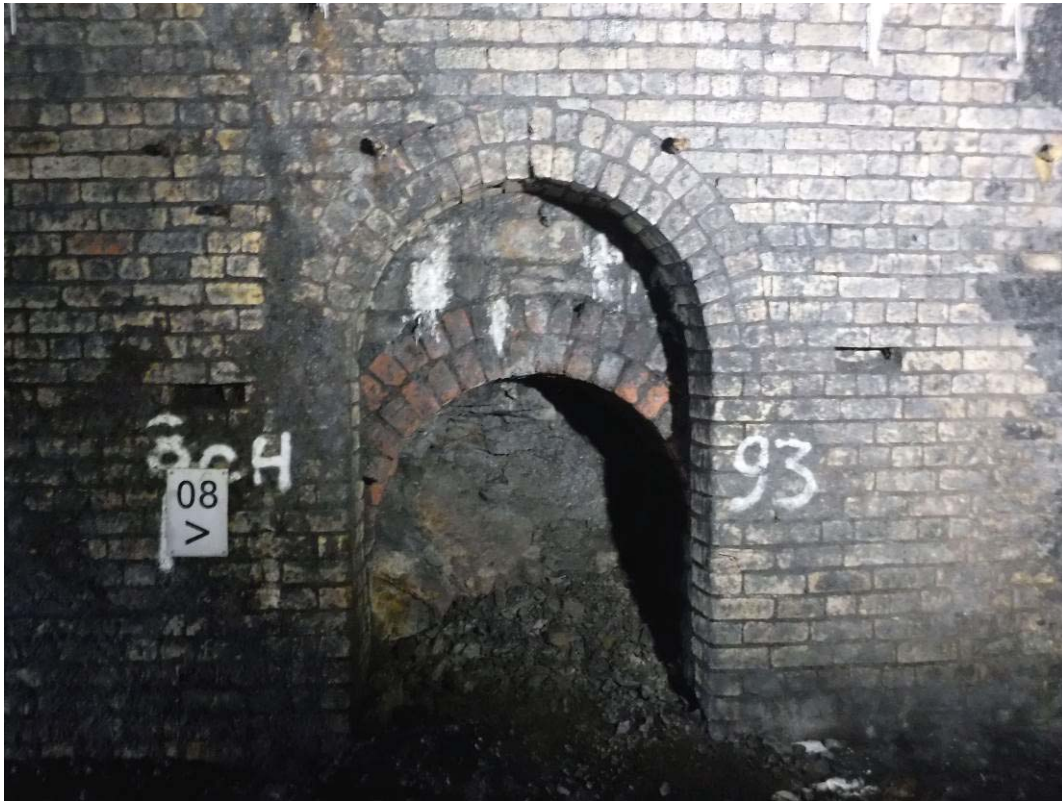
**Photo No.51:** 007+09 to 010+04 Full Profile Up & Down, Change in profile. Possibly original lining at opening of line or 1st relining in yellow brickwork (archaic).

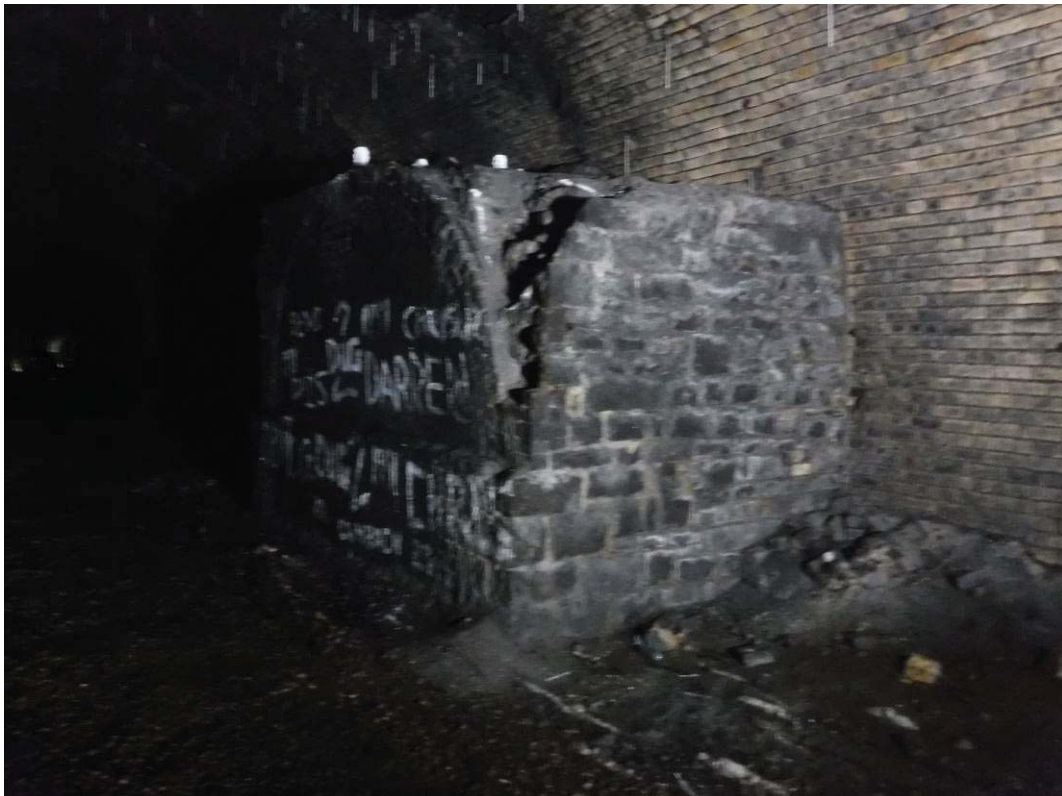
**Photo No.52:** 008+08 Sidewall Up, Old brick works cabin.

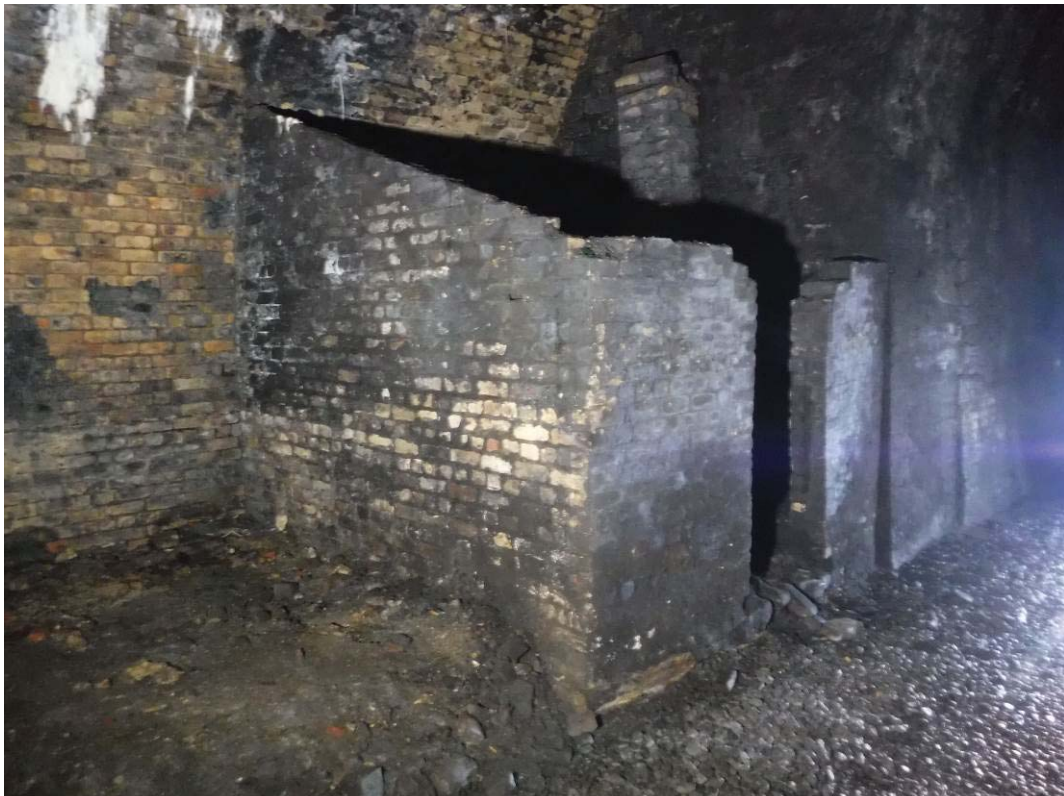
**Photo No.54:** 010+02 Sidewall Up, Old brick works cabin.

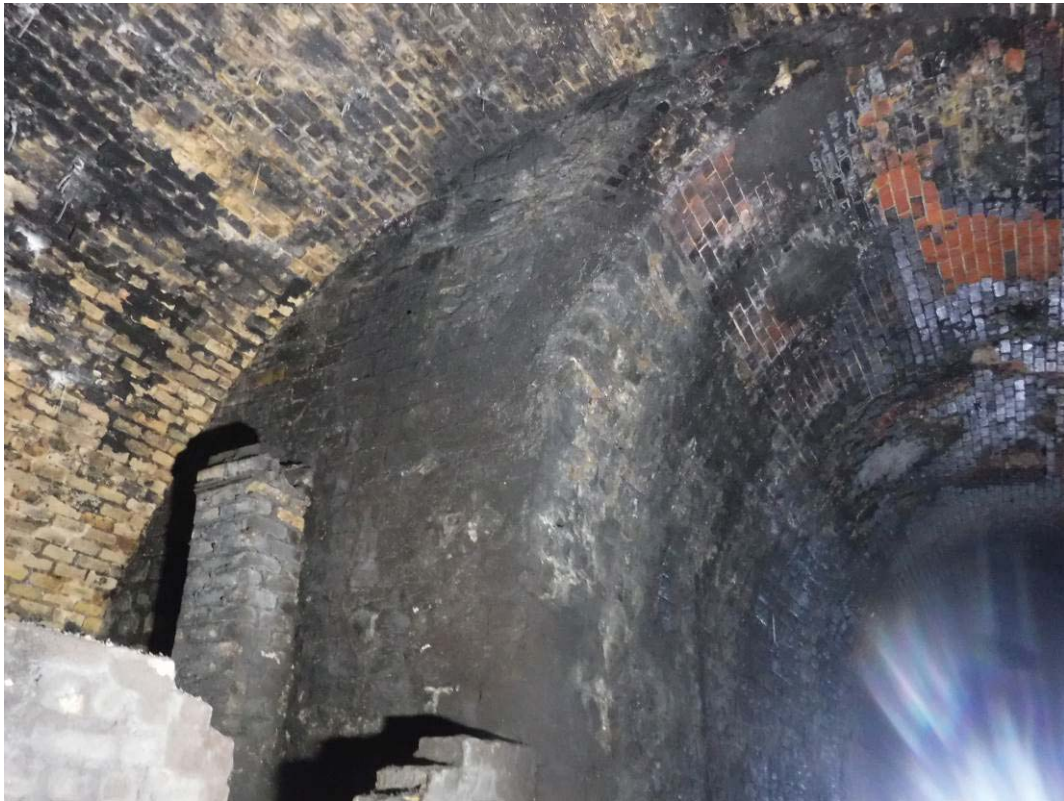
**Photo No.57:** 010+04 to 113+20 Full Profile Up & Down, Significant change in profile. Double track bore reduces to single track bore from ch.010+04 to the NE Portal.

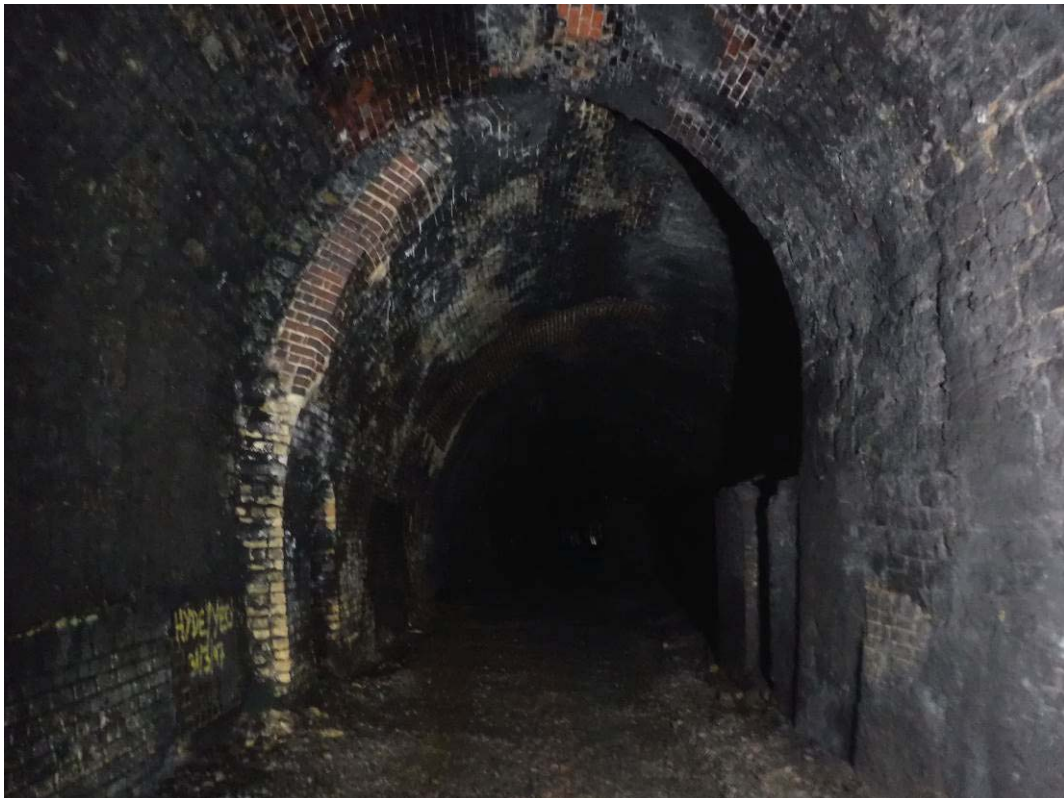
**Photo No.58:** 010+04 to 010+16 Full Profile Up & Down, Brickwork sidewall, height 4ft., stonework above to mid haunch level, brickwork high haunches and crown.

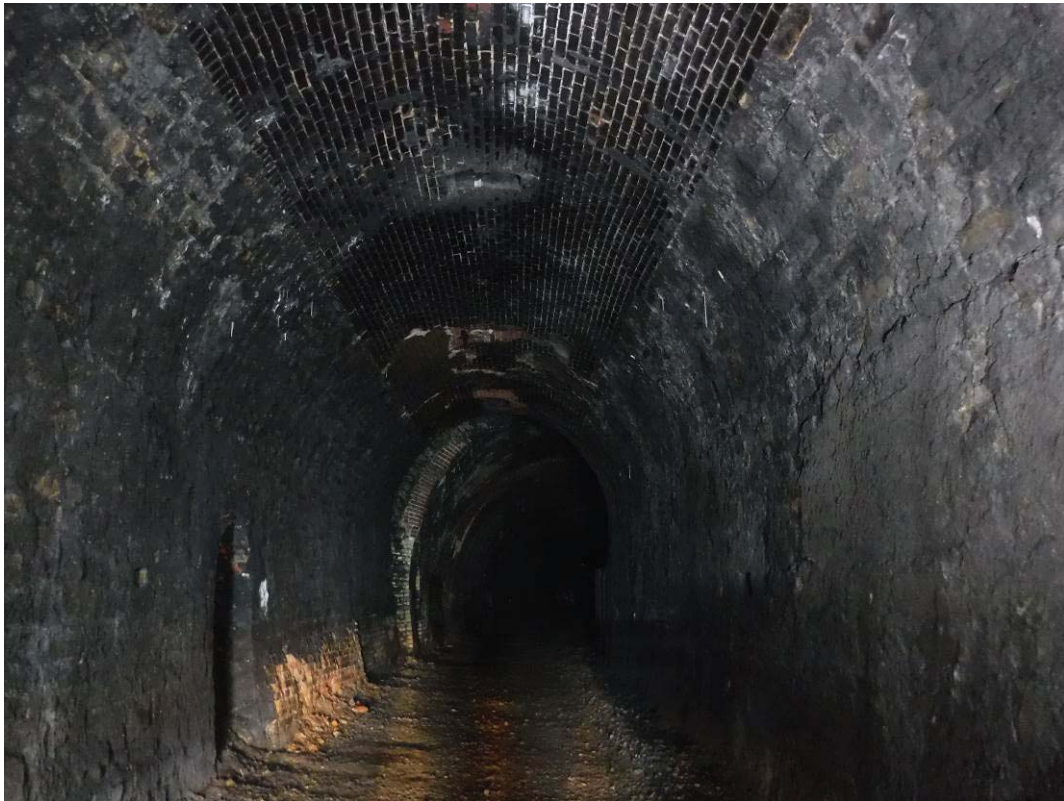
**Photo No.61:** 012+09 to 016+08 Full Profile Up & Down, Various sections repaired with brickwork. Some sections of natural rock faces.

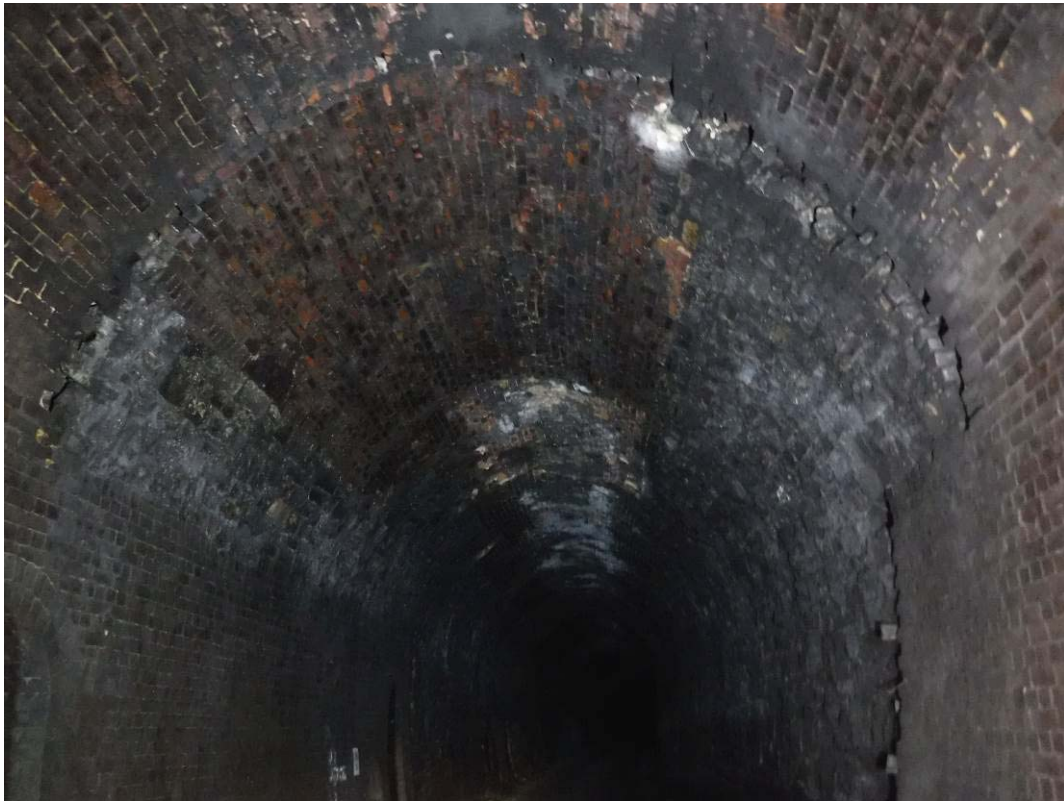
**Photo No.63:** 016+08 to 021+02 Full Profile Up & Down, Brickwork with some 6ft. high sections of stonework sidewalls.

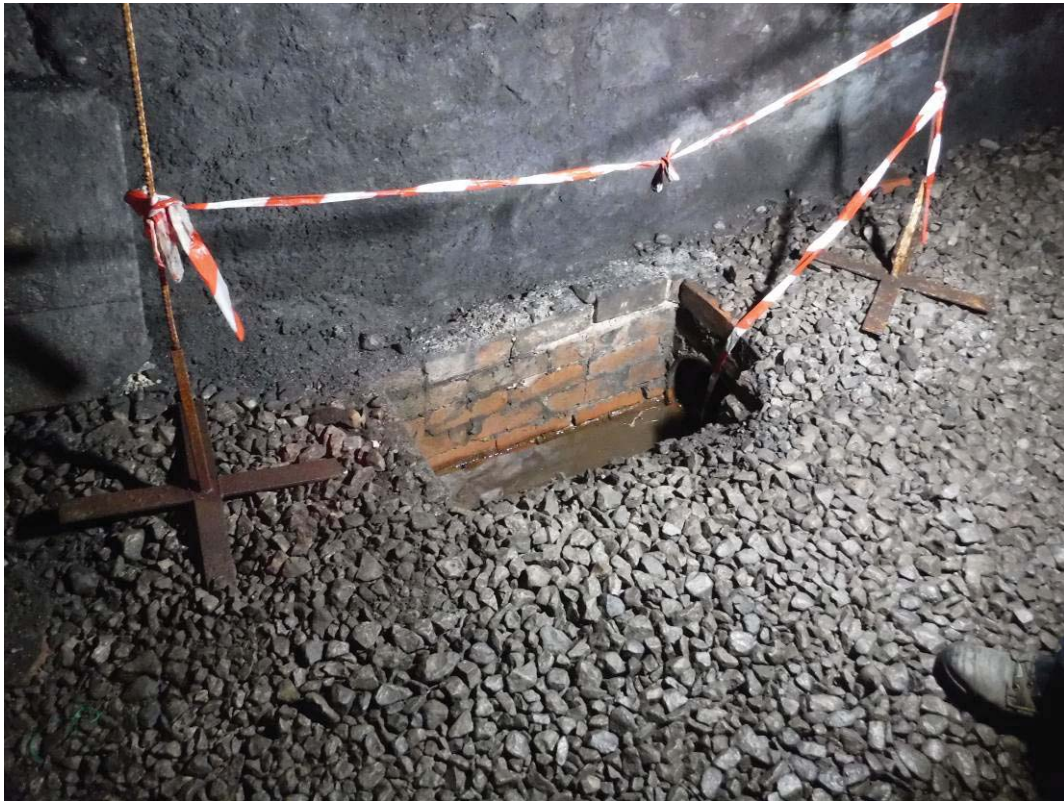
**Photo No.65:** 019+01 Cess Up, Open catch-pit.

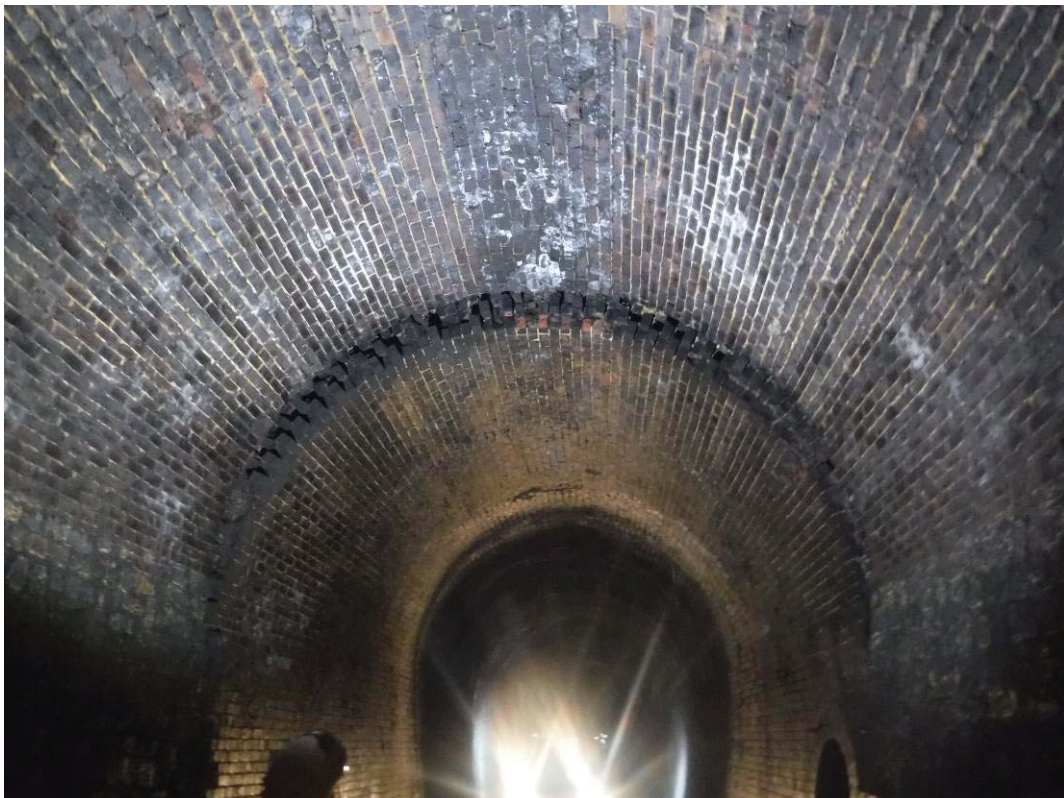
**Photo No.66:** 019+12 to 021+02 Crown & Haunch Up & Down, Change in profile. Step in arch at ch.019+12 where bore reduces by 2.5courses brickwork on edge at apex from this point towards the NE.

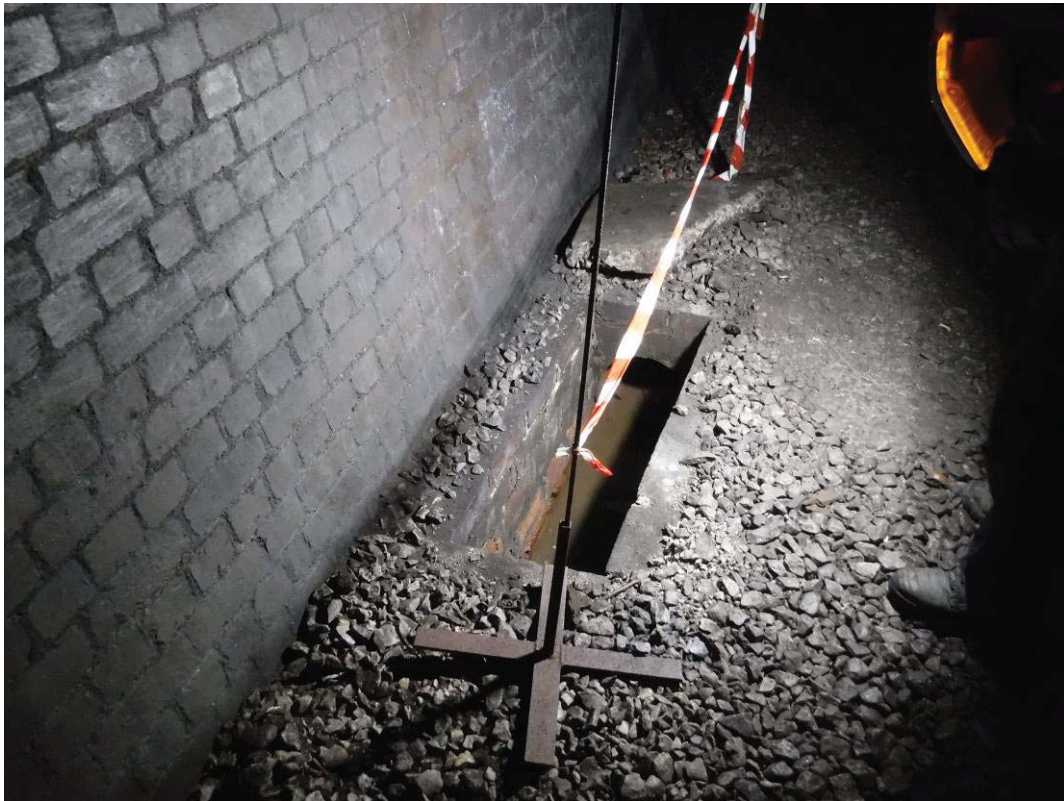
**Photo No.67:** 019+13 Cess Up, Open catch-pit.

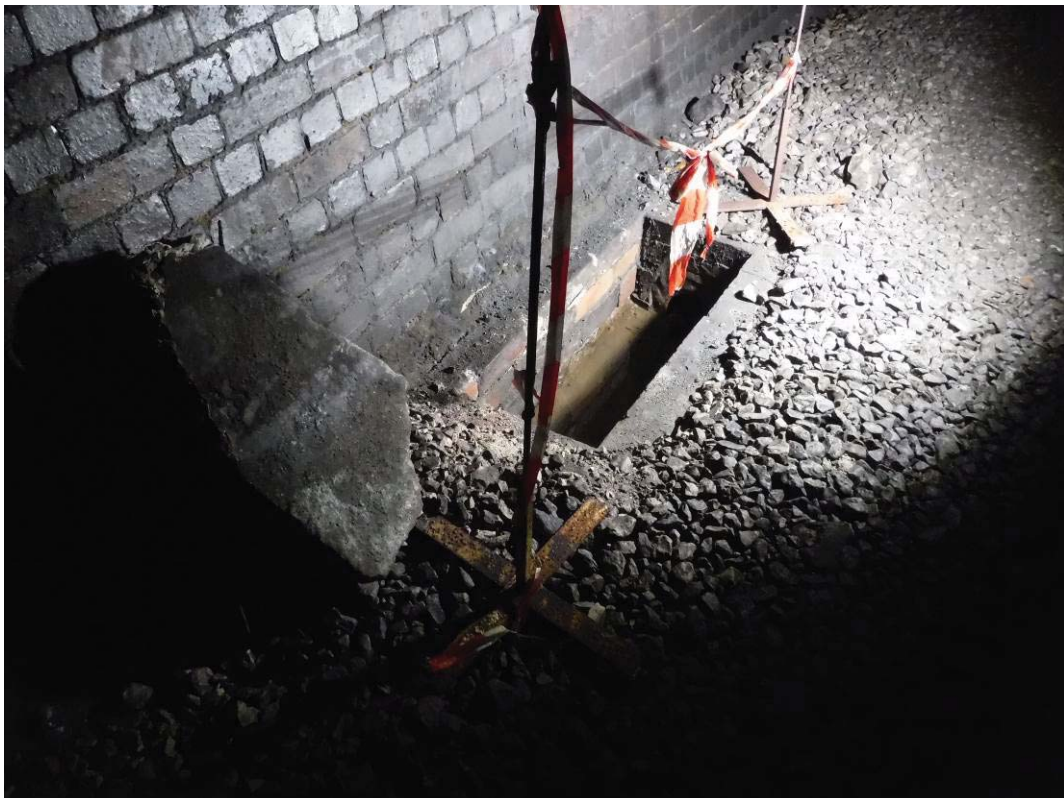
**Photo No.68:** 020+14 Cess Up, Open catch-pit.

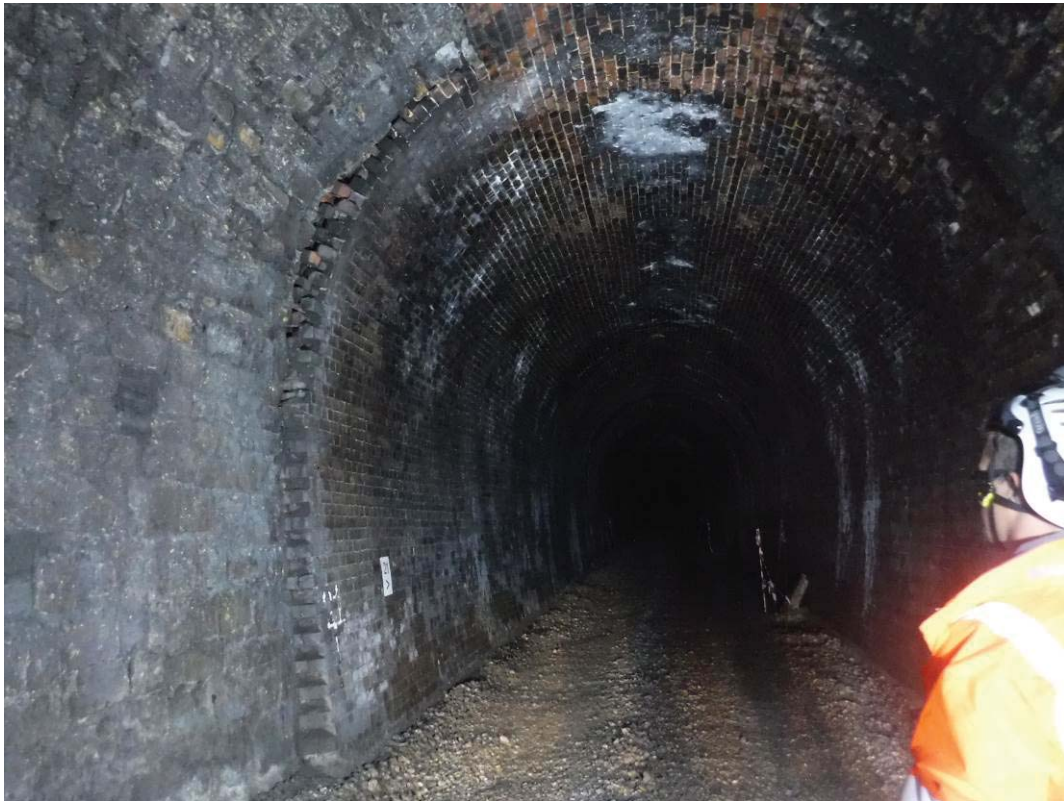
**Photo No.69:** 021+02 to 025+00 Sidewalls & Haunch Down,. Change in profile. Lining steps out at ch.021+02 by max. 2courses brickwork at base of sidewall from this point towards the NE.

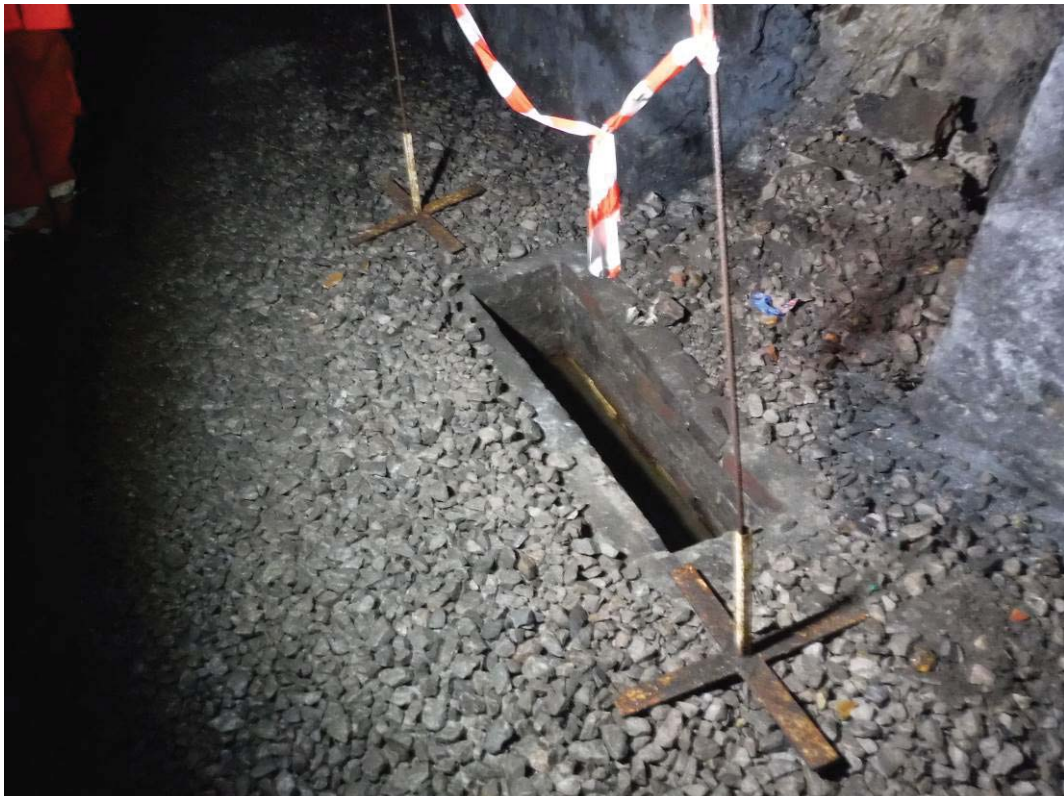
**Photo No.70:** 021+15 Cess Up, Open catch-pit.

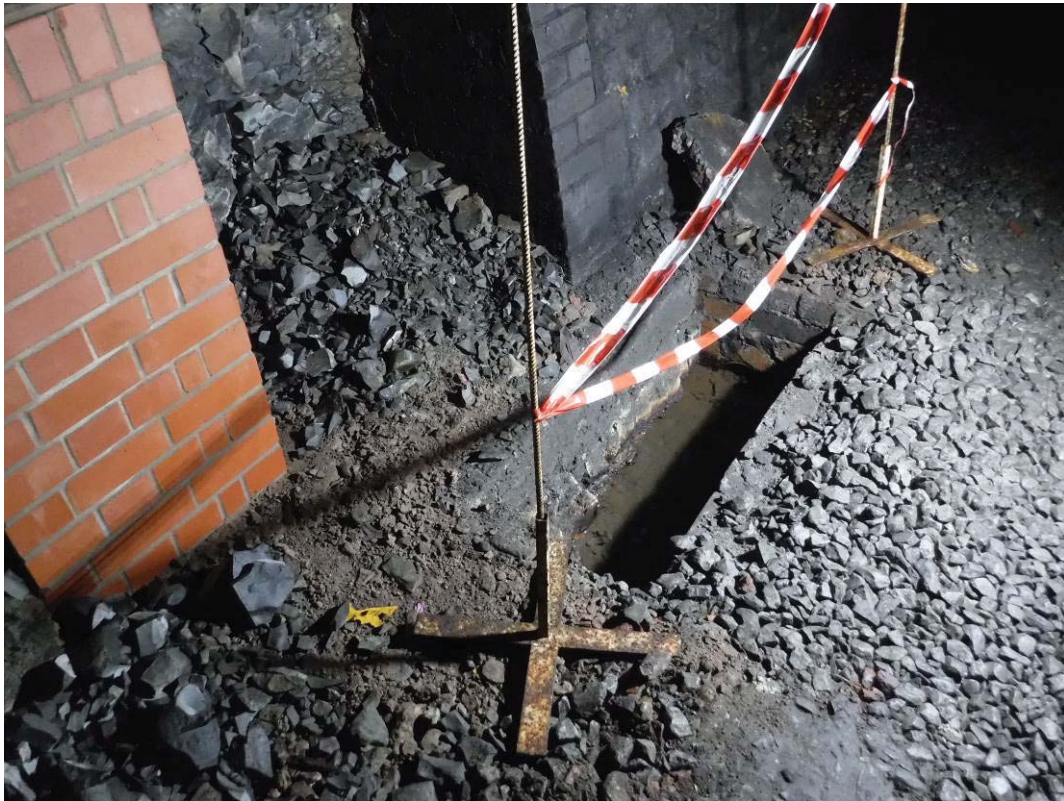
**Photo No.71:** 022+16 Cess Up, Open catch-pit.

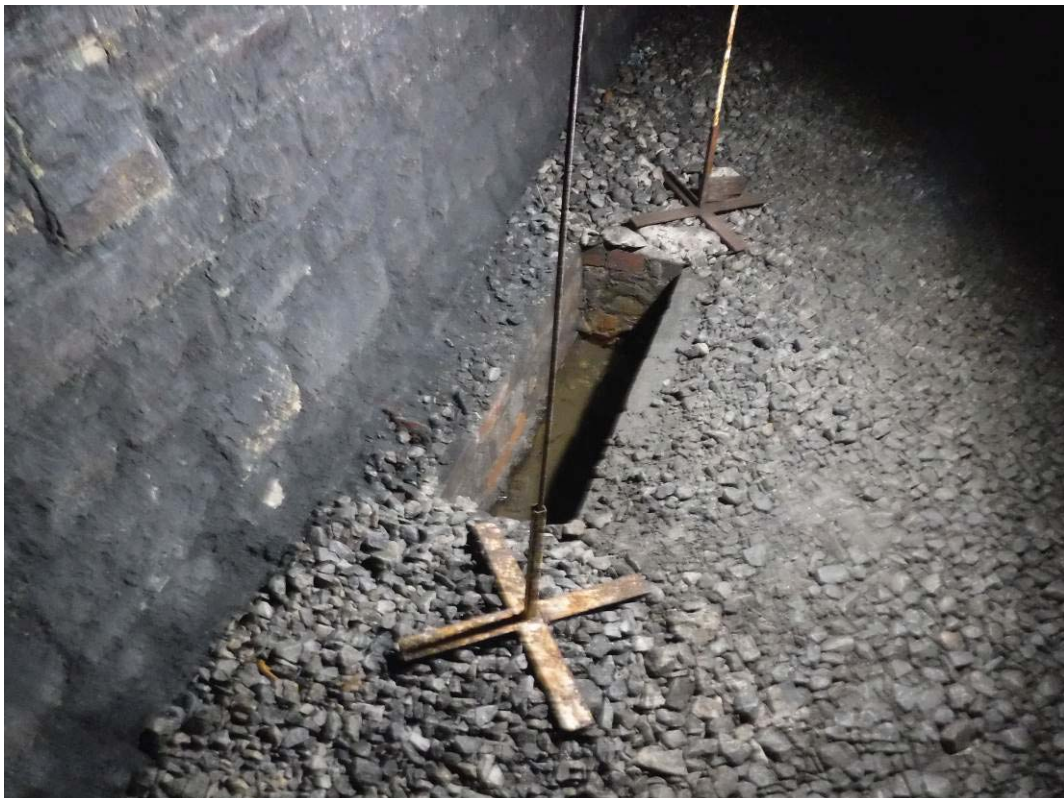
**Photo No.72:** 023+14 Cess Up, Open catch-pit.

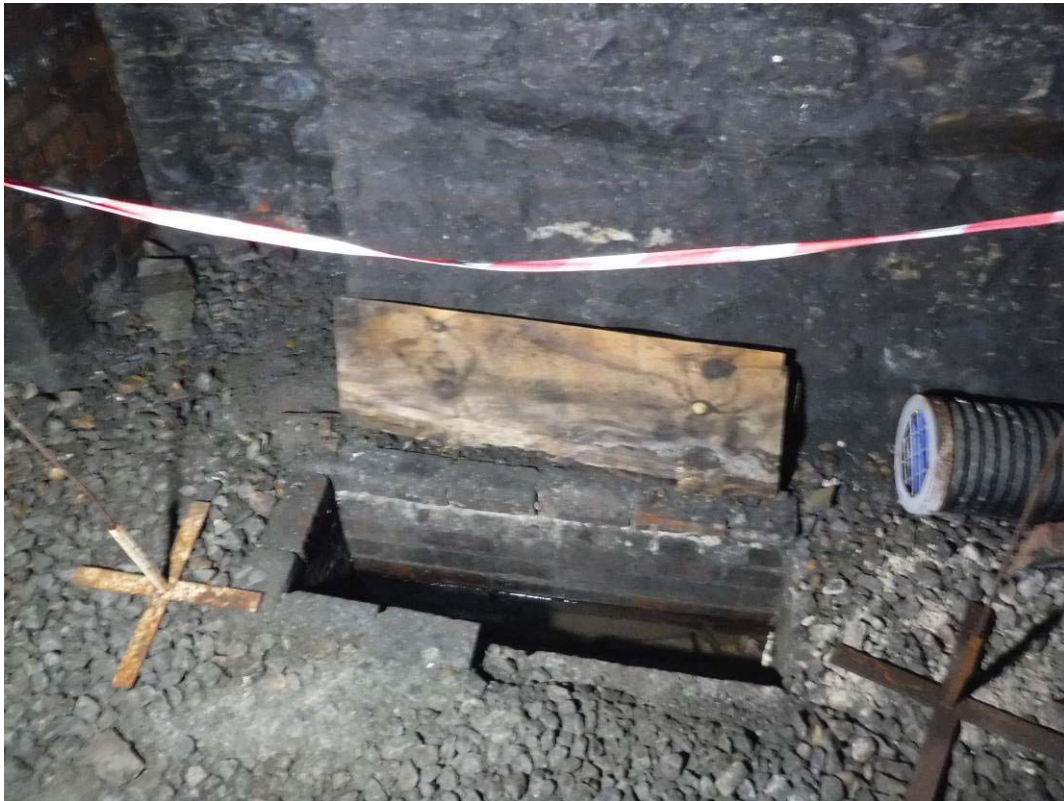
**Photo No.73:** 024+16 Cess Up, Open catch-pit.

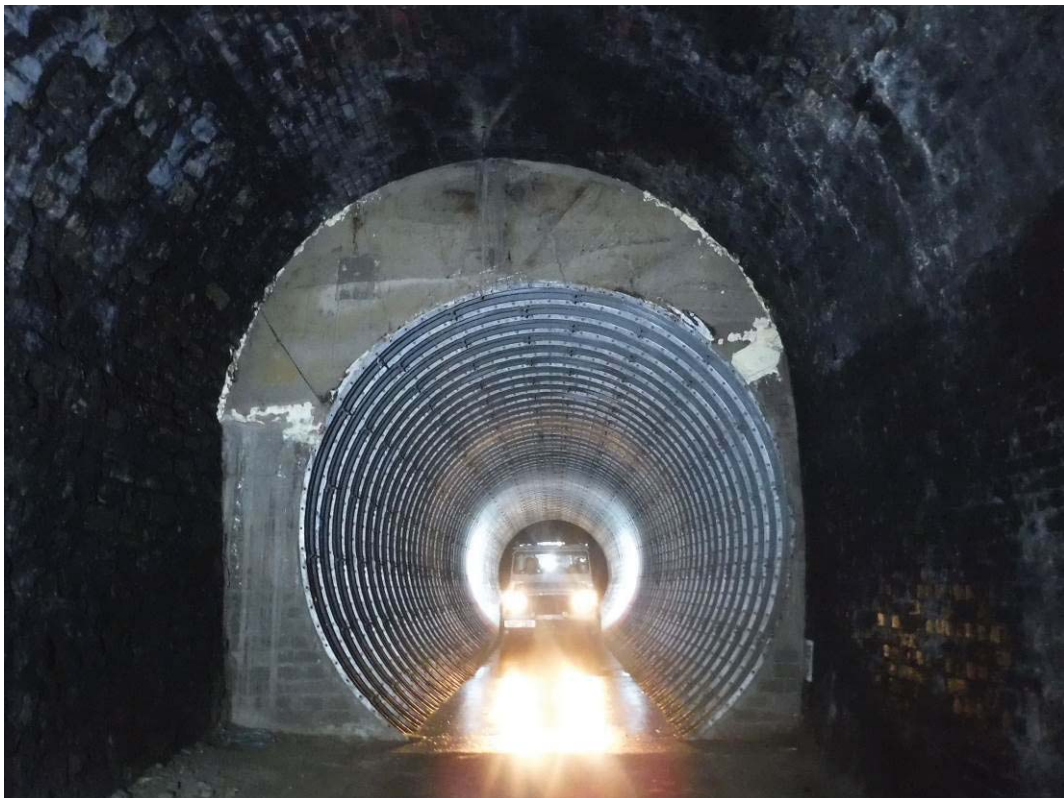
**Photo No.74:** 025+00 to 026+05 Full Profile Up & Down, New corrugated galvanised steel tube fitted to support lining under a possible hidden shaft.
