**TUNNEL EXAMINATION REPORT  
PHOTOGRAPHS OF STRUCTURE**

ELR : PTP Br. No. : 00

Mileage : 05 M 08 Ch Sheet 1 of 15

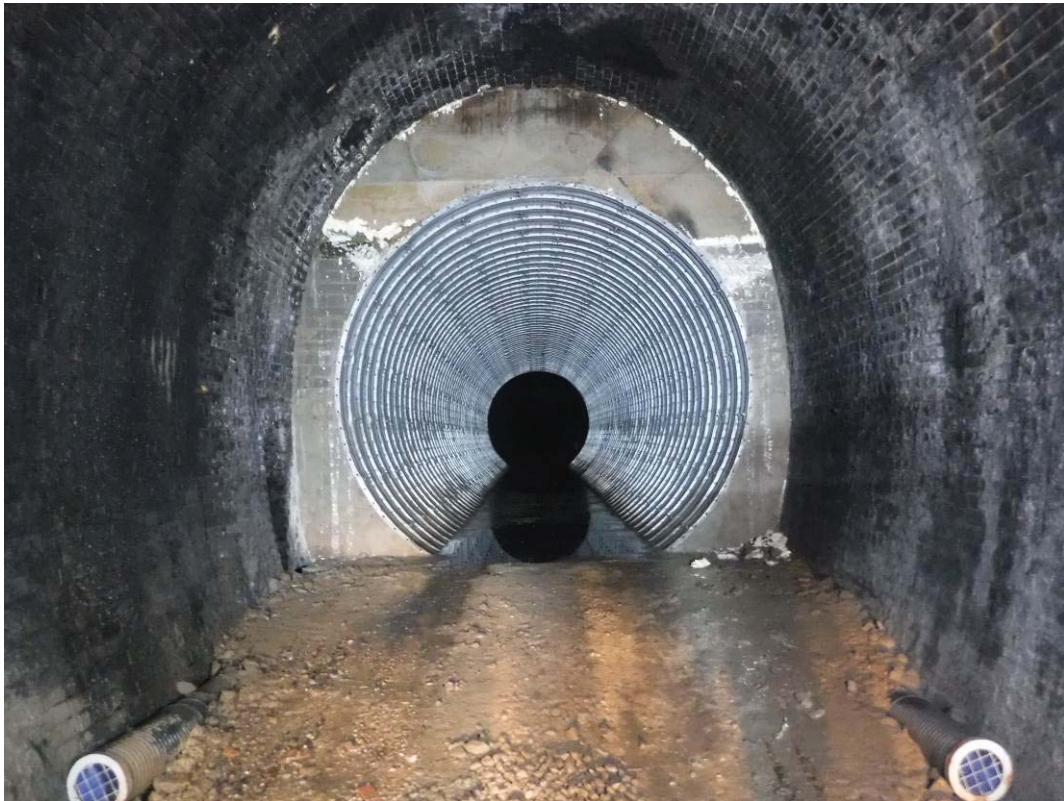
**Photo No.75:** 025+00 to 026+05 Full Profile Up & Down, New corrugated galvanised steel tube fitted to support lining under a possible hidden shaft.

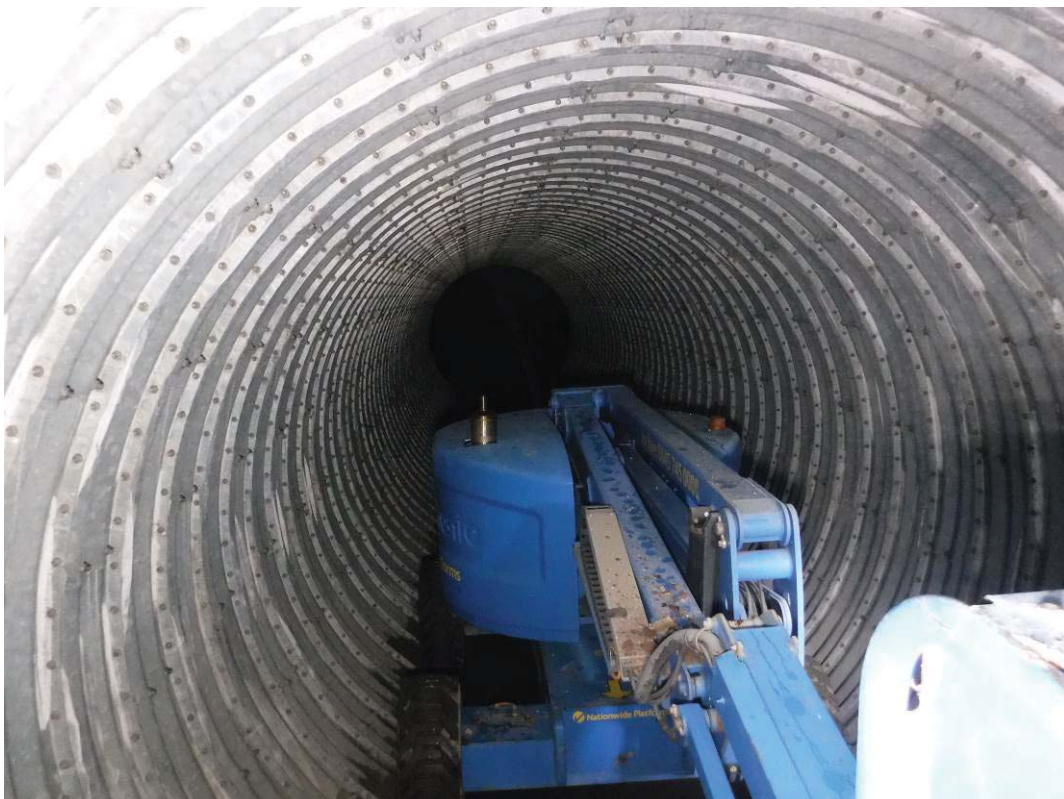
**Photo No.76:** 025+00 to 026+05 Full Profile Up & Down, New corrugated galvanised steel tube fitted to support lining under a possible hidden shaft.
